Accessibility Survey

City of Downey Arnett Street - Downey Avenue to Mcgovern Avenue

Date of Inspection
6/13/2017

Disability Access Consultants

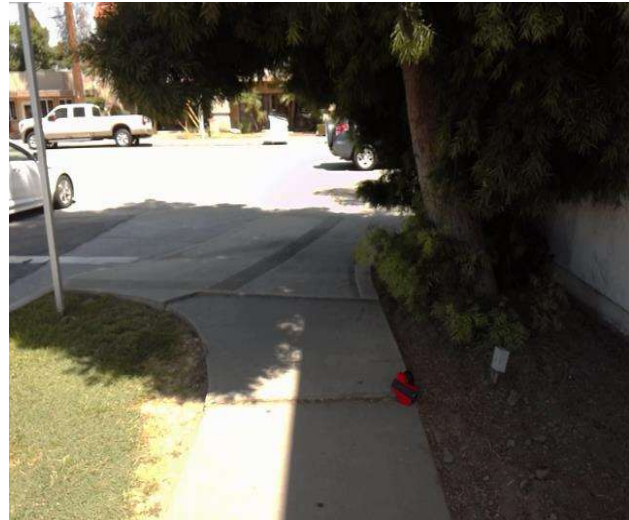
Change in Level West of Downey Avenue @ 33.937286227566, -118.135115951300

Sidewalks , Change in Level : Change in Level Non Beveled

There is a change in elevation greater than recommended value.

On-Site Finding 1.75 inches

Ensure that the change in elevation is within the recommended value.

Recommendation Up to 0.25 inches

Remove tripping hazards \$198

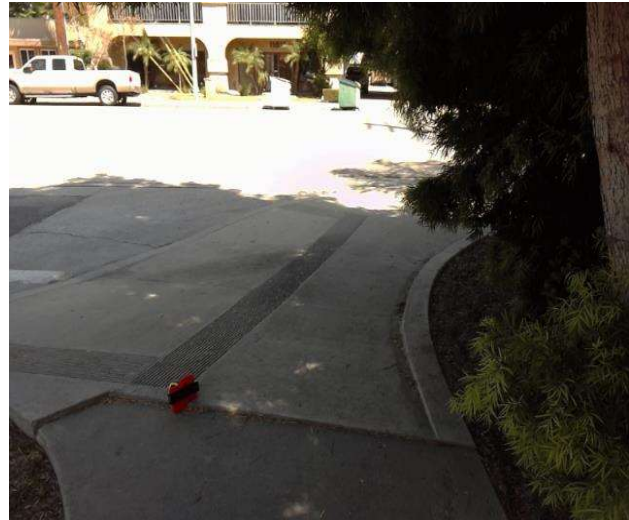
Change in Level West of Downey Avenue @ 33.937275101104, -118.135103881359

Sidewalks , Change in Level : Change in Level Non Beveled

There is a change in elevation greater than recommended value.

Ensure that the change in elevation is within the recommended value.

Recommendation Up to 0.25 inches

Remove tripping hazards \$198

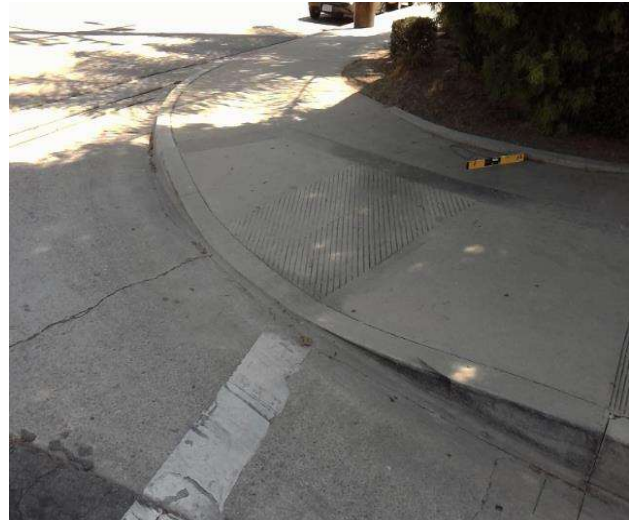
Curb Ramp , Landings and Transitions : Top Landing Slope

Recommendation Up to 2.08 percent

Provide compliant landing \$1,260

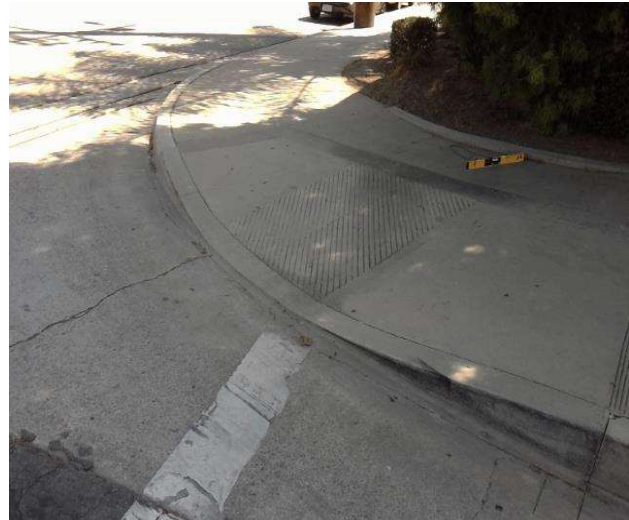
Curb Ramp , Landings and Transitions : Top Landing Clear Length - Landings

Recommendation At least 48.00 inches

Provide compliant landing \$240

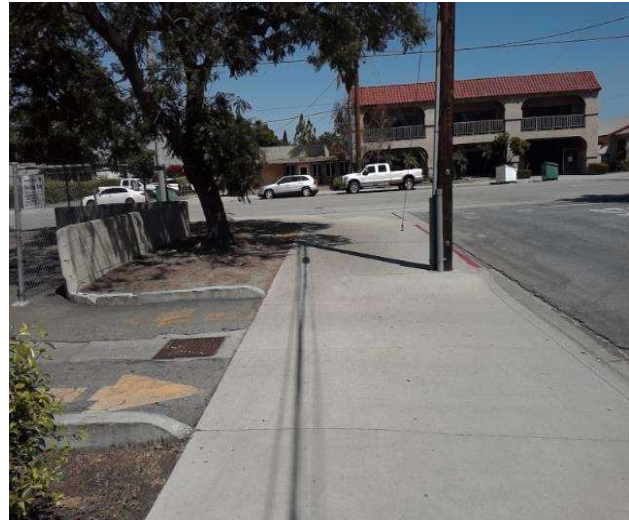
On-Site Finding Not Found

Install compliant detectable warnings \$190

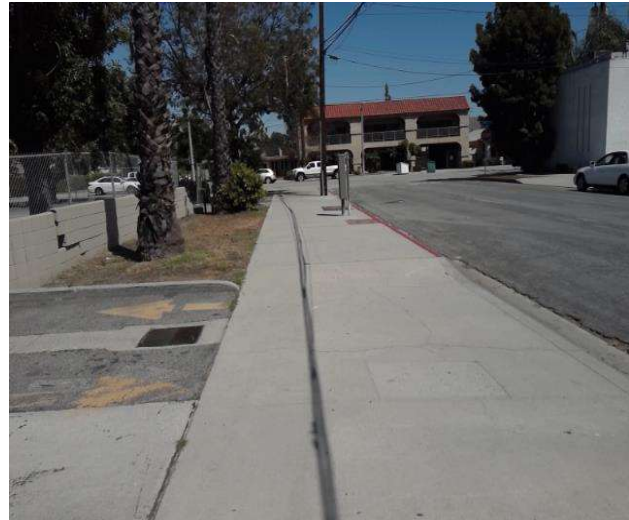
On-Site Finding Not Found

Install compliant detectable warnings \$190

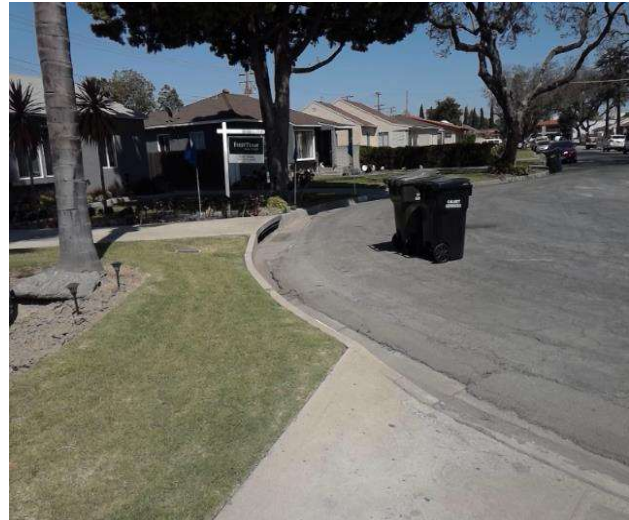
Sidewalks : Missing Sidewalk

Section of sidewalk is missing and consists of dirt, grass or gravel.

Provide a compliant sidewalk for the missing section.

\$1,260

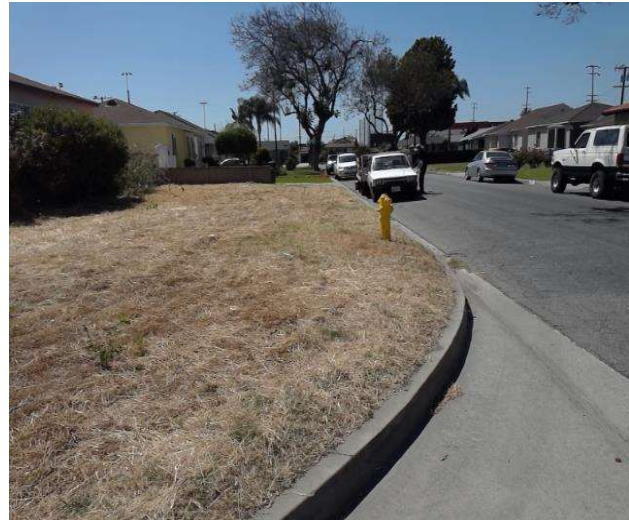
Sidewalks : Missing Sidewalk

Section of sidewalk is missing and consists of dirt, grass or gravel.

Provide a compliant sidewalk for the missing section.

\$1,260

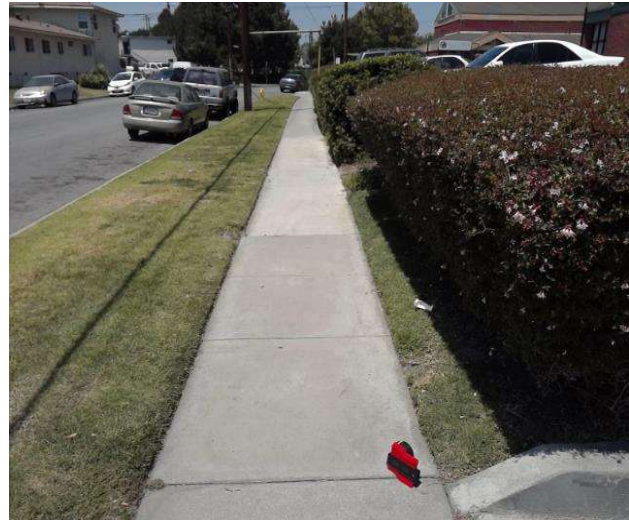
There is a change in elevation greater than recommended value.

Ensure that the change in elevation is within the recommended value.

Recommendation Up to 0.25 inches

Remove tripping hazards \$198

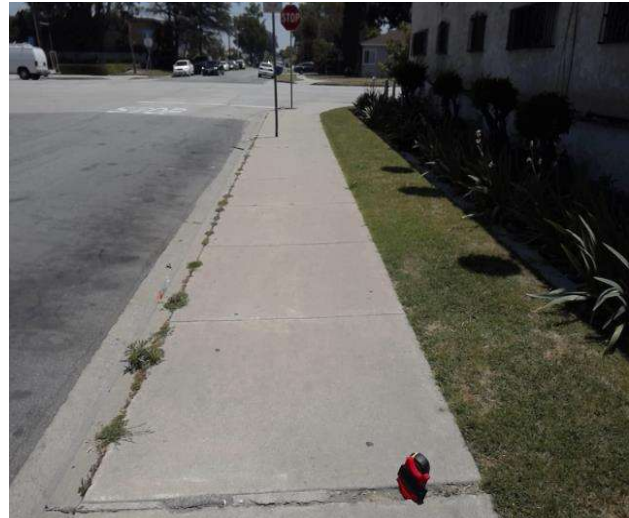
There is a change in elevation greater than recommended value.

Ensure that the change in elevation is within the recommended value.

Recommendation Up to 0.25 inches

Remove tripping hazards \$198

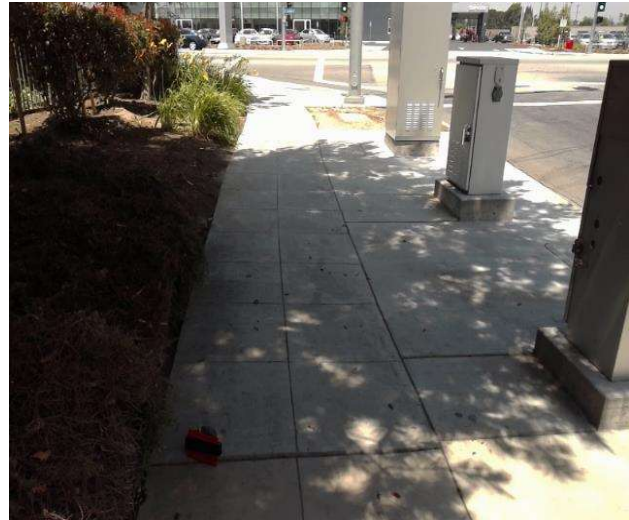
There is a change in elevation greater than recommended value.

Ensure that the change in elevation is within the recommended value.

Recommendation Up to 0.25 inches

Remove tripping hazards \$198

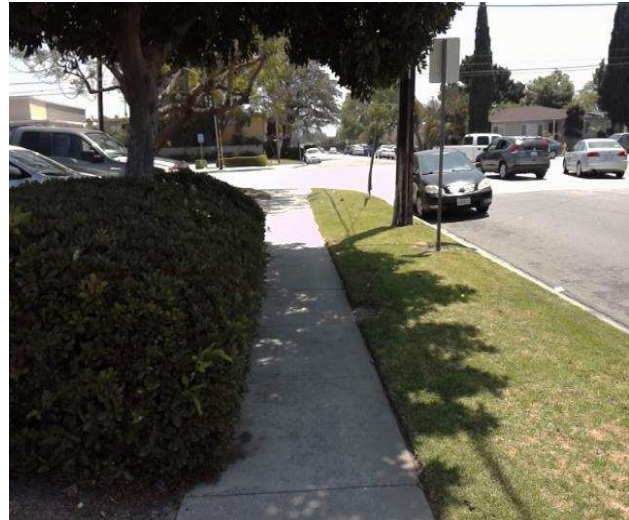
Sidewalks , Hazards & Gratings : Sidewalk Width at Obstruction

Sidewalk width at the obstruction shall have the recommended value.

Recommendation At least 48.00 inches

\$1,260

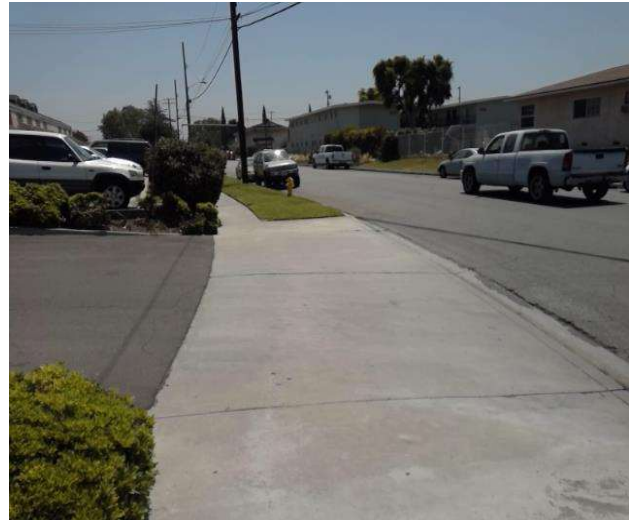
On-Site Finding Not Found

Install compliant detectable warnings \$190

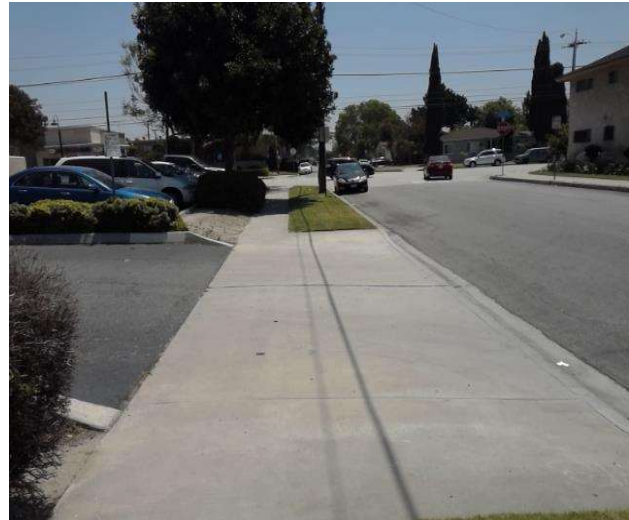
On-Site Finding Not Found

Install compliant detectable warnings \$190

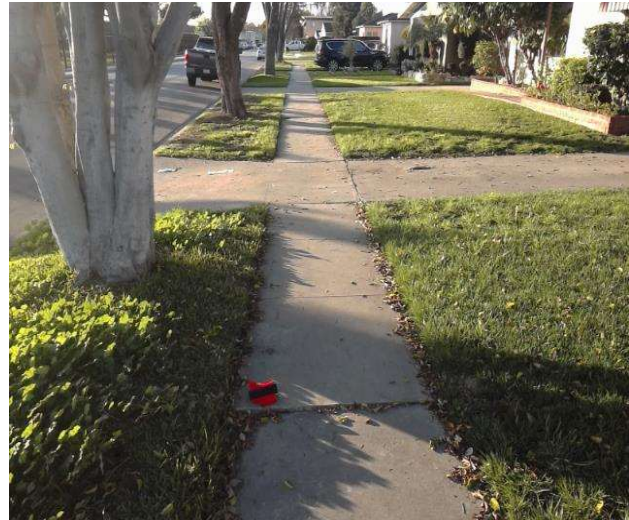
There is a change in elevation greater than recommended value.

Recommendation Up to 0.50 inches

Remove tripping hazards \$198

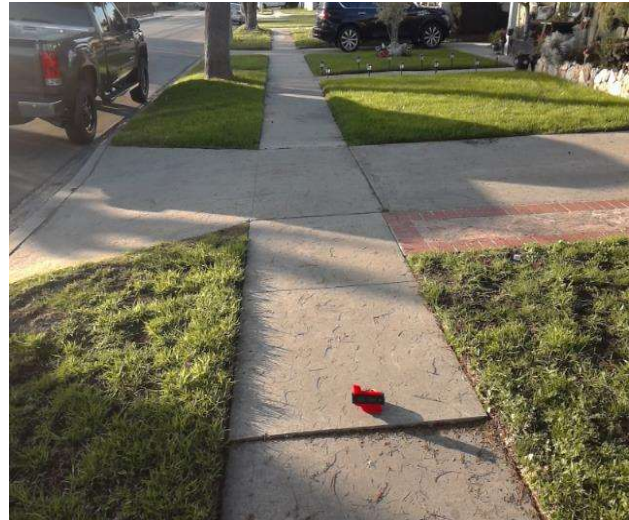
There is a change in elevation greater than recommended value.

Ensure that the change in elevation is within the recommended value.

Recommendation Up to 0.25 inches

Remove tripping hazards \$198

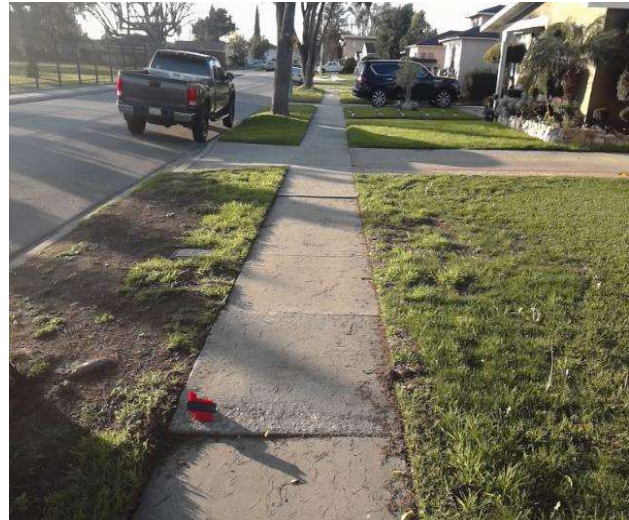
There is a change in elevation greater than recommended value.

Recommendation Up to 0.50 inches

Remove tripping hazards \$198

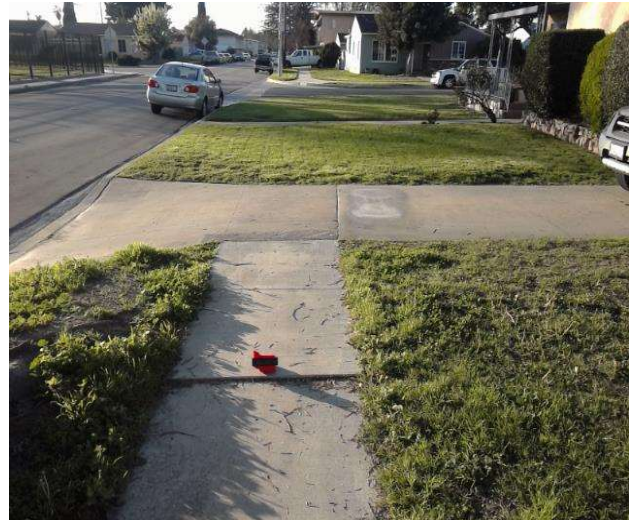
There is a change in elevation greater than recommended value.

Recommendation Up to 0.50 inches

Remove tripping hazards \$198

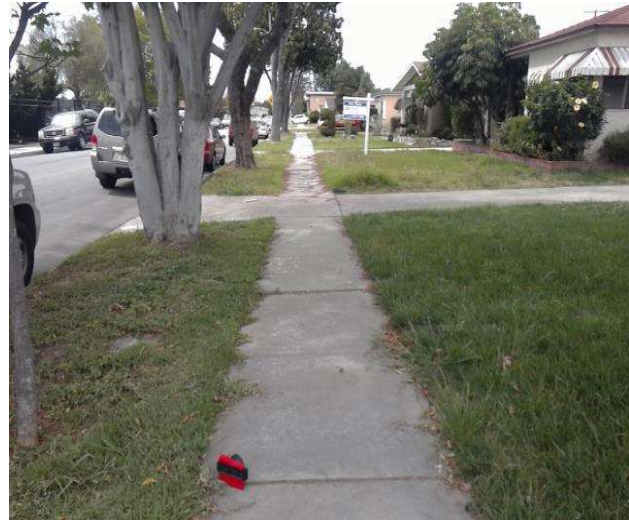
There is a change in elevation greater than recommended value.

Ensure that the change in elevation is within the recommended value.

Recommendation Up to 0.25 inches

Remove tripping hazards \$198

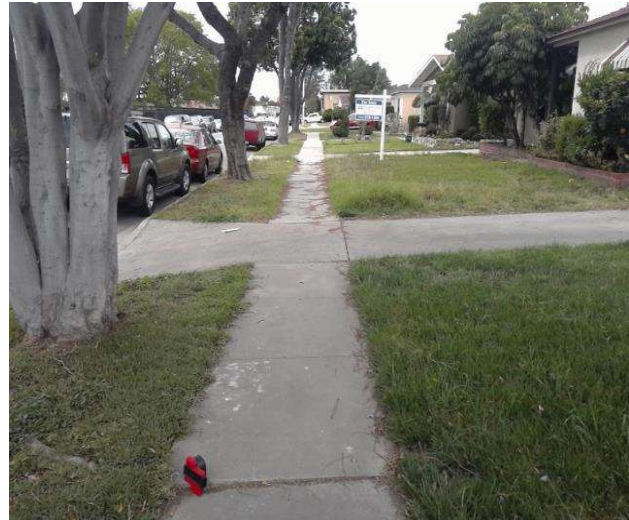
There is a change in elevation greater than recommended value.

Ensure that the change in elevation is within the recommended value.

Recommendation Up to 0.25 inches

Remove tripping hazards \$198

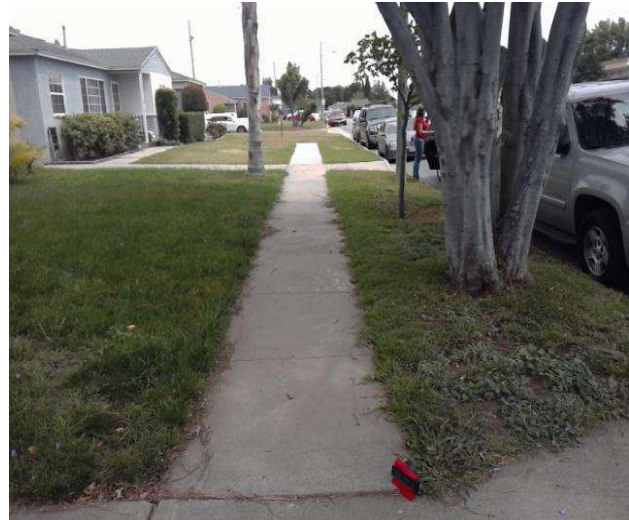
There is a change in elevation greater than recommended value.

Ensure that the change in elevation is within the recommended value.

Recommendation Up to 0.25 inches

Remove tripping hazards \$198

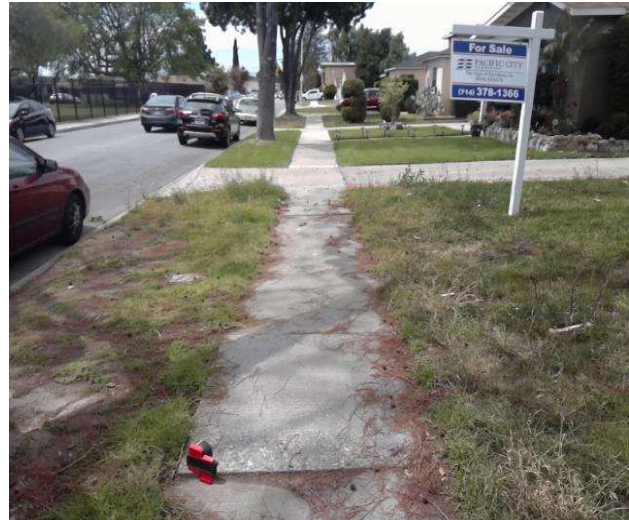
There is a change in elevation greater than recommended value.

Ensure that the change in elevation is within the recommended value.

Recommendation Up to 0.25 inches

Remove tripping hazards \$198

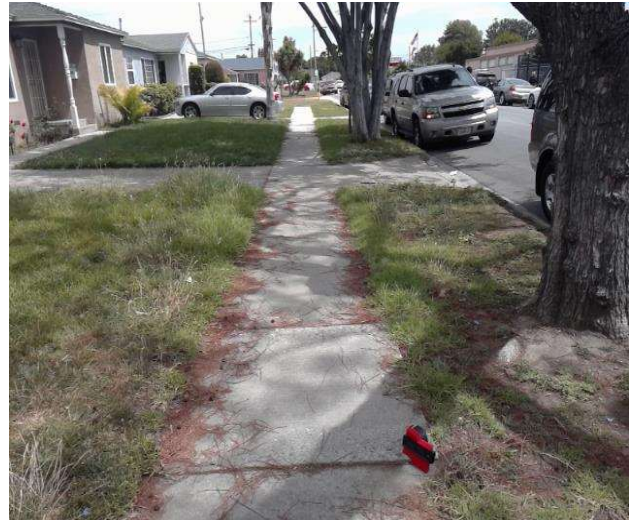
There is a change in elevation greater than recommended value.

Ensure that the change in elevation is within the recommended value.

Recommendation Up to 0.25 inches

Remove tripping hazards \$198
