Accessibility Survey

City of Downey Birchdale Avenue - 5th Street To End

Date of Inspection
4/18/2017

Disability Access Consultants

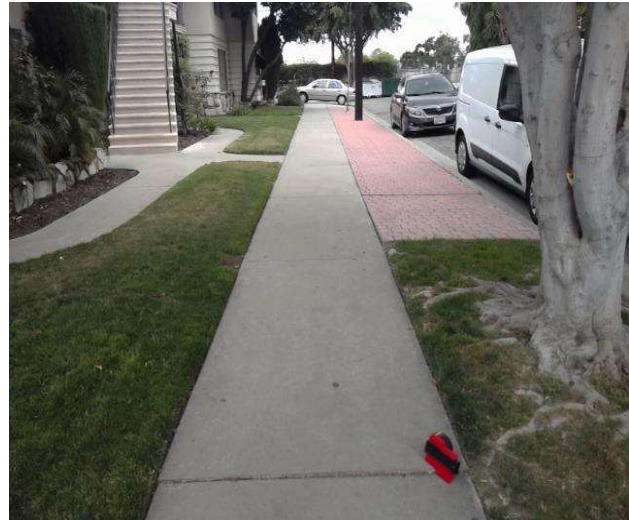
Change In Level South Of 5th Street @ 33.941070253239, -118.124861866236

Sidewalks , Change in Level : Change in Level Non Beveled

There is a change in elevation greater than recommended value.

On-Site Finding 0.62 inches

Ensure that the change in elevation is within the recommended value.

Recommendation Up to 0.25 inches

Remove tripping hazards \$198

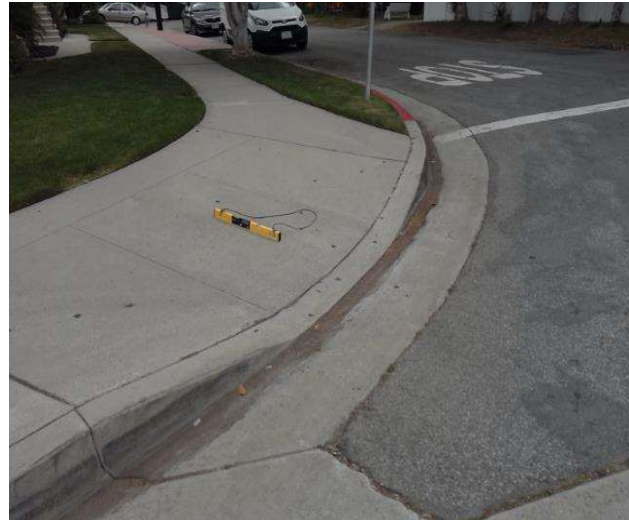
Southeast Corner Of 5th Street @ 33.941141459402, -118.124796152115

Curb Ramp : No Detectable Warnings

On-Site Finding Not Found

Provide detectable warning to surface \$248

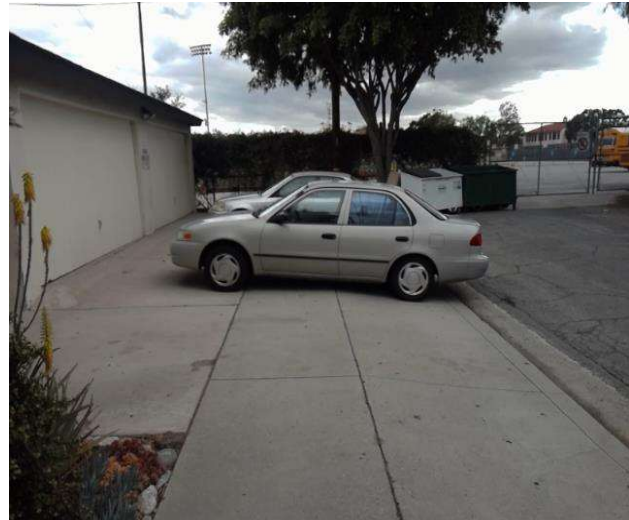
On-Site Finding Not Found

Install compliant detectable warnings \$190

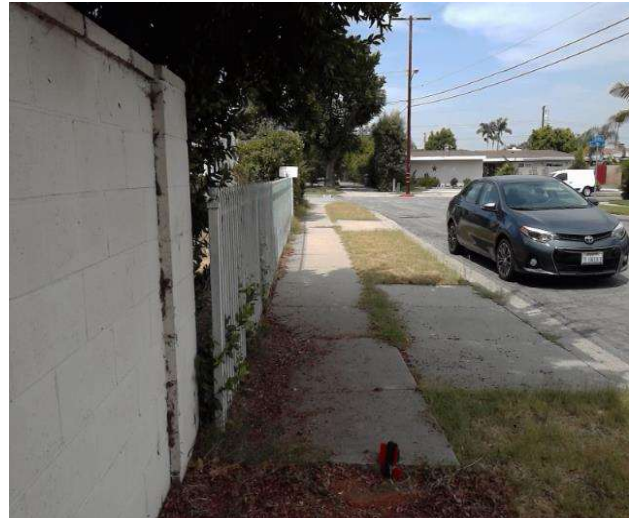
There is a change in elevation greater than recommended value.

Ensure that the change in elevation is within the recommended value.

Recommendation Up to 0.25 inches

Remove tripping hazards \$198

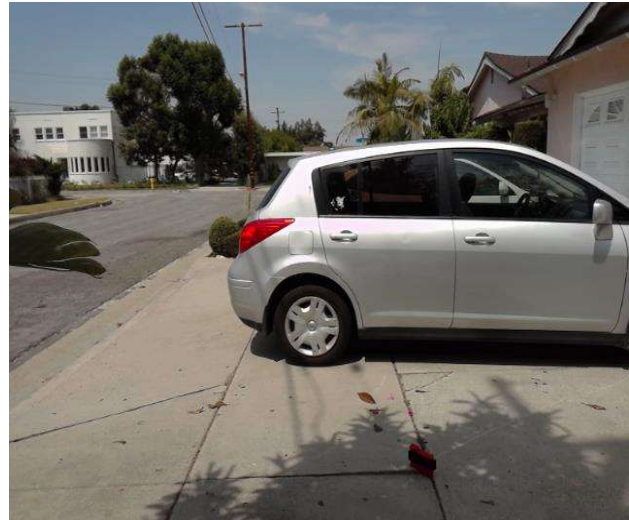
There is a change in elevation greater than recommended value.

Ensure that the change in elevation is within the recommended value.

Recommendation Up to 0.25 inches

Remove tripping hazards \$198

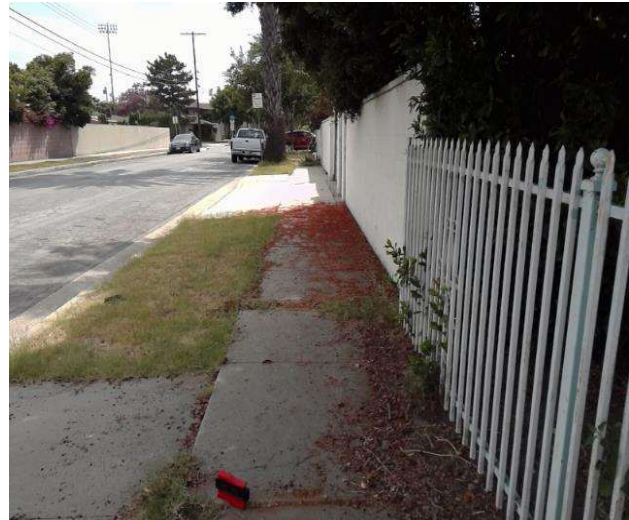
There is a change in elevation greater than recommended value.

Ensure that the change in elevation is within the recommended value.

Recommendation Up to 0.25 inches

Remove tripping hazards \$198

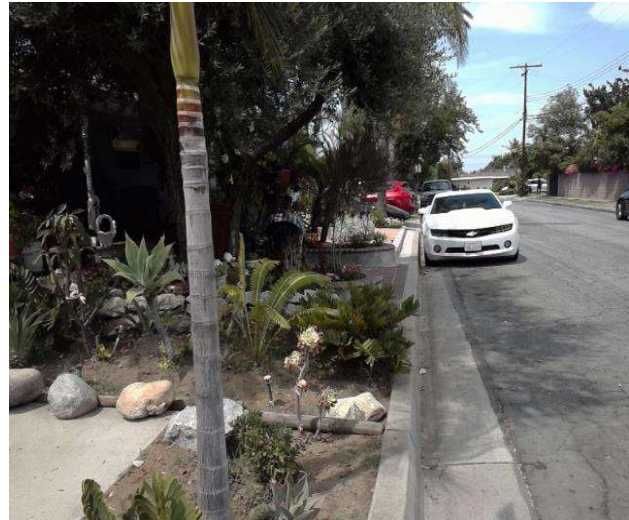
Sidewalks : Missing Sidewalk

Section of sidewalk is missing and consists of dirt, grass or gravel.

Provide a compliant sidewalk for the missing section.

\$1,260

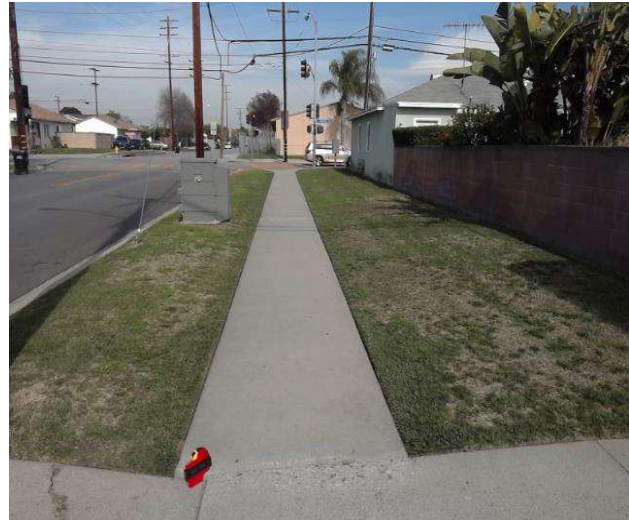
There is a change in elevation greater than recommended value.

Ensure that the change in elevation is within the recommended value.

Recommendation Up to 0.25 inches

Remove tripping hazards \$198

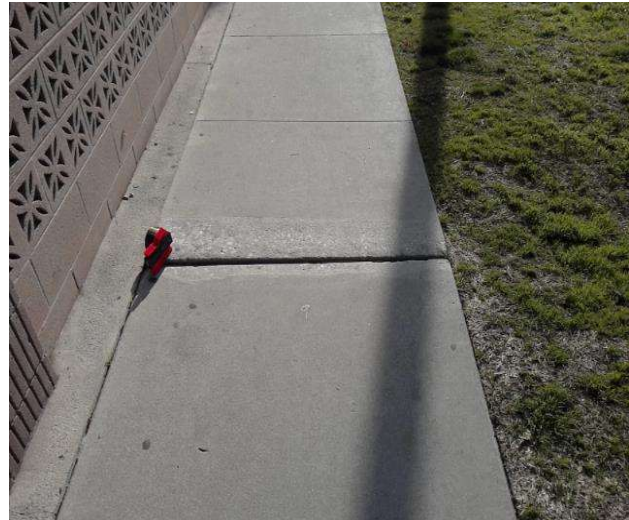
There is a change in elevation greater than recommended value.

Ensure that the change in elevation is within the recommended value.

Recommendation Up to 0.25 inches

Remove tripping hazards \$198

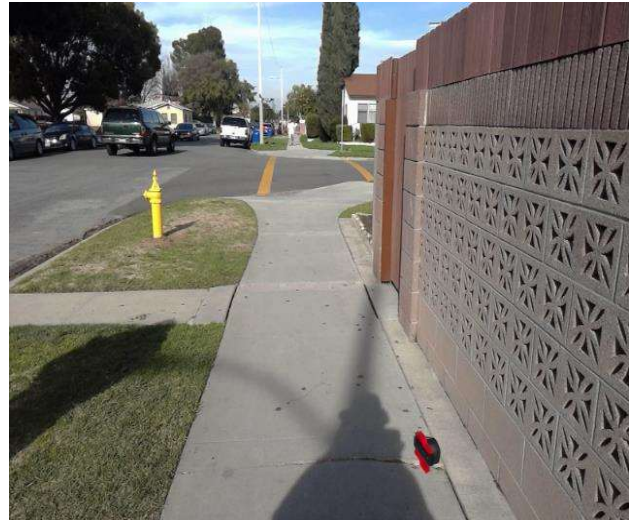
There is a change in elevation greater than recommended value.

Ensure that the change in elevation is within the recommended value.

Recommendation Up to 0.25 inches

Remove tripping hazards \$198

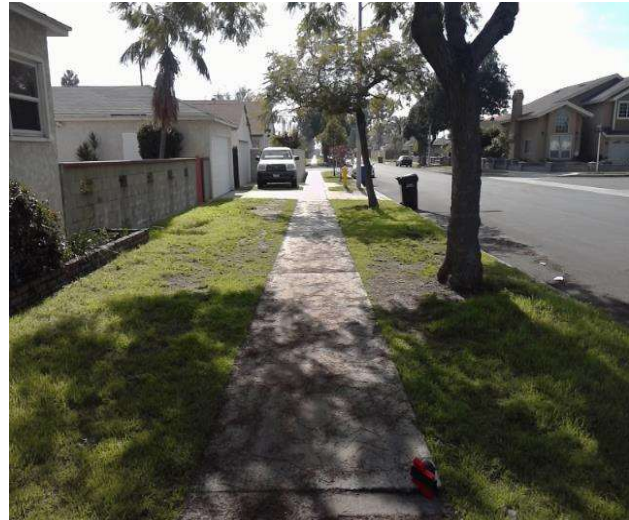
There is a change in elevation greater than recommended value.

Ensure that the change in elevation is within the recommended value.

Recommendation Up to 0.25 inches

Remove tripping hazards \$198

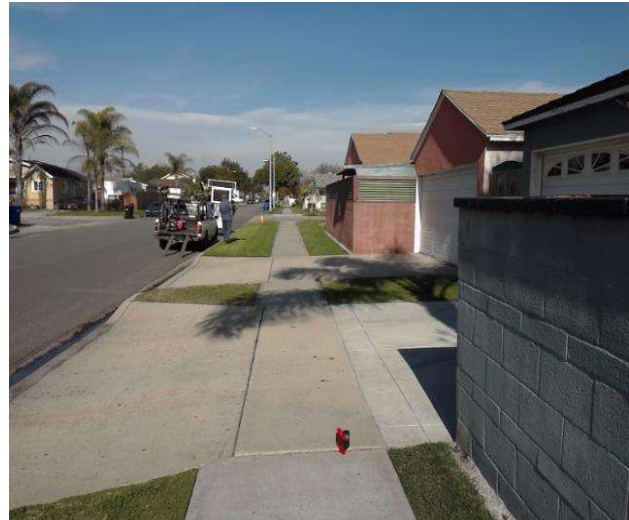
There is a change in elevation greater than recommended value.

Ensure that the change in elevation is within the recommended value.

Recommendation Up to 0.25 inches

Remove tripping hazards \$198

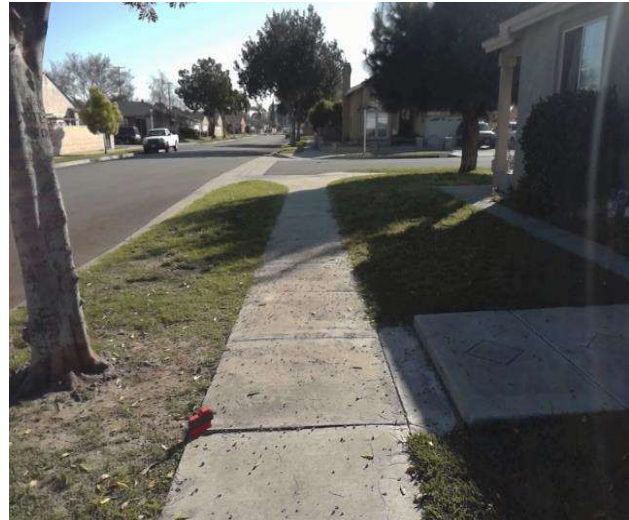
There is a change in elevation greater than recommended value.

Ensure that the change in elevation is within the recommended value.

Recommendation Up to 0.25 inches

Remove tripping hazards \$198

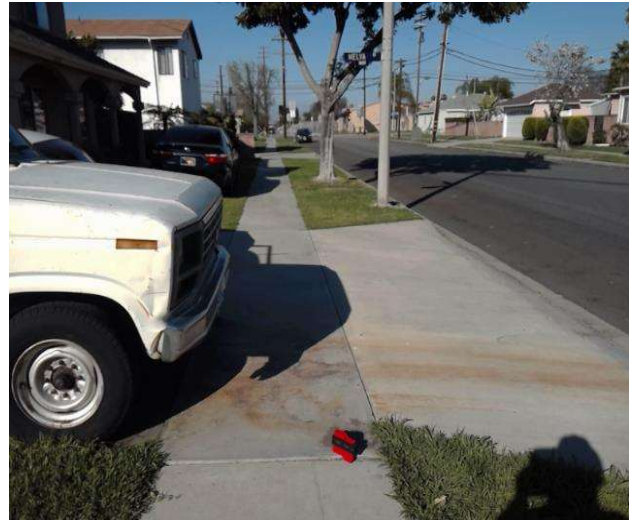
There is a change in elevation greater than recommended value.

Ensure that the change in elevation is within the recommended value.

Recommendation Up to 0.25 inches

Remove tripping hazards \$198

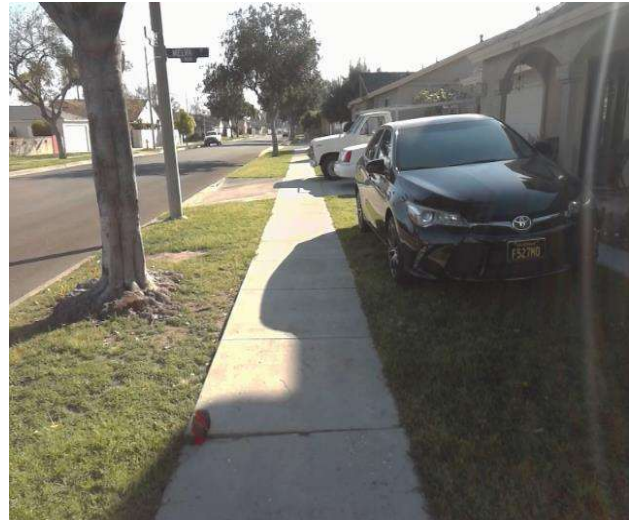
There is a change in elevation greater than recommended value.

Ensure that the change in elevation is within the recommended value.

Recommendation Up to 0.25 inches

Remove tripping hazards \$198

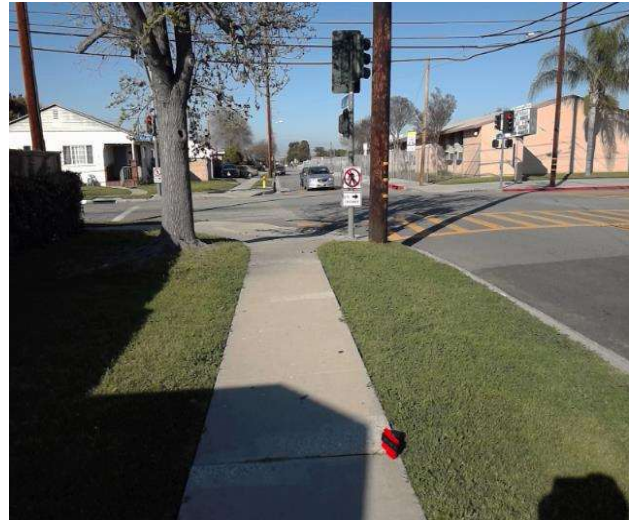
There is a change in elevation greater than recommended value.

Ensure that the change in elevation is within the recommended value.

Recommendation Up to 0.25 inches

Remove tripping hazards \$198

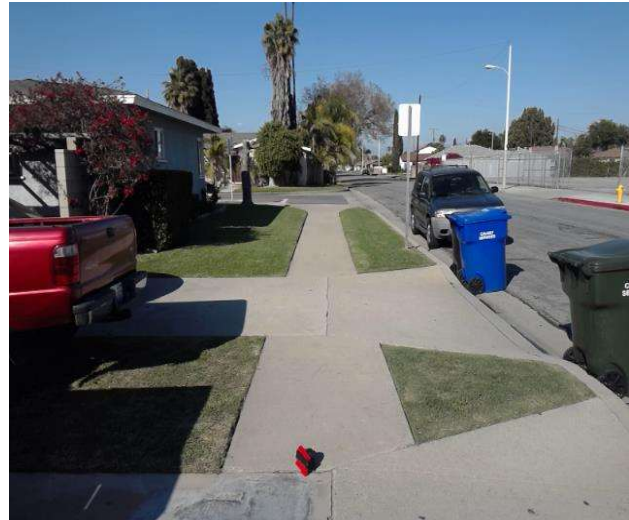
There is a change in elevation greater than recommended value.

Ensure that the change in elevation is within the recommended value.

Recommendation Up to 0.25 inches

Remove tripping hazards \$198

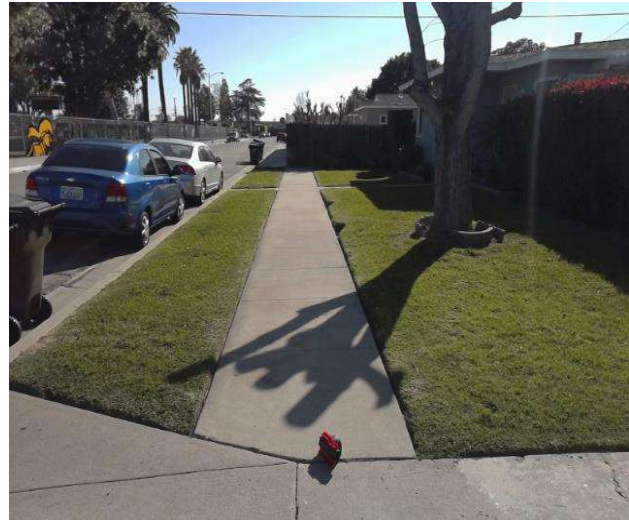
There is a change in elevation greater than recommended value.

Ensure that the change in elevation is within the recommended value.

Recommendation Up to 0.25 inches

Remove tripping hazards \$198

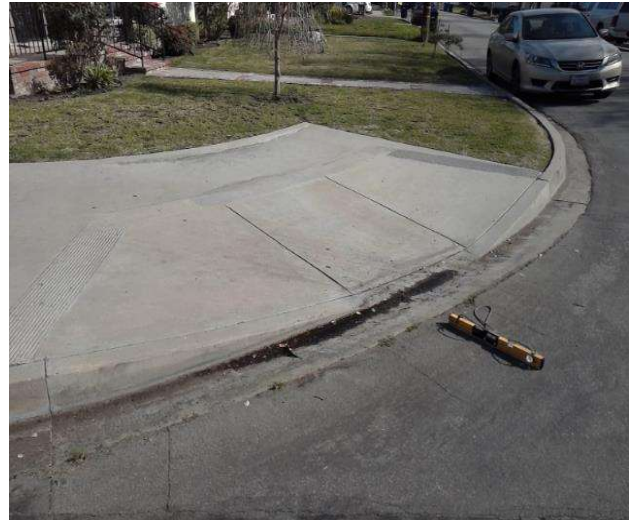
Curb Ramp , Landings and Transitions : Top Landing Clear Length - Landings

Recommendation At least 48.00 inches

Provide compliant landing \$240

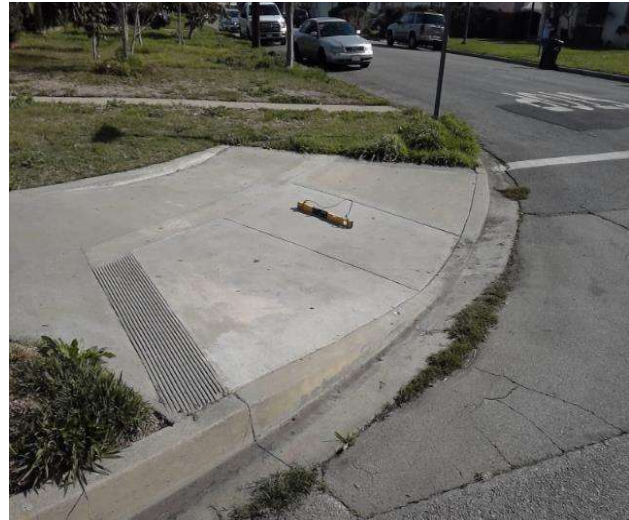
On-Site Finding Not Found

Provide detectable warning to surface \$248
