# Accessibility Survey

## City of Downey Brookshire Avenue & Civic Center Drive

Brookshire Avenue & Civic Center Drive  
Downey, CA 90240

Date of Inspection  
5/25/2017

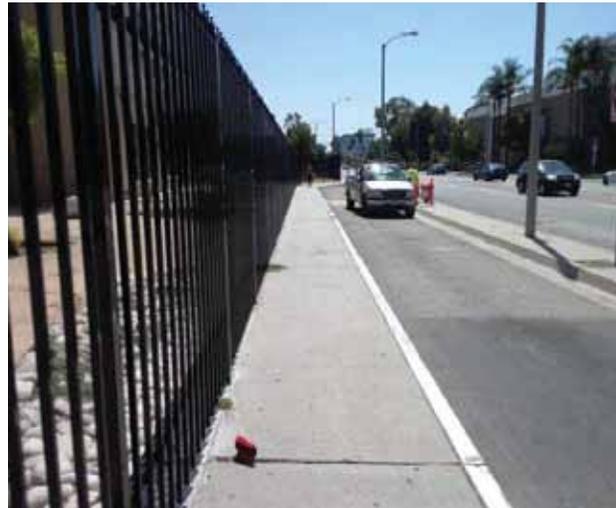
There is a change in elevation greater than recommended value.

Ensure that the change in elevation is within the recommended value.

Recommendation Up to 0.25 inches

Remove tripping hazards \$198

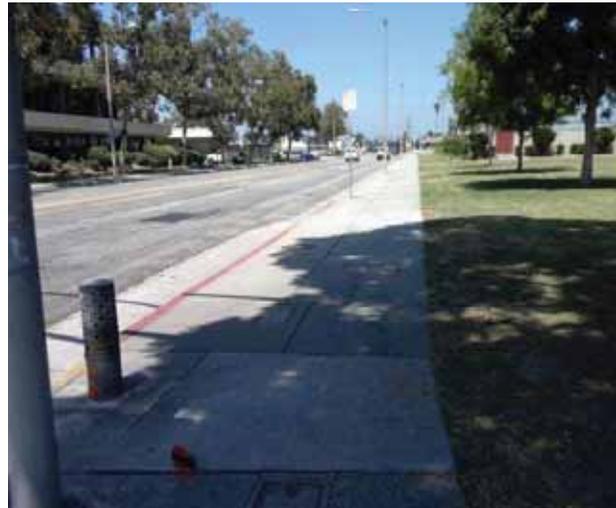
There is a change in elevation greater than recommended value.

Ensure that the change in elevation is within the recommended value.

Recommendation Up to 0.25 inches

Remove tripping hazards \$198

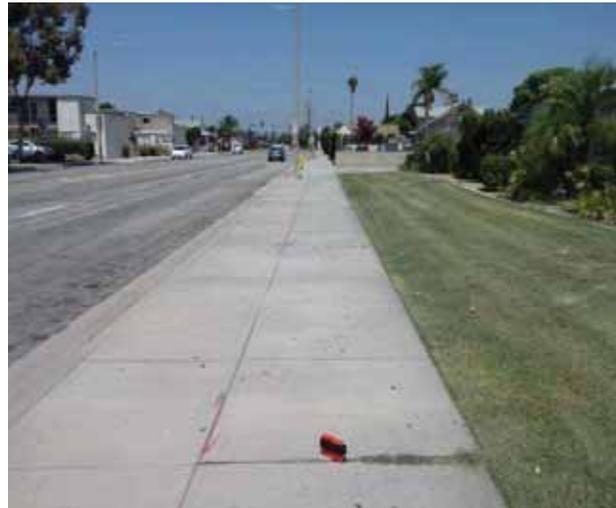
There is a change in elevation greater than recommended value.

Ensure that the change in elevation is within the recommended value.

Recommendation Up to 0.25 inches

Remove tripping hazards \$198

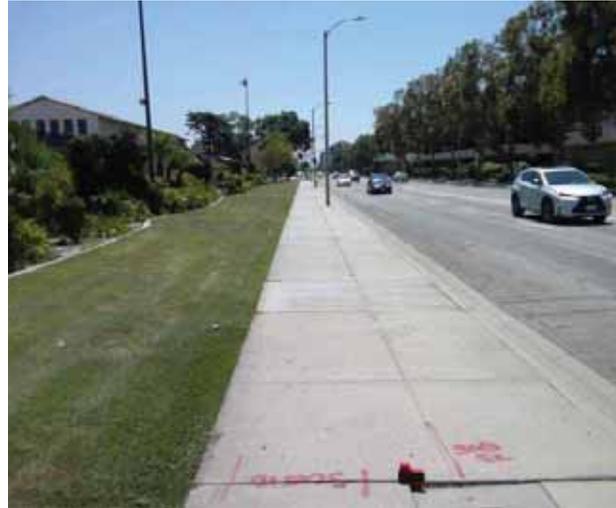
There is a change in elevation greater than recommended value.

Ensure that the change in elevation is within the recommended value.

Recommendation Up to 0.25 inches

Remove tripping hazards \$198

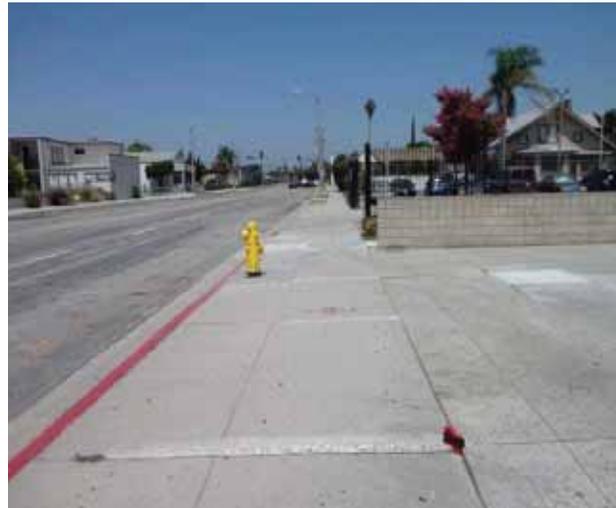
There is a change in elevation greater than recommended value.

Ensure that the change in elevation is within the recommended value.

Recommendation Up to 0.25 inches

Remove tripping hazards \$198

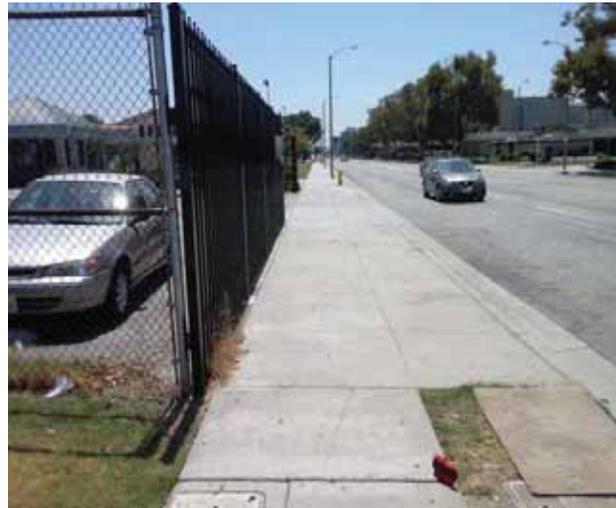
There is a change in elevation greater than recommended value.

Ensure that the change in elevation is within the recommended value.

Recommendation Up to 0.25 inches

Remove tripping hazards \$198

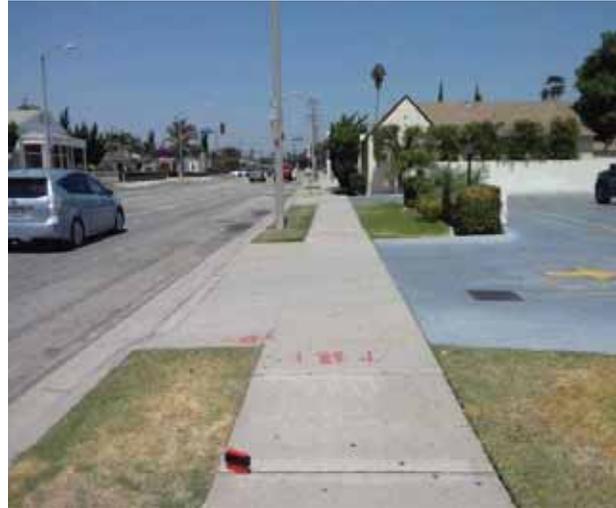
There is a change in elevation greater than recommended value.

Ensure that the change in elevation is within the recommended value.

Recommendation Up to 0.25 inches

Remove tripping hazards \$198

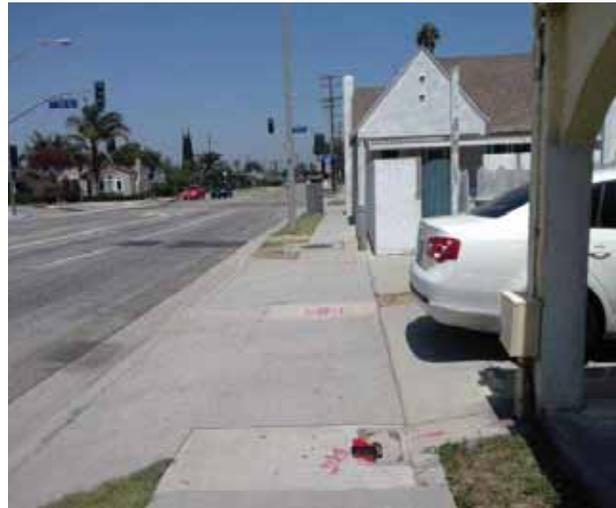
There is a change in elevation greater than recommended value.

Ensure that the change in elevation is within the recommended value.

Recommendation Up to 0.25 inches

Remove tripping hazards \$198

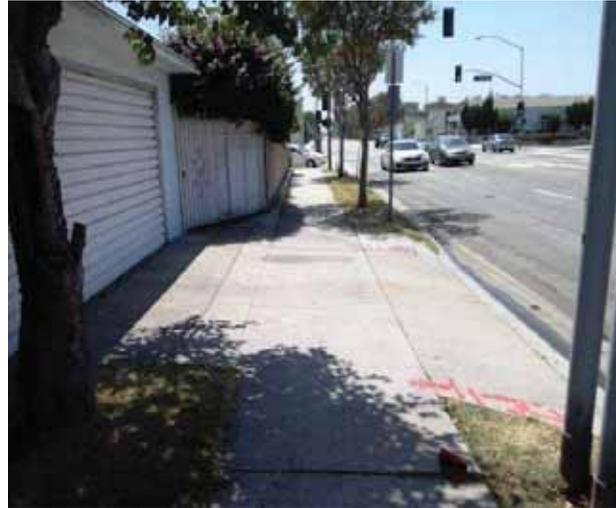
There is a change in elevation greater than recommended value.

Ensure that the change in elevation is within the recommended value.

Recommendation Up to 0.25 inches

Remove tripping hazards \$198

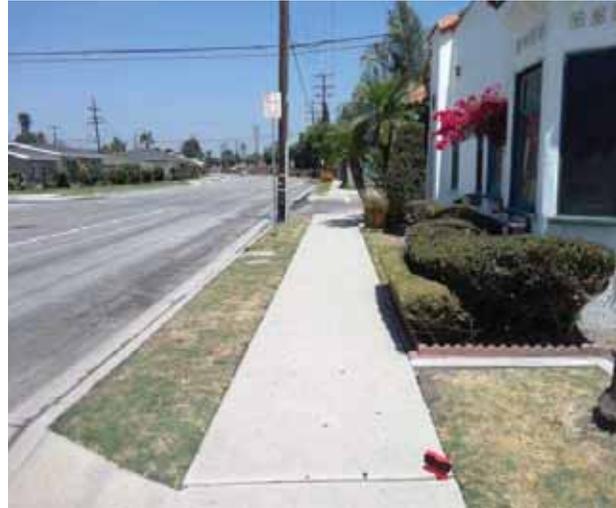
There is a change in elevation greater than recommended value.

Ensure that the change in elevation is within the recommended value.

Recommendation Up to 0.25 inches

Remove tripping hazards \$198

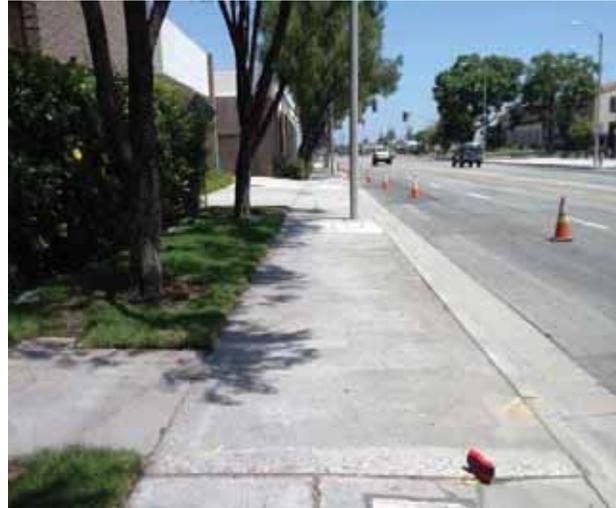
There is a change in elevation greater than recommended value.

Ensure that the change in elevation is within the recommended value.

Recommendation Up to 0.25 inches

Remove tripping hazards \$198

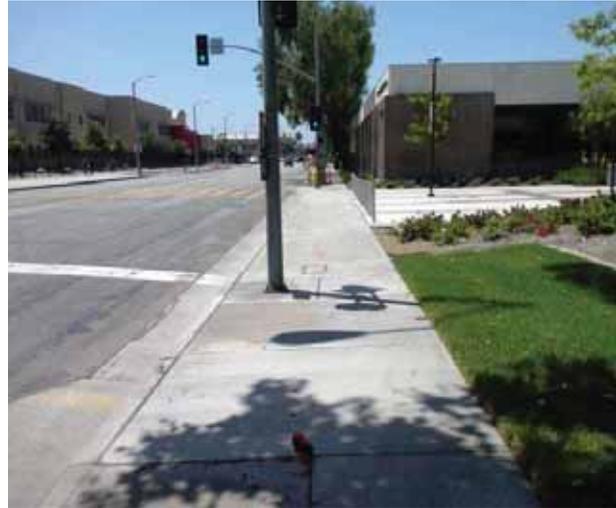
There is a change in elevation greater than recommended value.

Ensure that the change in elevation is within the recommended value.

Recommendation Up to 0.25 inches

Remove tripping hazards \$198

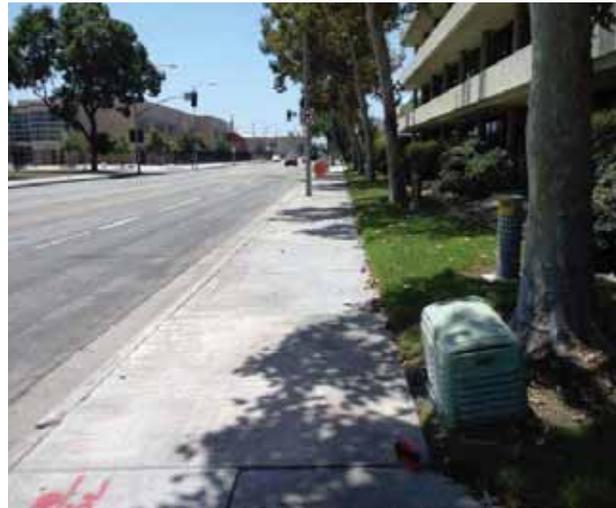
There is a change in elevation greater than recommended value.

Ensure that the change in elevation is within the recommended value.

Recommendation Up to 0.25 inches

Remove tripping hazards \$198

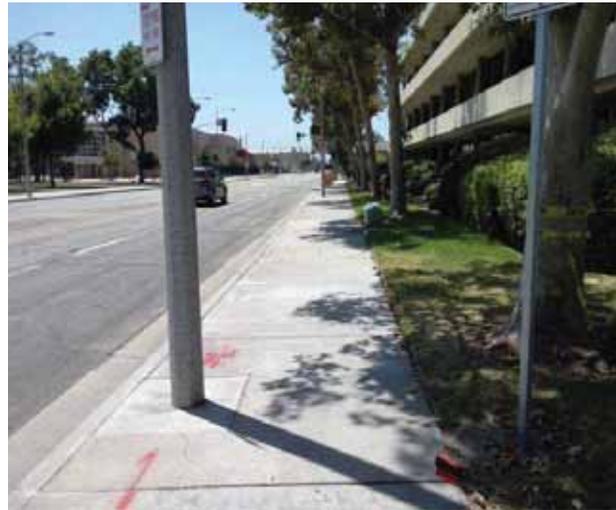
There is a change in elevation greater than recommended value.

Ensure that the change in elevation is within the recommended value.

Recommendation Up to 0.25 inches

Remove tripping hazards \$198

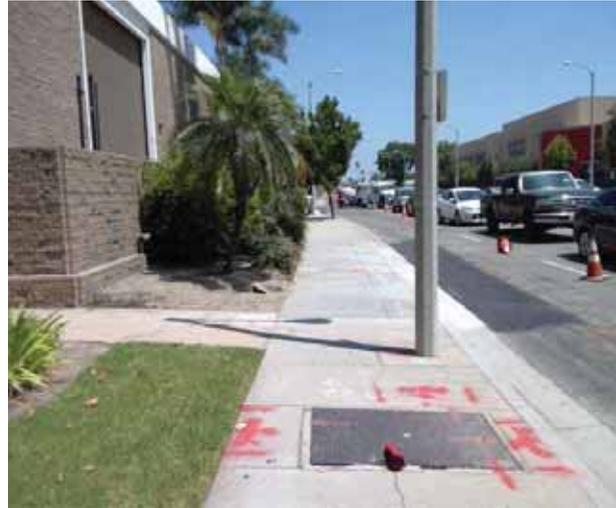
There is a change in elevation greater than recommended value.

Ensure that the change in elevation is within the recommended value.

Recommendation Up to 0.25 inches

Remove tripping hazards \$198
