## Accessibility Survey

## 11th Street - Brookshire Avenue to Birchdale Avenue

Brookshire Avenue to Birchdale Avenue  
Downey, CA 90242

Date of Inspection  
7/14/2017

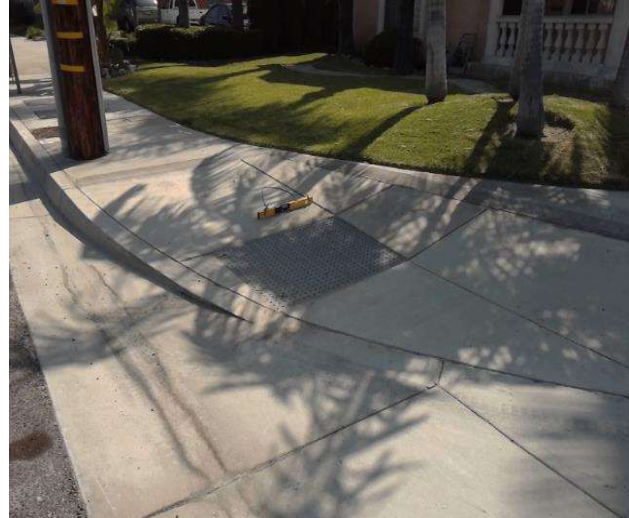
**Northeast Corner of Brookshire Avenue @ 33.949284158814, - 118.122176975012**

Curb Ramp : Curb Ramp - Cross Slope

The cross slope is greater than allowed.

**On-Site Finding** 5.60 percent

**Code Reference** ADA 402, 406.1, 405.3, CA 11B-406.5.7

Provide a compliant curb ramp.

Recommendation Up to 2.08 percent

Install curb ramp \$1,300

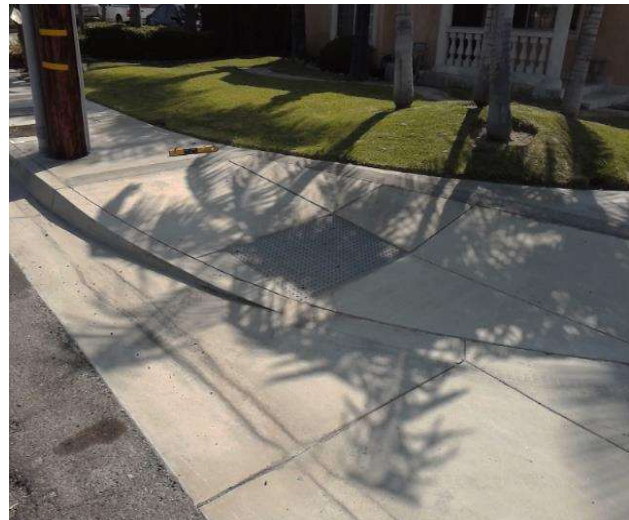
**Northeast Corner of Brookshire Avenue @ 33.949284158814, - 118.122176975012**

Curb Ramp , Landings and Transitions : Top Landing Slope

The slope at the top landing is greater than allowed.

**On-Site Finding** 2.90 percent

**Code Reference** ADA 402, 406.4, 403.3, 406.1, CA 11B-406.5.3

Provide a top landing surface that does not exceed the maximum slope and cross slope. Provide a sufficient maneuvering clearance that does not accumulate water.

Recommendation Up to 2.08 percent

Provide compliant landing \$1,260

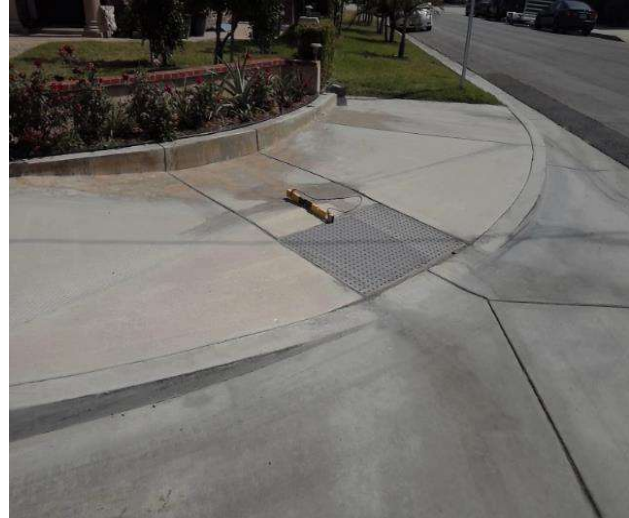
**Northwest Corner of Birchdale Avenue @ 33.948100461859, - 118.119874298573**

Curb Ramp : Curb Ramp Slope

The running slope is greater than allowed.

**On-Site Finding** 10.30 percent

**Code Reference** ADA 406, 406.1, 405.2, CA 11B-406

Provide a compliant curb ramp.

Recommendation Up to 8.33 percent

Install curb ramp \$1,300

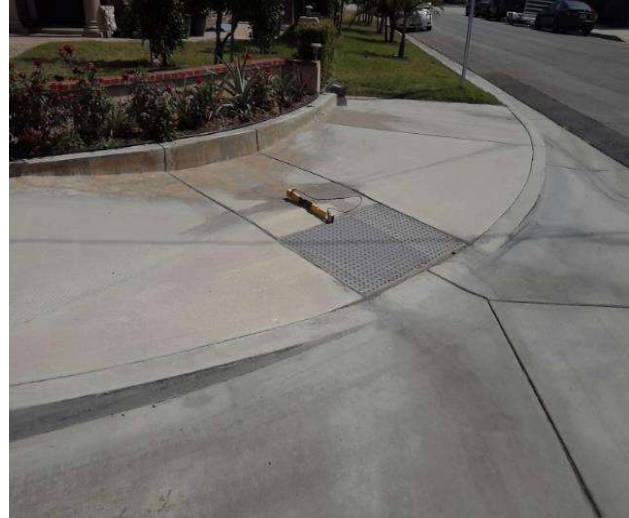
**Northwest Corner of Birchdale Avenue @ 33.948100461859, - 118.119874298573**

Curb Ramp : Side Flare Slope

The slope of the curb ramp side flare is greater than allowed.

**On-Site Finding** 11.80 percent

**Code Reference** ADA 406, 406.3,CA 11B-406.2.2

Provide curb ramp side flares with a compliant slope.

Recommendation Up to 10.00 percent

Install flared sides \$1,300

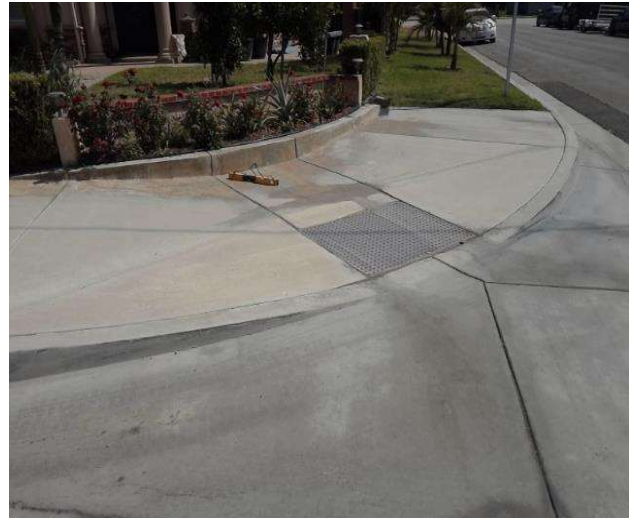
**Northwest Corner of Birchdale Avenue @ 33.948100461859, - 118.119874298573**

Curb Ramp , Landings and Transitions : Top Landing Slope

The slope at the top landing is greater than allowed.

**On-Site Finding** 3.30 percent

**Code Reference** ADA 402, 406.4, 403.3, 406.1, CA 11B-406.5.3

Provide a top landing surface that does not exceed the maximum slope and cross slope. Provide a sufficient maneuvering clearance that does not accumulate water.

Recommendation Up to 2.08 percent

Provide compliant landing \$1,260

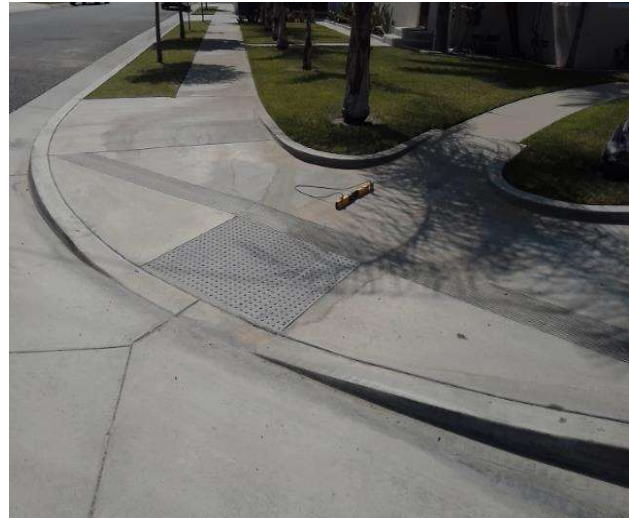
**Southeast Corner of Brookshire Avenue @ 33.949148434999, - 118.122264146805**

Curb Ramp , Landings and Transitions : Top Landing Slope

The slope at the top landing is greater than allowed.

**On-Site Finding** 3.80 percent

**Code Reference** ADA 402, 406.4, 403.3, 406.1, CA 11B-406.5.3

Provide a top landing surface that does not exceed the maximum slope and cross slope. Provide a sufficient maneuvering clearance that does not accumulate water.

Recommendation Up to 2.08 percent

Provide compliant landing \$1,260

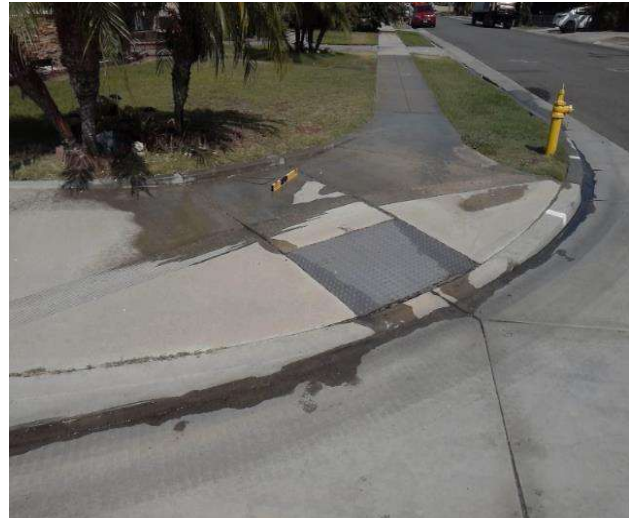
**Southwest Corner of Birchdale Avenue @ 33.947986986286, - 118.119970858097**

Curb Ramp , Landings and Transitions : Top Landing Slope

The slope at the top landing is greater than allowed.

**On-Site Finding** 2.90 percent

**Code Reference** ADA 402, 406.4, 403.3, 406.1, CA 11B-406.5.3

Provide a top landing surface that does not exceed the maximum slope and cross slope. Provide a sufficient maneuvering clearance that does not accumulate water.

Recommendation Up to 2.08 percent

Provide compliant landing \$1,260

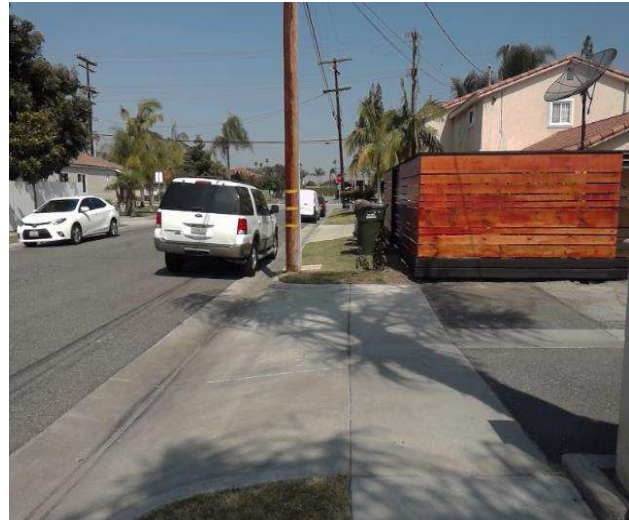
**Alley East of Brookshire Avenue @ 33.949024948389, -118.121730387211**

Sidewalks , Vehicular Traffic : Cross Walks and Detectable Warnings

There are no detectable warnings where the pedestrian route crosses vehicular traffic.

**On-Site Finding** Not Found

**Code Reference** ADA 705,CA 11B-705.1.2.5,CA 11B-247.1.2.5

Provide detectable warnings.

Install compliant detectable warnings \$190

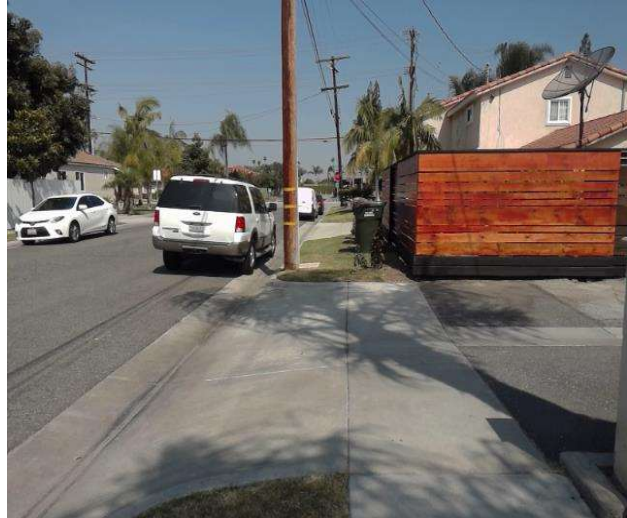
**Alley East of Brookshire Avenue @ 33.949024948389, -118.121730387211**

Sidewalks : Vehicular Traffic Cross Slope

Cross slope at vehicular traffic is not compliant.

**On-Site Finding** 3.20 percent

**Code Reference** ADA 206, 302, CA 11B-403.3

Repave the surface to provide a compliant cross slope.

Recommendation Up to 2.08 percent

Repave surface \$1,092

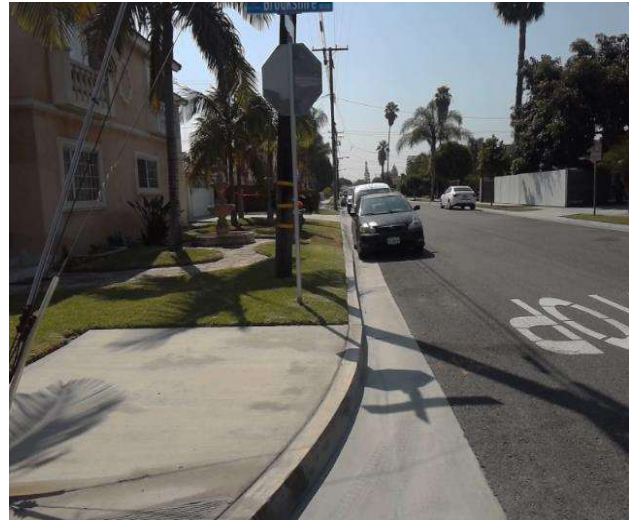
**Sidewalk East of Brookshire Avenue @ 33.949242996696, -118.122176975012**

Sidewalks : Missing Sidewalk

Section of sidewalk is missing and consists of dirt, grass or gravel.

**On-Site Finding** 146.00 feet

**Code Reference** ADA 206, 302,CA 11B-302,CA 11B-206

Provide a compliant sidewalk for the missing section.

\$1,260

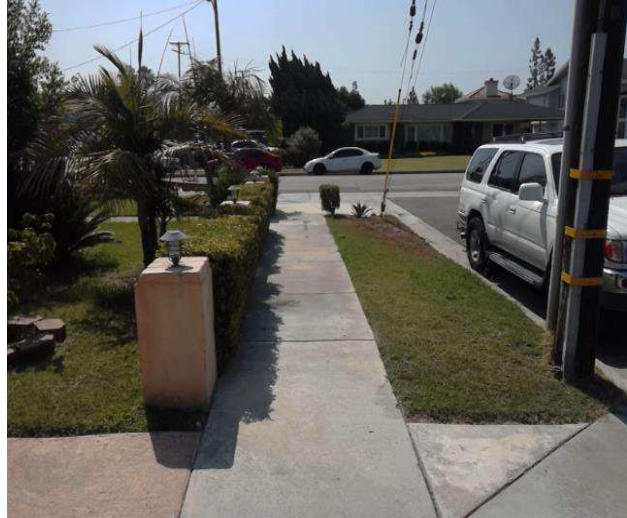
**Sidewalk East of Brookshire Avenue @ 33.948162762109, -118.128409023**

Sidewalks , Surface : Cross Slope

Sidewalk cross slope is not compliant.

**On-Site Finding** 4.20 percent for 7.00 feet

**Code Reference** ADA 206, 302, CA 11B-403.3

Repave the sidewalk surface with the recommended cross slope.

Recommendation Up to 2.08 percent

Repave surface \$1,092

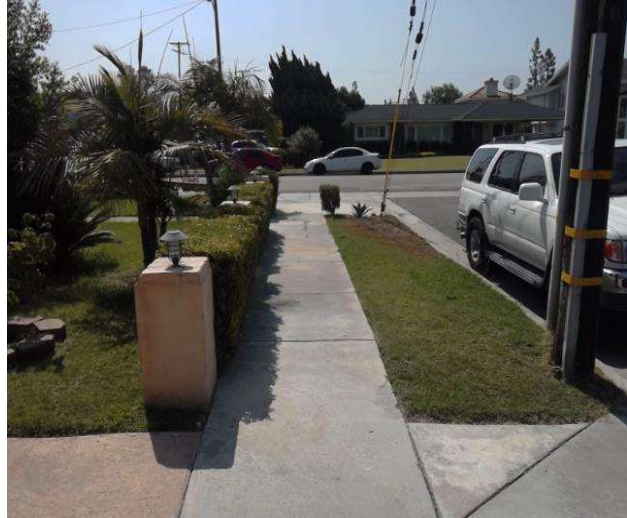
**Sidewalk East of Brookshire Avenue @ 33.948162762109, -118.128409023**

Sidewalks , Surface : Running Slope

Sidewalk running slope is not compliant.

**On-Site Finding** 6.60 percent for 7.00 feet

**Code Reference** ADA 206, 302

Repave the sidewalk surface with the recommended running slope.

Recommendation Up to 5.00 percent

Repave surface \$1,184

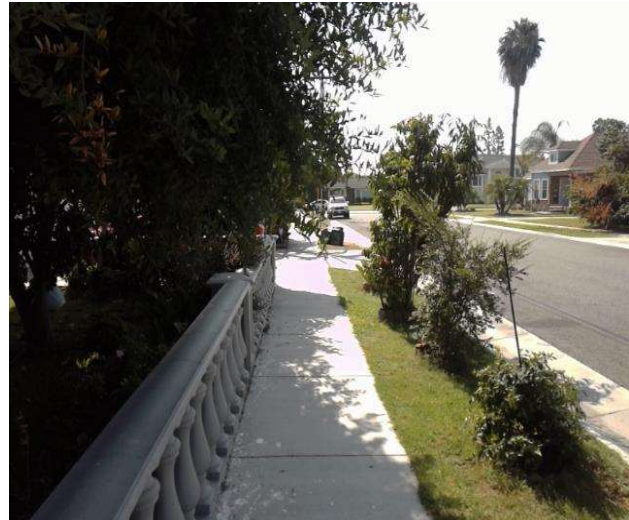
**Tree East of Brookshire Avenue @ 33.948359675100, -118.120382577181**

Sidewalks , Hazards & Gratings : Overhead Obstruction Height

Overhead obstruction height is not compliant.

**On-Site Finding** 54.00 inches

**Code Reference** ADA 206, 307.4, CA 11B-307.4

Provide a compliant vertical clearance height.

Recommendation At least 80.00 inches

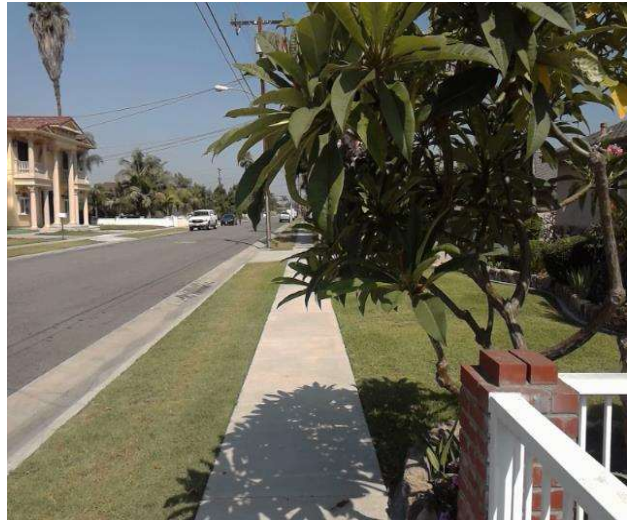
**Tree East of Brookshire Avenue @ 33.948447562672, -118.120573014021**

Sidewalks , Hazards & Gratings : Overhead Obstruction Height

Overhead obstruction height is not compliant.

**On-Site Finding** 49.00 inches

**Code Reference** ADA 206, 307.4, CA 11B-307.4

Provide a compliant vertical clearance height.

Recommendation At least 80.00 inches

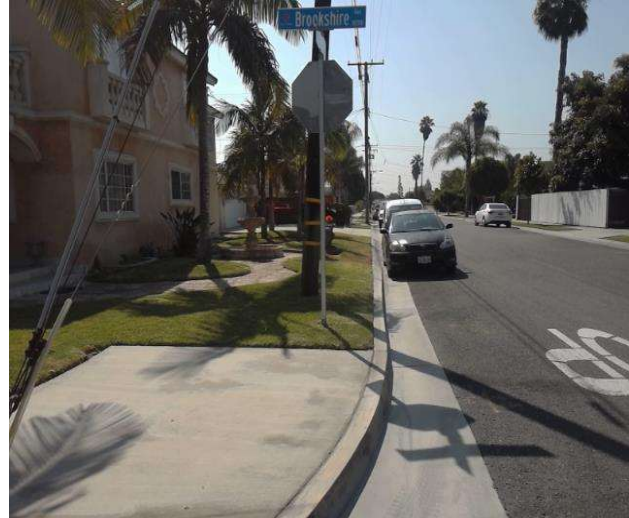
**North Side @ 33.949239659226, -118.122168928385**

Sidewalks : 60X60 Turn Area

There is no 60X60 turn area at every 200 feet.

**On-Site Finding** Not Found

**Code Reference** ADA 206, 302

Provide a 60X60 turn every 200 feet on the sidewalk.

\$2,400

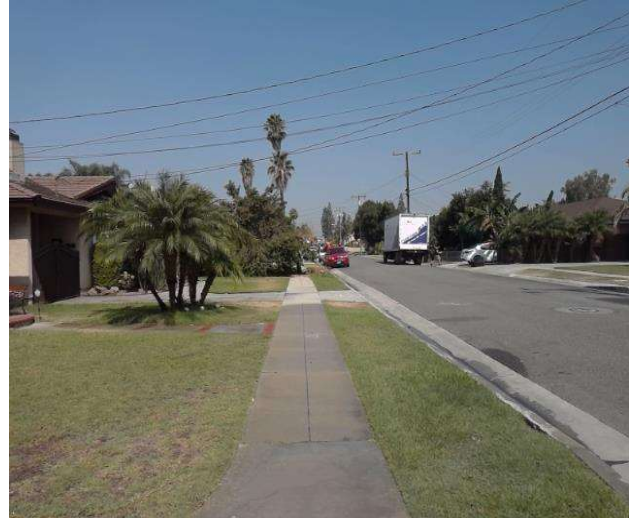
**South Side @ 33.948008123904, -118.119992315769**

Sidewalks : 60X60 Turn Area

There is no 60X60 turn area at every 200 feet.

**On-Site Finding** Not Found

**Code Reference** ADA 206, 302

Provide a 60X60 turn every 200 feet on the sidewalk.

\$2,400
