Accessibility Survey

City of Downey Earnshaw Avenue - Golden Street To Century Boulevard

Golden Street To Century Boulevard Downey, CA 90242

Date of Inspection 11/28/2016

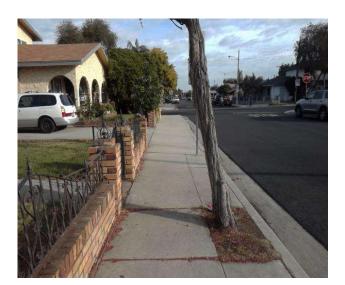
Change In Level North Of Century Boulevard @ 33.907105916192, - 118.149259239435

Sidewalks , Change in Level : Change in Level Non Beveled

There is a change in elevation greater than recommended value.

On-Site Finding 0.50 inches

Code Reference ADA 206, 302

Ensure that the change in elevation is within the recommended value.

Recommendation Up to 0.25 inches

Remove tripping hazards \$198

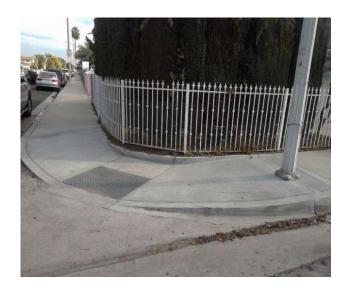
Northeast Corner Of Century Boulevard @ 33.905761352735, - 118.149988800287

Curb Ramp : Parallel Curb Ramp Right Side Slope

The running slope is greater than allowed.

On-Site Finding 8.60 percent

Code Reference ADA 406.1, 405.2,CA 11B-406

Provide a compliant curb ramp.

Recommendation Up to 8.33 percent

Install curb ramp \$1,300

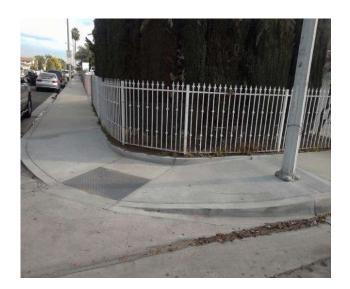
Northeast Corner Of Century Boulevard @ 33.905761352735, -118.149988800287

Curb Ramp : Appurtenances

Utilities, gratings or other appurtenances are located on the curb ramp.

On-Site Finding Not Compliant

Code Reference ADA 303.3,CA 11B-303.3

Provide a compliant curb ramp free of appurtenances.

Install curb ramp \$1,440

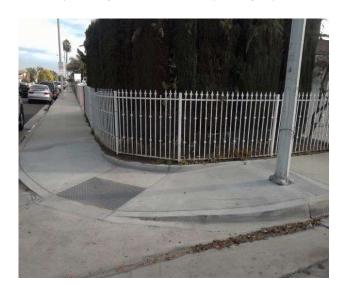
Curb Ramp, Landings and Transitions: Top Landing Slope

The slope at the top landing is greater than allowed.

On-Site Finding 3.60 percent

Code Reference ADA 402, 406.4, 403.3, 406.1,CA 11B-406.5.3

Provide a top landing surface that does not exceed the maximum slope and cross slope. Provide a sufficient maneuvering clearance that does not accumulate water.

Recommendation Up to 2.08 percent

Provide compliant landing \$1,260

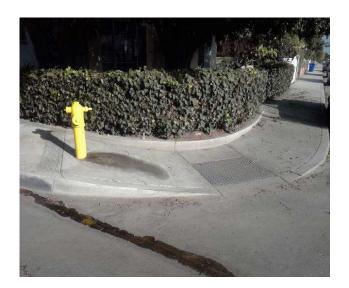
Northwest Corner Of Century Boulevard @ 33.905828136189, - 118.150136321783

Curb Ramp : Appurtenances

Utilities, gratings or other appurtenances are located on the curb ramp.

On-Site Finding Not Compliant

Code Reference ADA 303.3,CA 11B-303.3

Provide a compliant curb ramp free of appurtenances.

Install curb ramp \$1,440

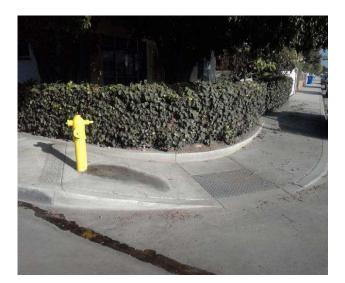
Curb Ramp , Landings and Transitions : Top Landing Slope

The slope at the top landing is greater than allowed.

On-Site Finding 4.70 percent

Code Reference ADA 402, 406.4, 403.3, 406.1,CA 11B-406.5.3

Provide a top landing surface that does not exceed the maximum slope and cross slope. Provide a sufficient maneuvering clearance that does not accumulate water.

Recommendation Up to 2.08 percent

Provide compliant landing \$1,260

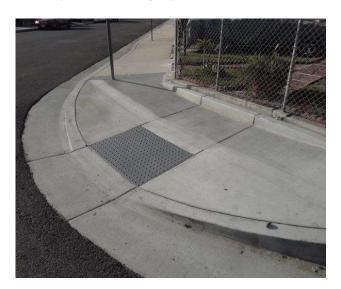
Curb Ramp : Bottom Landing Slope

The bottom landing of the curb ramp is on the street, and the slope of the bottom landing is not compliant.

On-Site Finding 5.40 percent

Code Reference ADA 406, 406.2,CA 11B-406.5.8

Ensure the bottom landing slope is compliant and provides a smooth transition.

Recommendation Up to 5.00 percent

Repave landing \$1,260

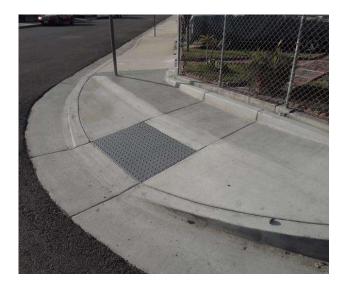
Curb Ramp, Landings and Transitions: Top Landing Slope

The slope at the top landing is greater than allowed.

On-Site Finding 2.70 percent

Code Reference ADA 402, 406.4, 403.3, 406.1,CA 11B-406.5.3

Provide a top landing surface that does not exceed the maximum slope and cross slope. Provide a sufficient maneuvering clearance that does not accumulate water.

Recommendation Up to 2.08 percent

Provide compliant landing \$1,260

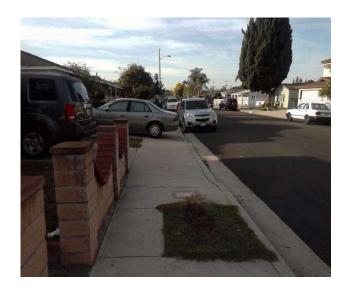
Sidewalk South Of Golden Street @ 33.908821094255, -118.147922158241

Sidewalks : Width

Sidewalk does not have enough width.

On-Site Finding 28.00 inches for 3.00 feet

Code Reference ADA 206, 302,CA 11B-403.5.1

Widen the sidewalk to the recommended value.

Recommendation At least 48.00 inches

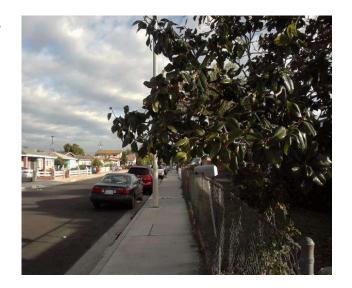
Tree South Of Prichard Street @ 33.906257775156, -118.149660229683

Sidewalks , Hazards & Gratings : Overhead Obstruction Height

Overhead obstruction height is not compliant.

On-Site Finding 66.00 inches

Code Reference ADA 206, 307.4,CA 11B-307.4

Provide a compliant vertical clearance height.

Recommendation At least 80.00 inches

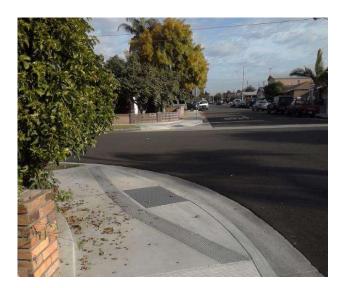
Prichard Street West Crossing @ 33.907357462960, -118.149079531431

Sidewalks : Vehicular Traffic Slope

Slope at vehicular traffic is not compliant.

On-Site Finding 5.50 percent

Repave the surface to provide a compliant slope.

Recommendation Up to 5.00 percent

Repave surface \$1,092

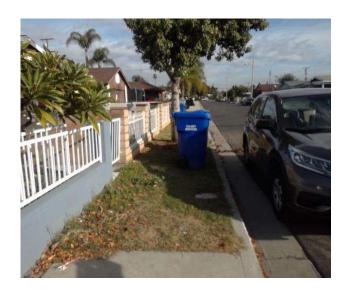
Sidewalk North Of Prichard Street @ 33.907728103527, -118.148831427097

Sidewalks : Missing Sidewalk

Section of sidewalk is missing and consists of dirt, grass or gravel.

On-Site Finding 39.00 feet

Code Reference ADA 206, 302,CA 11B-302,CA 11B-206

Provide a compliant sidewalk for the missing section.
