Accessibility Survey

City of Downey Lindsey Avenue - Cedartree Road to Brookpark Road

Cedartree Road to Brookpark Road Downey, CA 90242

Date of Inspection 6/14/2017

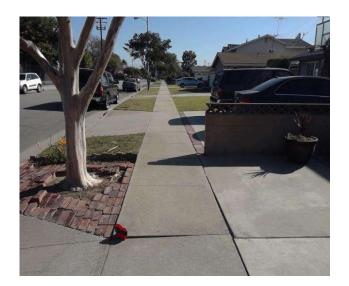
Change in Level South of Cedartree Road @ 33.954887583451, -118.106785118580

Sidewalks , Change in Level : Change in Level Non Beveled

There is a change in elevation greater than recommended value.

On-Site Finding 0.62 inches

Code Reference ADA 206, 302

Ensure that the change in elevation is within the recommended value.

Recommendation Up to 0.25 inches

Remove tripping hazards \$198

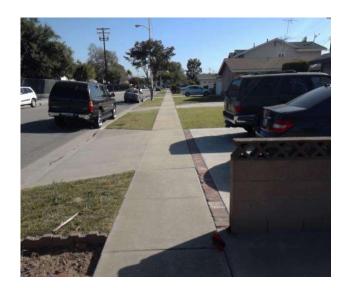
Change in Level South of Cedartree Road @ 33.954902044859, -118.106778413057

Sidewalks , Change in Level : Change in Level Non Beveled

There is a change in elevation greater than recommended value.

On-Site Finding 0.62 inches

Code Reference ADA 206, 302

Ensure that the change in elevation is within the recommended value.

Recommendation Up to 0.25 inches

Remove tripping hazards \$198

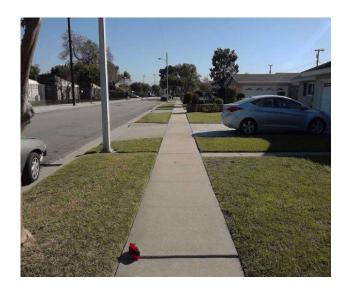
Change in Level South of Cedartree Road @ 33.955134539478, -118.106659054756

Sidewalks , Change in Level : Change in Level Non Beveled

There is a change in elevation greater than recommended value.

On-Site Finding 0.75 inches

Code Reference ADA 206, 302

Ensure that the change in elevation is within the recommended value.

Recommendation Up to 0.25 inches

Remove tripping hazards \$198

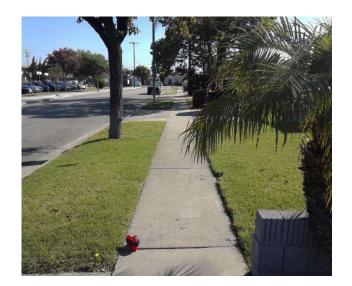
Change in Level South of Cedartree Road @ 33.955723003878, -118.106365352869

Sidewalks , Change in Level : Change in Level Non Beveled

There is a change in elevation greater than recommended value.

On-Site Finding 0.50 inches

Code Reference ADA 206, 302

Ensure that the change in elevation is within the recommended value.

Recommendation Up to 0.25 inches

Remove tripping hazards \$198

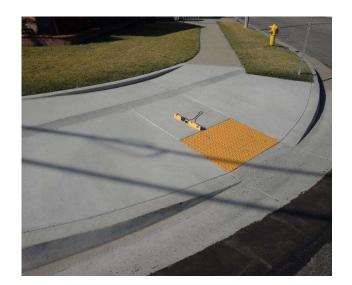
Southeast Corner of Cedartree Road @ 33.956499459185, - 118.105956315994

Curb Ramp : Not Wholly Contained Within The Marked Crossing

The curb ramp is not wholly contained within the marked crossing.

On-Site Finding Not Found

Code Reference ADA 406, 406.5

Provide a marked crossing on the path of travel; make certain the curb ramp is wholly contained within the marked crossing.

Install crosswalk \$800

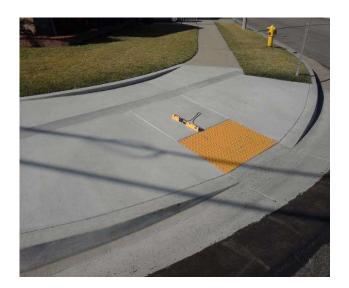
Southeast Corner of Cedartree Road @ 33.956499459185, - 118.105956315994

Curb Ramp : Curb Ramp Slope

The running slope is greater than allowed.

On-Site Finding 8.70 percent

Code Reference ADA 406, 406.1, 405.2,CA 11B-406

Provide a compliant curb ramp.

Recommendation Up to 8.33 percent

Install curb ramp \$1,300

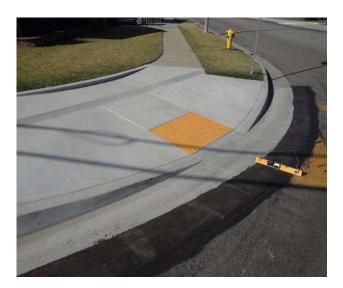
Southeast Corner of Cedartree Road @ 33.956499459185, - 118.105956315994

The bottom landing of the curb ramp is on the street, and the slope of the bottom landing is not compliant.

On-Site Finding 6.80 percent

Curb Ramp : Bottom Landing Slope

Code Reference ADA 406, 406.2,CA 11B-406.5.8

Ensure the bottom landing slope is compliant and provides a smooth transition.

Recommendation Up to 5.00 percent

Repave landing \$1,260

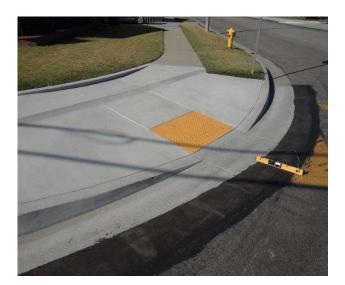
Southeast Corner of Cedartree Road @ 33.956499459185, - 118.105956315994

The slope at the top landing is greater than allowed.

On-Site Finding 3.80 percent

Curb Ramp , Landings and Transitions : Top Landing Slope

Code Reference ADA 402, 406.4, 403.3, 406.1,CA 11B-406.5.3

Provide a top landing surface that does not exceed the maximum slope and cross slope. Provide a sufficient maneuvering clearance that does not accumulate water.

Recommendation Up to 2.08 percent

Provide compliant landing \$1,260

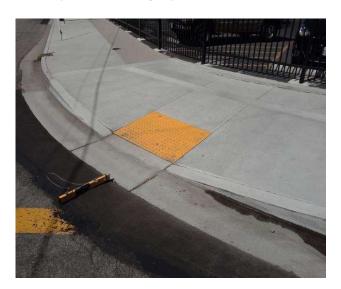
Southwest Corner of Cedartree Road @ 33.956609586226, - 118.106122612953

The bottom landing of the curb ramp is on the street, and the slope of the bottom landing is not compliant.

On-Site Finding 12.90 percent

Curb Ramp : Bottom Landing Slope

Code Reference ADA 406, 406.2,CA 11B-406.5.8

Ensure the bottom landing slope is compliant and provides a smooth transition.

Recommendation Up to 5.00 percent

Repave landing \$1,260

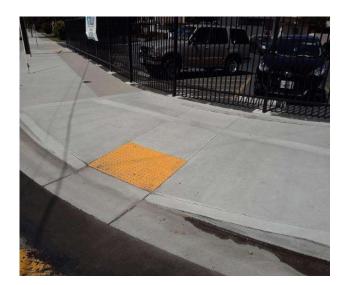
Southwest Corner of Cedartree Road @ 33.956609586226, - 118.106122612953

Curb Ramp : Not Wholly Contained Within The Marked Crossing

The curb ramp is not wholly contained within the marked crossing.

On-Site Finding Not Found

Code Reference ADA 406, 406.5

Provide a marked crossing on the path of travel; make certain the curb ramp is wholly contained within the marked crossing.

Install crosswalk \$800

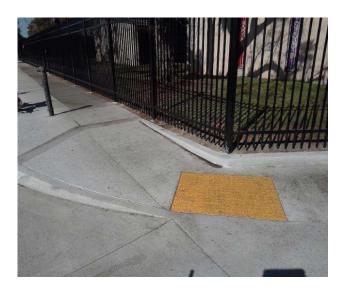
West Side North of Cedartree Road - 1st @ 33.955865391629, - 118.106491416693

Curb Ramp : Detectable Warning Domes Direction

Detectable warning domes are not aligned in the direction of travel.

On-Site Finding Not Compliant

Provide compliant detectable warnings with domes aligned in the direction of travel.

Install compliant detectable \$190 warnings

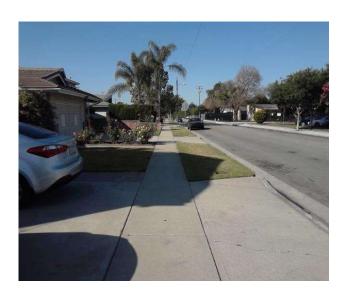
Driveway South of Cedartree Road @ 33.956319250992, -118.106066286564

Sidewalks , Vehicular Traffic : Cross Walks and Detectable Warnings

There are no detectable warnings where the pedestrian route crosses vehicular traffic.

On-Site Finding Not Found

Code Reference ADA 705,CA 11B-705.1.2.5,CA 11B-247.1.2.5

Provide detectable warnings.

Install compliant detectable \$190

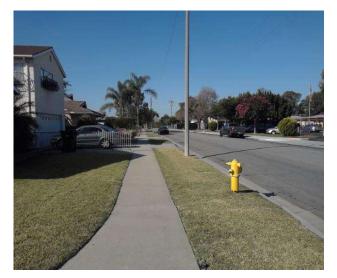
East Side @ 33.956482773257, -118.105969727039

Sidewalks : 60X60 Turn Area

There is no 60X60 turn area at every 200 feet.

On-Site Finding Not Found

Code Reference ADA 206, 302

Provide a 60X60 turn every 200 feet on the sidewalk.

\$2,400

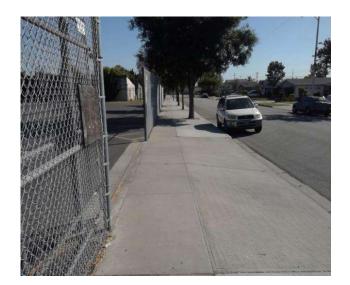
Driveway North of Cedartree Road @ 33.955080031227, -118.106874972582

Sidewalks , Vehicular Traffic : Cross Walks and Detectable Warnings

There are no detectable warnings where the pedestrian route crosses vehicular traffic.

On-Site Finding Not Found

Code Reference ADA 705,CA 11B-705.1.2.5,CA 11B-247.1.2.5

Provide detectable warnings.

Install compliant detectable \$190 warnings

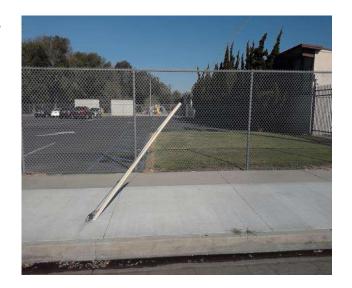
Guy Wire North of Cedartree Road @ 33.955357021771, -118.106716722250

Sidewalks , Hazards & Gratings : Overhead Obstruction Height

Overhead obstruction height is not compliant.

On-Site Finding 65.00 inches

Code Reference ADA 206, 307.4,CA 11B-307.4

Provide a compliant vertical clearance height.

Recommendation At least 80.00 inches
