Accessibility Survey

City of Downey Rutgers Avenue - Angell Street To Foster Road

Date of Inspection
12/3/2016

Prepared By
Disability Access Consultants
(800) 743-7067

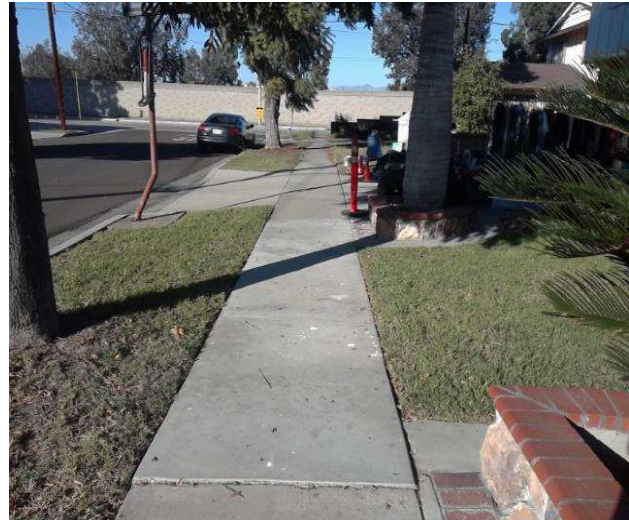
Change In Level South Of Angell Street @ 33.912143388367, -118.128659874201

Sidewalks , Change in Level : Change in Level Non Beveled

There is a change in elevation greater than recommended value.

On-Site Finding 0.75 inches

Code Reference ADA 206, 302

Ensure that the change in elevation is within the recommended value.

Recommendation Up to 0.25 inches

Remove tripping hazards \$198

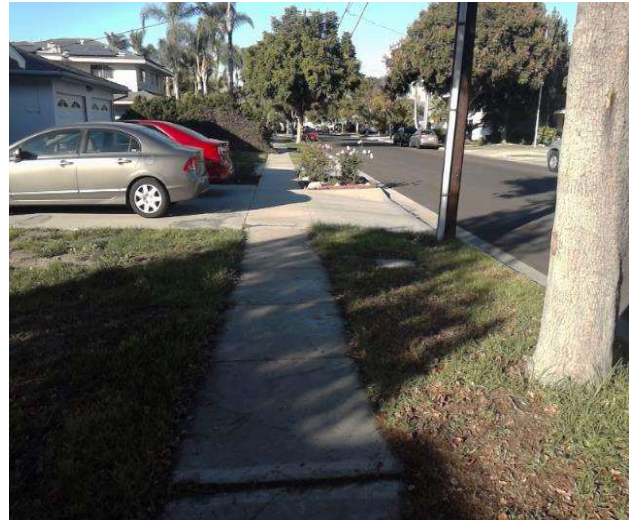
Change In Level North Of Foster Road @ 33.910280248421, -118.128838241100

Sidewalks , Change in Level : Change in Level Non Beveled

There is a change in elevation greater than recommended value.

On-Site Finding 0.37 inches

Code Reference ADA 206, 302

Ensure that the change in elevation is within the recommended value.

Recommendation Up to 0.25 inches

Remove tripping hazards \$198

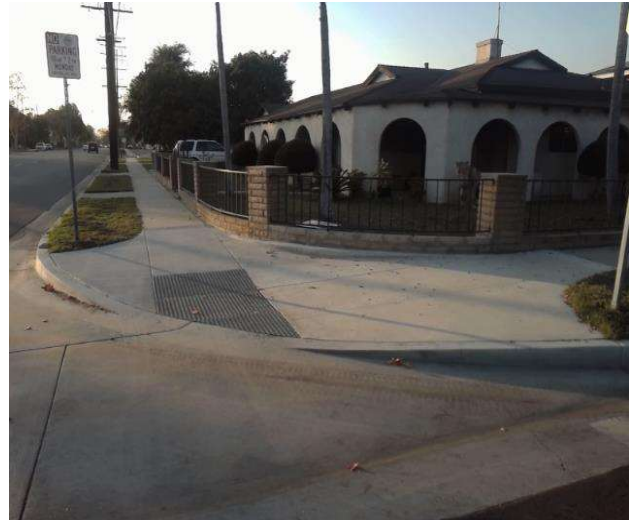
Northwest Corner Of Foster Road @ 33.909862872778, - 118.128842264414

Curb Ramp , Landings and Transitions : Top Landing Slope

The slope at the top landing is greater than allowed.

On-Site Finding 2.70 percent

Code Reference ADA 402, 406.4, 403.3, 406.1, CA 11B-406.5.3

Provide a top landing surface that does not exceed the maximum slope and cross slope. Provide a sufficient maneuvering clearance that does not accumulate water.

Recommendation Up to 2.08 percent

Provide compliant landing \$1,260

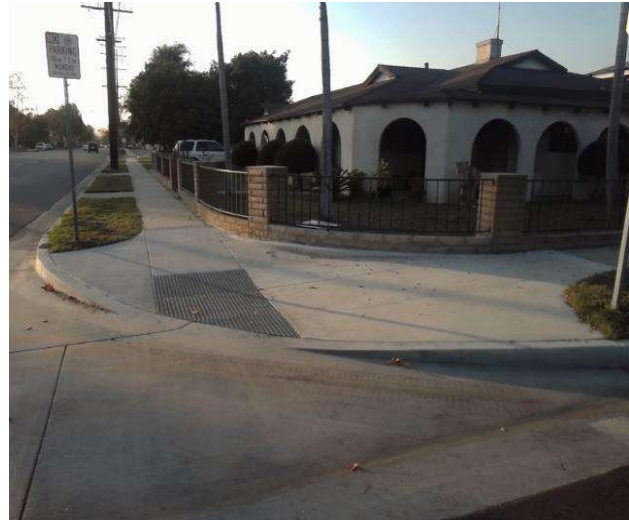
Northwest Corner Of Foster Road @ 33.909862872778, - 118.128842264414

The slope at the top landing is greater than allowed.

On-Site Finding 3.30 percent

Curb Ramp , Landings and Transitions : Top Landing Right Side
Slope - Parallel Curb Ramp

Code Reference ADA 406.4, 403.3, 406.1, CA 11B-406.5.3

Provide a top landing surface that does not exceed the maximum slope and cross slope. Provide a sufficient maneuvering clearance that does not accumulate water.

Recommendation Up to 2.08 percent

Provide compliant landing \$1,260

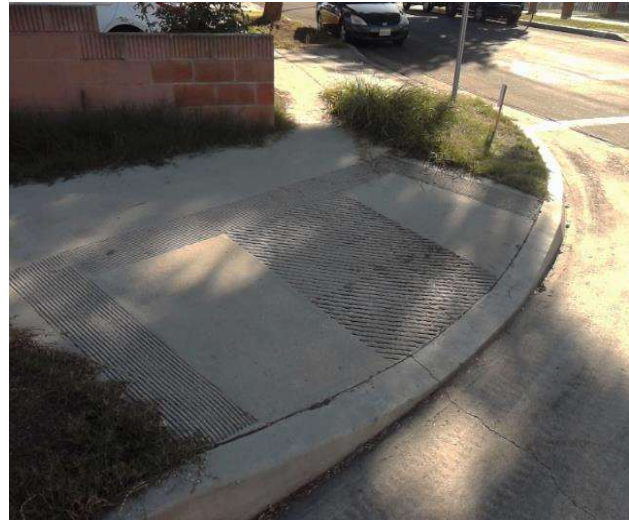
Southeast Corner Of Angell Street @ 33.912402711068, - 118.128667920828

Curb Ramp : No Detectable Warnings

The curb ramp does not provide a detectable warning surface which includes truncated domes.

On-Site Finding Not Found

Code Reference CA 11B-406.5.12

Provide compliant detectable warnings to surface.

Provide detectable warning to surface \$248

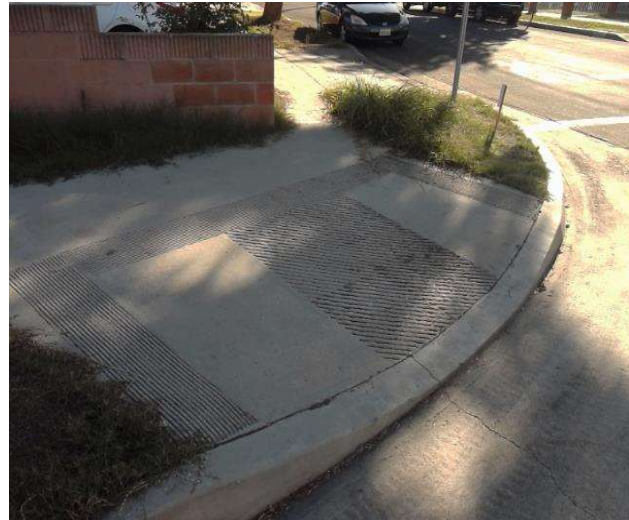
Southeast Corner Of Angell Street @ 33.912402711068, - 118.128667920828

Curb Ramp : Curb Ramp Slope

The running slope is greater than allowed.

On-Site Finding 11.30 percent

Code Reference ADA 406, 406.1, 405.2, CA 11B-406

Provide a compliant curb ramp.

Recommendation Up to 8.33 percent

Install curb ramp \$1,300

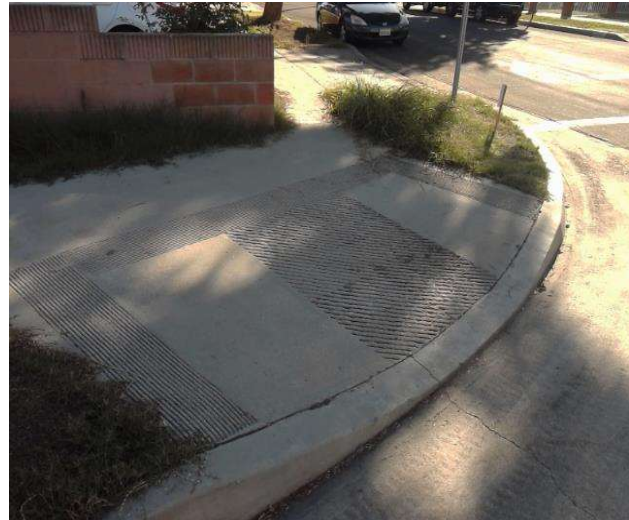
Southeast Corner Of Angell Street @ 33.912402711068, - 118.128667920828

Curb Ramp : Side Flare Slope

The slope of the curb ramp side flare is greater than allowed.

On-Site Finding 12.40 percent

Code Reference ADA 406, 406.3, CA 11B-406.2.2

Provide curb ramp side flares with a compliant slope.

Recommendation Up to 10.00 percent

Install flared sides \$1,300

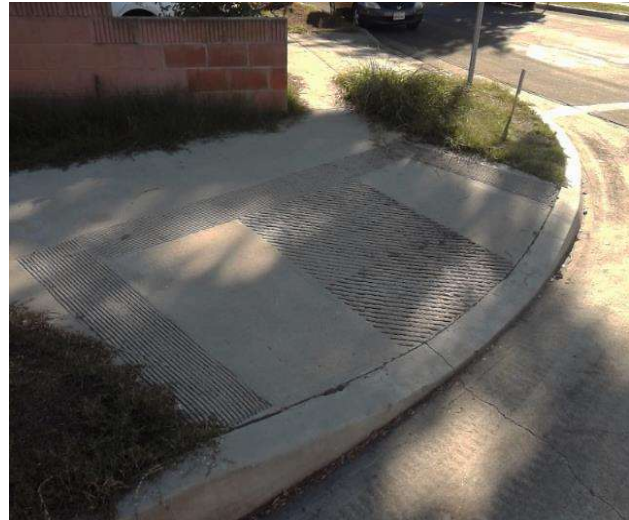
Southeast Corner Of Angell Street @ 33.912402711068, - 118.128667920828

The transition from the bottom of the curb ramp to the walk, gutter, or street is abrupt.

On-Site Finding 1.25 inches

Curb Ramp , Landings And Transitions : Bottom Landing Change in Level

Code Reference ADA 302, 303, 406.2, 303.1

Patch the transition area at the bottom of the curb ramp so that the transition is flush and free of abrupt changes.

Recommendation Up to 0.50 inches

Patch lip at curb ramp \$255

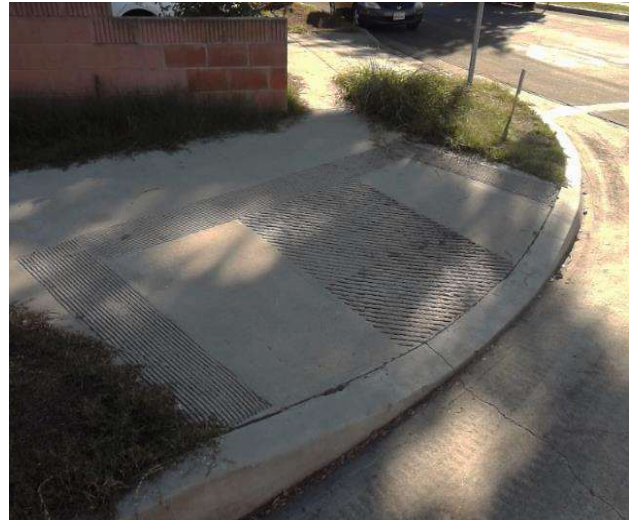
Southeast Corner Of Angell Street @ 33.912402711068, - 118.128667920828

Curb Ramp , Landings and Transitions : Top Landing Slope

The slope at the top landing is greater than allowed.

On-Site Finding 8.80 percent

Code Reference ADA 402, 406.4, 403.3, 406.1, CA 11B-406.5.3

Provide a top landing surface that does not exceed the maximum slope and cross slope. Provide a sufficient maneuvering clearance that does not accumulate water.

Recommendation Up to 2.08 percent

Provide compliant landing \$1,260

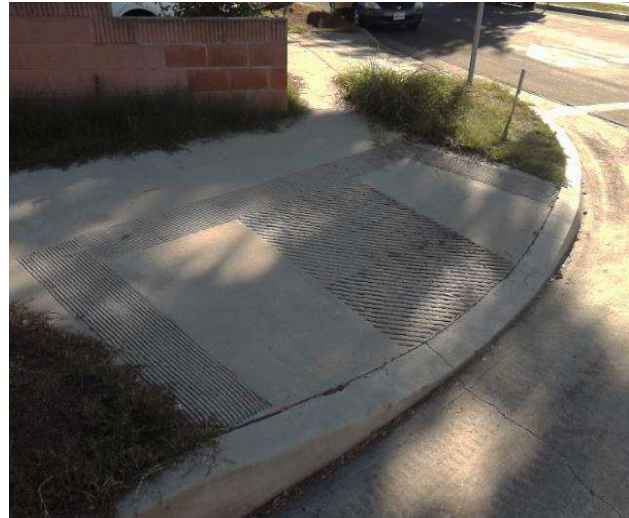
Southeast Corner Of Angell Street @ 33.912402711068, - 118.128667920828

Curb Ramp , Landings and Transitions : Top Landing Clear Length - Landings

There is not enough top landing clear length.

On-Site Finding 47.00 inches

Code Reference ADA 406, 406.4,CA 11B-406.5.3

Provide a level top landing with enough clear length.

Recommendation At least 48.00 inches

Provide compliant landing \$240

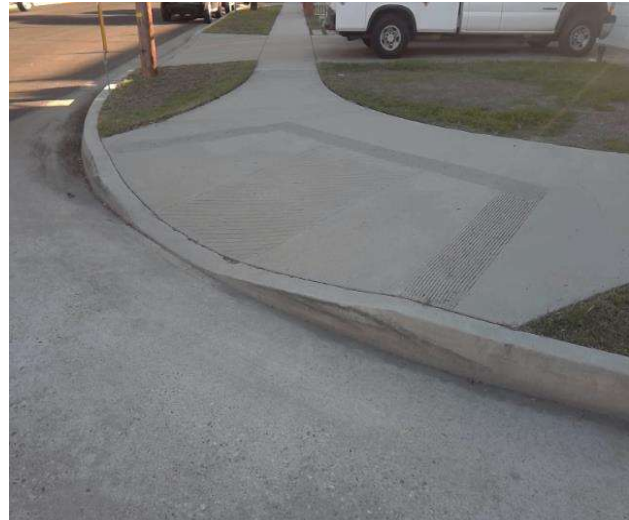
Southwest Corner Of Angell Street @ 33.912391581355, - 118.128857016563

Curb Ramp : No Detectable Warnings

The curb ramp does not provide a detectable warning surface which includes truncated domes.

On-Site Finding Not Found

Code Reference CA 11B-406.5.12

Provide compliant detectable warnings to surface.

Provide detectable warning to surface \$248

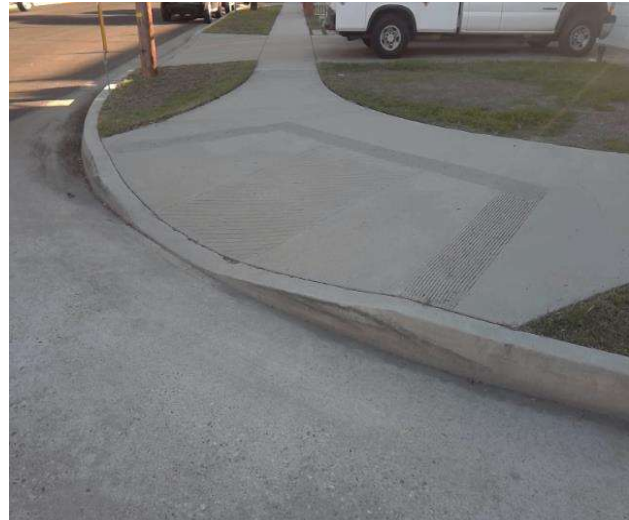
Southwest Corner Of Angell Street @ 33.912391581355, - 118.128857016563

Curb Ramp : Curb Ramp Slope

The running slope is greater than allowed.

On-Site Finding 13.40 percent

Code Reference ADA 406, 406.1, 405.2, CA 11B-406

Provide a compliant curb ramp.

Recommendation Up to 8.33 percent

Install curb ramp \$1,300

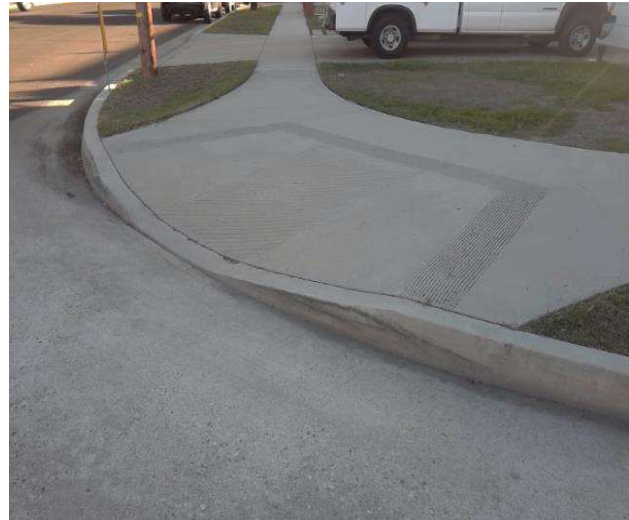
Southwest Corner Of Angell Street @ 33.912391581355, - 118.128857016563

Curb Ramp : Side Flare Slope

The slope of the curb ramp side flare is greater than allowed.

On-Site Finding 13.80 percent

Code Reference ADA 406, 406.3, CA 11B-406.2.2

Provide curb ramp side flares with a compliant slope.

Recommendation Up to 10.00 percent

Install flared sides \$1,300

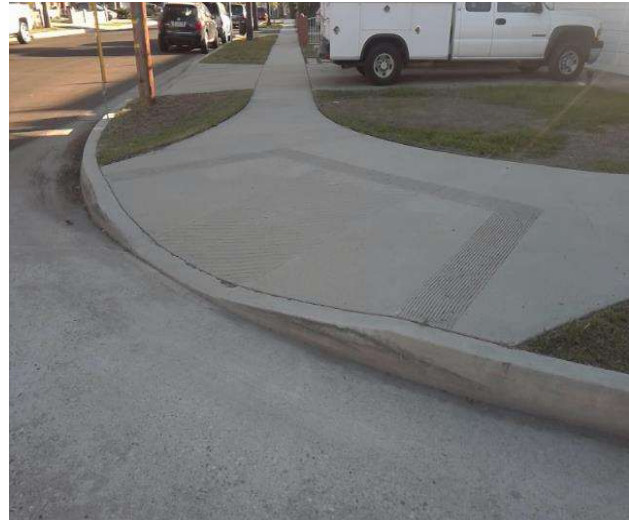
Southwest Corner Of Angell Street @ 33.912391581355, - 118.128857016563

Curb Ramp : Bottom Landing Slope

The bottom landing of the curb ramp is on the street, and the slope of the bottom landing is not compliant.

On-Site Finding 7.30 percent

Code Reference ADA 406, 406.2, CA 11B-406.5.8

Ensure the bottom landing slope is compliant and provides a smooth transition.

Recommendation Up to 5.00 percent

Repave landing \$1,260

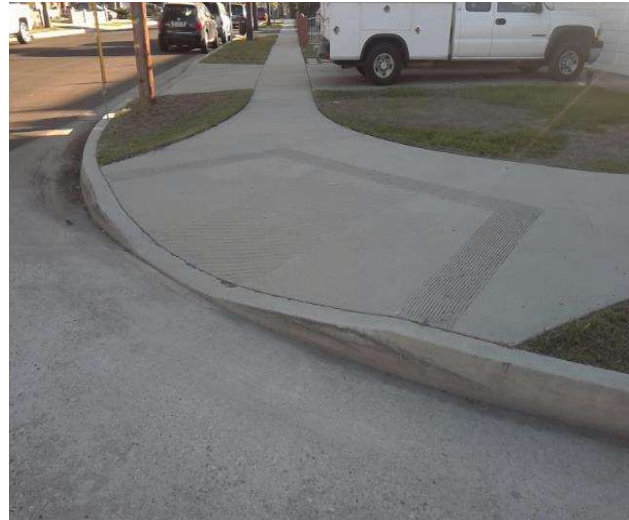
Southwest Corner Of Angell Street @ 33.912391581355, - 118.128857016563

The transition from the bottom of the curb ramp to the walk, gutter, or street is abrupt.

On-Site Finding 1.00 inches

Curb Ramp , Landings And Transitions : Bottom Landing Change in Level

Code Reference ADA 302, 303, 406.2, 303.1

Patch the transition area at the bottom of the curb ramp so that the transition is flush and free of abrupt changes.

Recommendation Up to 0.50 inches

Patch lip at curb ramp \$255

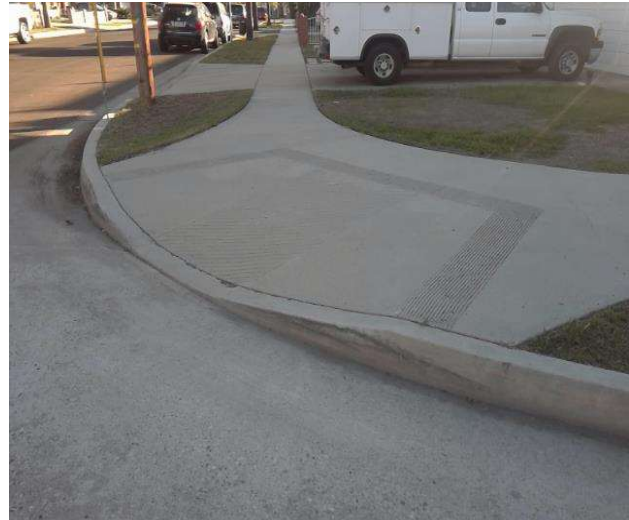
Southwest Corner Of Angell Street @ 33.912391581355, - 118.128857016563

The slope at the top landing is greater than allowed.

On-Site Finding 2.70 percent

Curb Ramp , Landings and Transitions : Top Landing Slope

Code Reference ADA 402, 406.4, 403.3, 406.1,CA 11B-406.5.3

Provide a top landing surface that does not exceed the maximum slope and cross slope. Provide a sufficient maneuvering clearance that does not accumulate water.

Recommendation Up to 2.08 percent

Provide compliant landing \$1,260

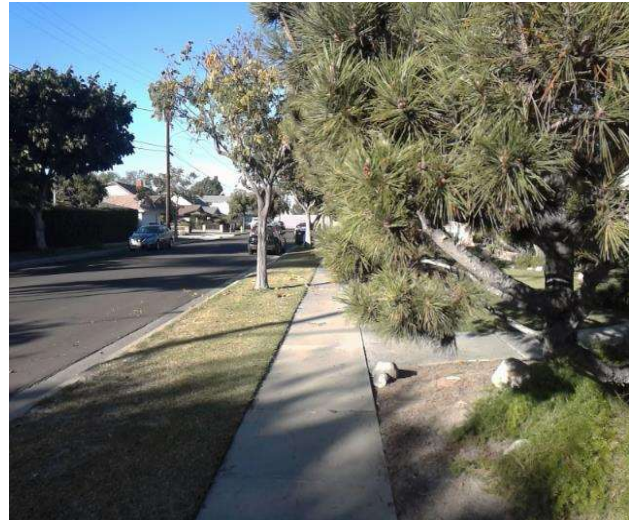
Tree South Of Angell Street @ 33.911279715654, -118.128667920828

Sidewalks , Hazards & Gratings : Overhead Obstruction Height

Overhead obstruction height is not compliant.

On-Site Finding 48.00 inches

Code Reference ADA 206, 307.4,CA 11B-307.4

Provide a compliant vertical clearance height.

Recommendation At least 80.00 inches

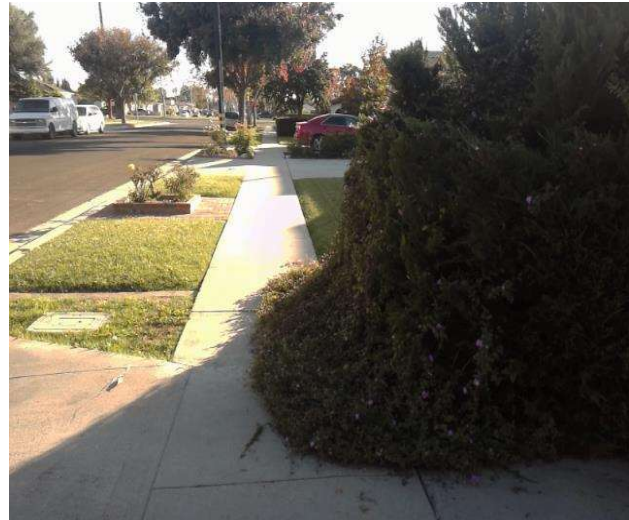
Bush North Of Foster Road @ 33.910529559830, -118.128847628832

Sidewalks , Hazards & Gratings : Sidewalk Width at Obstruction

Sidewalk width at the obstruction is not compliant.

On-Site Finding 25.00 inches

Code Reference ADA 206, 302, 403.5.1, CA 11B-403.5

Sidewalk width at the obstruction shall have the recommended value.

Recommendation At least 48.00 inches

\$1,260

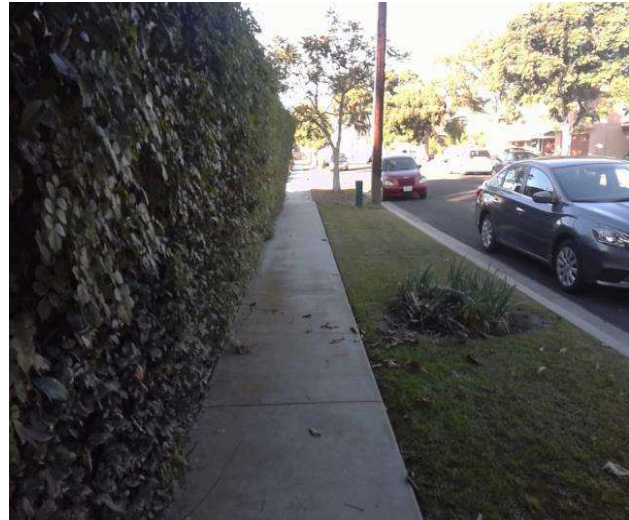
Sidewalk North Of Foster Road @ 33.911408821926, -118.128843605518

Sidewalks , Surface : Cross Slope

Sidewalk cross slope is not compliant.

On-Site Finding 3.90 percent for 130.00 feet

Code Reference ADA 206, 302, CA 11B-403.3

Repave the sidewalk surface with the recommended cross slope.

Recommendation Up to 2.08 percent

Repave surface \$1,092
