Accessibility Survey

City of Downey Premiere Avenue - Angell Street To Foster Road

Angell Street To Foster Road
Downey, CA 90242

Date of Inspection
12/3/2016

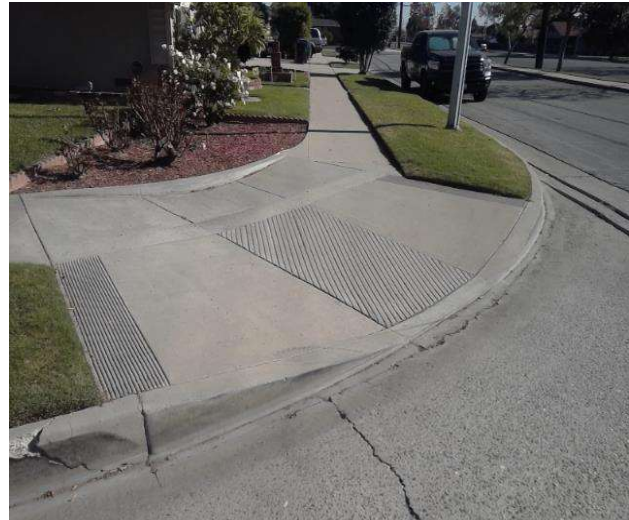
Northeast Corner Of Foster Road @ 33.909965269125, - 118.130517303944

Curb Ramp : No Detectable Warnings

The curb ramp does not provide a detectable warning surface which includes truncated domes.

On-Site Finding Not Found

Code Reference CA 11B-406.5.12

Provide compliant detectable warnings to surface.

Provide detectable warning to surface \$248

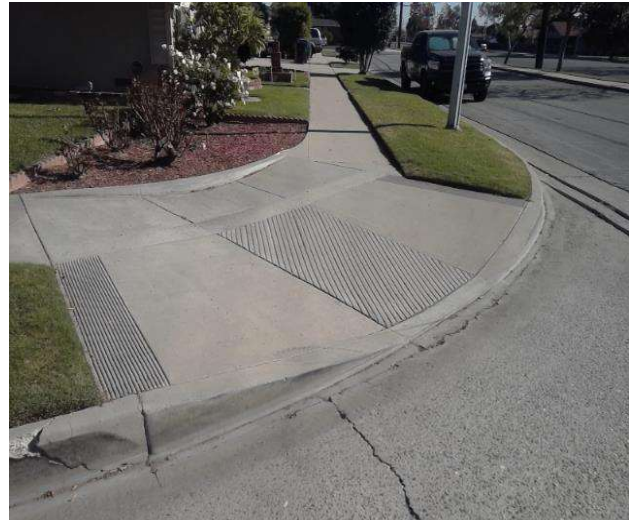
Northeast Corner Of Foster Road @ 33.909965269125, - 118.130517303944

Curb Ramp : Side Flare Slope

The slope of the curb ramp side flare is greater than allowed.

On-Site Finding 13.80 percent

Code Reference ADA 406, 406.3, CA 11B-406.2.2

Provide curb ramp side flares with a compliant slope.

Recommendation Up to 10.00 percent

Install flared sides \$1,300

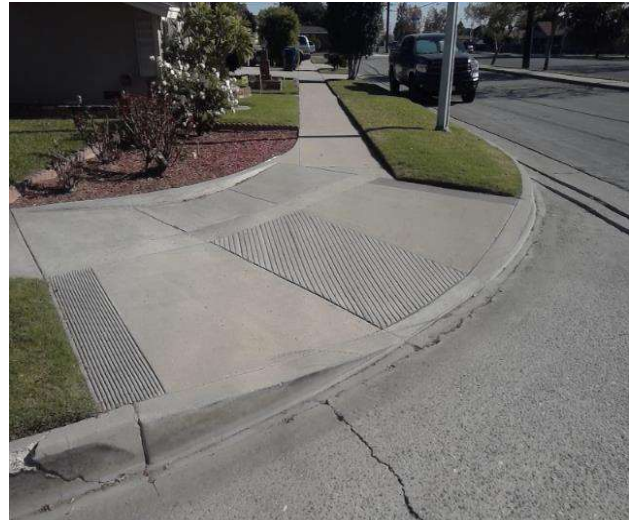
Northeast Corner Of Foster Road @ 33.909965269125, - 118.130517303944

Curb Ramp : Bottom Landing Slope

The bottom landing of the curb ramp is on the street, and the slope of the bottom landing is not compliant.

On-Site Finding 6.30 percent

Code Reference ADA 406, 406.2, CA 11B-406.5.8

Ensure the bottom landing slope is compliant and provides a smooth transition.

Recommendation Up to 5.00 percent

Repave landing \$1,260

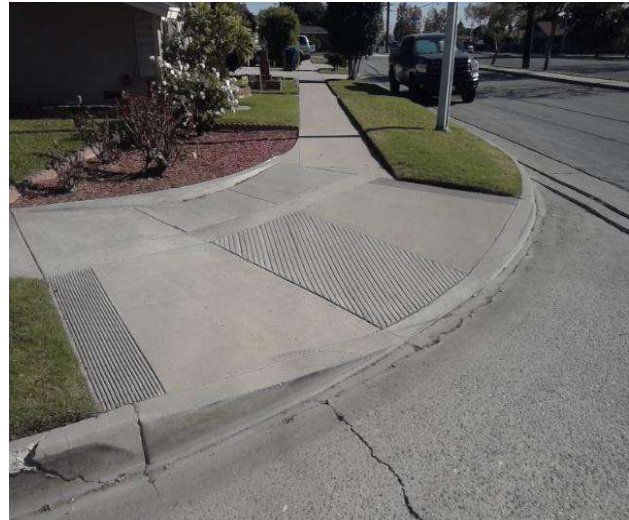
Northeast Corner Of Foster Road @ 33.909965269125, - 118.130517303944

Curb Ramp , Landings and Transitions : Top Landing Slope

The slope at the top landing is greater than allowed.

On-Site Finding 2.60 percent

Code Reference ADA 402, 406.4, 403.3, 406.1, CA 11B-406.5.3

Provide a top landing surface that does not exceed the maximum slope and cross slope. Provide a sufficient maneuvering clearance that does not accumulate water.

Recommendation Up to 2.08 percent

Provide compliant landing \$1,260

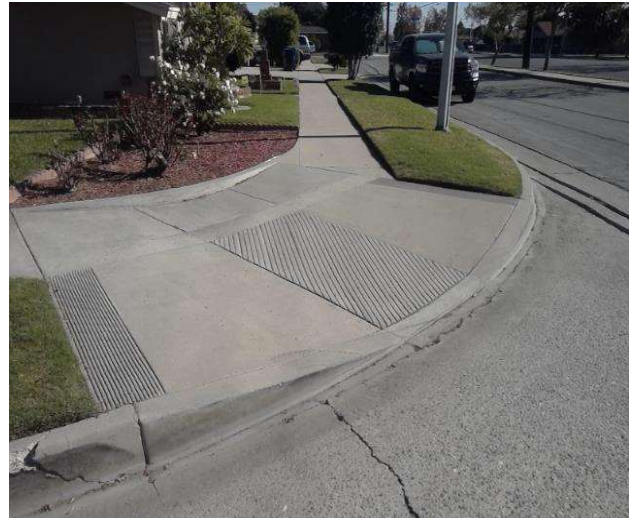
**Northeast Corner Of Foster Road @ 33.909965269125, -
118.130517303944**

Curb Ramp , Landings and Transitions : Top Landing Clear Length - Landings

There is not enough top landing clear length.

On-Site Finding 46.00 inches

Code Reference ADA 406, 406.4,CA 11B-406.5.3

Provide a level top landing with enough clear length.

Recommendation At least 48.00 inches

Provide compliant landing \$240

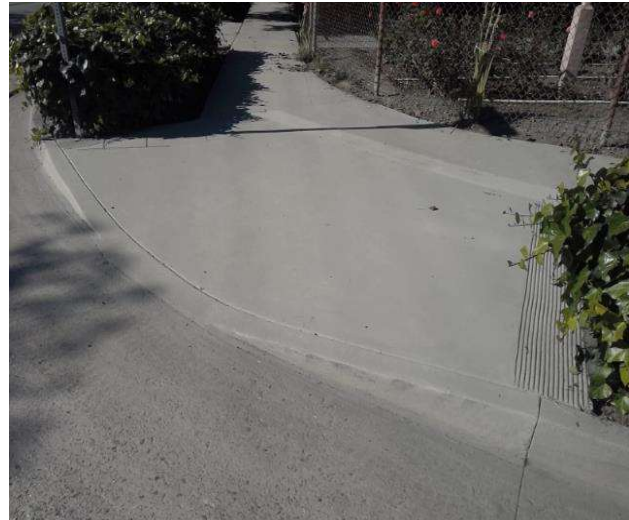
Northwest Corner Of Angell Street @ 33.909973060146, - 118.130687624216

Curb Ramp : No Detectable Warnings

The curb ramp does not provide a detectable warning surface which includes truncated domes.

On-Site Finding Not Found

Code Reference CA 11B-406.5.12

Provide compliant detectable warnings to surface.

Provide detectable warning to surface \$248

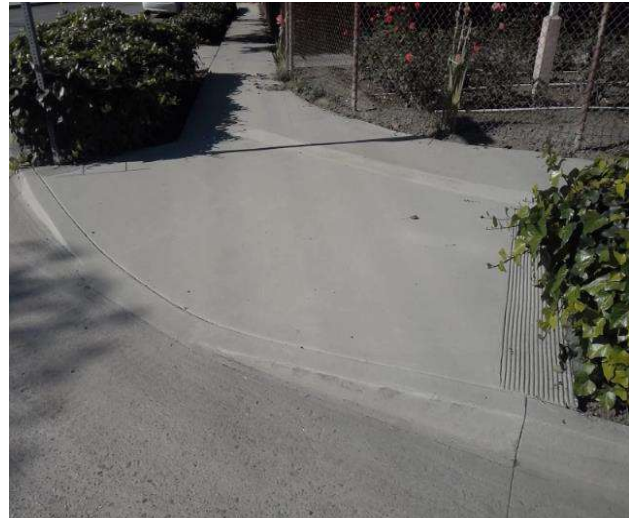
**Northwest Corner Of Angell Street @ 33.909973060146, -
118.130687624216**

Curb Ramp , Landings and Transitions : Top Landing Slope

The slope at the top landing is greater than allowed.

On-Site Finding 2.60 percent

Code Reference ADA 402, 406.4, 403.3, 406.1, CA 11B-406.5.3

Provide a top landing surface that does not exceed the maximum slope and cross slope. Provide a sufficient maneuvering clearance that does not accumulate water.

Recommendation Up to 2.08 percent

Provide compliant landing \$1,260

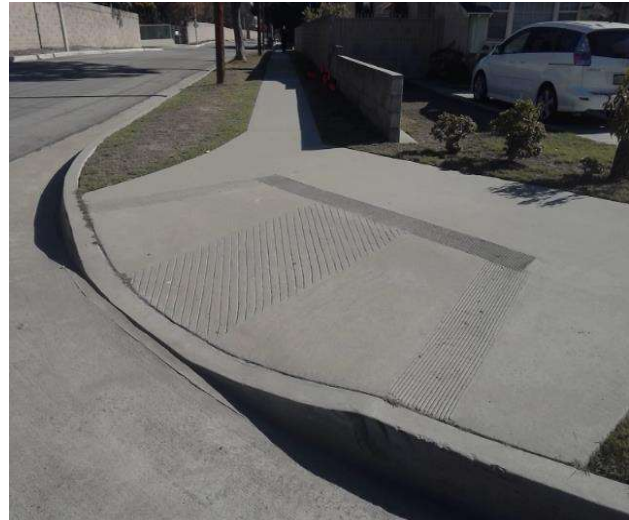
Southeast Corner Of Angell Street @ 33.912392694326, - 118.130522668362

Curb Ramp : No Detectable Warnings

The curb ramp does not provide a detectable warning surface which includes truncated domes.

On-Site Finding Not Found

Code Reference CA 11B-406.5.12

Provide compliant detectable warnings to surface.

Provide detectable warning to surface \$248

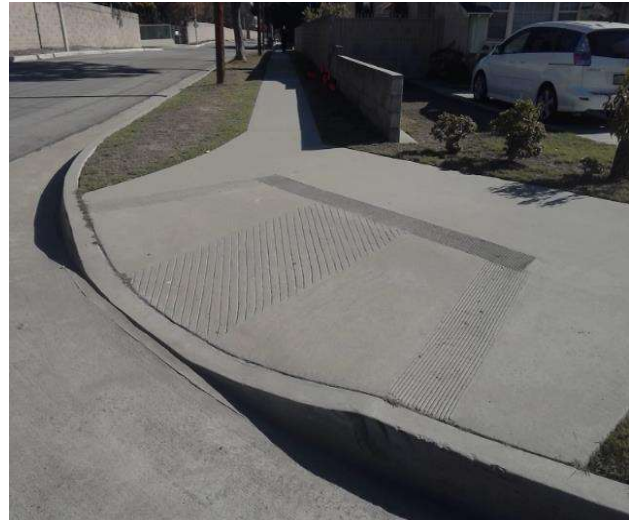
Southeast Corner Of Angell Street @ 33.912392694326, - 118.130522668362

Curb Ramp : Curb Ramp Slope

The running slope is greater than allowed.

On-Site Finding 12.60 percent

Code Reference ADA 406, 406.1, 405.2, CA 11B-406

Provide a compliant curb ramp.

Recommendation Up to 8.33 percent

Install curb ramp \$1,300

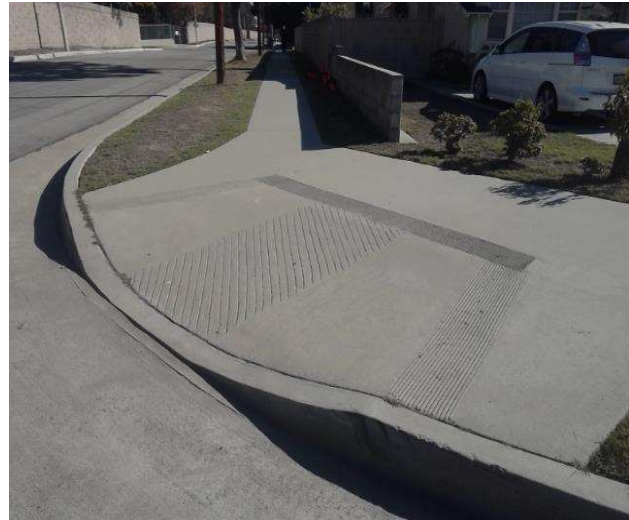
Southeast Corner Of Angell Street @ 33.912392694326, - 118.130522668362

Curb Ramp : Side Flare Slope

The slope of the curb ramp side flare is greater than allowed.

On-Site Finding 21.80 percent

Code Reference ADA 406, 406.3, CA 11B-406.2.2

Provide curb ramp side flares with a compliant slope.

Recommendation Up to 10.00 percent

Install flared sides \$1,300

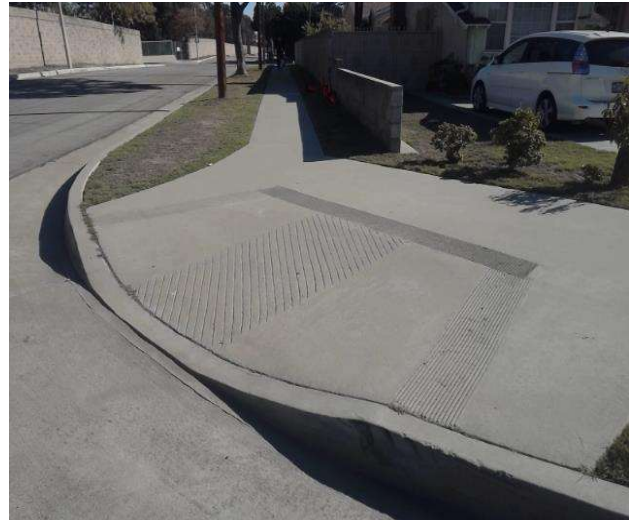
Southeast Corner Of Angell Street @ 33.912392694326, - 118.130522668362

Curb Ramp : Bottom Landing Slope

The bottom landing of the curb ramp is on the street, and the slope of the bottom landing is not compliant.

On-Site Finding 6.60 percent

Code Reference ADA 406, 406.2, CA 11B-406.5.8

Ensure the bottom landing slope is compliant and provides a smooth transition.

Recommendation Up to 5.00 percent

Repave landing \$1,260

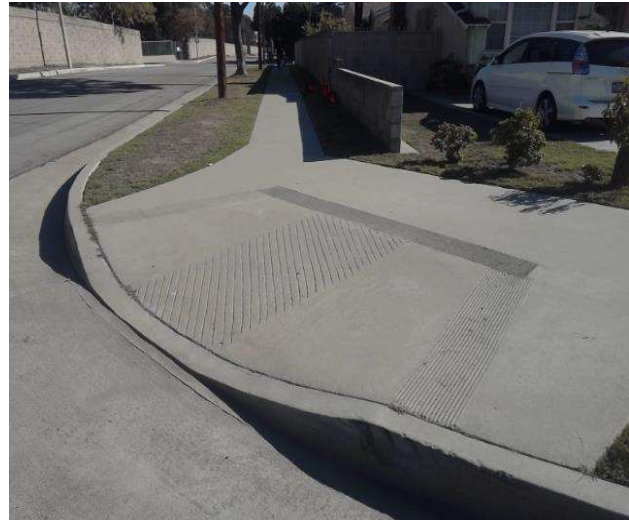
Southeast Corner Of Angell Street @ 33.912392694326, - 118.130522668362

The transition from the bottom of the curb ramp to the walk, gutter, or street is abrupt.

On-Site Finding 0.75 inches

Curb Ramp , Landings And Transitions : Bottom Landing Change in Level

Code Reference ADA 302, 303, 406.2, 303.1

Patch the transition area at the bottom of the curb ramp so that the transition is flush and free of abrupt changes.

Recommendation Up to 0.50 inches

Patch lip at curb ramp \$255

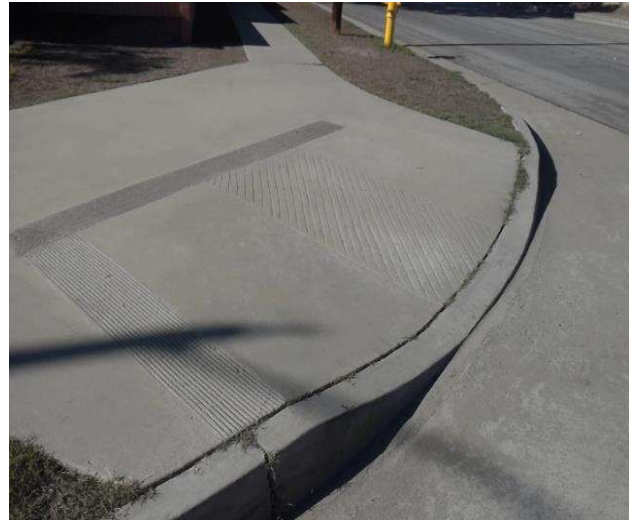
Southwest Corner Of Angell Street @ 33.912393807298, - 118.130692988634

Curb Ramp : No Detectable Warnings

The curb ramp does not provide a detectable warning surface which includes truncated domes.

On-Site Finding Not Found

Code Reference CA 11B-406.5.12

Provide compliant detectable warnings to surface.

Provide detectable warning to surface \$248

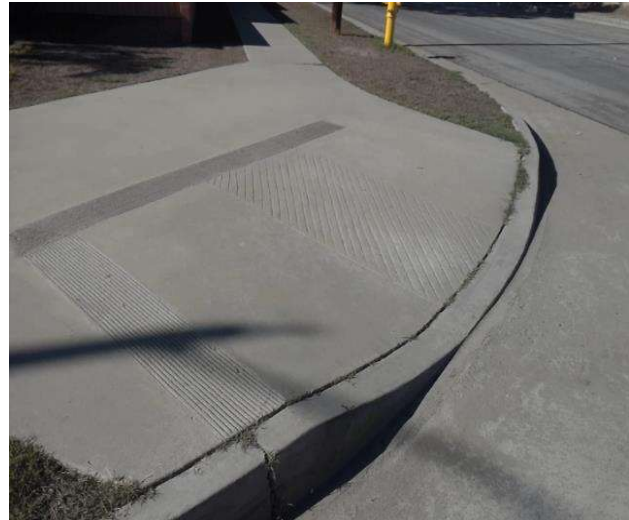
Southwest Corner Of Angell Street @ 33.912393807298, - 118.130692988634

Curb Ramp : Curb Ramp Slope

The running slope is greater than allowed.

On-Site Finding 10.60 percent

Code Reference ADA 406, 406.1, 405.2, CA 11B-406

Provide a compliant curb ramp.

Recommendation Up to 8.33 percent

Install curb ramp \$1,300

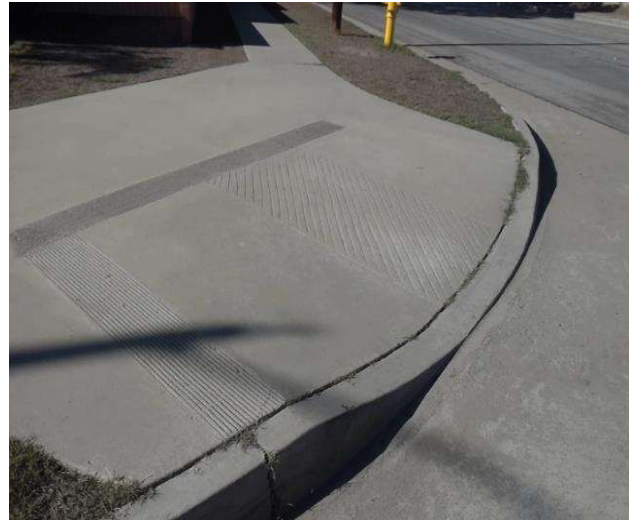
Southwest Corner Of Angell Street @ 33.912393807298, - 118.130692988634

Curb Ramp : Side Flare Slope

The slope of the curb ramp side flare is greater than allowed.

On-Site Finding 13.20 percent

Code Reference ADA 406, 406.3,CA 11B-406.2.2

Provide curb ramp side flares with a compliant slope.

Recommendation Up to 10.00 percent

Install flared sides \$1,300

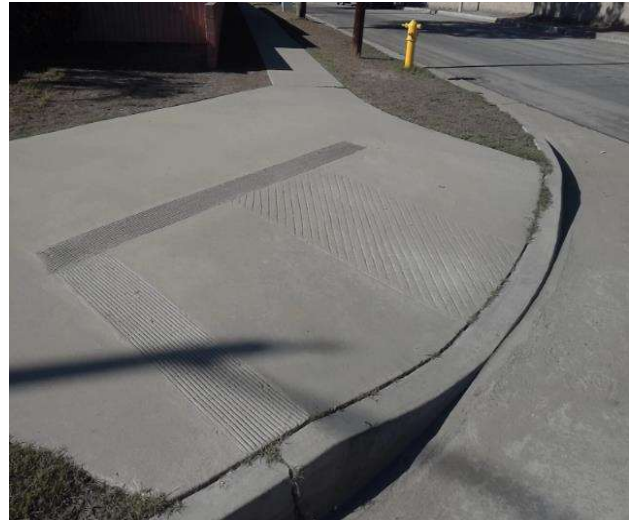
**Southwest Corner Of Angell Street @ 33.912393807298, -
118.130692988634**

The transition from the bottom of the curb ramp to the walk, gutter, or street is abrupt.

On-Site Finding 1.00 inches

Curb Ramp , Landings And Transitions : Bottom Landing Change in Level

Code Reference ADA 302, 303, 406.2, 303.1

Patch the transition area at the bottom of the curb ramp so that the transition is flush and free of abrupt changes.

Recommendation Up to 0.50 inches

Patch lip at curb ramp \$255

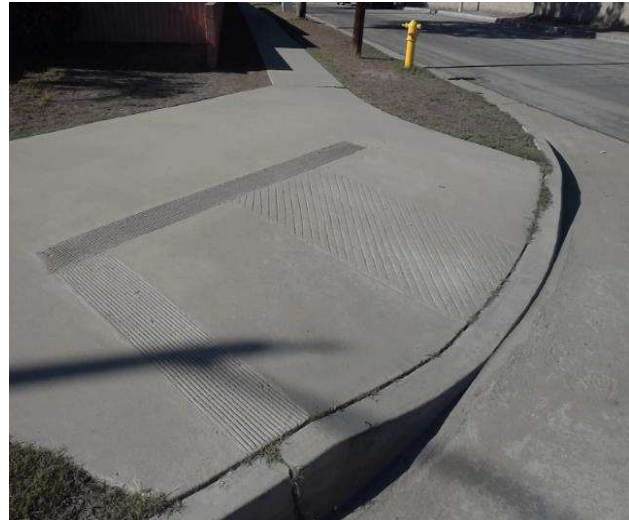
**Southwest Corner Of Angell Street @ 33.912393807298, -
118.130692988634**

Curb Ramp , Landings and Transitions : Top Landing Slope

The slope at the top landing is greater than allowed.

On-Site Finding 2.70 percent

Code Reference ADA 402, 406.4, 403.3, 406.1, CA 11B-406.5.3

Provide a top landing surface that does not exceed the maximum slope and cross slope. Provide a sufficient maneuvering clearance that does not accumulate water.

Recommendation Up to 2.08 percent

Provide compliant landing \$1,260

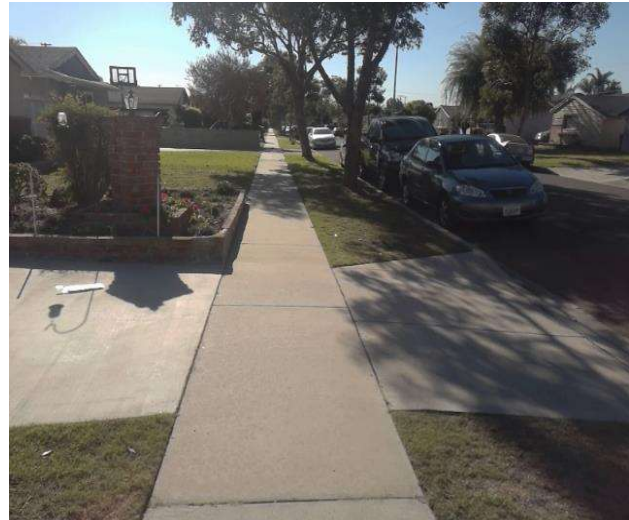
Sidewalk South Of Angell Street @ 33.912347062486, -118.130532056093

Sidewalks , Surface : Cross Slope

Sidewalk cross slope is not compliant.

On-Site Finding 3.30 percent for 865.00 feet

Code Reference ADA 206, 302,CA 11B-403.3

Repave the sidewalk surface with the recommended cross slope.

Recommendation Up to 2.08 percent

Repave surface \$1,092

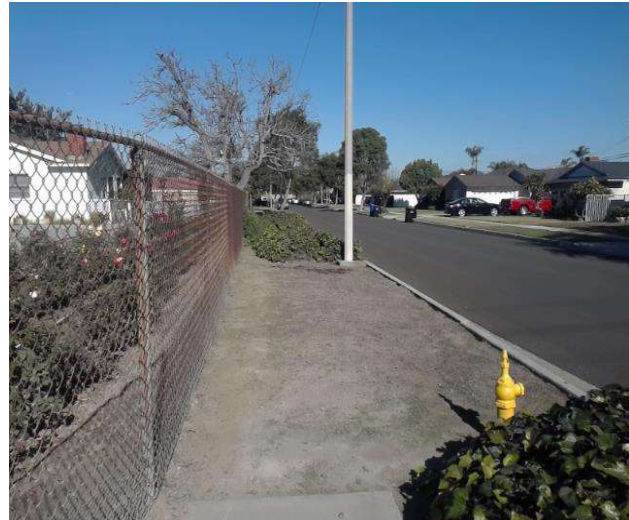
Sidewalk North Of Foster Road @ 33.910017580255, -118.130690306425

Sidewalks : Missing Sidewalk

Section of sidewalk is missing and consists of dirt, grass or gravel.

On-Site Finding 853.00 feet

Code Reference ADA 206, 302,CA 11B-302,CA 11B-206

Provide a compliant sidewalk for the missing section.

\$1,260
