## Accessibility Survey

## City of Downey Stanbridge Avenue - Angell Street To Foster Road

Date of Inspection  
12/5/2016

Prepared By  
**Disability Access Consultants**  
(800) 743-7067

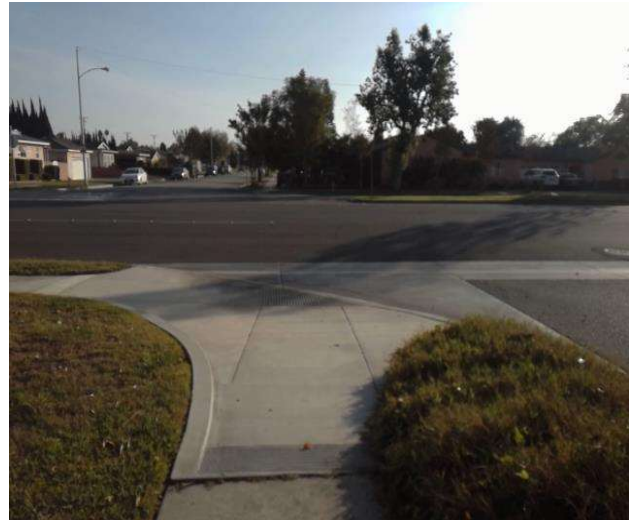
#### Change In Level South Of Angell Street @ 33.909906279940, -118.127660751343

Sidewalks , Change in Level : Change in Level Non Beveled

There is a change in elevation greater than recommended value.

**On-Site Finding** 0.75 inches

**Code Reference** ADA 206, 302

Ensure that the change in elevation is within the recommended value.

Recommendation Up to 0.25 inches

Remove tripping hazards \$198

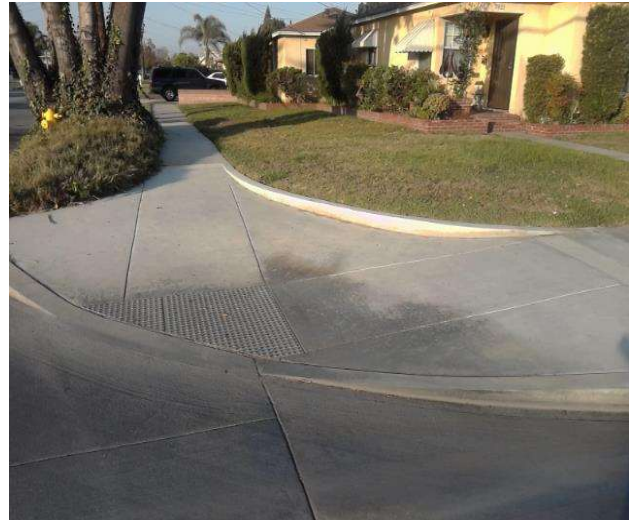
#### Northeast Corner Of Foster Road @ 33.909867324795, - 118.127667456865

The slope at the top landing is greater than allowed.

**On-Site Finding** 2.90 percent

Curb Ramp , Landings and Transitions : Top Landing Right Side  
Slope - Parallel Curb Ramp

**Code Reference** ADA 406.4, 403.3, 406.1, CA 11B-406.5.3

Provide a top landing surface that does not exceed the maximum slope and cross slope. Provide a sufficient maneuvering clearance that does not accumulate water.

Recommendation Up to 2.08 percent

Provide compliant landing \$1,260

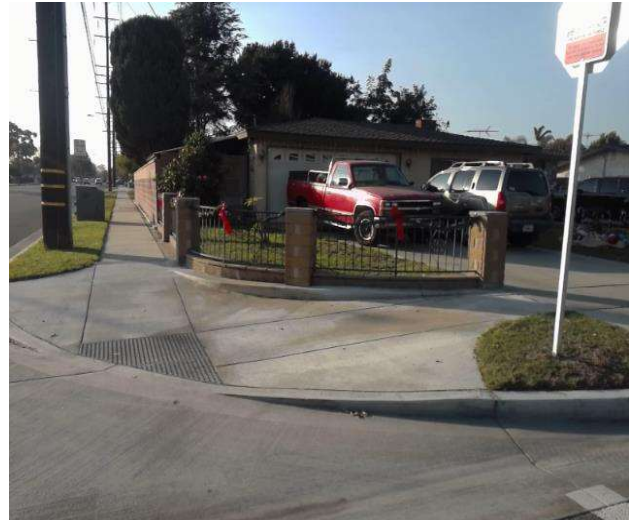
#### Northwest Corner Of Foster Road @ 33.909866211791, - 118.127845823765

Curb Ramp , Landings and Transitions : Top Landing Slope

The slope at the top landing is greater than allowed.

**On-Site Finding** 4.00 percent

**Code Reference** ADA 402, 406.4, 403.3, 406.1, CA 11B-406.5.3

Provide a top landing surface that does not exceed the maximum slope and cross slope. Provide a sufficient maneuvering clearance that does not accumulate water.

Recommendation Up to 2.08 percent

Provide compliant landing \$1,260

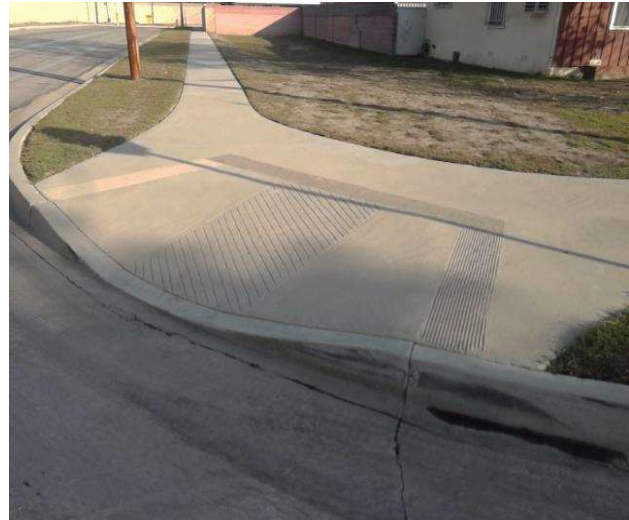
#### **Southeast Corner Of Angell Street @ 33.912363757065, - 118.127674162388**

Curb Ramp : No Detectable Warnings

The curb ramp does not provide a detectable warning surface which includes truncated domes.

**On-Site Finding** Not Found

**Code Reference** CA 11B-406.5.12

Provide compliant detectable warnings to surface.

Provide detectable warning to surface \$248

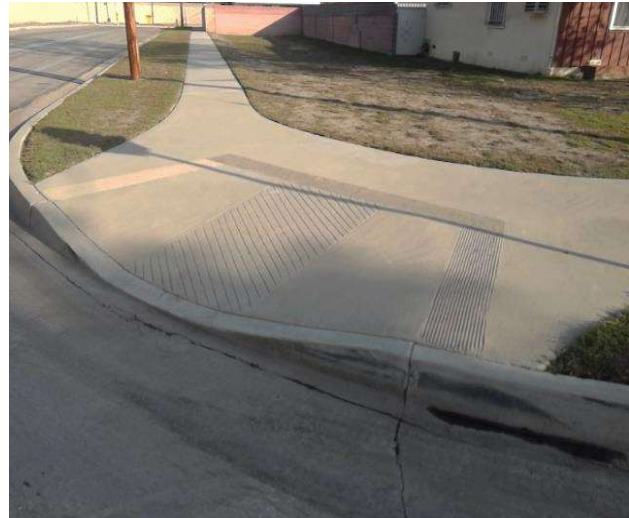
**Southeast Corner Of Angell Street @ 33.912363757065, - 118.127674162388**

Curb Ramp : Curb Ramp Slope

The running slope is greater than allowed.

**On-Site Finding** 14.90 percent

**Code Reference** ADA 406, 406.1, 405.2, CA 11B-406

Provide a compliant curb ramp.

Recommendation Up to 8.33 percent

Install curb ramp \$1,300

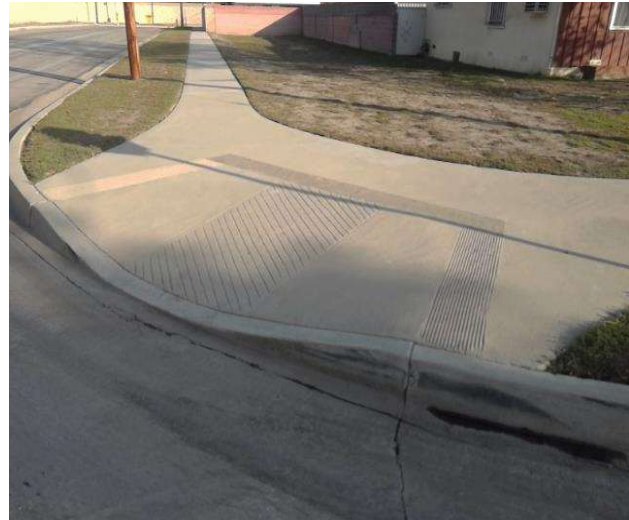
#### **Southeast Corner Of Angell Street @ 33.912363757065, - 118.127674162388**

Curb Ramp : Side Flare Slope

The slope of the curb ramp side flare is greater than allowed.

**On-Site Finding** 16.60 percent

**Code Reference** ADA 406, 406.3,CA 11B-406.2.2

Provide curb ramp side flares with a compliant slope.

Recommendation Up to 10.00 percent

Install flared sides \$1,300

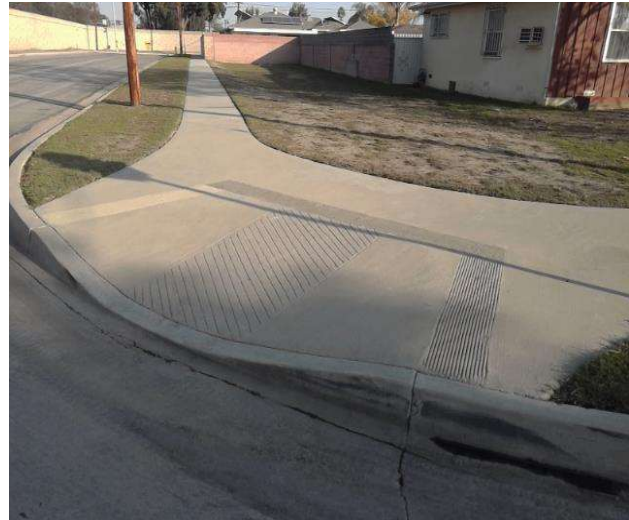
#### **Southeast Corner Of Angell Street @ 33.912363757065, - 118.127674162388**

Curb Ramp : Bottom Landing Slope

The bottom landing of the curb ramp is on the street, and the slope of the bottom landing is not compliant.

**On-Site Finding** 9.70 percent

**Code Reference** ADA 406, 406.2, CA 11B-406.5.8

Ensure the bottom landing slope is compliant and provides a smooth transition.

Recommendation Up to 5.00 percent

Repave landing \$1,260

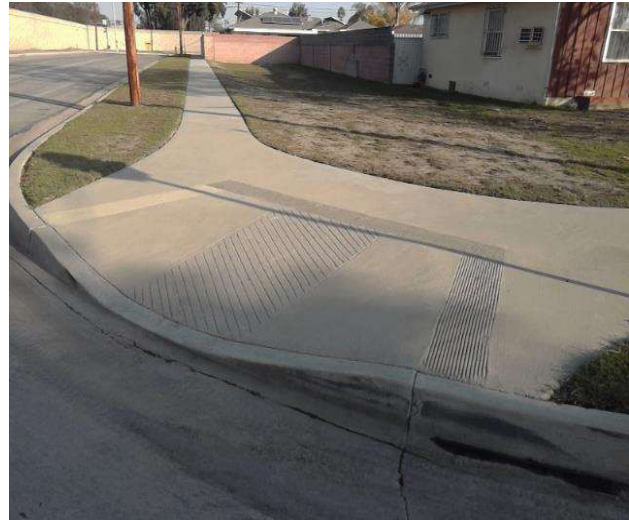
**Southeast Corner Of Angell Street @ 33.912363757065, - 118.127674162388**

The transition from the bottom of the curb ramp to the walk, gutter, or street is abrupt.

**On-Site Finding** 2.00 inches

Curb Ramp , Landings And Transitions : Bottom Landing Change in Level

**Code Reference** ADA 302, 303, 406.2, 303.1

Patch the transition area at the bottom of the curb ramp so that the transition is flush and free of abrupt changes.

Recommendation Up to 0.50 inches

Patch lip at curb ramp \$255

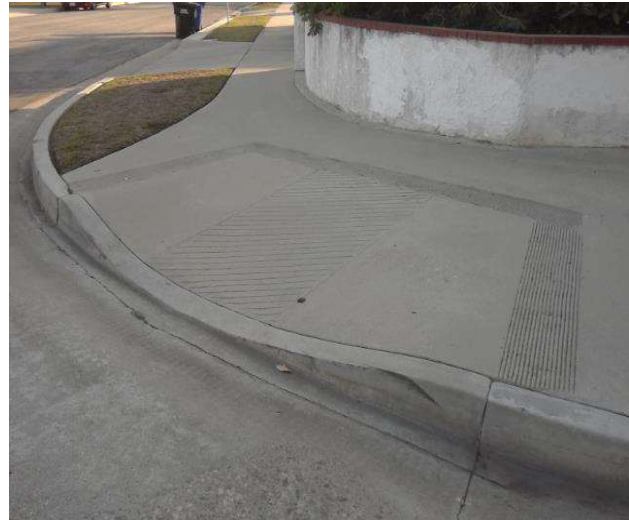
#### Southwest Corner Of Angell Street @ 33.912368208952, - 118.127864599228

Curb Ramp : No Detectable Warnings

The curb ramp does not provide a detectable warning surface which includes truncated domes.

**On-Site Finding** Not Found

**Code Reference** CA 11B-406.5.12

Provide compliant detectable warnings to surface.

Provide detectable warning to surface \$248

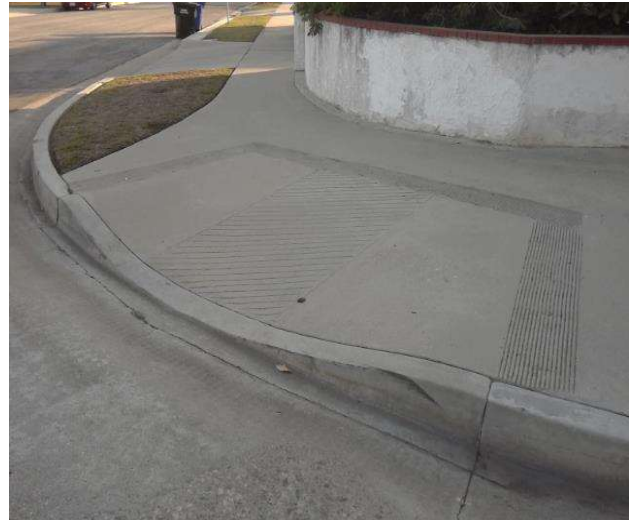
#### Southwest Corner Of Angell Street @ 33.912368208952, - 118.127864599228

Curb Ramp : Curb Ramp Slope

The running slope is greater than allowed.

**On-Site Finding** 13.20 percent

**Code Reference** ADA 406, 406.1, 405.2, CA 11B-406

Provide a compliant curb ramp.

Recommendation Up to 8.33 percent

Install curb ramp \$1,300

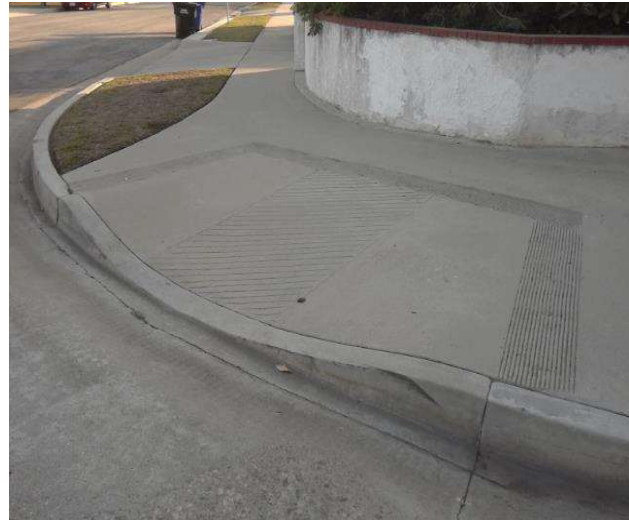
#### Southwest Corner Of Angell Street @ 33.912368208952, - 118.127864599228

Curb Ramp : Side Flare Slope

The slope of the curb ramp side flare is greater than allowed.

**On-Site Finding** 16.40 percent

**Code Reference** ADA 406, 406.3,CA 11B-406.2.2

Provide curb ramp side flares with a compliant slope.

Recommendation Up to 10.00 percent

Install flared sides \$1,300

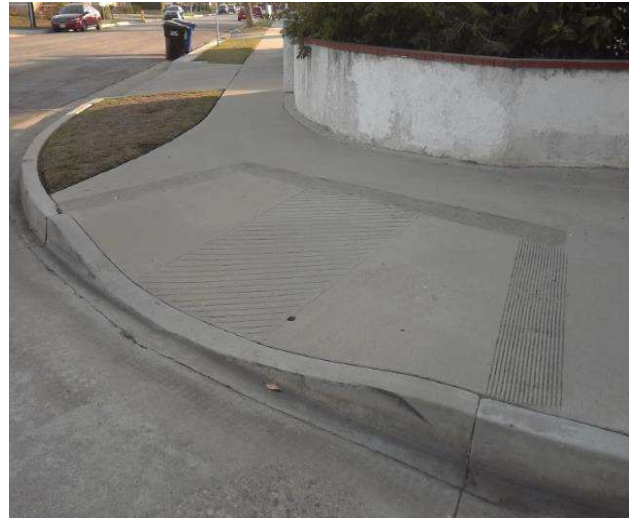
#### Southwest Corner Of Angell Street @ 33.912368208952, - 118.127864599228

Curb Ramp : Bottom Landing Slope

The bottom landing of the curb ramp is on the street, and the slope of the bottom landing is not compliant.

**On-Site Finding** 10.60 percent

**Code Reference** ADA 406, 406.2, CA 11B-406.5.8

Ensure the bottom landing slope is compliant and provides a smooth transition.

Recommendation Up to 5.00 percent

Repave landing \$1,260

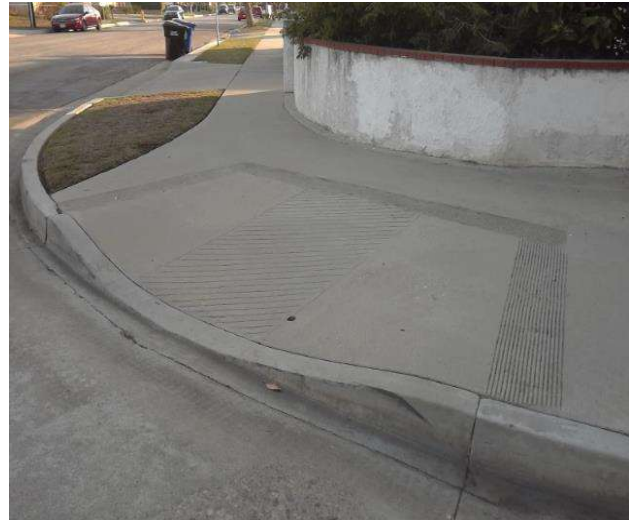
#### Southwest Corner Of Angell Street @ 33.912368208952, - 118.127864599228

The transition from the bottom of the curb ramp to the walk, gutter, or street is abrupt.

**On-Site Finding** 1.50 inches

Curb Ramp , Landings And Transitions : Bottom Landing Change in Level

**Code Reference** ADA 302, 303, 406.2, 303.1

Patch the transition area at the bottom of the curb ramp so that the transition is flush and free of abrupt changes.

Recommendation Up to 0.50 inches

Patch lip at curb ramp \$255

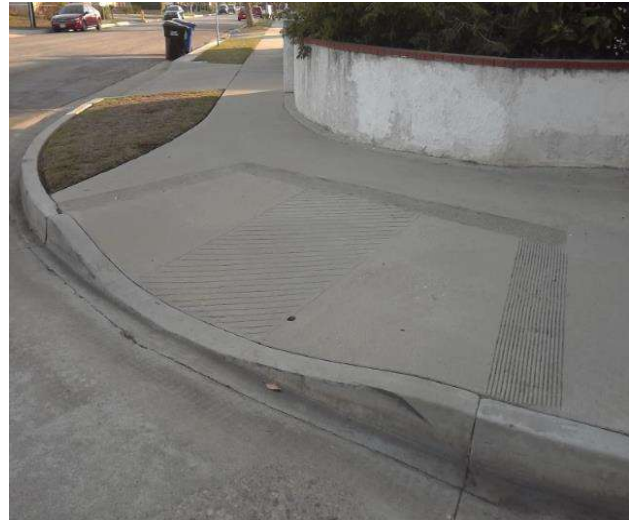
#### Southwest Corner Of Angell Street @ 33.912368208952, - 118.127864599228

Curb Ramp , Landings and Transitions : Top Landing Slope

The slope at the top landing is greater than allowed.

**On-Site Finding** 2.80 percent

**Code Reference** ADA 402, 406.4, 403.3, 406.1, CA 11B-406.5.3

Provide a top landing surface that does not exceed the maximum slope and cross slope. Provide a sufficient maneuvering clearance that does not accumulate water.

Recommendation Up to 2.08 percent

Provide compliant landing \$1,260

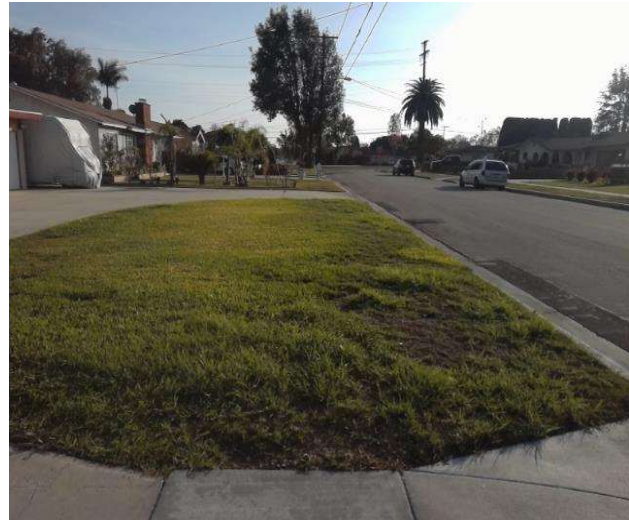
#### Sidewalk South Of Angell Street @ 33.910708751955, -118.127667456865

Sidewalks : Missing Sidewalk

Section of sidewalk is missing and consists of dirt, grass or gravel.

**On-Site Finding** 230.00 feet

**Code Reference** ADA 206, 302,CA 11B-302,CA 11B-206

Provide a compliant sidewalk for the missing section.

\$1,260

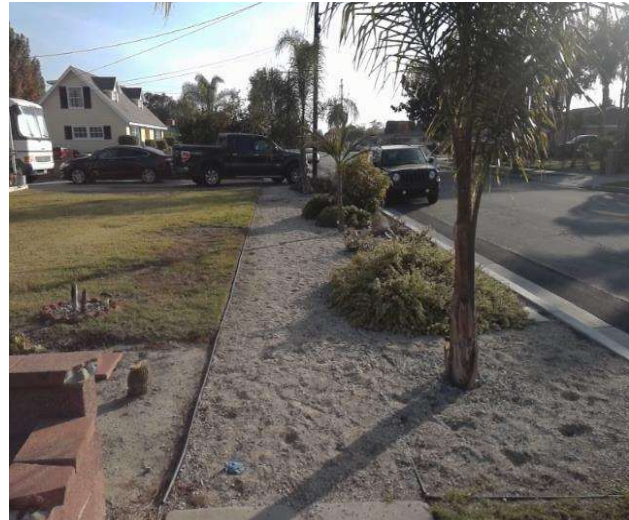
#### Sidewalk South Of Angell Street @ 33.911416612815, -118.127671480179

Sidewalks : Missing Sidewalk

Section of sidewalk is missing and consists of dirt, grass or gravel.

**On-Site Finding** 61.00 feet

**Code Reference** ADA 206, 302,CA 11B-302,CA 11B-206

Provide a compliant sidewalk for the missing section.

\$1,260

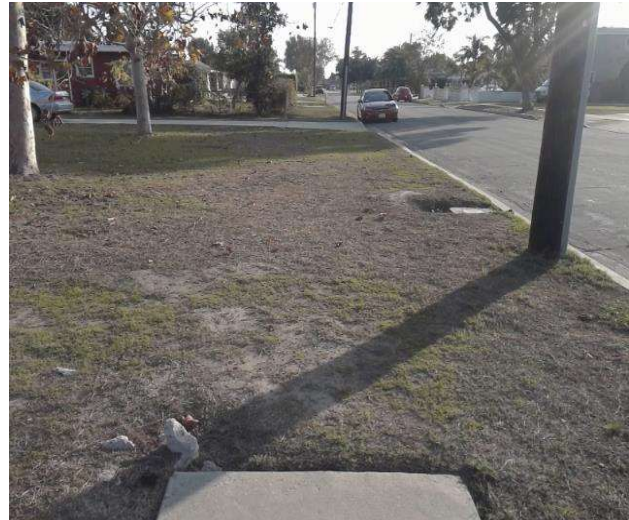
#### Sidewalk South Of Angell Street @ 33.912299204677, -118.127670139074

Sidewalks : Missing Sidewalk

Section of sidewalk is missing and consists of dirt, grass or gravel.

**On-Site Finding** 246.00 feet

**Code Reference** ADA 206, 302,CA 11B-302,CA 11B-206

Provide a compliant sidewalk for the missing section.

\$1,260
