Accessibility Survey

City of Downey Elmcroft Avenue - Cecilia Street to End

Date of Inspection
2/8/2017

Prepared By
Disability Access Consultants
(800) 743-7067

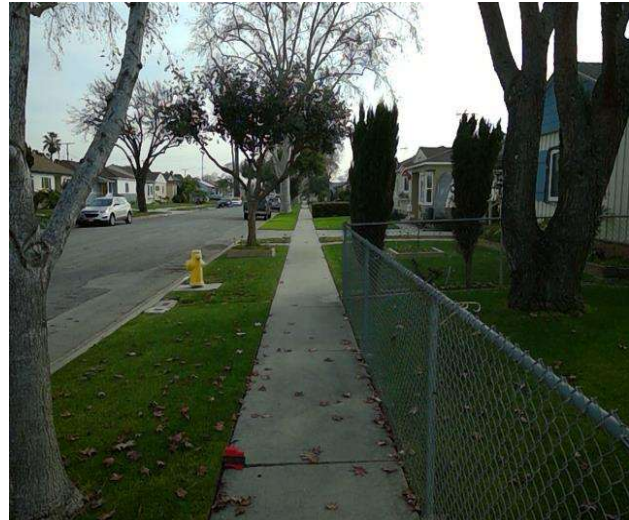
Change In Level North of Cecilia Street @ 33.933812475240, -118.095856457949

Sidewalks , Change in Level : Change in Level Non Beveled

There is a change in elevation greater than recommended value.

On-Site Finding 0.62 inches

Code Reference ADA 206, 302

Ensure that the change in elevation is within the recommended value.

Recommendation Up to 0.25 inches

Remove tripping hazards \$198

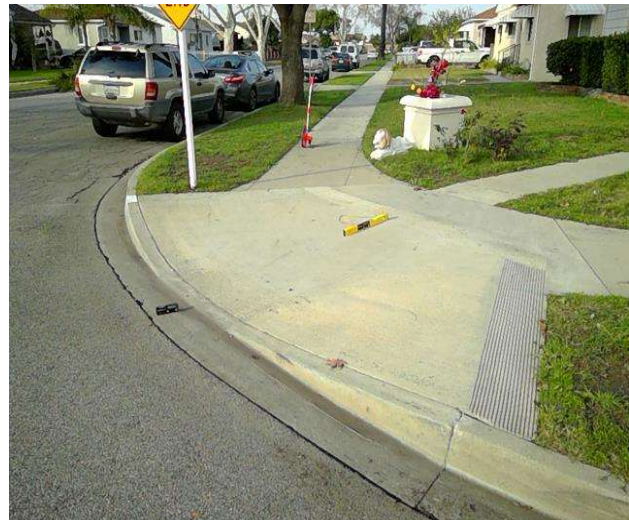
**Northeast Corner of Cecilia Street @ 33.932125618064, -
118.095661997795**

Curb Ramp : No Detectable Warnings

The curb ramp does not provide a detectable warning surface which includes truncated domes.

On-Site Finding Not Found

Code Reference CA 11B-406.5.12

Provide compliant detectable warnings to surface.

Provide detectable warning to surface \$248

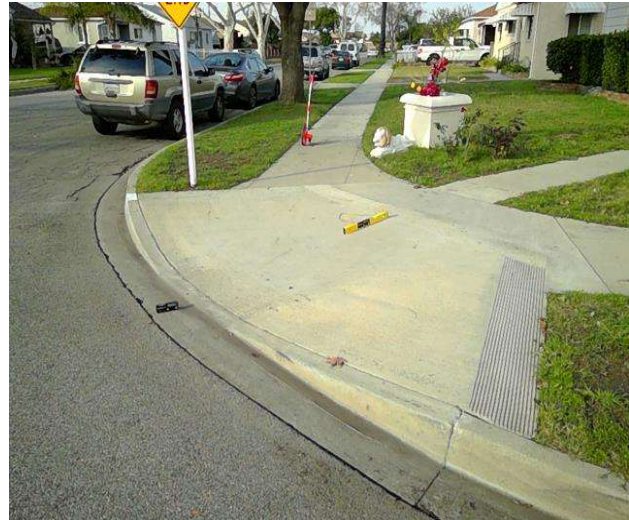
**Northeast Corner of Cecilia Street @ 33.932125618064, -
118.095661997795**

Curb Ramp : Curb Ramp Slope

The running slope is greater than allowed.

On-Site Finding 10.20 percent

Code Reference ADA 406, 406.1, 405.2, CA 11B-406

Provide a compliant curb ramp.

Recommendation Up to 8.33 percent

Install curb ramp \$1,300

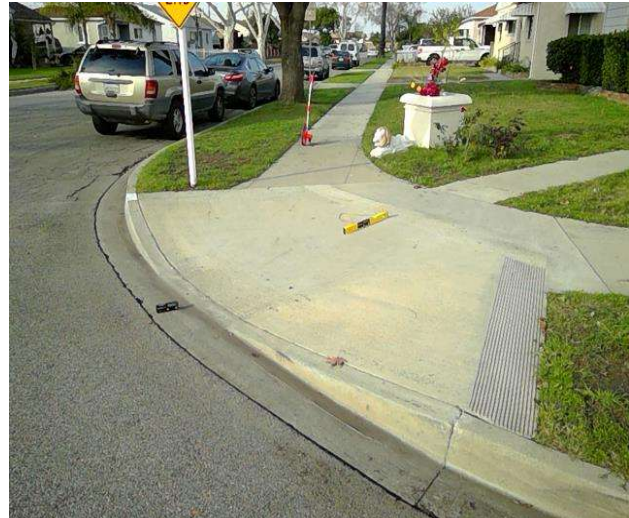
**Northeast Corner of Cecilia Street @ 33.932125618064, -
118.095661997795**

Curb Ramp : Side Flare Slope

The slope of the curb ramp side flare is greater than allowed.

On-Site Finding 12.70 percent

Code Reference ADA 406, 406.3, CA 11B-406.2.2

Provide curb ramp side flares with a compliant slope.

Recommendation Up to 10.00 percent

Install flared sides \$1,300

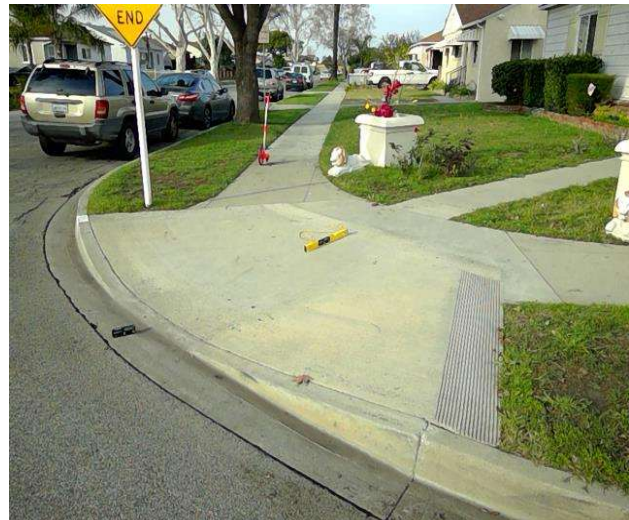
Northeast Corner of Cecilia Street @ 33.932125618064, - 118.095661997795

Curb Ramp : Bottom Landing Slope

The bottom landing of the curb ramp is on the street, and the slope of the bottom landing is not compliant.

On-Site Finding 9.70 percent

Code Reference ADA 406, 406.2, CA 11B-406.5.8

Ensure the bottom landing slope is compliant and provides a smooth transition.

Recommendation Up to 5.00 percent

Repave landing \$1,260

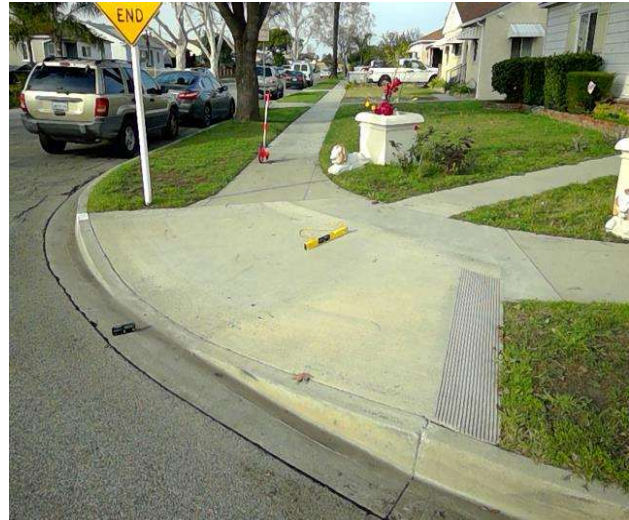
Northeast Corner of Cecilia Street @ 33.932125618064, - 118.095661997795

Curb Ramp , Landings and Transitions : Top Landing Slope

The slope at the top landing is greater than allowed.

On-Site Finding 3.40 percent

Code Reference ADA 402, 406.4, 403.3, 406.1, CA 11B-406.5.3

Provide a top landing surface that does not exceed the maximum slope and cross slope. Provide a sufficient maneuvering clearance that does not accumulate water.

Recommendation Up to 2.08 percent

Provide compliant landing \$1,260

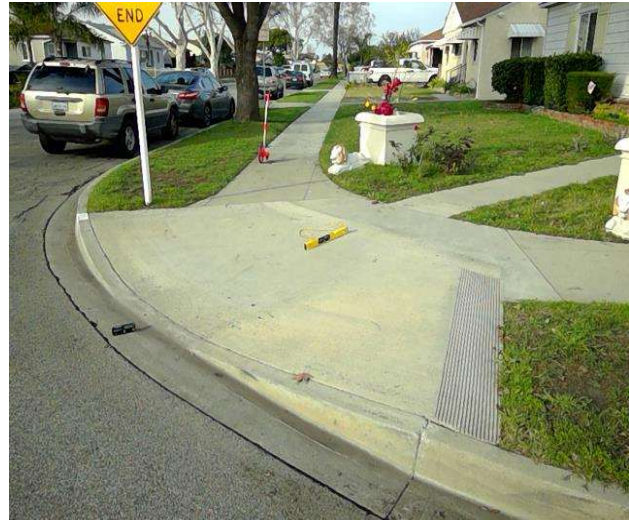
**Northeast Corner of Cecilia Street @ 33.932125618064, -
118.095661997795**

Curb Ramp , Landings and Transitions : Top Landing Clear Length - Landings

There is not enough top landing clear length.

On-Site Finding 46.00 inches

Code Reference ADA 406, 406.4,CA 11B-406.5.3

Provide a level top landing with enough clear length.

Recommendation At least 48.00 inches

Provide compliant landing \$240

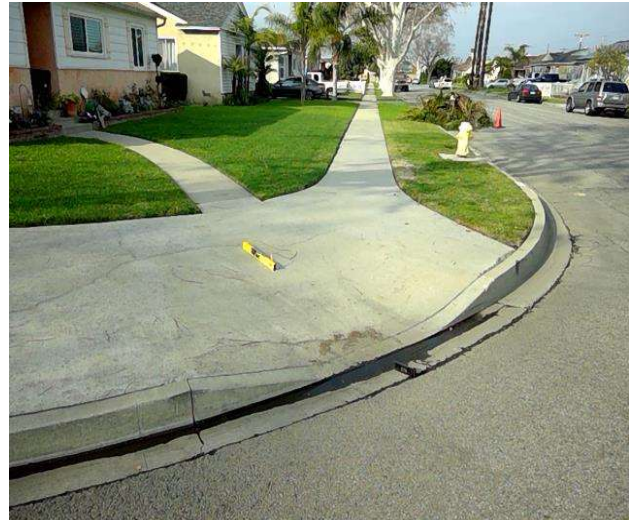
**Northwest Corner of Cecilia Street @ 33.932126730778, -
118.095855116844**

Curb Ramp : No Detectable Warnings

The curb ramp does not provide a detectable warning surface which includes truncated domes.

On-Site Finding Not Found

Code Reference CA 11B-406.5.12

Provide compliant detectable warnings to surface.

Provide detectable warning to surface \$248

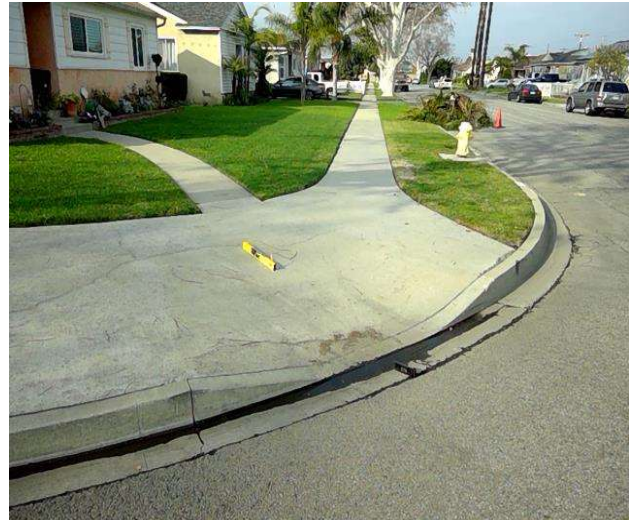
**Northwest Corner of Cecilia Street @ 33.932126730778, -
118.095855116844**

Curb Ramp : Curb Ramp Slope

The running slope is greater than allowed.

On-Site Finding 11.00 percent

Code Reference ADA 406, 406.1, 405.2, CA 11B-406

Provide a compliant curb ramp.

Recommendation Up to 8.33 percent

Install curb ramp \$1,300

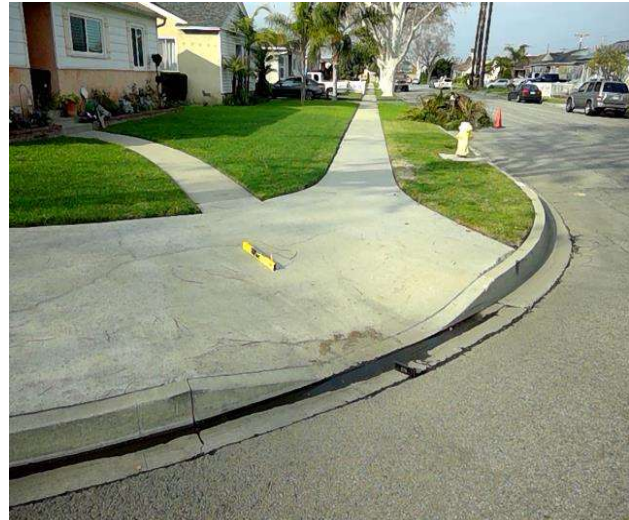
**Northwest Corner of Cecilia Street @ 33.932126730778, -
118.095855116844**

Curb Ramp : Side Flare Slope

The slope of the curb ramp side flare is greater than allowed.

On-Site Finding 17.30 percent

Code Reference ADA 406, 406.3, CA 11B-406.2.2

Provide curb ramp side flares with a compliant slope.

Recommendation Up to 10.00 percent

Install flared sides \$1,300

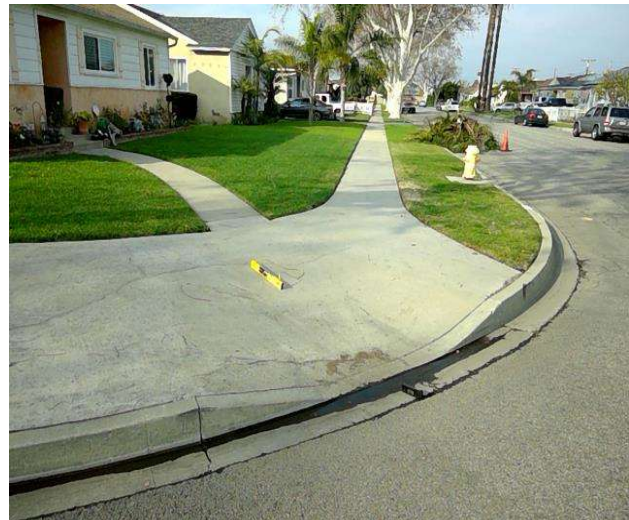
Northwest Corner of Cecilia Street @ 33.932126730778, - 118.095855116844

Curb Ramp : Bottom Landing Slope

The bottom landing of the curb ramp is on the street, and the slope of the bottom landing is not compliant.

On-Site Finding 13.40 percent

Code Reference ADA 406, 406.2, CA 11B-406.5.8

Ensure the bottom landing slope is compliant and provides a smooth transition.

Recommendation Up to 5.00 percent

Repave landing \$1,260

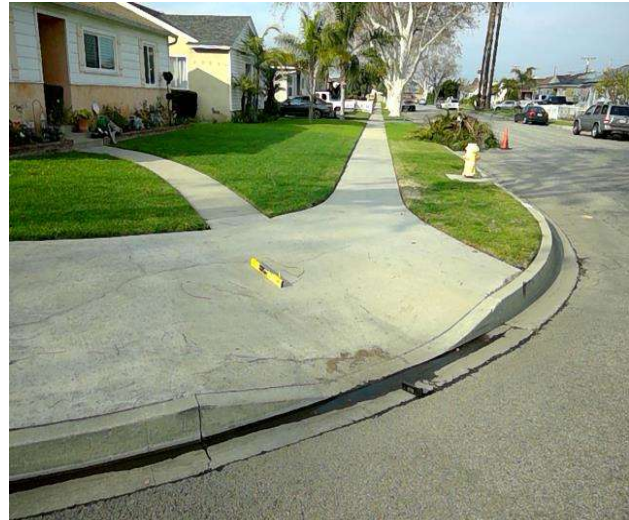
**Northwest Corner of Cecilia Street @ 33.932126730778, -
118.095855116844**

Curb Ramp , Landings and Transitions : Landing Accumulates Water - Wet Conditions

The curb ramp landing accumulates water.

On-Site Finding Accumulates Water

Code Reference ADA 405, 406.1, 405.10

Provide sufficient clear space at the bottom of the curb ramp that does not accumulate water.

Provide compliant landing \$255

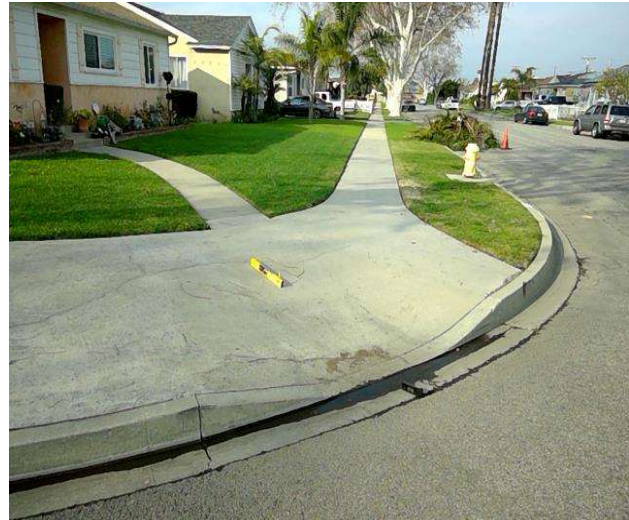
**Northwest Corner of Cecilia Street @ 33.932126730778, -
118.095855116844**

The transition from the bottom of the curb ramp to the walk, gutter, or street is abrupt.

On-Site Finding Not Beveled

Curb Ramp , Landings and Transitions : Bottom Landing Change in Level - Curb Ramps

Code Reference ADA 302, 406.2

Patch the transition area at the bottom of the curb ramp so that the transition is flush and free of abrupt changes.

Patch lip at curb ramp \$255

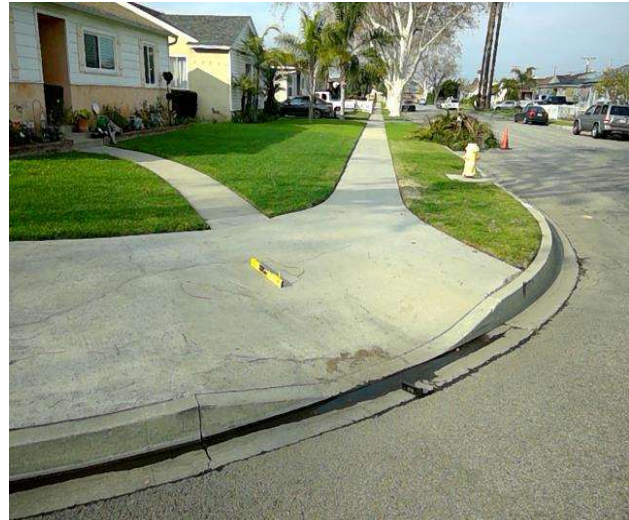
**Northwest Corner of Cecilia Street @ 33.932126730778, -
118.095855116844**

Curb Ramp , Landings And Transitions : Bottom Landing Change in Level due to Overlayment

The overlayment causes a noncompliant change in level.

On-Site Finding 0.62 inches

Code Reference ADA 303.2, 303.3,CA 11B-303.3,CA 11B-303.2

Ensure the change in elevation is within the recommended height.

Recommendation Up to 0.50 inches

Provide smooth surface \$150

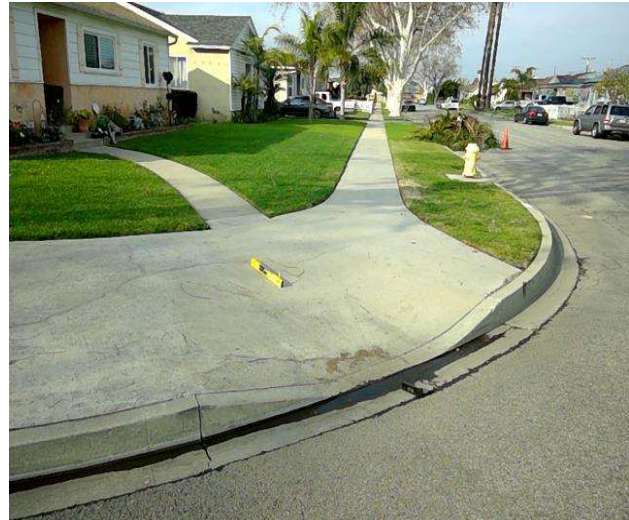
**Northwest Corner of Cecilia Street @ 33.932126730778, -
118.095855116844**

Curb Ramp , Landings and Transitions : Top Landing Slope

The slope at the top landing is greater than allowed.

On-Site Finding 4.00 percent

Code Reference ADA 402, 406.4, 403.3, 406.1, CA 11B-406.5.3

Provide a top landing surface that does not exceed the maximum slope and cross slope. Provide a sufficient maneuvering clearance that does not accumulate water.

Recommendation Up to 2.08 percent

Provide compliant landing \$1,260

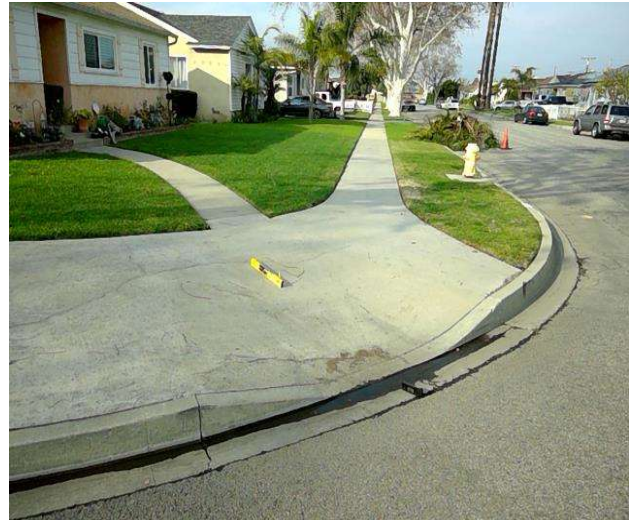
**Northwest Corner of Cecilia Street @ 33.932126730778, -
118.095855116844**

Curb Ramp , Landings and Transitions : Top Landing Clear Length - Landings

There is not enough top landing clear length.

On-Site Finding 40.00 inches

Code Reference ADA 406, 406.4,CA 11B-406.5.3

Provide a level top landing with enough clear length.

Recommendation At least 48.00 inches

Provide compliant landing \$240

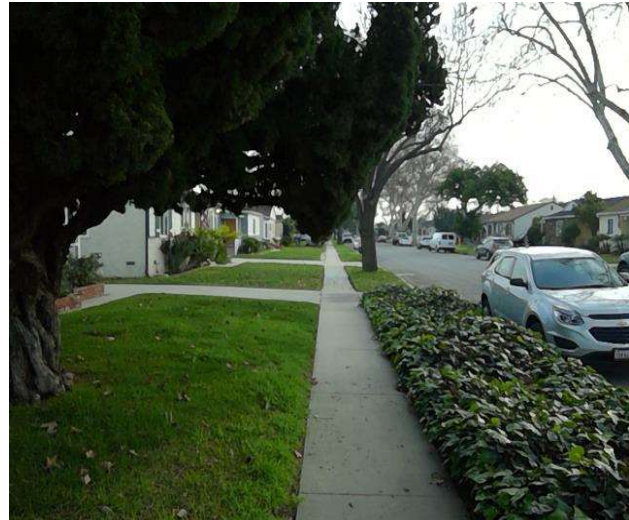
Tree South of End @ 33.933563231956, -118.095686137676

Sidewalks , Hazards & Gratings : Overhead Obstruction Height

Overhead obstruction height is not compliant.

On-Site Finding 65.00 inches

Code Reference ADA 206, 307.4, CA 11B-307.4

Provide a compliant vertical clearance height.

Recommendation At least 80.00 inches
