Accessibility Survey

City of Downey Glenshire Avenue - Imperial Highway To Borson Street

Date of Inspection
12/27/2016

Disability Access Consultants

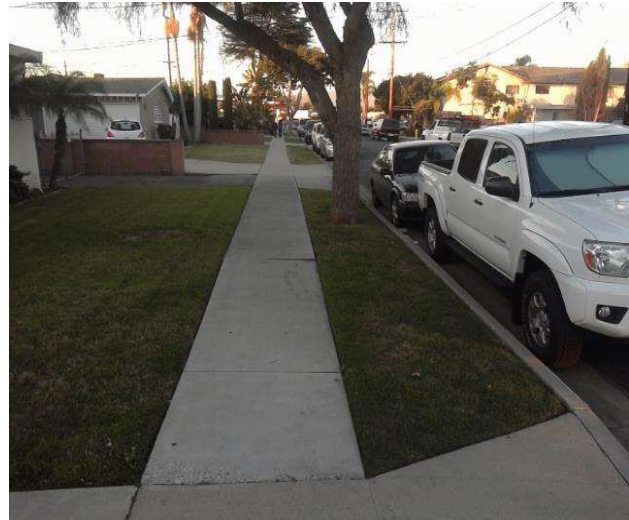
Change In Level North Of Borson Street @ 33.915968596425, -118.137102127075

Sidewalks , Change in Level : Change in Level Non Beveled

There is a change in elevation greater than recommended value.

On-Site Finding 0.50 inches

Code Reference ADA 206, 302

Ensure that the change in elevation is within the recommended value.

Recommendation Up to 0.25 inches

Remove tripping hazards \$198

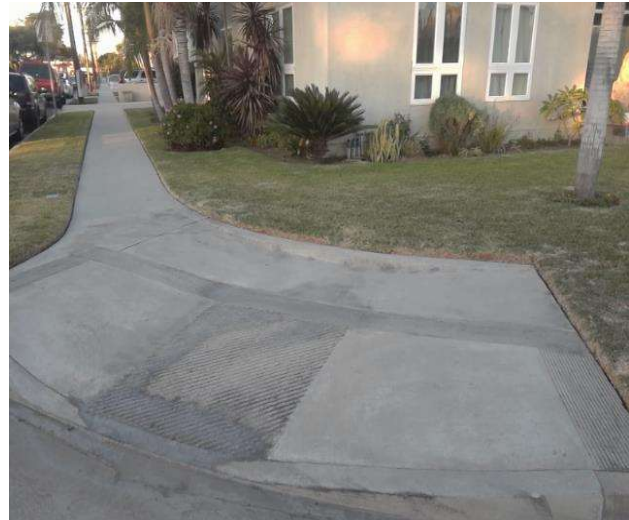
Northeast Corner Of Borson Street @ 33.914886826747, - 118.136941194534

The slope at the top landing is greater than allowed.

On-Site Finding 3.60 percent

Curb Ramp , Landings and Transitions : Top Landing Slope

Code Reference ADA 402, 406.4, 403.3, 406.1, CA 11B-406.5.3

Provide a top landing surface that does not exceed the maximum slope and cross slope. Provide a sufficient maneuvering clearance that does not accumulate water.

Recommendation Up to 2.08 percent

Provide compliant landing \$1,260

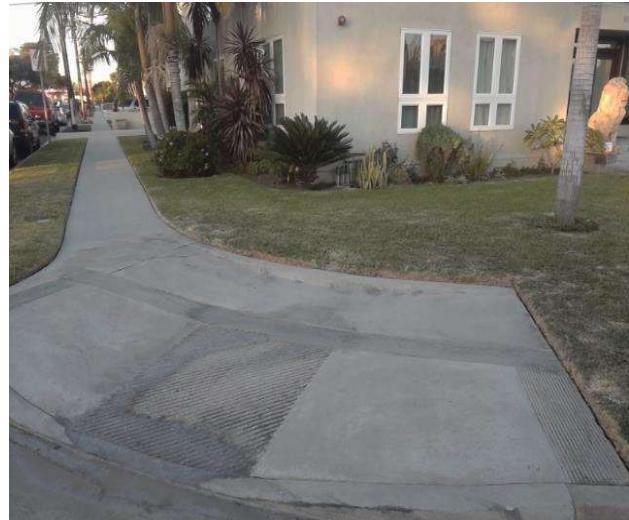
Northeast Corner Of Borson Street @ 33.914886826747, - 118.136941194534

Curb Ramp : No Detectable Warnings

The curb ramp does not provide a detectable warning surface which includes truncated domes.

On-Site Finding Not Found

Code Reference CA 11B-406.5.12

Provide compliant detectable warnings to surface.

Provide detectable warning to surface \$248

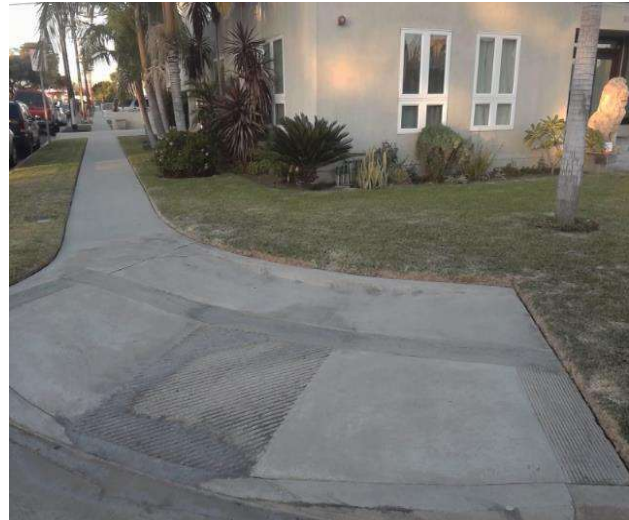
Northeast Corner Of Borson Street @ 33.914886826747, - 118.136941194534

Curb Ramp : Curb Ramp Slope

The running slope is greater than allowed.

On-Site Finding 11.00 percent

Code Reference ADA 406, 406.1, 405.2, CA 11B-406

Provide a compliant curb ramp.

Recommendation Up to 8.33 percent

Install curb ramp \$1,300

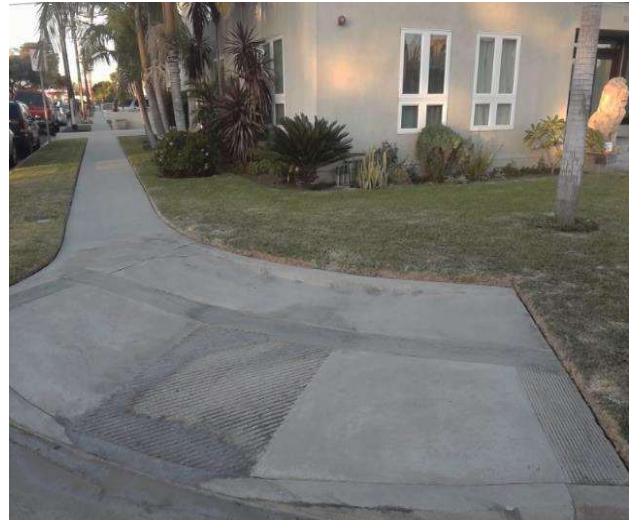
Northeast Corner Of Borson Street @ 33.914886826747, - 118.136941194534

Curb Ramp : Side Flare Slope

The slope of the curb ramp side flare is greater than allowed.

On-Site Finding 12.00 percent

Code Reference ADA 406, 406.3, CA 11B-406.2.2

Provide curb ramp side flares with a compliant slope.

Recommendation Up to 10.00 percent

Install flared sides \$1,300

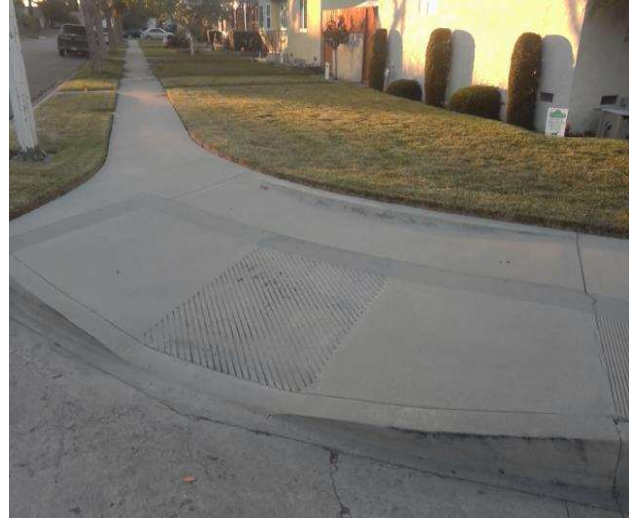
Northwest Corner Of Borson Street @ 33.914895730257, - 118.137107491493

Curb Ramp , Landings and Transitions : Top Landing Slope

The slope at the top landing is greater than allowed.

On-Site Finding 3.60 percent

Code Reference ADA 402, 406.4, 403.3, 406.1, CA 11B-406.5.3

Provide a top landing surface that does not exceed the maximum slope and cross slope. Provide a sufficient maneuvering clearance that does not accumulate water.

Recommendation Up to 2.08 percent

Provide compliant landing \$1,260

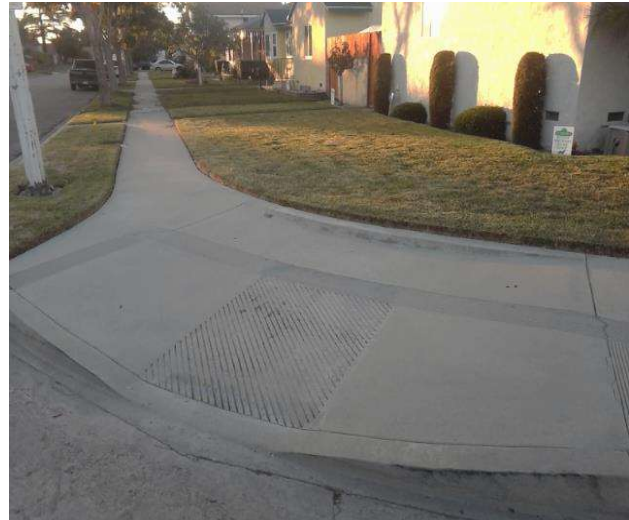
Northwest Corner Of Borson Street @ 33.914895730257, - 118.137107491493

Curb Ramp : No Detectable Warnings

The curb ramp does not provide a detectable warning surface which includes truncated domes.

On-Site Finding Not Found

Code Reference CA 11B-406.5.12

Provide compliant detectable warnings to surface.

Provide detectable warning to surface \$248

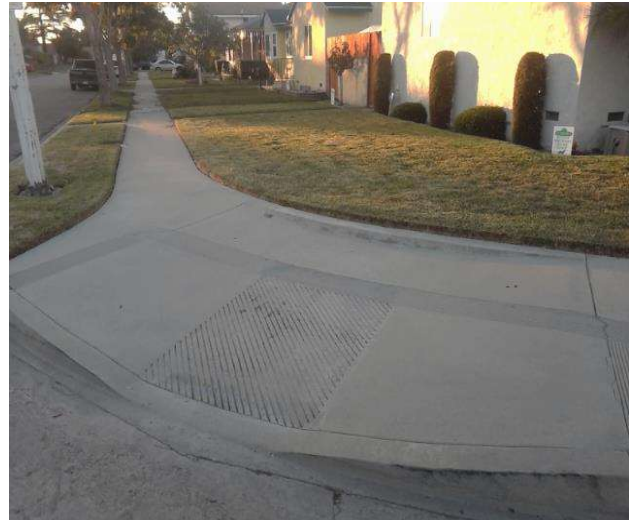
Northwest Corner Of Borson Street @ 33.914895730257, - 118.137107491493

Curb Ramp : Curb Ramp Slope

The running slope is greater than allowed.

On-Site Finding 12.20 percent

Code Reference ADA 406, 406.1, 405.2, CA 11B-406

Provide a compliant curb ramp.

Recommendation Up to 8.33 percent

Install curb ramp \$1,300

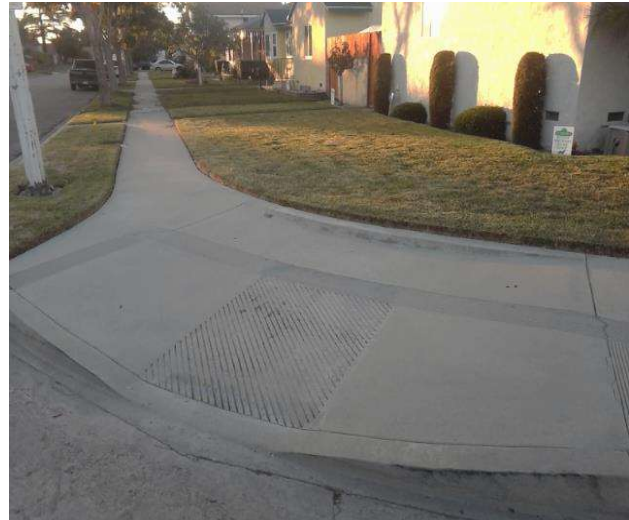
Northwest Corner Of Borson Street @ 33.914895730257, - 118.137107491493

Curb Ramp : Side Flare Slope

The slope of the curb ramp side flare is greater than allowed.

On-Site Finding 13.83 percent

Code Reference ADA 406, 406.3, CA 11B-406.2.2

Provide curb ramp side flares with a compliant slope.

Recommendation Up to 10.00 percent

Install flared sides \$1,300

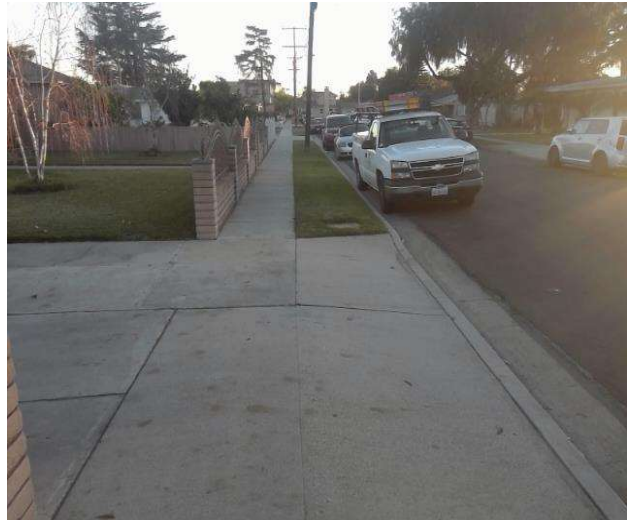
Driveway South Of Imperial Highway @ 33.916084340516, -118.136957287788

Sidewalks : Vehicular Traffic Surface

Surface is not firm, stable or slip resistant.

On-Site Finding Not Compliant

Provide compliant surface at vehicular traffic.

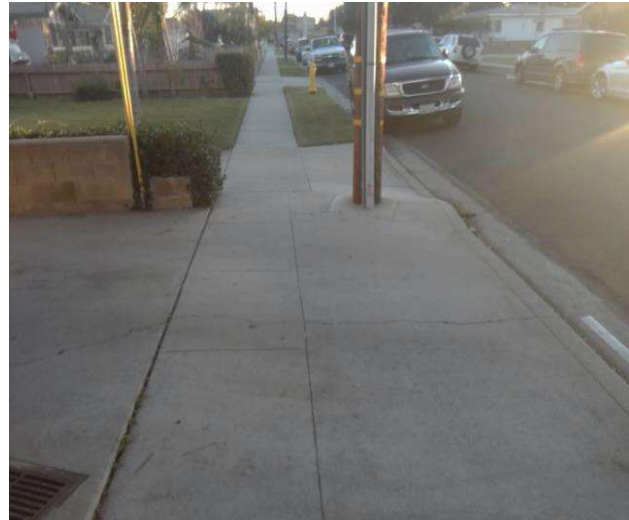
Driveway South Of Imperial Highway @ 33.916373755, -118.136957287788

Sidewalks , Vehicular Traffic : Cross Walks and Detectable Warnings

There are no detectable warnings where the pedestrian route crosses vehicular traffic.

On-Site Finding Not Found

Code Reference ADA 705,CA 11B-705.1.2.5,CA 11B-247.1.2.5

Provide detectable warnings.

Install compliant detectable warnings \$190

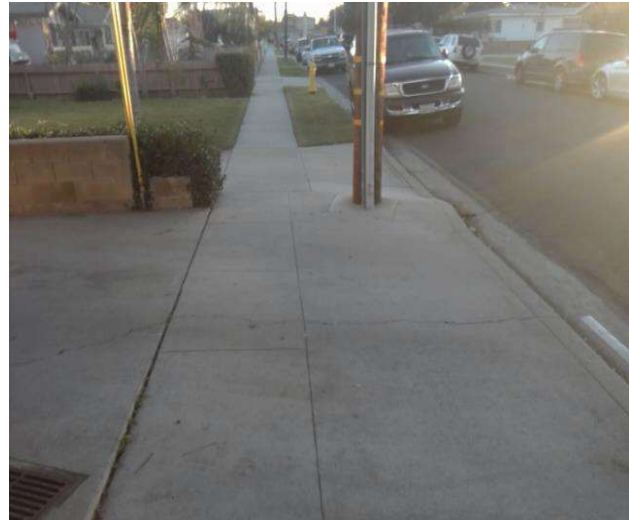
Driveway South Of Imperial Highway @ 33.916373755, -118.136957287788

Sidewalks : Vehicular Traffic Cross Slope

Cross slope at vehicular traffic is not compliant.

On-Site Finding 2.60 percent

Code Reference ADA 206, 302, CA 11B-403.3

Repave the surface to provide a compliant cross slope.

Recommendation Up to 2.08 percent

Repave surface \$1,092

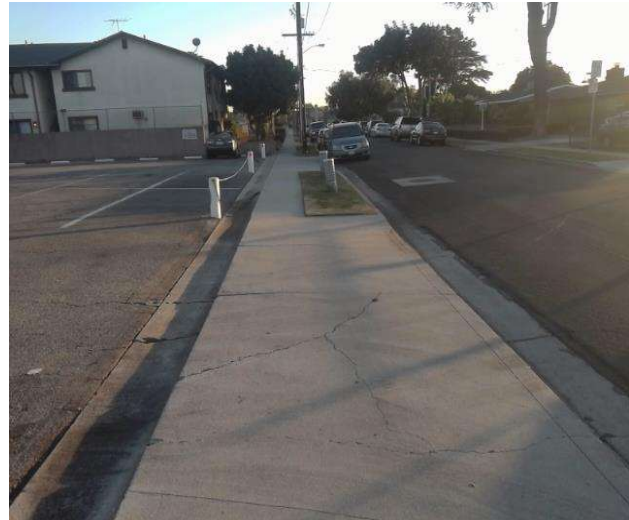
Driveway South Of Imperial Highway @ 33.916698671904, -118.136962652206

Sidewalks , Vehicular Traffic : Cross Walks and Detectable Warnings

There are no detectable warnings where the pedestrian route crosses vehicular traffic.

On-Site Finding Not Found

Code Reference ADA 705,CA 11B-705.1.2.5,CA 11B-247.1.2.5

Provide detectable warnings.

Install compliant detectable warnings \$190

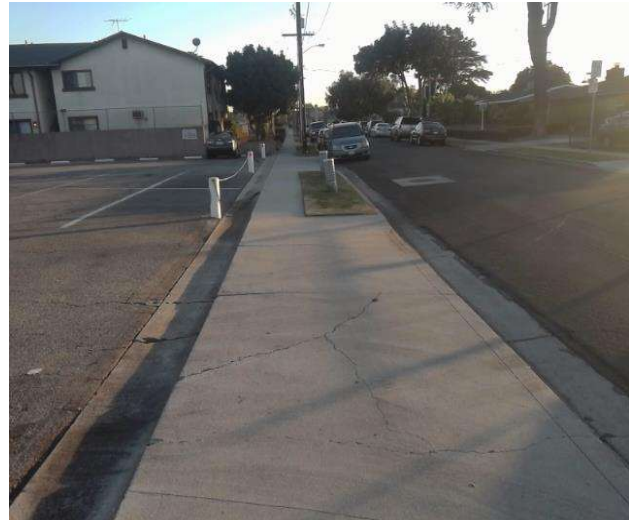
Driveway South Of Imperial Highway @ 33.916698671904, -118.136962652206

Sidewalks : Vehicular Traffic Cross Slope

Cross slope at vehicular traffic is not compliant.

On-Site Finding 2.30 percent

Code Reference ADA 206, 302, CA 11B-403.3

Repave the surface to provide a compliant cross slope.

Recommendation Up to 2.08 percent

Repave surface \$1,092

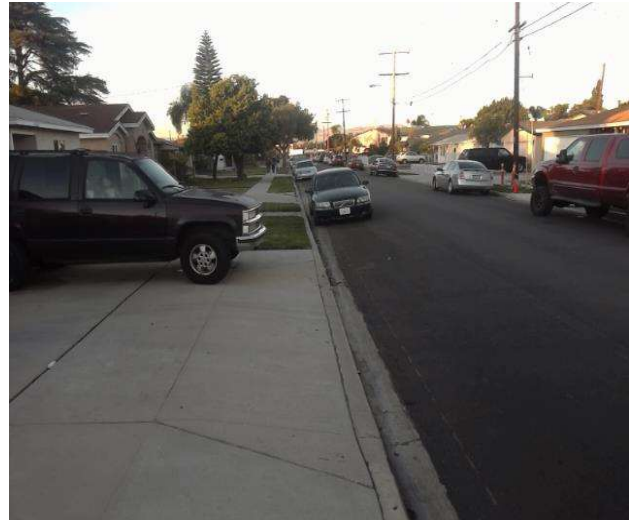
Driveway North Of Borson Street @ 33.915087155501, -118.137096762657

Sidewalks : Vehicular Traffic Surface

Surface is not firm, stable or slip resistant.

On-Site Finding Not Compliant

Provide compliant surface at vehicular traffic.

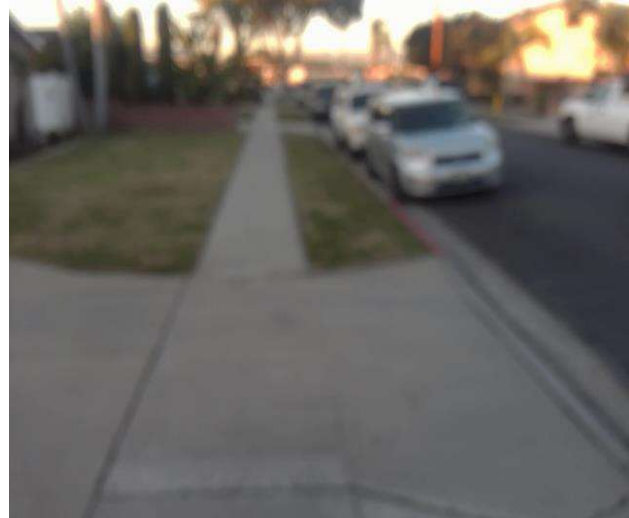
Driveway North Of Borson Street @ 33.916084340516, -118.137150406837

Sidewalks , Vehicular Traffic : Cross Walks and Detectable Warnings

There are no detectable warnings where the pedestrian route crosses vehicular traffic.

On-Site Finding Not Found

Code Reference ADA 705,CA 11B-705.1.2.5,CA 11B-247.1.2.5

Provide detectable warnings.

Install compliant detectable warnings \$190

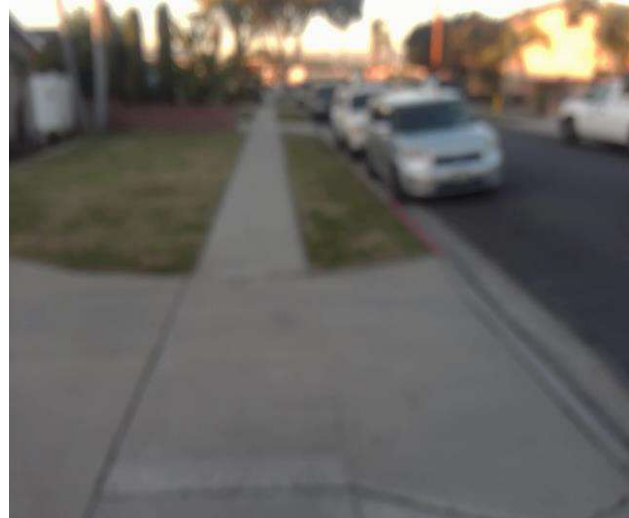
Driveway North Of Borson Street @ 33.916084340516, -118.137150406837

Sidewalks : Vehicular Traffic Cross Slope

Cross slope at vehicular traffic is not compliant.

On-Site Finding 2.80 percent

Code Reference ADA 206, 302, CA 11B-403.3

Repave the surface to provide a compliant cross slope.

Recommendation Up to 2.08 percent

Repave surface \$1,092

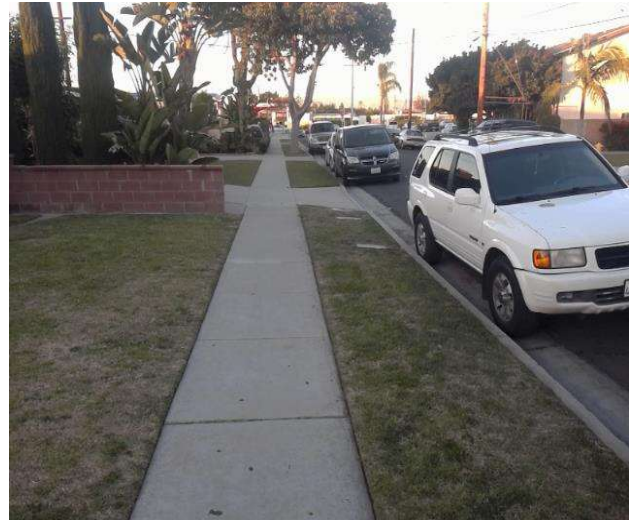
Sidewalk North Of Borson Street @ 33.916084340516, -118.137150406837

Sidewalks : Width

Sidewalk does not have enough width.

On-Site Finding 40.00 inches for 54.00 feet

Code Reference ADA 206, 302, CA 11B-403.5.1

Widen the sidewalk to the recommended value.

Recommendation At least 48.00 inches

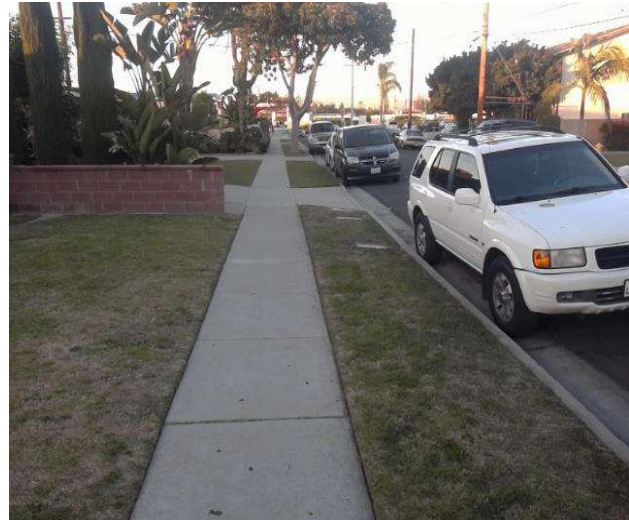
Sidewalk North Of Borson Street @ 33.916084340516, -118.137150406837

Sidewalks , Surface : Cross Slope

Sidewalk cross slope is not compliant.

On-Site Finding 2.80 percent for 54.00 feet

Code Reference ADA 206, 302, CA 11B-403.3

Repave the sidewalk surface with the recommended cross slope.

Recommendation Up to 2.08 percent

Repave surface \$1,092

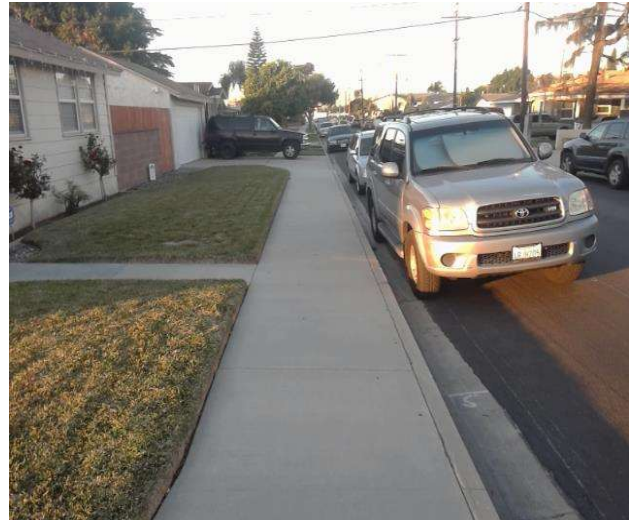
West Side @ 33.914895730257, -118.137107491493

Sidewalks : 60X60 Turn Area

There is no 60X60 turn area at every 200 feet.

On-Site Finding Not Found

Code Reference ADA 206, 302

Provide a 60X60 turn every 200 feet on the sidewalk.
