## Accessibility Survey

## City of Downey Quoit Street - Orizaba Avenue To Downey Avenue

Date of Inspection  
1/29/2017

Prepared By  
**Disability Access Consultants**  
(800) 743-7067

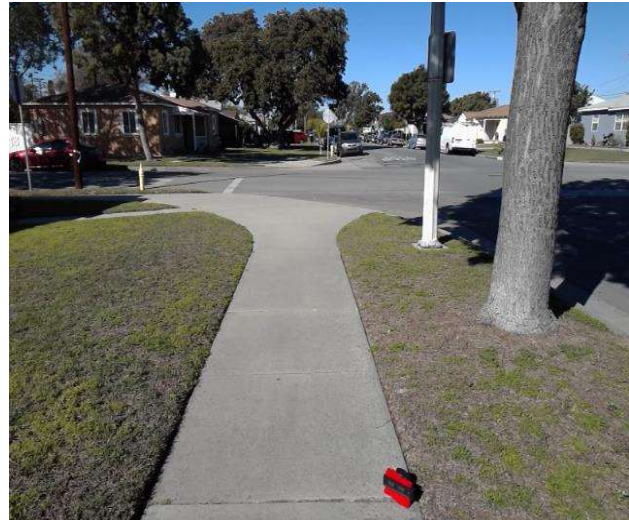
#### Change In Level East Of Orizaba Avenue @ 33.925045126847, -118.147358894348

Sidewalks , Change in Level : Change in Level Non Beveled

There is a change in elevation greater than recommended value.

**On-Site Finding** 0.50 inches

**Code Reference** ADA 206, 302

Ensure that the change in elevation is within the recommended value.

Recommendation Up to 0.25 inches

Remove tripping hazards \$198

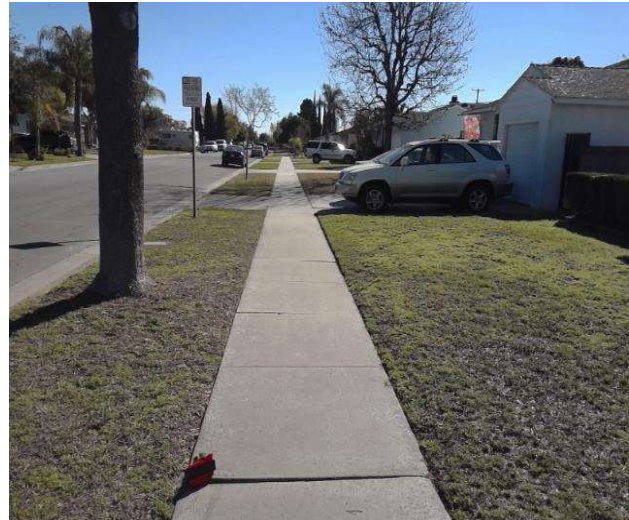
#### Change In Level East Of Orizaba Avenue @ 33.925084075053, -118.147433996201

Sidewalks , Change in Level : Change in Level Non Beveled

There is a change in elevation greater than recommended value.

**On-Site Finding** 0.75 inches

**Code Reference** ADA 206, 302

Ensure that the change in elevation is within the recommended value.

Recommendation Up to 0.25 inches

Remove tripping hazards \$198

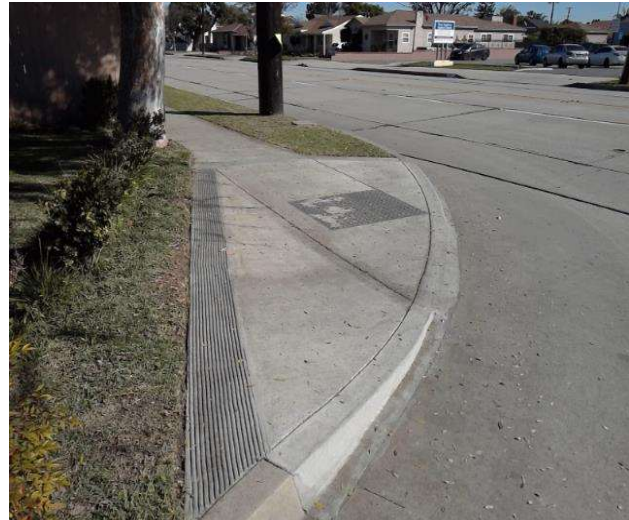
#### Northwest Corner Of Downey Avenue @ 33.924025790317, - 118.144981116056

Curb Ramp : Not Wholly Contained Within The Marked Crossing

The curb ramp is not wholly contained within the marked crossing.

**On-Site Finding** Not Found

**Code Reference** ADA 406, 406.5

Notes : Truncated Domes Are Damaged And Partially Missing

Provide a marked crossing on the path of travel; make certain the curb ramp is wholly contained within the marked crossing.

Install crosswalk \$800

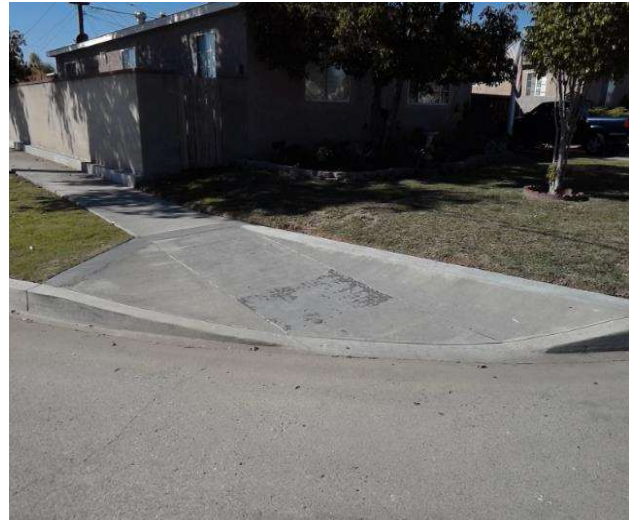
#### Southwest Corner Of Downey Avenue @ 33.923895590341, - 118.145069628954

Curb Ramp : No Detectable Warnings

The curb ramp does not provide a detectable warning surface which includes truncated domes.

**On-Site Finding** Not Found

**Code Reference** CA 11B-406.5.12

Provide compliant detectable warnings to surface.

Provide detectable warning to surface \$248

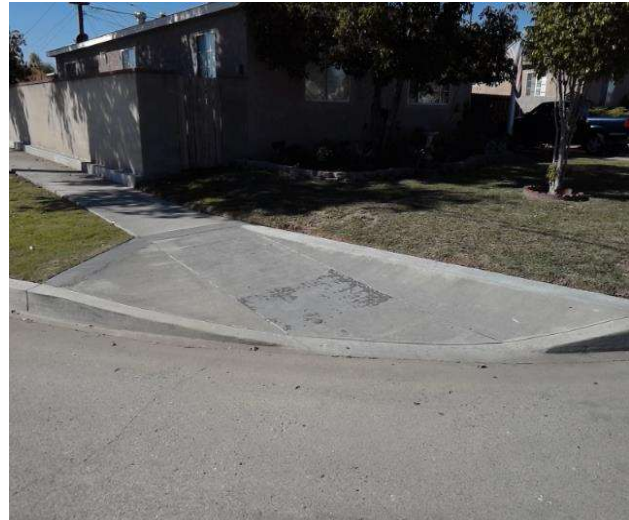
#### Southwest Corner Of Downey Avenue @ 33.923895590341, - 118.145069628954

Curb Ramp : Not Wholly Contained Within The Marked Crossing

The curb ramp is not wholly contained within the marked crossing.

**On-Site Finding** Not Found

**Code Reference** ADA 406, 406.5

Provide a marked crossing on the path of travel; make certain the curb ramp is wholly contained within the marked crossing.

Install crosswalk \$800

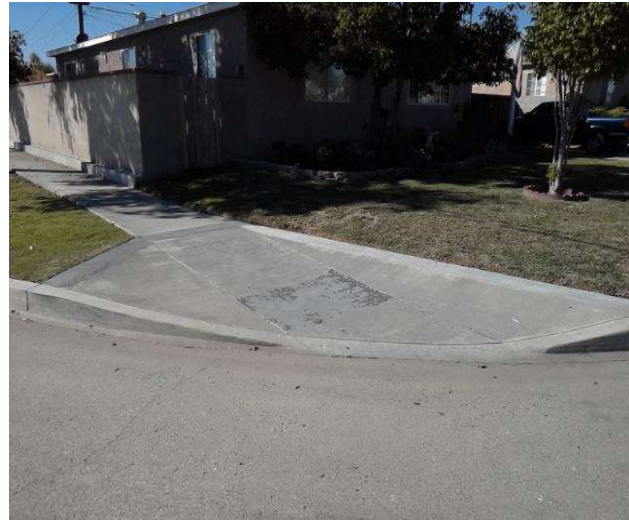
#### Southwest Corner Of Downey Avenue @ 33.923895590341, - 118.145069628954

Curb Ramp : Curb Ramp - Cross Slope

The cross slope is greater than allowed.

**On-Site Finding** 2.90 percent

**Code Reference** ADA 402, 406.1, 405.3, CA 11B-406.5.7

Provide a compliant curb ramp.

Recommendation Up to 2.08 percent

Install curb ramp \$1,300

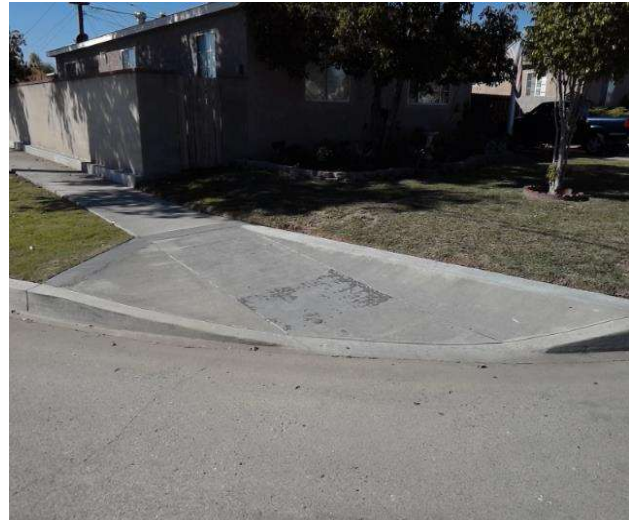
#### Southwest Corner Of Downey Avenue @ 33.923895590341, - 118.145069628954

Curb Ramp : Side Flare Slope

The slope of the curb ramp side flare is greater than allowed.

**On-Site Finding** 17.60 percent

**Code Reference** ADA 406, 406.3,CA 11B-406.2.2

Provide curb ramp side flares with a compliant slope.

Recommendation Up to 10.00 percent

Install flared sides \$1,300

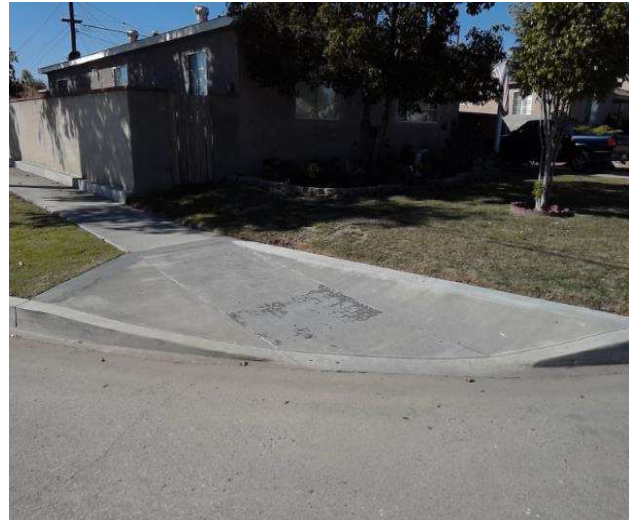
#### Southwest Corner Of Downey Avenue @ 33.923895590341, - 118.145069628954

Curb Ramp : Bottom Landing Slope

The bottom landing of the curb ramp is on the street, and the slope of the bottom landing is not compliant.

**On-Site Finding** 7.40 percent

**Code Reference** ADA 406, 406.2, CA 11B-406.5.8

Ensure the bottom landing slope is compliant and provides a smooth transition.

Recommendation Up to 5.00 percent

Repave landing \$1,260

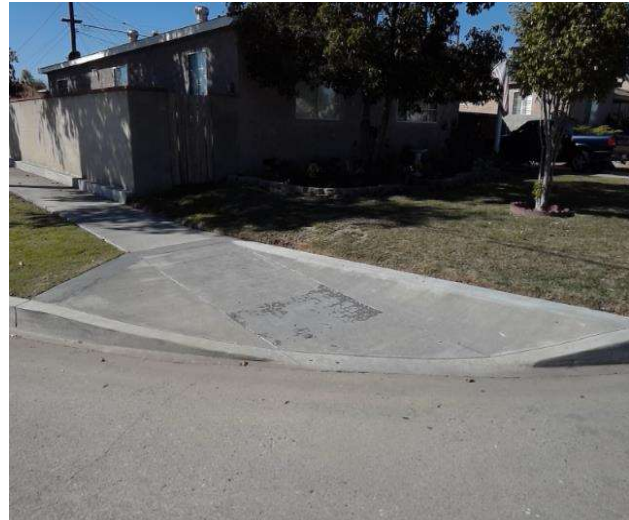
#### Southwest Corner Of Downey Avenue @ 33.923895590341, - 118.145069628954

Curb Ramp , Landings and Transitions : Top Landing Slope

The slope at the top landing is greater than allowed.

**On-Site Finding** 2.60 percent

**Code Reference** ADA 402, 406.4, 403.3, 406.1, CA 11B-406.5.3

Provide a top landing surface that does not exceed the maximum slope and cross slope. Provide a sufficient maneuvering clearance that does not accumulate water.

Recommendation Up to 2.08 percent

Provide compliant landing \$1,260

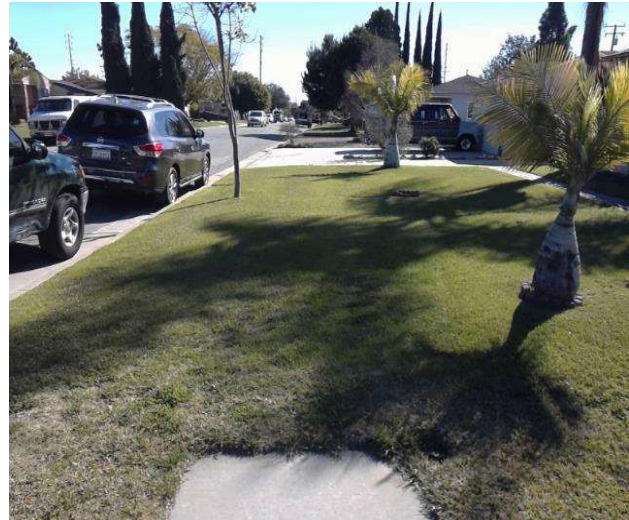
**Sidewalk East Of Orizaba Avenue @ 33.924709058727, -118.146680295467**

Sidewalks : Missing Sidewalk

Section of sidewalk is missing and consists of dirt, grass or gravel.

**On-Site Finding** 568.00 feet

**Code Reference** ADA 206, 302,CA 11B-302,CA 11B-206

Provide a compliant sidewalk for the missing section.

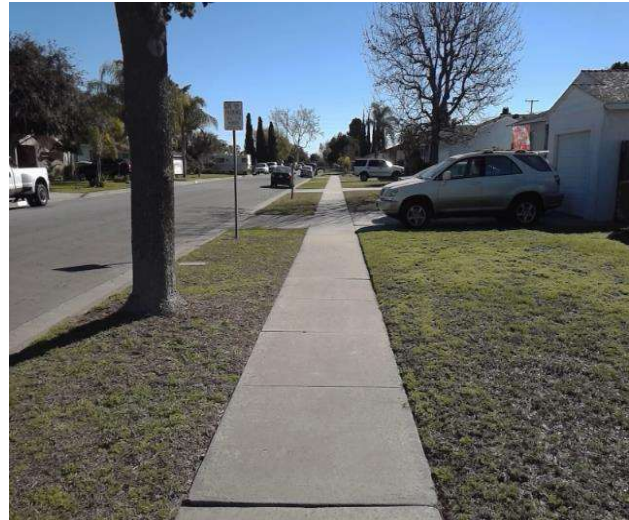
**South Side @ 33.925084075053, -118.147433996201**

Sidewalks : 60X60 Turn Area

There is no 60X60 turn area at every 200 feet.

**On-Site Finding** Not Found

**Code Reference** ADA 206, 302

Provide a 60X60 turn every 200 feet on the sidewalk.
