Accessibility Survey

City of Downey Country Club Drive - Old River School Road to End

Date of Inspection
7/6/2017

Disability Access Consultants

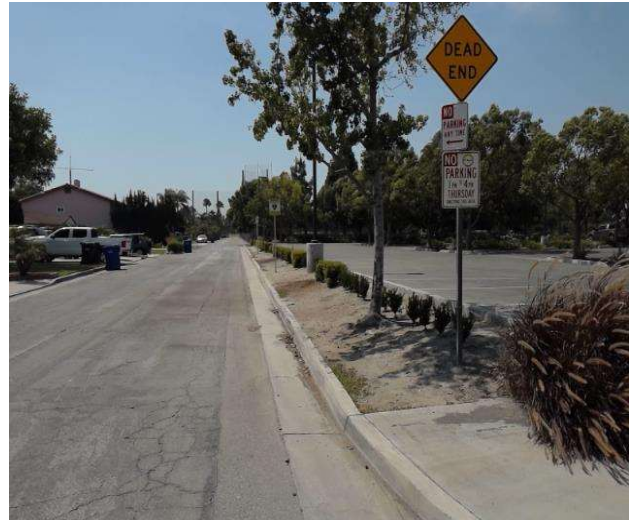
North Side @ 33.952364143, -118.145549744368

Sidewalks : No Sidewalk

No sidewalk exists at the location.

No action necessary until a sidewalk is provided.

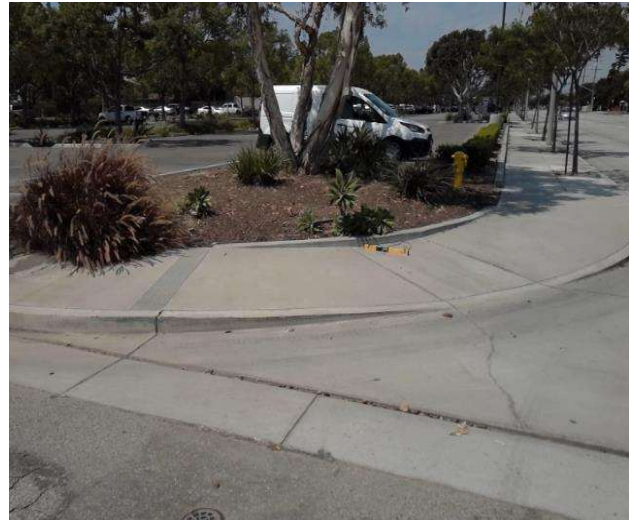
Northwest Corner of Old River School Road @ 33.952295614343, - 118.145496100187

Curb Ramp , Landings and Transitions : Bottom Landing Slope

The slope at the bottom landing is greater than allowed.

On-Site Finding 3.60 percent

Code Reference ADA 402, 406.4, 406.2, 403.3, 406.1, CA 11B-406.5.3

Provide a compliant bottom landing that does not exceed the maximum slope requirements.

Recommendation Up to 2.08 percent

Provide compliant landing \$240

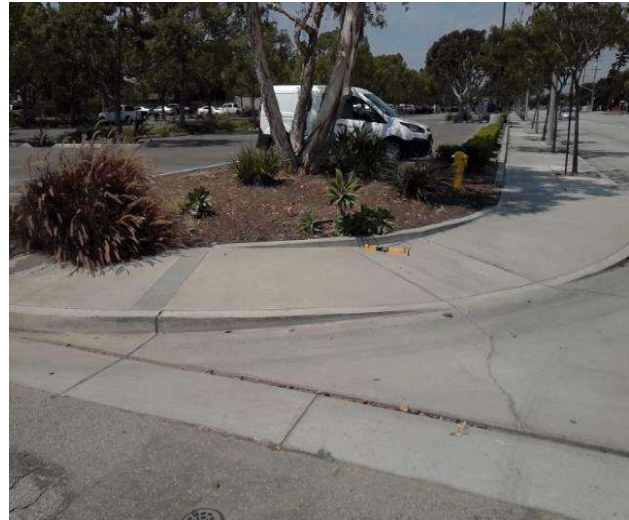
Northwest Corner of Old River School Road @ 33.952295614343, -118.145496100187

Curb Ramp , Landings and Transitions : Top Landing Slope

The slope at the top landing is greater than allowed.

On-Site Finding 3.80 percent

Code Reference ADA 402, 406.4, 403.3, 406.1, CA 11B-406.5.3

Provide a top landing surface that does not exceed the maximum slope and cross slope. Provide a sufficient maneuvering clearance that does not accumulate water.

Recommendation Up to 2.08 percent

Provide compliant landing \$1,260

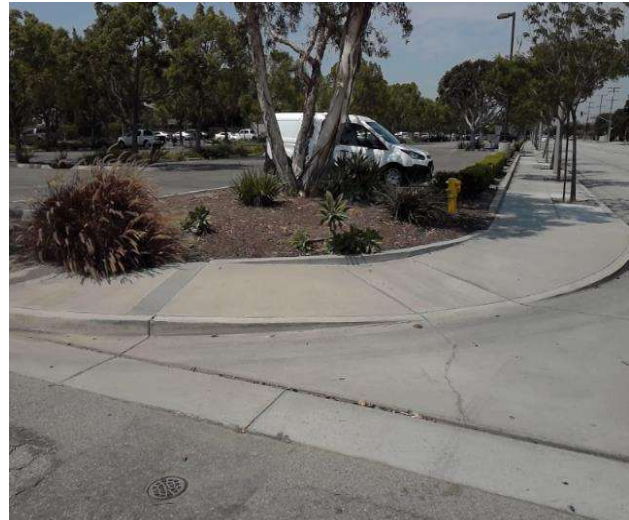
Northwest Corner of Old River School Road @ 33.952295614343, -118.145496100187

Curb Ramp : No Detectable Warnings

The curb ramp does not provide a detectable warning surface which includes truncated domes.

Code Reference CA 11B-406.5.12

Provide compliant detectable warnings to surface.

Provide detectable warning to surface \$248

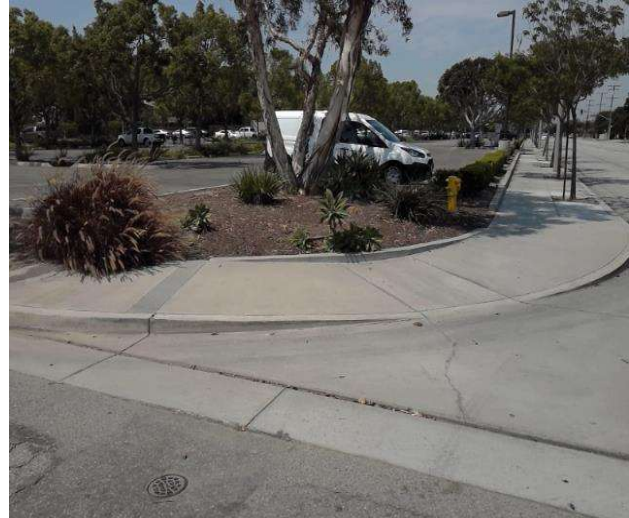
Northwest Corner of Old River School Road @ 33.952295614343, -118.145496100187

Curb Ramp : Parallel Curb Ramp Left Side Cross Slope

The cross slope is greater than allowed.

On-Site Finding 3.40 percent

Code Reference ADA 406.1, 405.3, CA 11B-406.5.7

Provide a compliant curb ramp.

Recommendation Up to 2.08 percent

Install curb ramp \$1,300

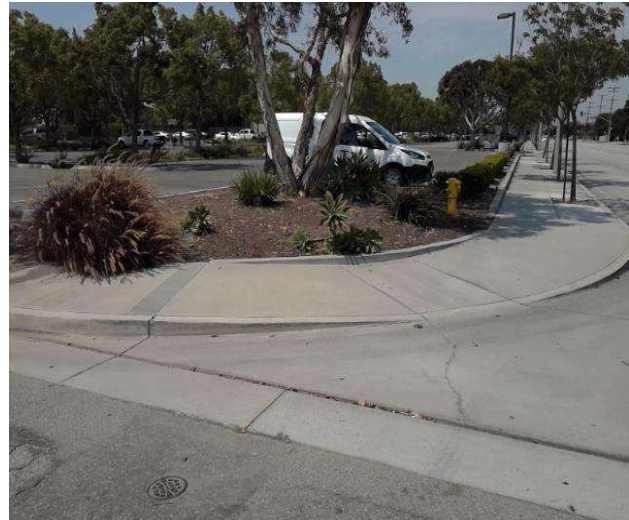
Northwest Corner of Old River School Road @ 33.952295614343, -118.145496100187

Curb Ramp : Parallel Curb Ramp Right Side Cross Slope

The cross slope is greater than allowed.

On-Site Finding 3.40 percent

Code Reference ADA 406.1, 405.3, CA 11B-406.5.7

Provide a compliant curb ramp.

Recommendation Up to 2.08 percent

Install curb ramp \$1,300

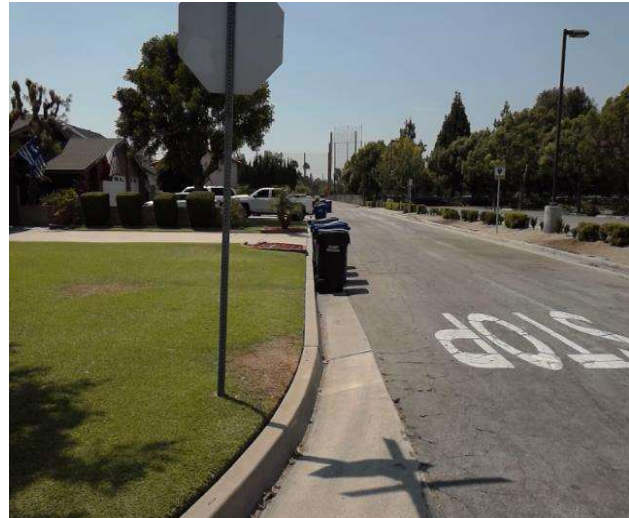
South Side @ 33.952204393391, -118.145569860935

Sidewalks : No Sidewalk

No sidewalk exists at the location.

No action necessary until a sidewalk is provided.

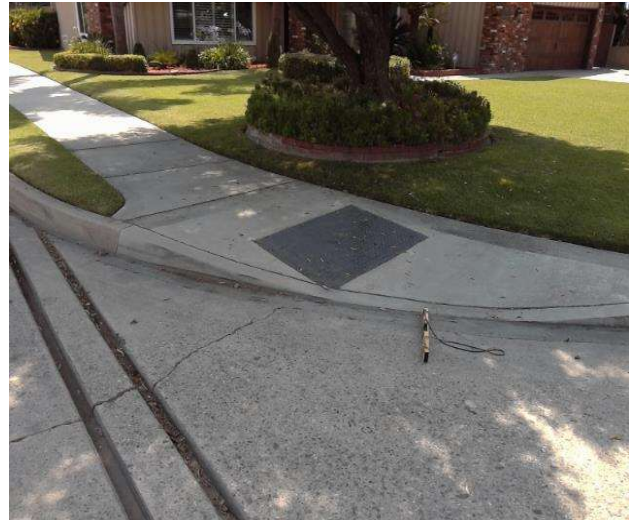
Southwest Corner of Old River School Road @ 33.952204393391, - 118.145569860935

Curb Ramp : Bottom Landing Slope

The bottom landing of the curb ramp is on the street, and the slope of the bottom landing is not compliant.

On-Site Finding 6.50 percent

Code Reference ADA 406, 406.2, CA 11B-406.5.8

Ensure the bottom landing slope is compliant and provides a smooth transition.

Recommendation Up to 5.00 percent

Repave landing \$1,260

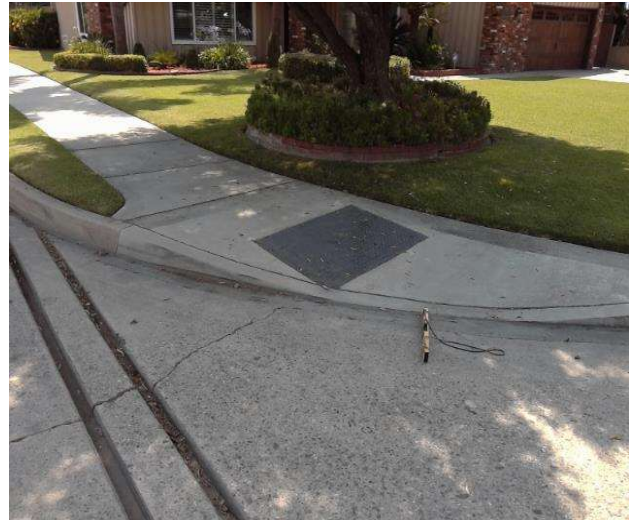
Southwest Corner of Old River School Road @ 33.952204393391, - 118.145569860935

The slope at the top landing is greater than allowed.

On-Site Finding 3.60 percent

Curb Ramp , Landings and Transitions : Top Landing Slope

Code Reference ADA 402, 406.4, 403.3, 406.1, CA 11B-406.5.3

Provide a top landing surface that does not exceed the maximum slope and cross slope. Provide a sufficient maneuvering clearance that does not accumulate water.

Recommendation Up to 2.08 percent

Provide compliant landing \$1,260

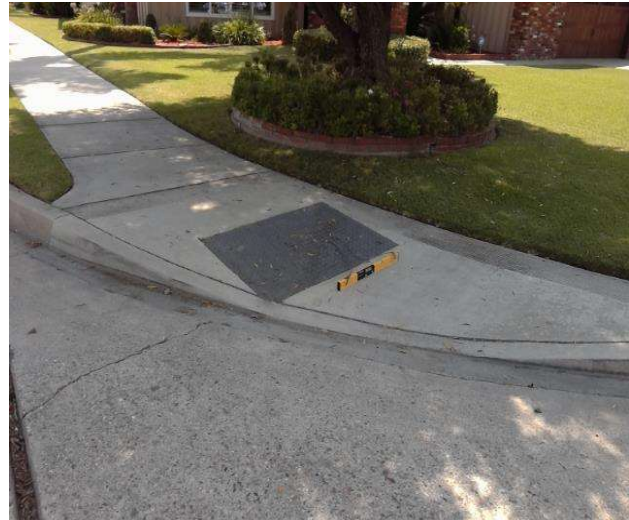
Southwest Corner of Old River School Road @ 33.952204393391, - 118.145569860935

Curb Ramp : Curb Ramp - Cross Slope

The cross slope is greater than allowed.

On-Site Finding 10.00 percent

Code Reference ADA 402, 406.1, 405.3, CA 11B-406.5.7

Provide a compliant curb ramp.

Recommendation Up to 2.08 percent

Install curb ramp \$1,300

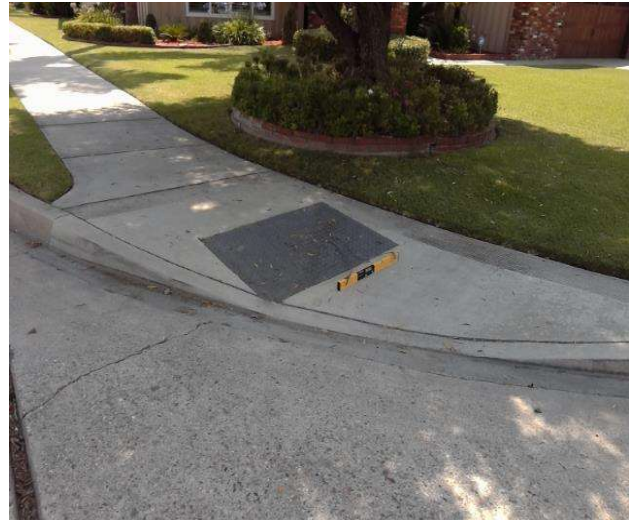
Southwest Corner of Old River School Road @ 33.952204393391, - 118.145569860935

Curb Ramp : Side Flare Slope

The slope of the curb ramp side flare is greater than allowed.

On-Site Finding 10.60 percent

Code Reference ADA 406, 406.3, CA 11B-406.2.2

Provide curb ramp side flares with a compliant slope.

Recommendation Up to 10.00 percent

Install flared sides \$1,300
