Accessibility Survey

City of Downey Eucalyptus Street - Birchdale Avenue To Brookshire Avenue

Date of Inspection
2/5/2017

Disability Access Consultants

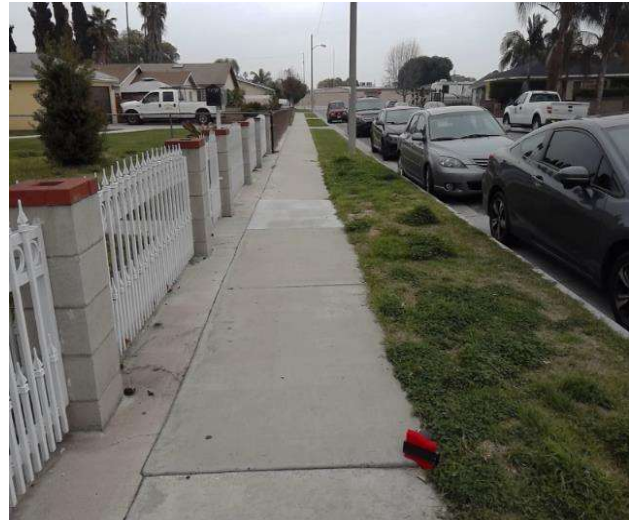
Change In Level East Brookshire Avenue @ 33.922246373412, -118.140193372965

Sidewalks , Change in Level : Change in Level Non Beveled

There is a change in elevation greater than recommended value.

On-Site Finding 0.87 inches

Code Reference ADA 206, 302

Ensure that the change in elevation is within the recommended value.

Recommendation Up to 0.25 inches

Remove tripping hazards \$198

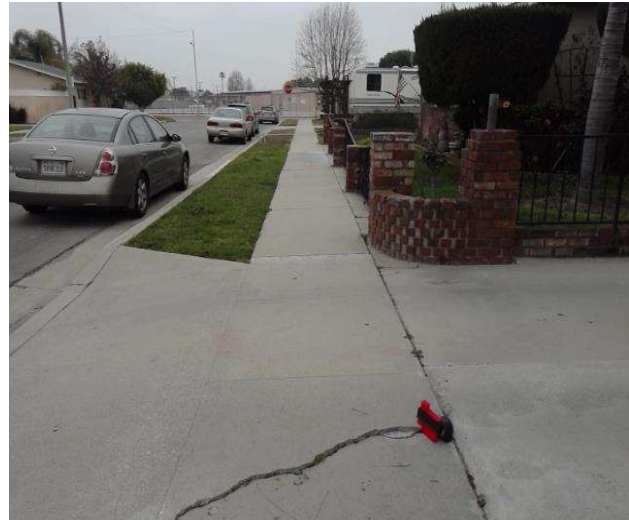
Change In Level West Of Birchdale Avenue @ 33.921964823742, -118.139954656363

Sidewalks , Change in Level : Change in Level Non Beveled

There is a change in elevation greater than recommended value.

On-Site Finding 0.87 inches

Code Reference ADA 206, 302

Ensure that the change in elevation is within the recommended value.

Recommendation Up to 0.25 inches

Remove tripping hazards \$198

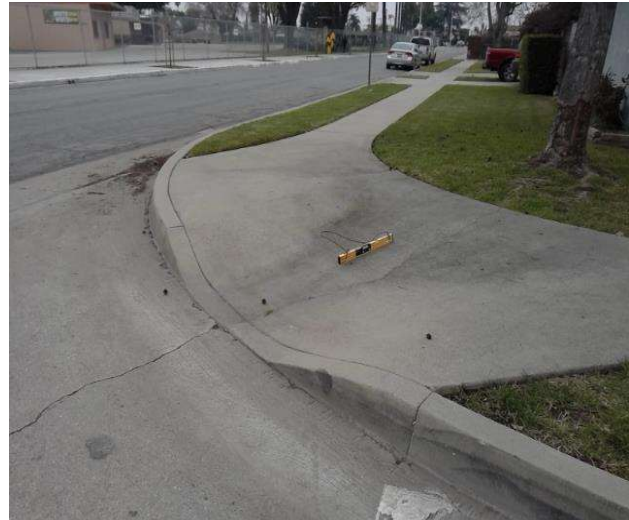
Southwest Corner Of Birchdale Avenue @ 33.921673257490, - 118.139428943396

Curb Ramp : No Detectable Warnings

The curb ramp does not provide a detectable warning surface which includes truncated domes.

On-Site Finding Not Found

Code Reference CA 11B-406.5.12

Provide compliant detectable warnings to surface.

Provide detectable warning to surface \$248

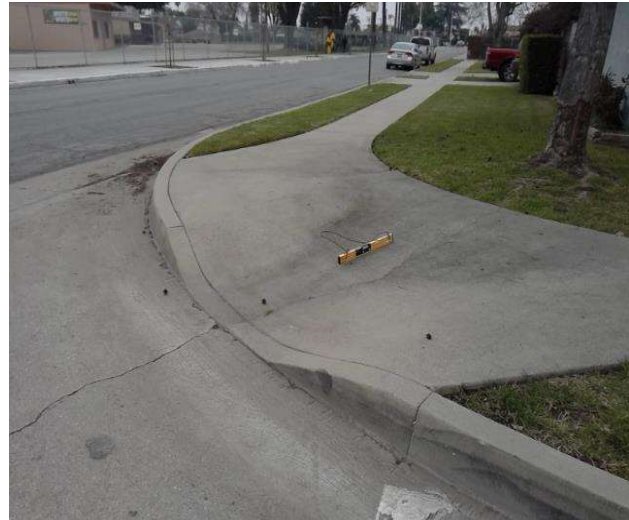
Southwest Corner Of Birchdale Avenue @ 33.921673257490, - 118.139428943396

Curb Ramp : Curb Ramp Width

The width of the curb ramp is less than required.

On-Site Finding 46.00 inches

Code Reference ADA 406, 406.1, 405.5, CA 11B-406.5.2

Provide a compliant curb ramp.

Recommendation At least 48.00 inches

Install curb ramp \$1,300

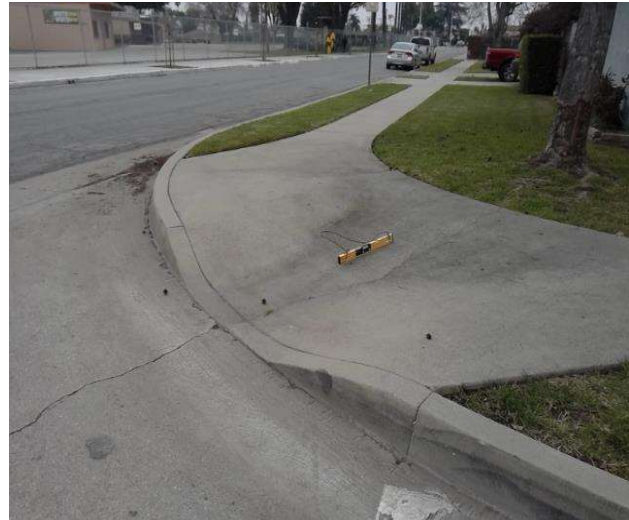
**Southwest Corner Of Birchdale Avenue @ 33.921673257490, -
118.139428943396**

Curb Ramp : Curb Ramp Slope

The running slope is greater than allowed.

On-Site Finding 9.50 percent

Code Reference ADA 406, 406.1, 405.2, CA 11B-406

Provide a compliant curb ramp.

Recommendation Up to 8.33 percent

Install curb ramp \$1,300

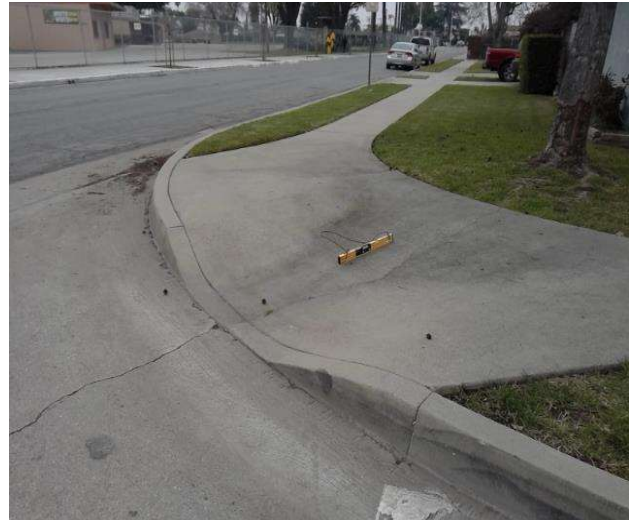
Southwest Corner Of Birchdale Avenue @ 33.921673257490, - 118.139428943396

Curb Ramp : Side Flare Slope

The slope of the curb ramp side flare is greater than allowed.

On-Site Finding 21.70 percent

Code Reference ADA 406, 406.3,CA 11B-406.2.2

Provide curb ramp side flares with a compliant slope.

Recommendation Up to 10.00 percent

Install flared sides \$1,300

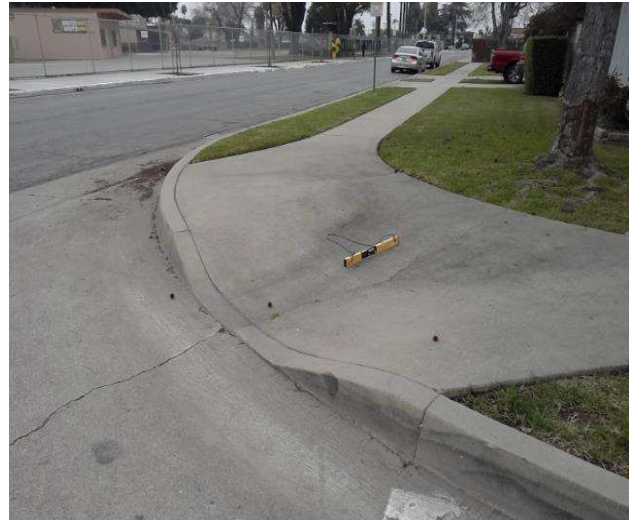
Southwest Corner Of Birchdale Avenue @ 33.921673257490, - 118.139428943396

Curb Ramp : Bottom Landing Slope

The bottom landing of the curb ramp is on the street, and the slope of the bottom landing is not compliant.

On-Site Finding 5.50 percent

Code Reference ADA 406, 406.2, CA 11B-406.5.8

Ensure the bottom landing slope is compliant and provides a smooth transition.

Recommendation Up to 5.00 percent

Repave landing \$1,260

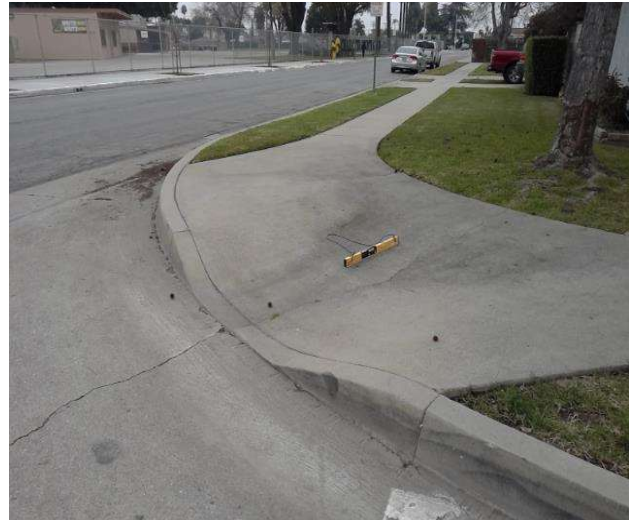
Southwest Corner Of Birchdale Avenue @ 33.921673257490, - 118.139428943396

The transition from the bottom of the curb ramp to the walk, gutter, or street is abrupt.

On-Site Finding 0.75 inches

Curb Ramp , Landings And Transitions : Bottom Landing Change in Level

Code Reference ADA 302, 303, 406.2, 303.1

Patch the transition area at the bottom of the curb ramp so that the transition is flush and free of abrupt changes.

Recommendation Up to 0.50 inches

Patch lip at curb ramp \$255

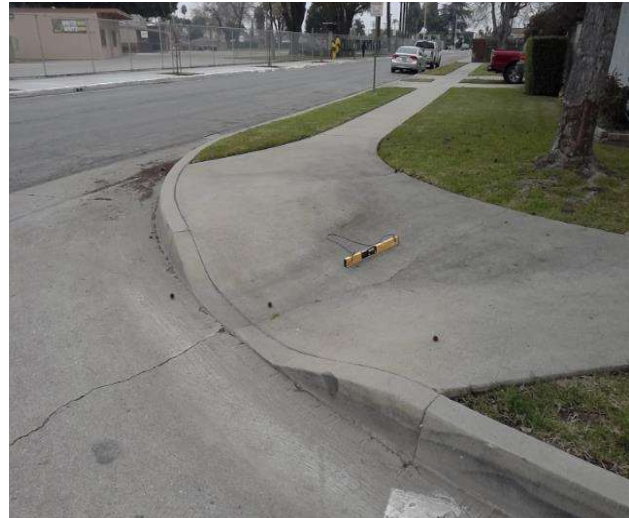
Southwest Corner Of Birchdale Avenue @ 33.921673257490, - 118.139428943396

Curb Ramp , Landings and Transitions : Top Landing Clear Length - Landings

There is not enough top landing clear length.

On-Site Finding 0.00 inches

Code Reference ADA 406, 406.4,CA 11B-406.5.3

Provide a level top landing with enough clear length.

Recommendation At least 48.00 inches

Provide compliant landing \$240

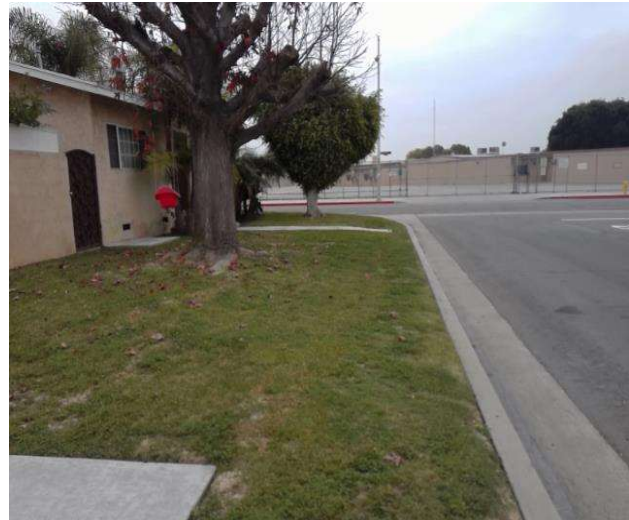
Sidewalk East Of Brookshire Avenue @ 33.921884698765, -118.139521935

Sidewalks : Missing Sidewalk

Section of sidewalk is missing and consists of dirt, grass or gravel.

On-Site Finding 65.00 feet

Code Reference ADA 206, 302,CA 11B-302,CA 11B-206

Provide a compliant sidewalk for the missing section.

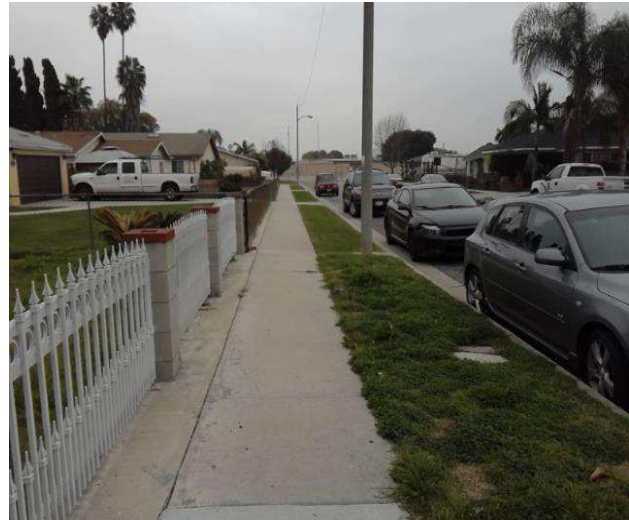
Sidewalk East Of Brookshire Avenue @ 33.922212988124, -118.140127658844

Sidewalks , Surface : Cross Slope

Sidewalk cross slope is not compliant.

On-Site Finding 3.70 percent for 98.00 feet

Code Reference ADA 206, 302,CA 11B-403.3

Repave the sidewalk surface with the recommended cross slope.

Recommendation Up to 2.08 percent

Repave surface \$1,092

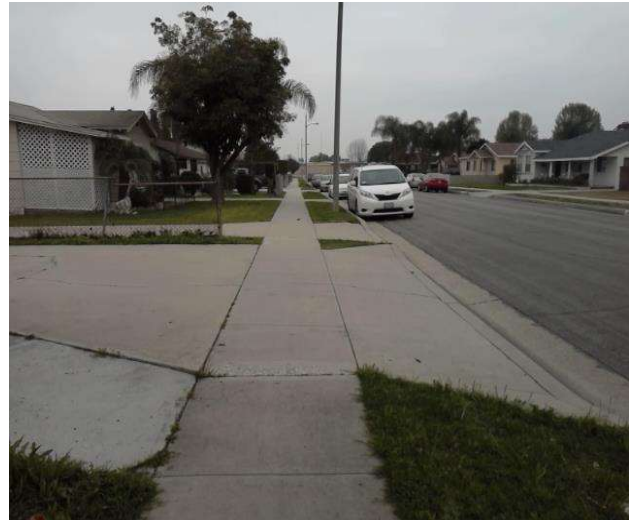
Sidewalk East Of Brookshire Avenue @ 33.922525696474, -118.140719085932

Sidewalks , Surface : Cross Slope

Sidewalk cross slope is not compliant.

On-Site Finding 5.20 percent for 95.00 feet

Code Reference ADA 206, 302,CA 11B-403.3

Repave the sidewalk surface with the recommended cross slope.

Recommendation Up to 2.08 percent

Repave surface \$1,092

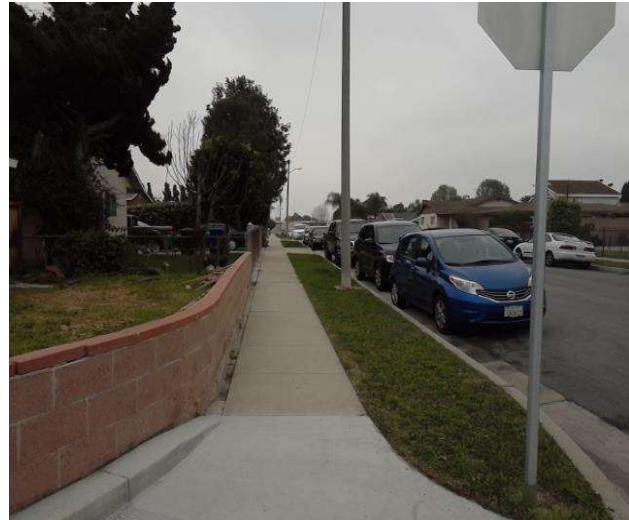
North Side @ 33.922728232942, -118.141109347343

Sidewalks : 60X60 Turn Area

There is no 60X60 turn area at every 200 feet.

On-Site Finding Not Found

Code Reference ADA 206, 302

Provide a 60X60 turn every 200 feet on the sidewalk.

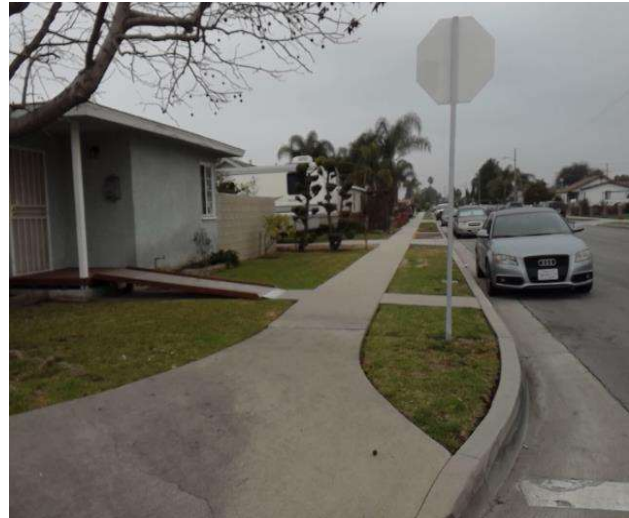
South Side @ 33.921686611691, -118.139443695545

Sidewalks : 60X60 Turn Area

There is no 60X60 turn area at every 200 feet.

On-Site Finding Not Found

Code Reference ADA 206, 302

Provide a 60X60 turn every 200 feet on the sidewalk.
