Accessibility Survey

City of Downey

Rio Hondo Drive - Dinwiddie Street To Cul-de-sac

Date of Inspection
2/13/2017

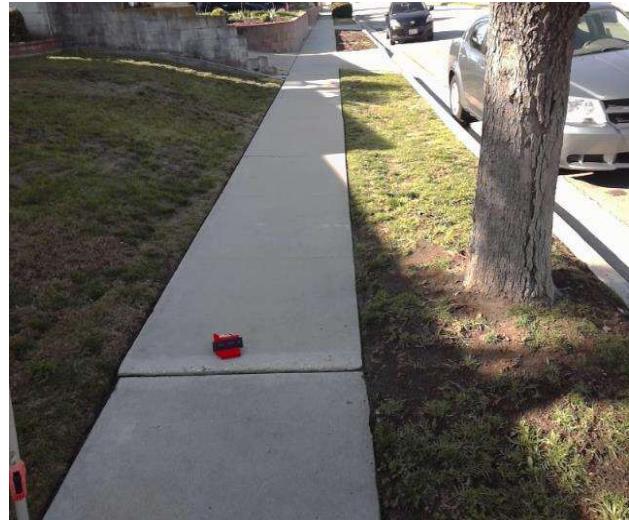
Change In Level South Of Pellet Street @ 33.953314612475, -118.155614733696

Sidewalks , Change in Level : Change in Level - Beveled

There is a change in elevation greater than recommended value.

On-Site Finding 0.75 inches

Code Reference ADA 206, 302

Ensure that the change in elevation not exceed a .5 beveled inch.

Recommendation Up to 0.50 inches

Remove tripping hazards \$198

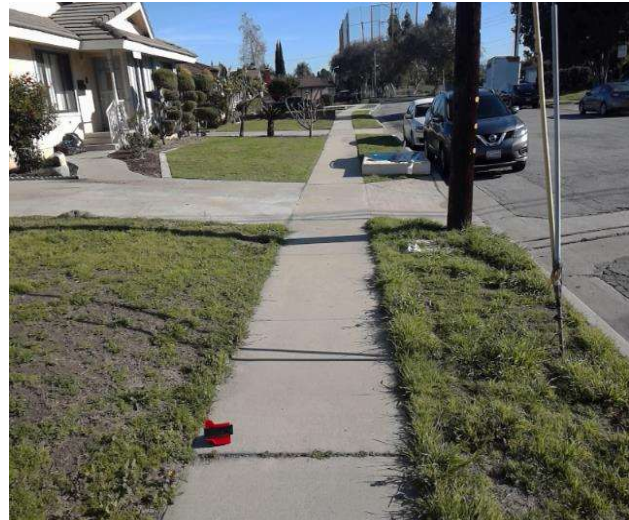
Change In Level North Of Dinwiddie Street @ 33.953523750320, - 118.155641555786

Sidewalks , Change in Level : Change in Level - Beveled

There is a change in elevation greater than recommended value.

On-Site Finding 0.75 inches

Code Reference ADA 206, 302

Ensure that the change in elevation not exceed a .5 beveled inch.

Recommendation Up to 0.50 inches

Remove tripping hazards \$198

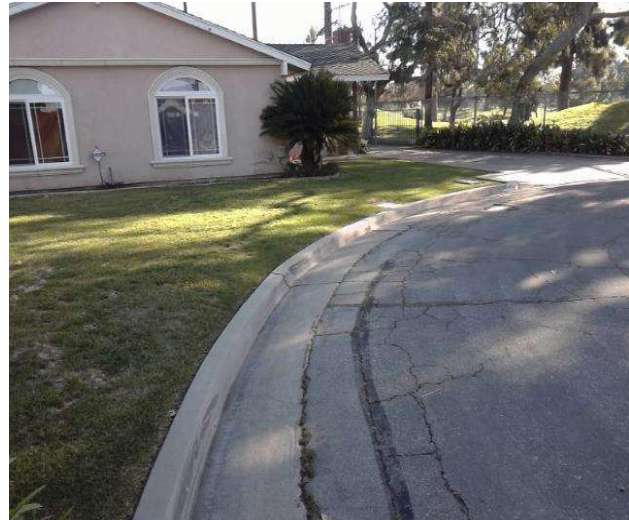
Sidewalk South Of Cul-de-sac @ 33.954680673795, -118.154348731041

Sidewalks : Missing Sidewalk

Section of sidewalk is missing and consists of dirt, grass or gravel.

On-Site Finding 379.00 feet

Code Reference ADA 206, 302,CA 11B-302,CA 11B-206

Provide a compliant sidewalk for the missing section.

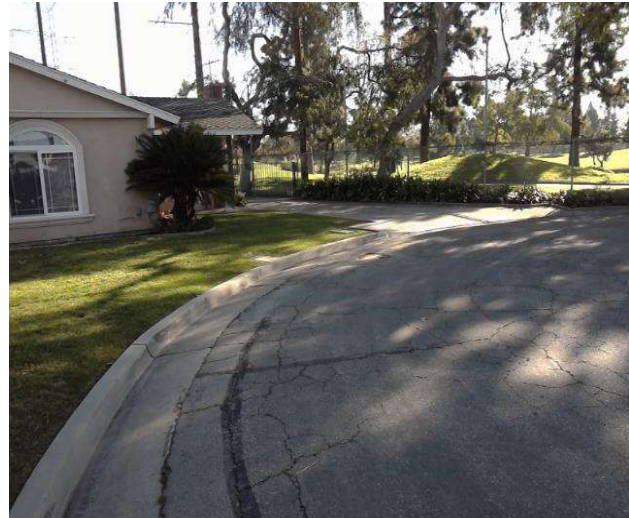
East Side @ 33.954680673795, -118.154348731041

Sidewalks : 60X60 Turn Area

There is no 60X60 turn area at every 200 feet.

On-Site Finding Not Found

Code Reference ADA 206, 302

Provide a 60X60 turn every 200 feet on the sidewalk.

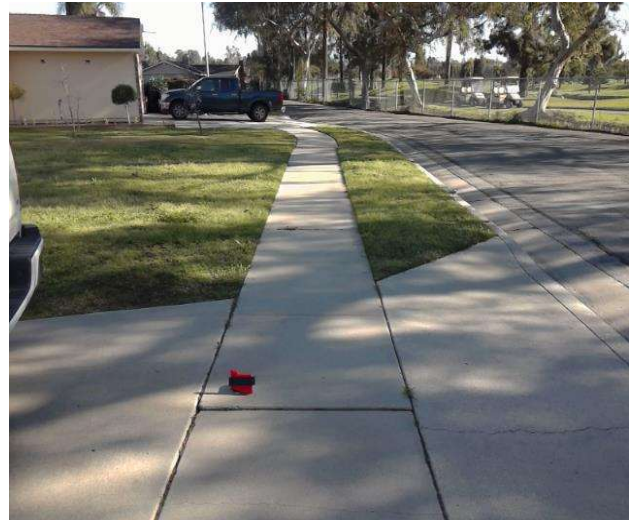
Change In Level North Of Dinwiddie Street @ 33.954249054184, - 118.154579401016

Sidewalks , Change in Level : Change in Level - Beveled

There is a change in elevation greater than recommended value.

On-Site Finding 0.62 inches

Code Reference ADA 206, 302

Ensure that the change in elevation not exceed a .5 beveled inch.

Recommendation Up to 0.50 inches

Remove tripping hazards \$198

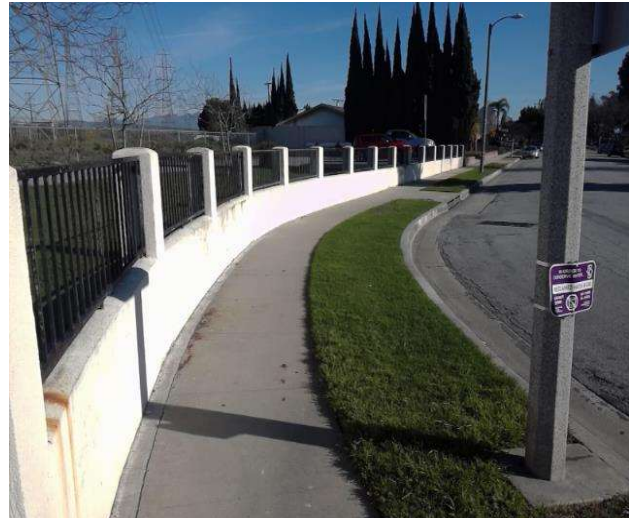
West Side @ 33.952624898917, -118.156725168228

Sidewalks : 60X60 Turn Area

There is no 60X60 turn area at every 200 feet.

On-Site Finding Not Found

Code Reference ADA 206, 302

Provide a 60X60 turn every 200 feet on the sidewalk.
