Accessibility Survey

City of Downey Spry Street - End To Izetta Avenue

End
Izetta Avenue
Downey, CA 90242

Date of Inspection
12/7/2016

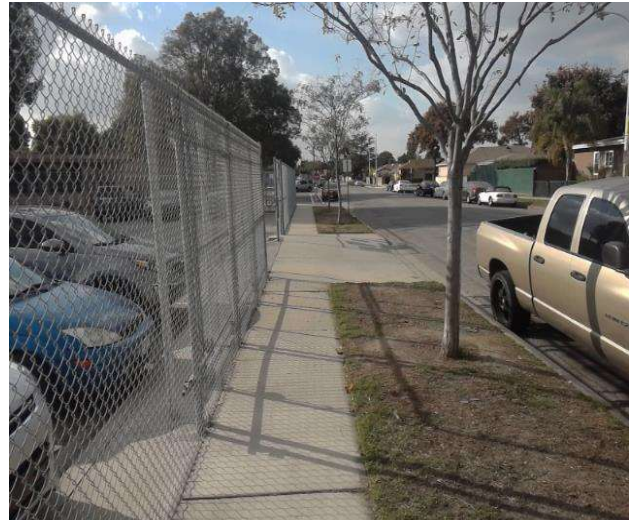
Change In Level West Of End @ 33.920660557795, -118.119313716888

Sidewalks , Change in Level : Change in Level Non Beveled

There is a change in elevation greater than recommended value.

On-Site Finding 0.50 inches

Code Reference ADA 206, 302

Ensure that the change in elevation is within the recommended value.

Recommendation Up to 0.25 inches

Remove tripping hazards \$198

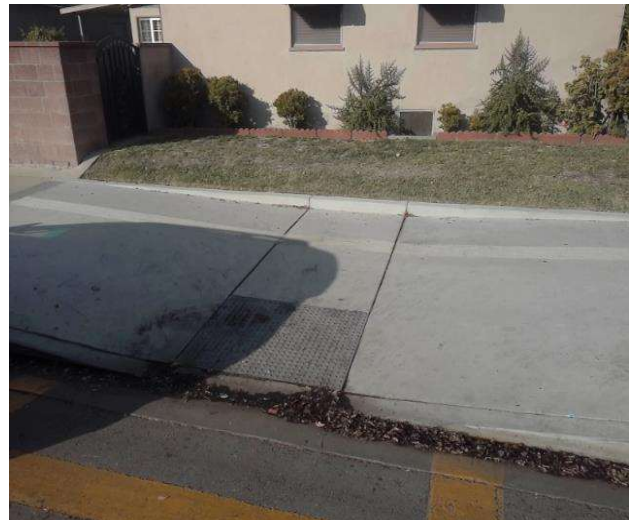
North Side East Of Dunrobin Avenue @ 33.920785198407, - 118.120402693748

Curb Ramp : Bottom Landing Slope

The bottom landing of the curb ramp is on the street, and the slope of the bottom landing is not compliant.

On-Site Finding 10.10 percent

Code Reference ADA 406, 406.2, CA 11B-406.5.8

Ensure the bottom landing slope is compliant and provides a smooth transition.

Recommendation Up to 5.00 percent

Repave landing \$1,260

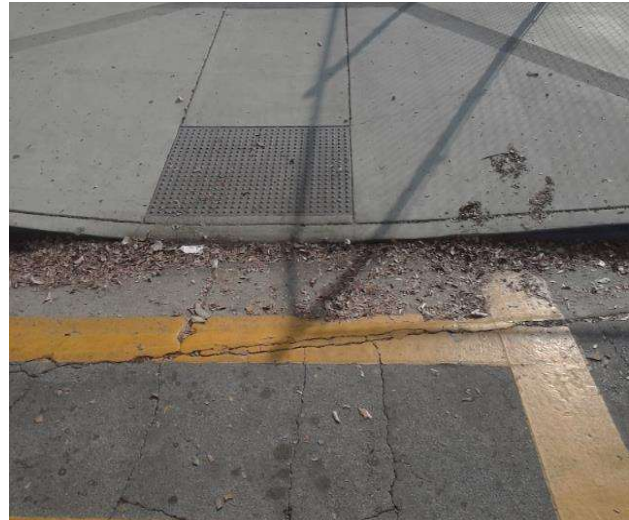
South Side West Of End @ 33.920642751979, -118.120389282703

Curb Ramp : Bottom Landing Slope

The bottom landing of the curb ramp is on the street, and the slope of the bottom landing is not compliant.

On-Site Finding 9.20 percent

Code Reference ADA 406, 406.2,CA 11B-406.5.8

Ensure the bottom landing slope is compliant and provides a smooth transition.

Recommendation Up to 5.00 percent

Repave landing \$1,260

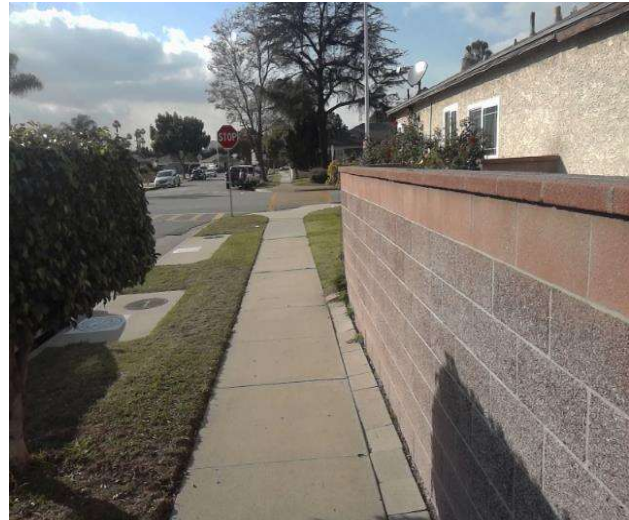
Sidewalk East Of Dunrobin Avenue @ 33.920803004194, -118.120882809162

Sidewalks , Surface : Cross Slope

Sidewalk cross slope is not compliant.

On-Site Finding 3.10 percent for 47.00 feet

Code Reference ADA 206, 302, CA 11B-403.3

Repave the sidewalk surface with the recommended cross slope.

Recommendation Up to 2.08 percent

Repave surface \$1,092

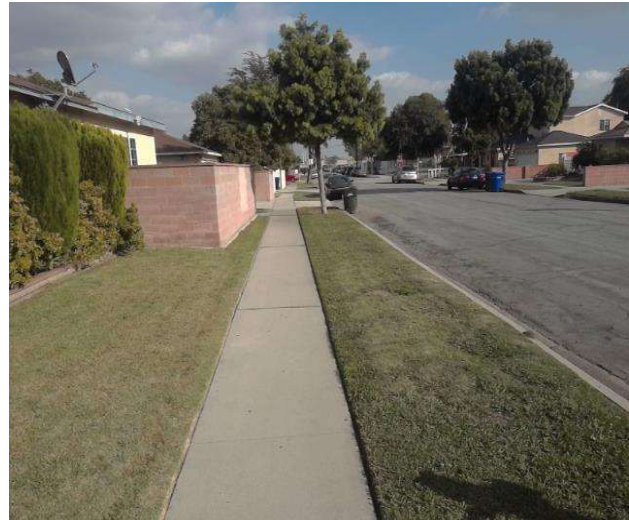
North Side @ 33.920787424131, -118.121982514858

Sidewalks : 60X60 Turn Area

There is no 60X60 turn area at every 200 feet.

On-Site Finding Not Found

Code Reference ADA 206, 302

Provide a 60X60 turn every 200 feet on the sidewalk.

\$2,400

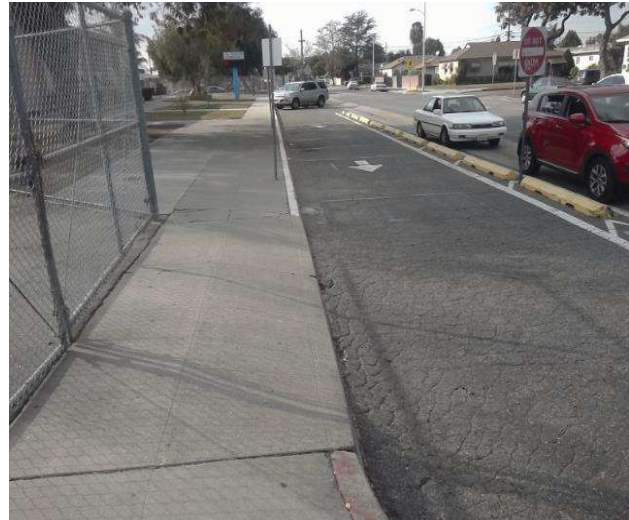
Driveway West Of End @ 33.920660557795, -118.119313716888

Sidewalks , Vehicular Traffic : Cross Walks and Detectable Warnings

There are no detectable warnings where the pedestrian route crosses vehicular traffic.

On-Site Finding Not Found

Code Reference ADA 705,CA 11B-705.1.2.5,CA 11B-247.1.2.5

Provide detectable warnings.

Install compliant detectable warnings \$190

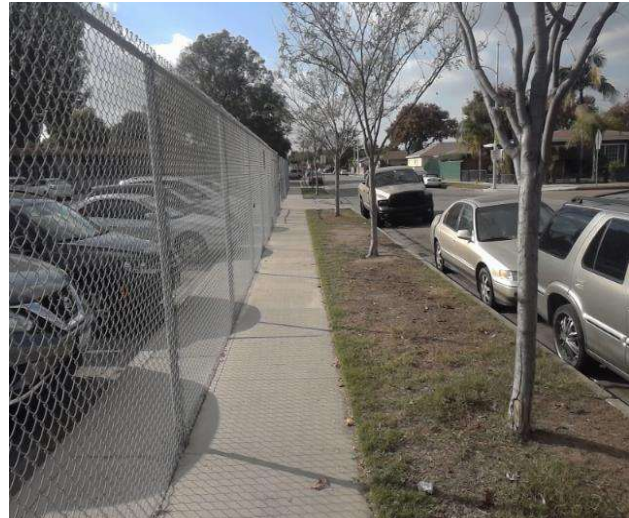
South Side @ 33.920649429160, -118.118897974491

Sidewalks : 60X60 Turn Area

There is no 60X60 turn area at every 200 feet.

On-Site Finding Not Found

Code Reference ADA 206, 302

Provide a 60X60 turn every 200 feet on the sidewalk.

\$2,400
