Accessibility Survey

City of Downey Clancey Avenue - Cecilia Street to Baysinger Street

Date of Inspection
6/12/2017

Disability Access Consultants

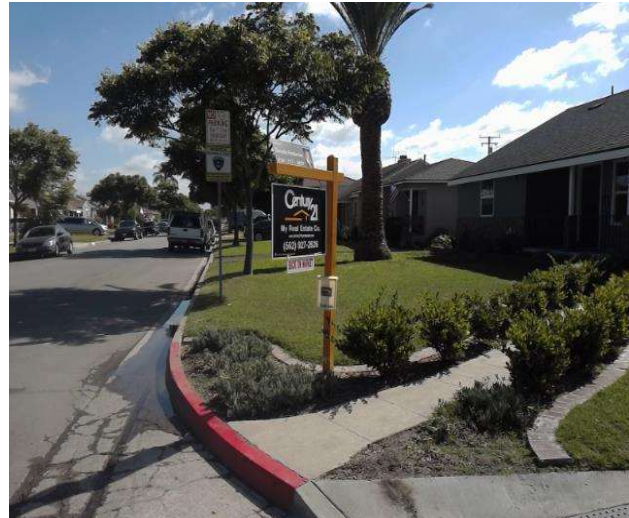
East Side @ 33.938097342791, -118.119781762362

Sidewalks : No Sidewalk

No sidewalk exists at the location.

No action necessary until a sidewalk is provided.

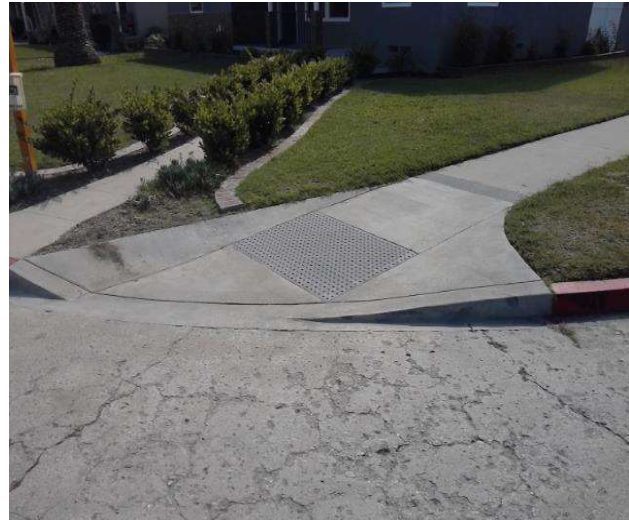
**Northeast Corner of Cecilia Street @ 33.938066188988, -
118.119775056839**

Curb Ramp : Side Flare Slope

The slope of the curb ramp side flare is greater than allowed.

On-Site Finding 26.80 percent

Code Reference ADA 406, 406.3, CA 11B-406.2.2

Provide curb ramp side flares with a compliant slope.

Recommendation Up to 10.00 percent

Install flared sides \$1,300

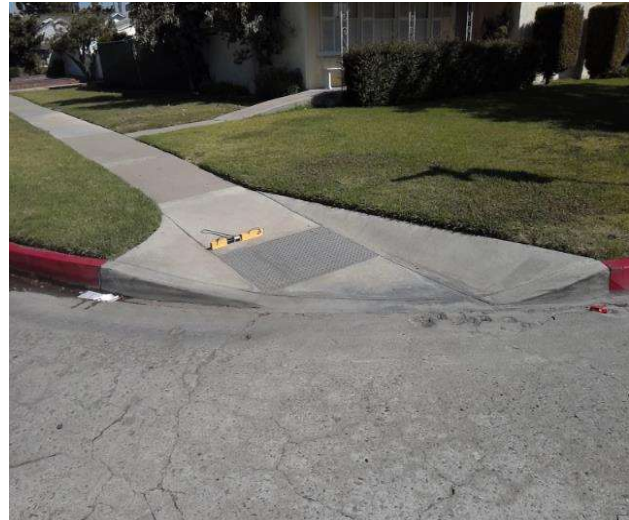
Northwest Corner of Cecilia Street @ 33.938140735568, -118.119925260544

Curb Ramp : Curb Ramp - Cross Slope

The cross slope is greater than allowed.

On-Site Finding 3.40 percent

Code Reference ADA 402, 406.1, 405.3, CA 11B-406.5.7

Provide a compliant curb ramp.

Recommendation Up to 2.08 percent

Install curb ramp \$1,300

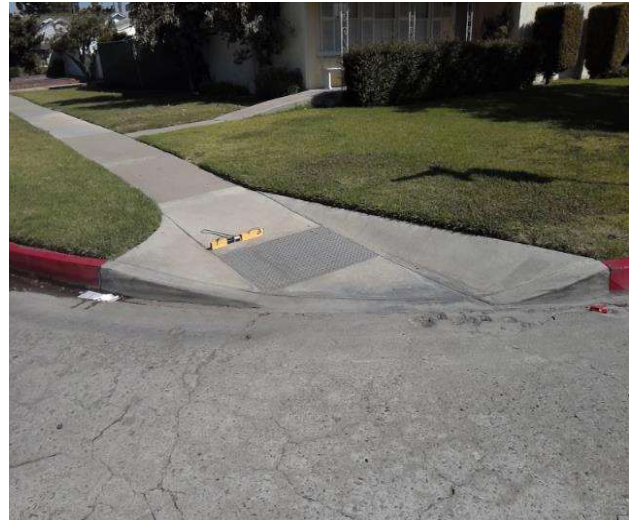
Northwest Corner of Cecilia Street @ 33.938140735568, - 118.119925260544

Curb Ramp : Side Flare Slope

The slope of the curb ramp side flare is greater than allowed.

On-Site Finding 13.20 percent

Code Reference ADA 406, 406.3, CA 11B-406.2.2

Provide curb ramp side flares with a compliant slope.

Recommendation Up to 10.00 percent

Install flared sides \$1,300

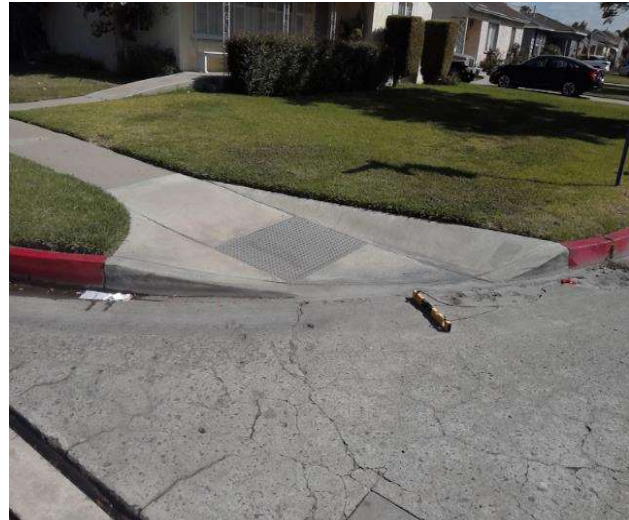
Northwest Corner of Cecilia Street @ 33.938140735568, - 118.119925260544

Curb Ramp : Bottom Landing Slope

The bottom landing of the curb ramp is on the street, and the slope of the bottom landing is not compliant.

On-Site Finding 6.80 percent

Code Reference ADA 406, 406.2, CA 11B-406.5.8

Ensure the bottom landing slope is compliant and provides a smooth transition.

Recommendation Up to 5.00 percent

Repave landing \$1,260

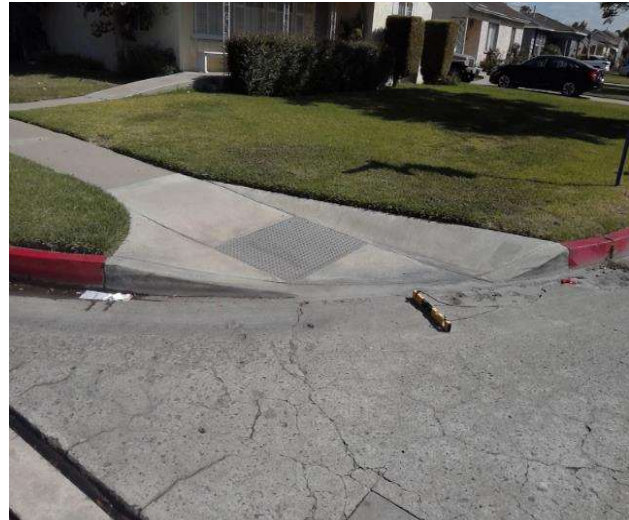
Northwest Corner of Cecilia Street @ 33.938140735568, - 118.119925260544

Curb Ramp , Landings and Transitions : Top Landing Slope

The slope at the top landing is greater than allowed.

On-Site Finding 3.30 percent

Code Reference ADA 402, 406.4, 403.3, 406.1, CA 11B-406.5.3

Provide a top landing surface that does not exceed the maximum slope and cross slope. Provide a sufficient maneuvering clearance that does not accumulate water.

Recommendation Up to 2.08 percent

Provide compliant landing \$1,260

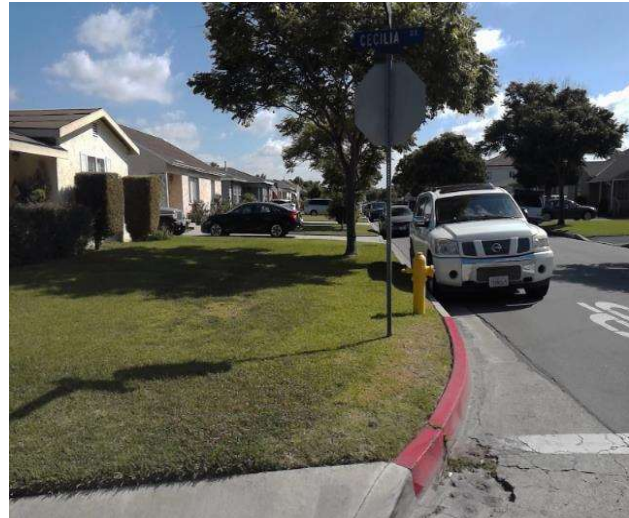
West Side @ 33.938142960838, -118.119898438454

Sidewalks : No Sidewalk

No sidewalk exists at the location.

No action necessary until a sidewalk is provided.
