## Accessibility Survey

## City of Downey Gunderson Avenue - Rosecrans Avenue To Reydon Street

Date of Inspection  
12/1/2016

**Disability Access Consultants**

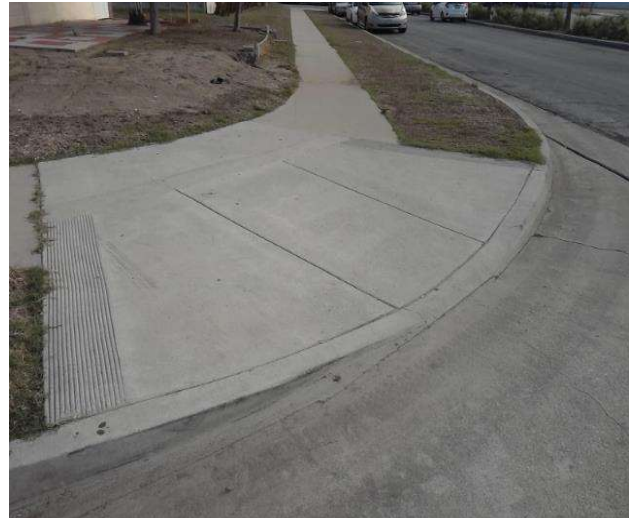
Curb Ramp : No Detectable Warnings

The curb ramp does not provide a detectable warning surface which includes truncated domes.

**On-Site Finding** Not Found

**Code Reference** CA 11B-406.5.12

Provide compliant detectable warnings to surface.

Provide detectable warning to surface \$248

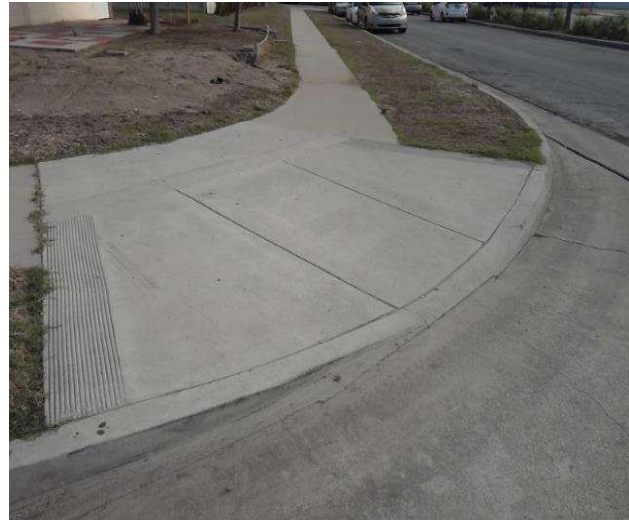
Curb Ramp : Side Flare Slope

The slope of the curb ramp side flare is greater than allowed.

**On-Site Finding** 10.30 percent

**Code Reference** ADA 406, 406.3,CA 11B-406.2.2

Provide curb ramp side flares with a compliant slope.

Recommendation Up to 10.00 percent

Install flared sides \$1,300

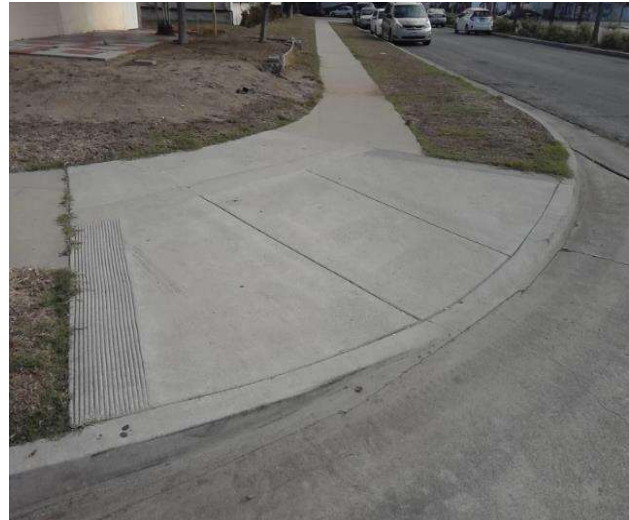
Curb Ramp , Landings and Transitions : Top Landing Slope

The slope at the top landing is greater than allowed.

**On-Site Finding** 5.00 percent

**Code Reference** ADA 402, 406.4, 403.3, 406.1, CA 11B-406.5.3

Provide a top landing surface that does not exceed the maximum slope and cross slope. Provide a sufficient maneuvering clearance that does not accumulate water.

Recommendation Up to 2.08 percent

Provide compliant landing \$1,260

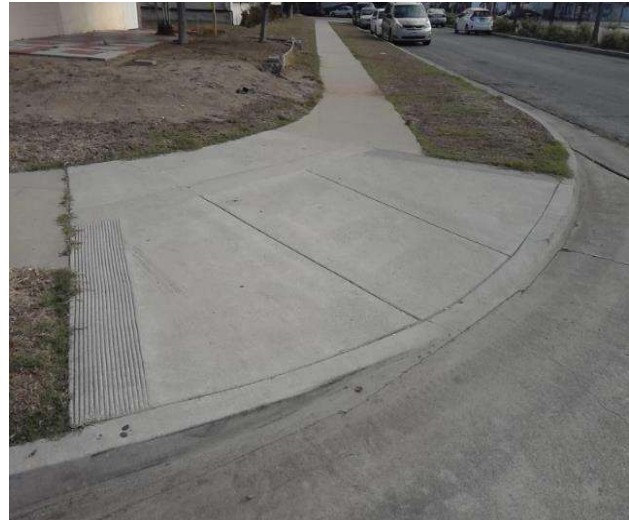
Curb Ramp , Landings and Transitions : Top Landing Clear Length - Landings

There is not enough top landing clear length.

**On-Site Finding** 46.50 inches

**Code Reference** ADA 406, 406.4,CA 11B-406.5.3

Provide a level top landing with enough clear length.

Recommendation At least 48.00 inches

Provide compliant landing \$240

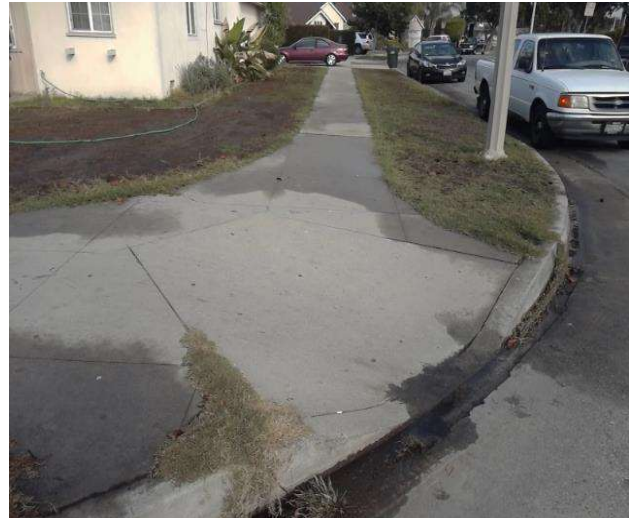
Curb Ramp : No Detectable Warnings

The curb ramp does not provide a detectable warning surface which includes truncated domes.

**On-Site Finding** Not Found

**Code Reference** CA 11B-406.5.12

Provide compliant detectable warnings to surface.

Provide detectable warning to surface \$248

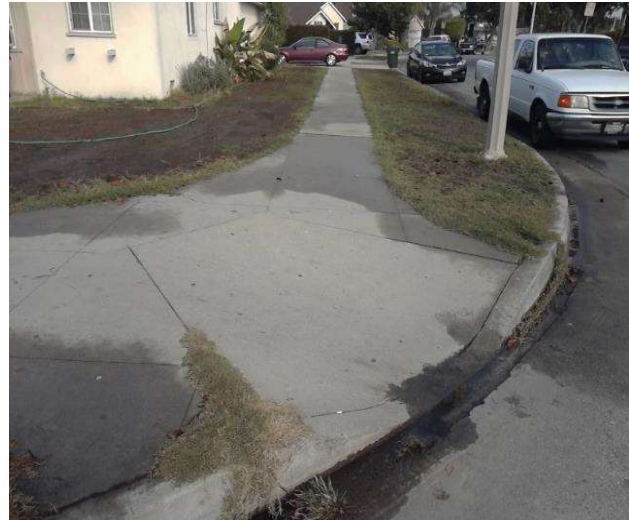
Curb Ramp : Curb Ramp Width

The width of the curb ramp is less than required.

**On-Site Finding** 32.00 inches

**Code Reference** ADA 406, 406.1, 405.5, CA 11B-406.5.2

Provide a compliant curb ramp.

Recommendation At least 48.00 inches

Install curb ramp \$1,300

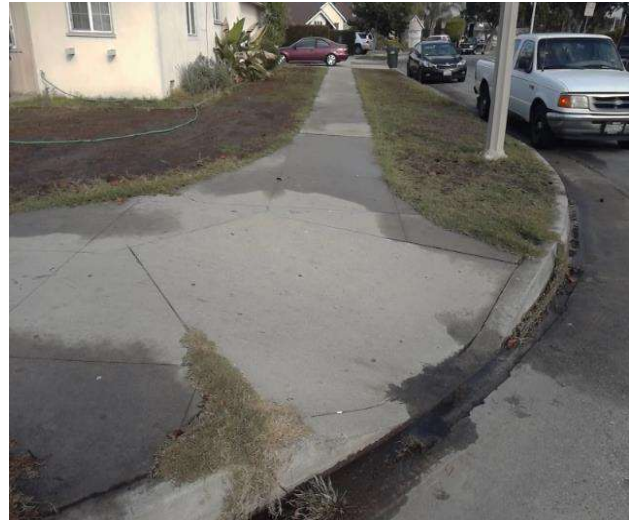
Curb Ramp : Curb Ramp Slope

The running slope is greater than allowed.

**On-Site Finding** 16.00 percent

**Code Reference** ADA 406, 406.1, 405.2, CA 11B-406

Provide a compliant curb ramp.

Recommendation Up to 8.33 percent

Install curb ramp \$1,300

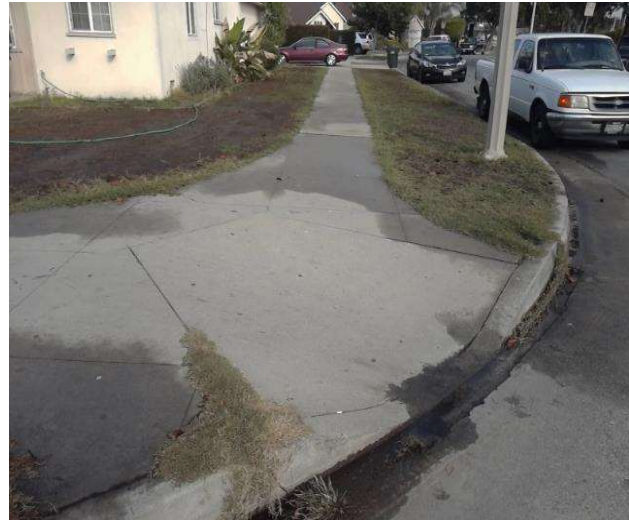
Curb Ramp : Side Flare Slope

The slope of the curb ramp side flare is greater than allowed.

**On-Site Finding** 28.80 percent

**Code Reference** ADA 406, 406.3, CA 11B-406.2.2

Provide curb ramp side flares with a compliant slope.

Recommendation Up to 10.00 percent

Install flared sides \$1,300

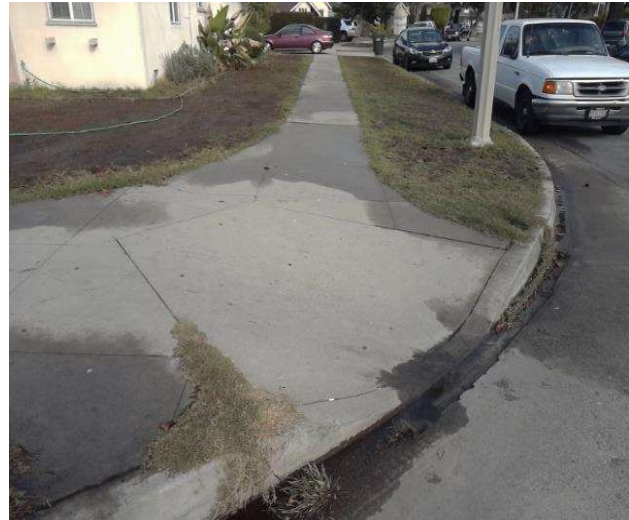
Curb Ramp , Landings and Transitions : Top Landing Slope

The slope at the top landing is greater than allowed.

**On-Site Finding** 3.00 percent

**Code Reference** ADA 402, 406.4, 403.3, 406.1, CA 11B-406.5.3

Provide a top landing surface that does not exceed the maximum slope and cross slope. Provide a sufficient maneuvering clearance that does not accumulate water.

Recommendation Up to 2.08 percent

Provide compliant landing \$1,260

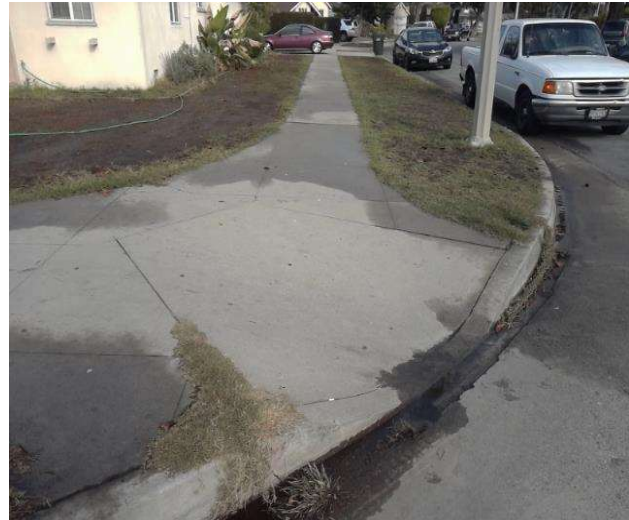
Curb Ramp , Landings and Transitions : Top Landing Clear Length - Landings

There is not enough top landing clear length.

**On-Site Finding** 45.00 inches

**Code Reference** ADA 406, 406.4,CA 11B-406.5.3

Provide a level top landing with enough clear length.

Recommendation At least 48.00 inches

Provide compliant landing \$240

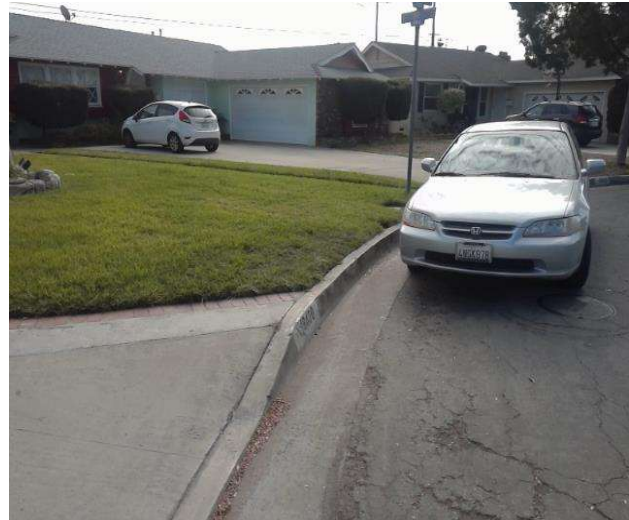
Sidewalks : Missing Sidewalk

Section of sidewalk is missing and consists of dirt, grass or gravel.

**On-Site Finding** 1158.00 feet

**Code Reference** ADA 206, 302,CA 11B-302,CA 11B-206

Provide a compliant sidewalk for the missing section.

\$1,260

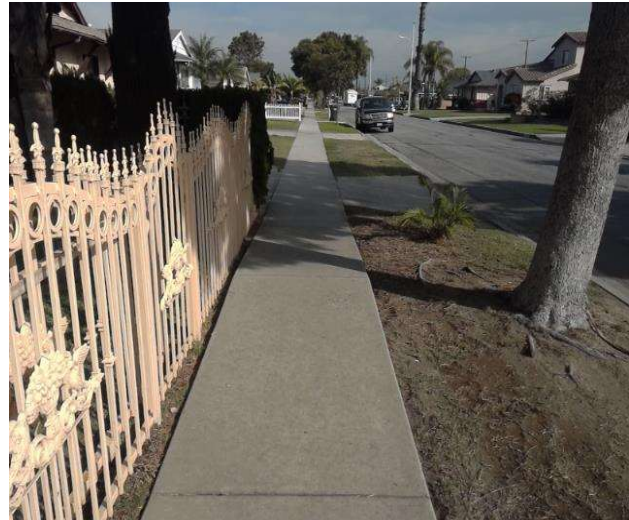
Sidewalks , Surface : Running Slope

Sidewalk running slope is not compliant.

**On-Site Finding** 5.50 percent for 8.00 feet

**Code Reference** ADA 206, 302

Repave the sidewalk surface with the recommended running slope.

Recommendation Up to 5.00 percent

Repave surface \$1,184
