## Accessibility Survey

### City of Downey Seaaca Street - Pangborn Avenue To Cul-de-sac

Pangborn Avenue  
Cul-de-sac  
Downey, CA 90424

Date of Inspection  
12/7/2016

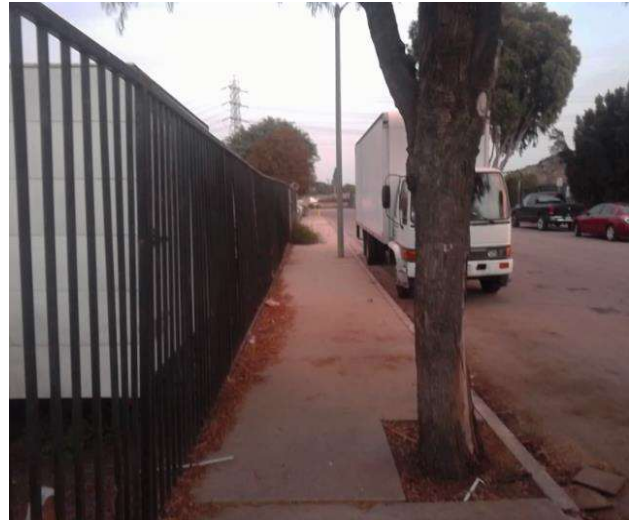
**Change In Level East Of Pangborn Avenue @ 33.921935889731, -118.112997114658**

Sidewalks , Change in Level : Change in Level Non Beveled

There is a change in elevation greater than recommended value.

**On-Site Finding** 0.50 inches

**Code Reference** ADA 206, 302

Ensure that the change in elevation is within the recommended value.

Recommendation Up to 0.25 inches

Remove tripping hazards \$198

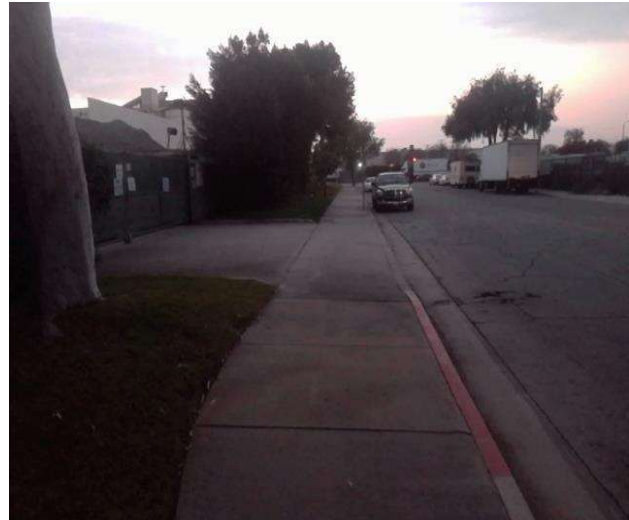
**Change In Level West Of Cul-de-sac @ 33.921755608365, -118.112482130527**

Sidewalks , Change in Level : Change in Level Non Beveled

There is a change in elevation greater than recommended value.

**On-Site Finding** 0.50 inches

**Code Reference** ADA 206, 302

Ensure that the change in elevation is within the recommended value.

Recommendation Up to 0.25 inches

Remove tripping hazards \$198

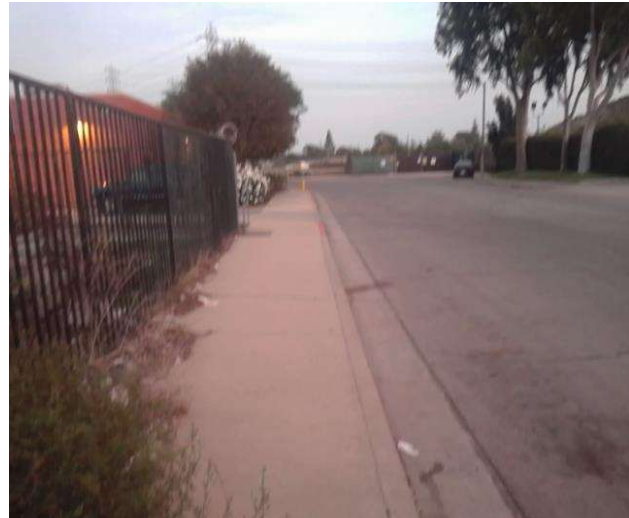
**Driveway East Of Pangborn Avenue @ 33.921940341118, -118.112584054470**

Sidewalks , Vehicular Traffic : Cross Walks and Detectable Warnings

There are no detectable warnings where the pedestrian route crosses vehicular traffic.

**On-Site Finding** Not Found

**Code Reference** ADA 705,CA 11B-705.1.2.5,CA 11B-247.1.2.5

Provide detectable warnings.

Install compliant detectable warnings \$190

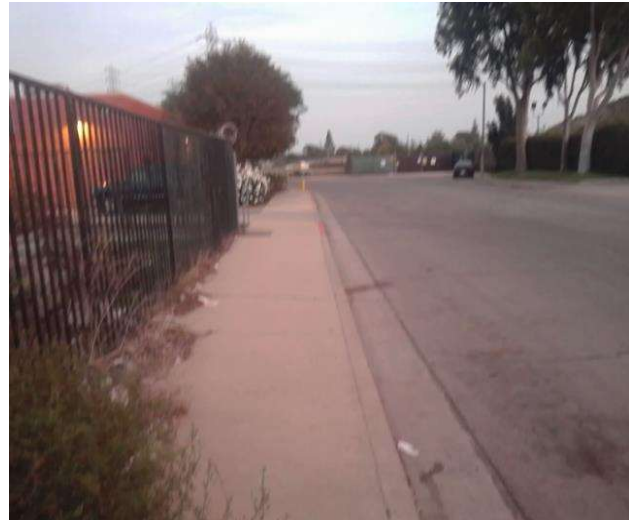
**Driveway East Of Pangborn Avenue @ 33.921940341118, -118.112584054470**

Sidewalks : Vehicular Traffic Cross Slope

Cross slope at vehicular traffic is not compliant.

**On-Site Finding** 8.30 percent

**Code Reference** ADA 206, 302,CA 11B-403.3

Repave the surface to provide a compliant cross slope.

Recommendation Up to 2.08 percent

Repave surface \$1,092

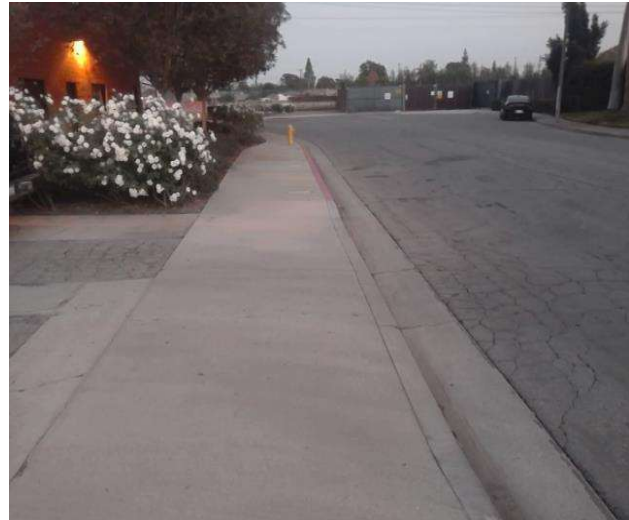
**Driveway East Of Pangborn Avenue @ 33.921944792505, -118.112527728081**

Sidewalks , Vehicular Traffic : Cross Walks and Detectable Warnings

There are no detectable warnings where the pedestrian route crosses vehicular traffic.

**On-Site Finding** Not Found

**Code Reference** ADA 705,CA 11B-705.1.2.5,CA 11B-247.1.2.5

Provide detectable warnings.

Install compliant detectable warnings \$190

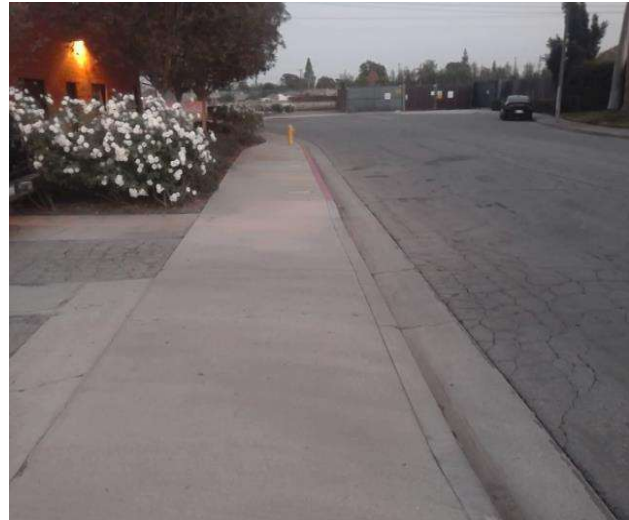
#### Driveway East Of Pangborn Avenue @ 33.921944792505, -118.112527728081

Sidewalks : Vehicular Traffic Cross Slope

Cross slope at vehicular traffic is not compliant.

**On-Site Finding** 5.60 percent

**Code Reference** ADA 206, 302, CA 11B-403.3

Repave the surface to provide a compliant cross slope.

Recommendation Up to 2.08 percent

Repave surface \$1,092

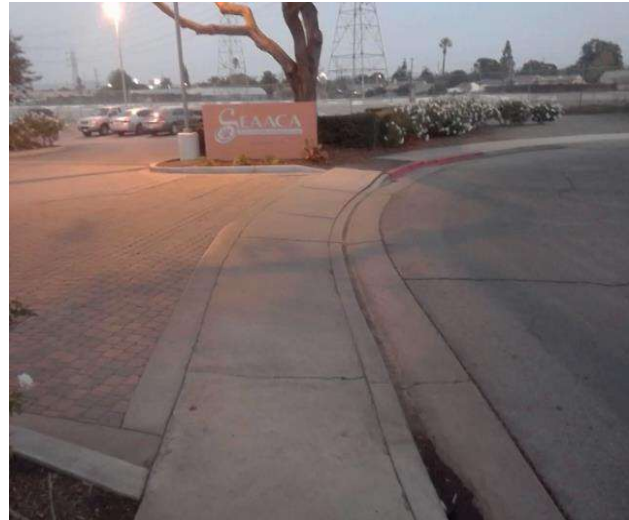
#### Driveway East Of Pangborn Avenue @ 33.921989306359, -118.112149536610

Sidewalks , Vehicular Traffic : Cross Walks and Detectable Warnings

There are no detectable warnings where the pedestrian route crosses vehicular traffic.

**On-Site Finding** Not Found

**Code Reference** ADA 705,CA 11B-705.1.2.5,CA 11B-247.1.2.5

Provide detectable warnings.

Install compliant detectable warnings \$190

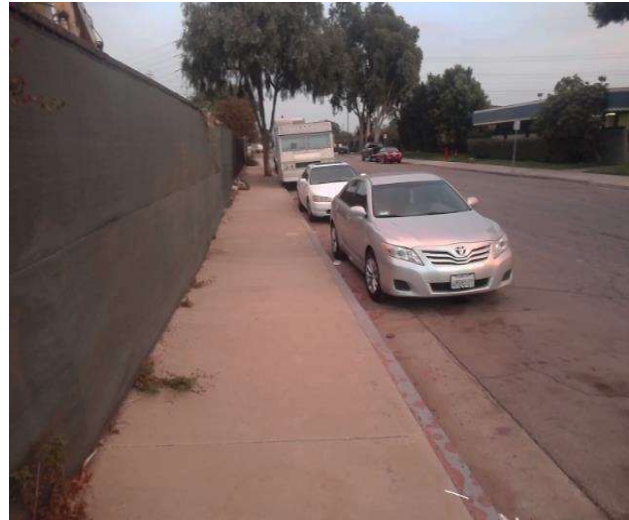
**Sidewalk North Of Pangborn Avenue @ 33.921938115425, -118.113284111023**

Sidewalks , Surface : Cross Slope

Sidewalk cross slope is not compliant.

**On-Site Finding** 3.30 percent

**Code Reference** ADA 206, 302, CA 11B-403.3

Repave the sidewalk surface with the recommended cross slope.

Recommendation Up to 2.08 percent

Repave surface \$1,092

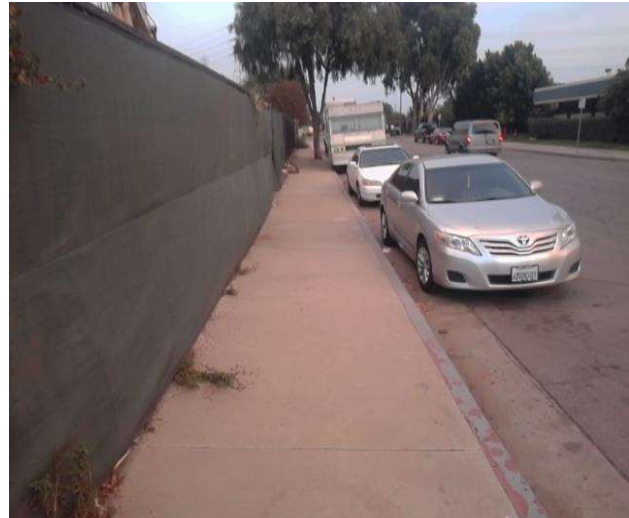
**North Side @ 33.921938115425, -118.113284111023**

Sidewalks : 60X60 Turn Area

There is no 60X60 turn area at every 200 feet.

**On-Site Finding** Not Found

**Code Reference** ADA 206, 302

Provide a 60X60 turn every 200 feet on the sidewalk.

\$2,400

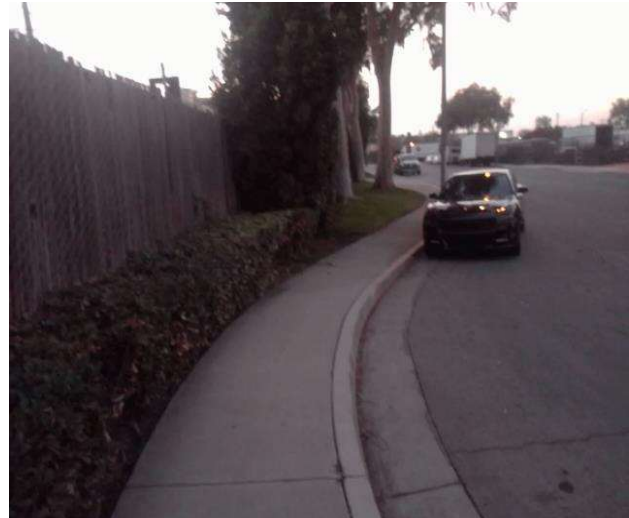
**Sidewalk West Of Cul-de-sac @ 33.921811250802, -118.111967146397**

Sidewalks , Surface : Cross Slope

Sidewalk cross slope is not compliant.

**On-Site Finding** 4.00 percent for 52.00 feet

**Code Reference** ADA 206, 302,CA 11B-403.3

Repave the sidewalk surface with the recommended cross slope.

Recommendation Up to 2.08 percent

Repave surface \$1,092

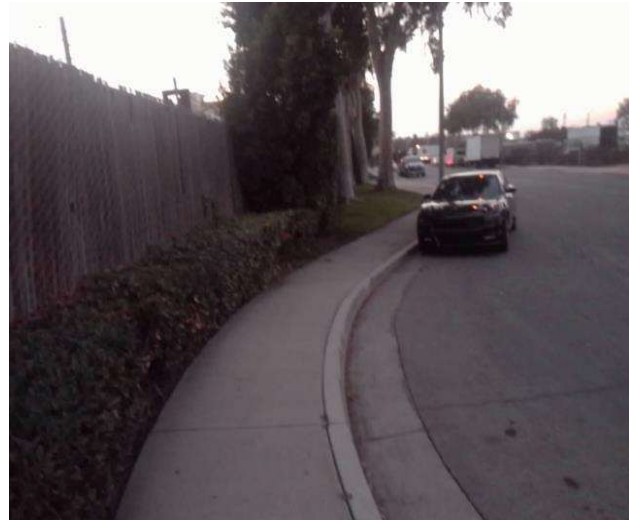
#### South Side @ 33.921811250802, -118.111967146397

Sidewalks : 60X60 Turn Area

There is no 60X60 turn area at every 200 feet.

**On-Site Finding** Not Found

**Code Reference** ADA 206, 302

Provide a 60X60 turn every 200 feet on the sidewalk.

\$2,400
