Accessibility Survey

City of Downey Shellyfield Road - Cecilia Street to Gotham Street

Cecilia Street to Gotham Street Downey, CA 90242

Date of Inspection 6/9/2017

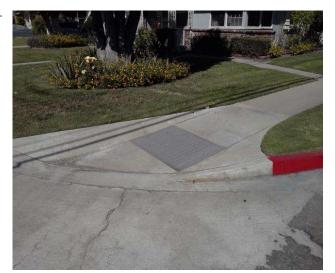
Northeast Corner of Cecilia Street @ 33.938481201211, - 118.120573014021

Curb Ramp : Side Flare Slope

The slope of the curb ramp side flare is greater than allowed.

On-Site Finding 18.90 percent

Code Reference ADA 406, 406.3,CA 11B-406.2.2

Provide curb ramp side flares with a compliant slope.

Recommendation Up to 10.00 percent

Install flared sides \$1,300

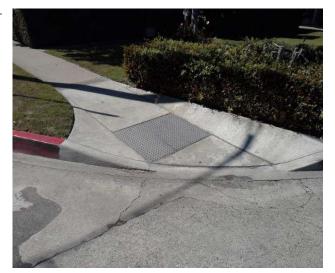
Northwest Corner of Cecilia Street @ 33.938545733761, - 118.120709806681

Curb Ramp : Side Flare Slope

The slope of the curb ramp side flare is greater than allowed.

On-Site Finding 17.60 percent

Code Reference ADA 406, 406.3,CA 11B-406.2.2

Provide curb ramp side flares with a compliant slope.

Recommendation Up to 10.00 percent

Install flared sides \$1,300

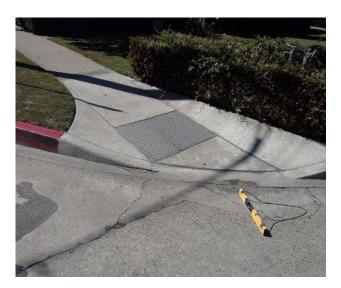
Northwest Corner of Cecilia Street @ 33.938545733761, - 118.120709806681

Bottom Landing

The bottom landing of the curb ramp is on the street, and the slope of the bottom landing is not compliant.

On-Site Finding 5.80 percent

Curb Ramp : Bottom Landing Slope

Code Reference ADA 406, 406.2,CA 11B-406.5.8

Ensure the bottom landing slope is compliant and provides a smooth transition.

Recommendation Up to 5.00 percent

Repave landing \$1,260

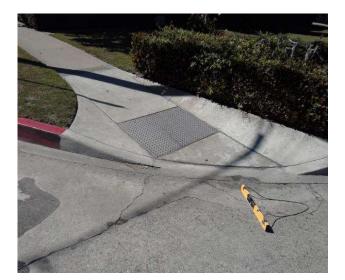
Northwest Corner of Cecilia Street @ 33.938545733761, - 118.120709806681

Top Landing

The slope at the top landing is greater than allowed.

On-Site Finding 3.00 percent

Curb Ramp , Landings and Transitions : Top Landing Slope

Code Reference ADA 402, 406.4, 403.3, 406.1,CA 11B-406.5.3

Provide a top landing surface that does not exceed the maximum slope and cross slope. Provide a sufficient maneuvering clearance that does not accumulate water.

Recommendation Up to 2.08 percent

Provide compliant landing \$1,260

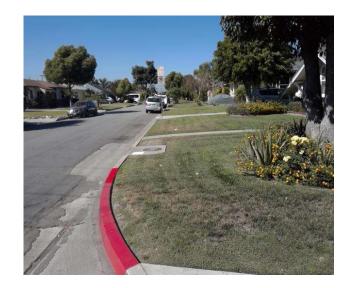
East Side @ 33.938481201211, -118.120573014021

Sidewalks : No Sidewalk

No sidewalk exists at the location.

No action necessary until a sidewalk is provided.

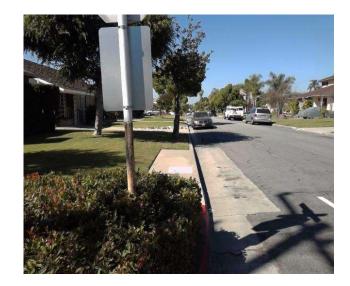
West Side @ 33.938515692753, -118.120636045933

Sidewalks : No Sidewalk

No sidewalk exists at the location.

No action necessary until a sidewalk is provided.
