Accessibility Survey

City of Downey Dorion Street - Barlin Avenue To Blodgett Avenue

Date of Inspection
11/28/2016

Prepared By
Disability Access Consultants
(800) 743-7067

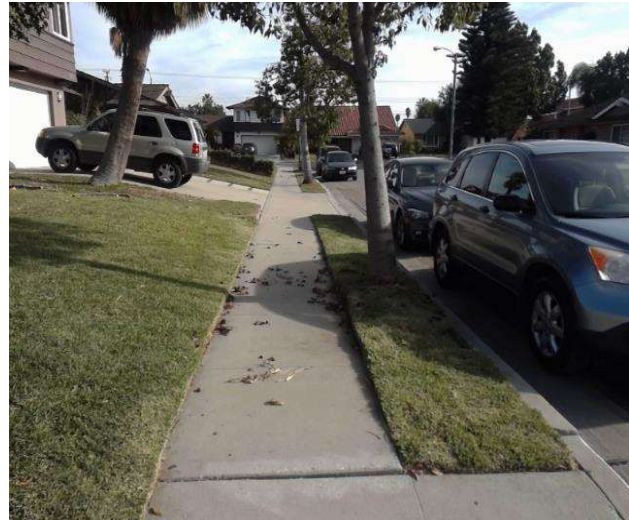
Change In Level East Of Barlin Avenue @ 33.905889354309, -118.147554695606

Sidewalks , Change in Level : Change in Level Non Beveled

There is a change in elevation greater than recommended value.

On-Site Finding 0.50 inches

Code Reference ADA 206, 302

Ensure that the change in elevation is within the recommended value.

Recommendation Up to 0.25 inches

Remove tripping hazards \$198

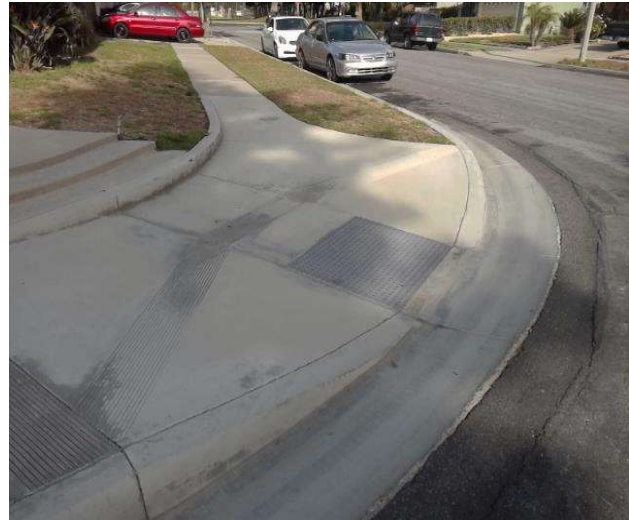
Northwest Corner Of Blodgett Avenue @ 33.905724621813, - 118.147168457508

Curb Ramp : Bottom Landing Slope

The bottom landing of the curb ramp is on the street, and the slope of the bottom landing is not compliant.

On-Site Finding 14.90 percent

Code Reference ADA 406, 406.2, CA 11B-406.5.8

Ensure the bottom landing slope is compliant and provides a smooth transition.

Recommendation Up to 5.00 percent

Repave landing \$1,260

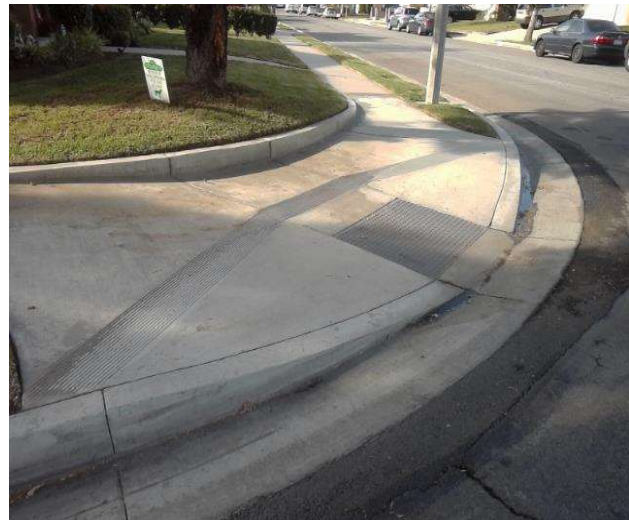
Southwest Corner Of Blodgett Avenue @ 33.90597733053, - 118.147262334824

Curb Ramp : Bottom Landing Slope

The bottom landing of the curb ramp is on the street, and the slope of the bottom landing is not compliant.

On-Site Finding 14.70 percent

Code Reference ADA 406, 406.2, CA 11B-406.5.8

Ensure the bottom landing slope is compliant and provides a smooth transition.

Recommendation Up to 5.00 percent

Repave landing \$1,260
