Accessibility Survey

2nd Street - Brookshire Avenue to End

Date of Inspection
8/9/2017

Prepared By
Disability Access Consultants
(800) 743-7067

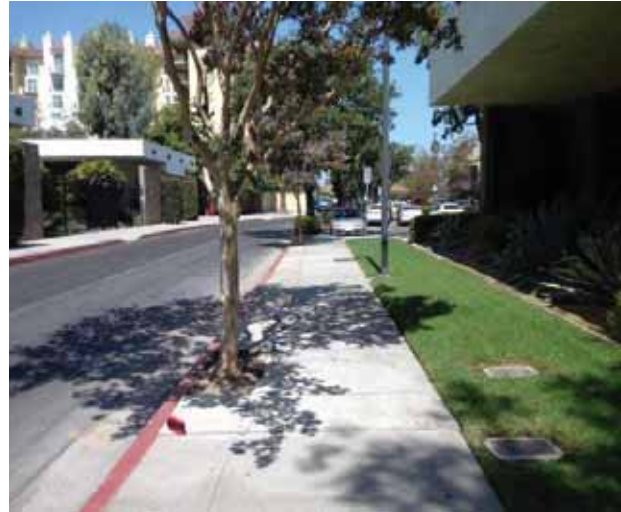
Change in Level East of End @ 33.939403566978, -118.129307627678

Sidewalks , Change in Level : Change in Level Non Beveled

There is a change in elevation greater than recommended value.

On-Site Finding 1.00 inches

Code Reference ADA 206, 302

Ensure that the change in elevation is within the recommended value.

Recommendation Up to 0.25 inches

Remove tripping hazards \$198

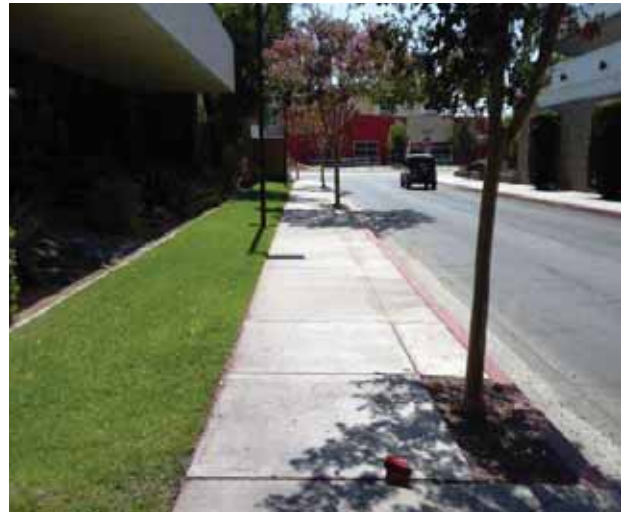
Change in Level East of End @ 33.939478112388, -118.129439055920

Sidewalks , Change in Level : Change in Level Non Beveled

There is a change in elevation greater than recommended value.

Code Reference ADA 206, 302

Ensure that the change in elevation is within the recommended value.

Recommendation Up to 0.25 inches

Remove tripping hazards \$198

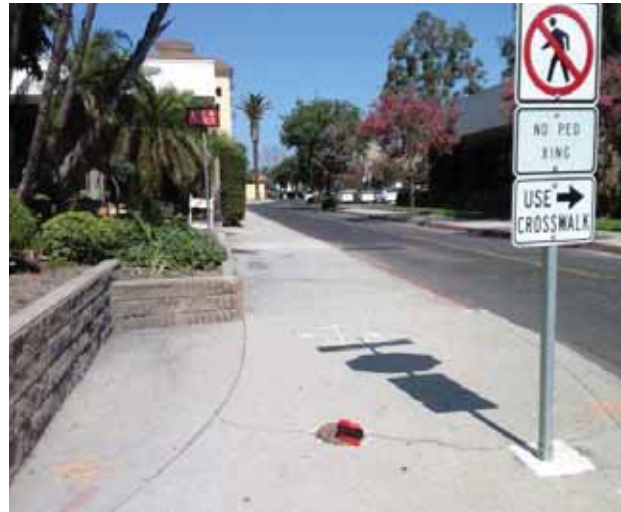
There is a change in elevation greater than recommended value.

Code Reference ADA 206, 302

Ensure that the change in elevation is within the recommended value.

Recommendation Up to 0.25 inches

Remove tripping hazards \$198

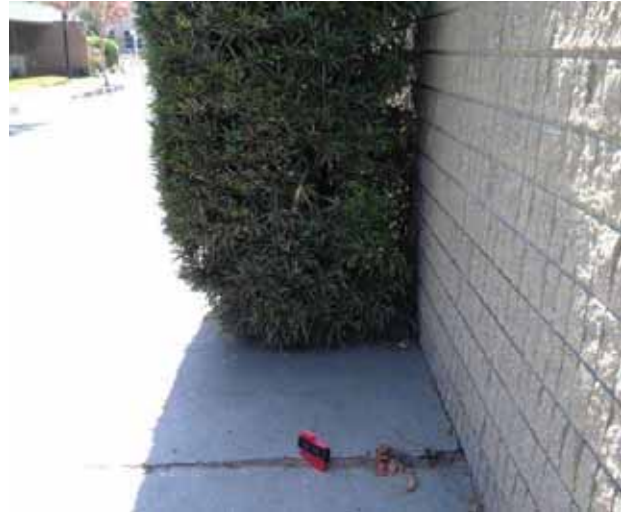
There is a change in elevation greater than recommended value.

Code Reference ADA 206, 302

Ensure that the change in elevation is within the recommended value.

Recommendation Up to 0.25 inches

Remove tripping hazards \$198

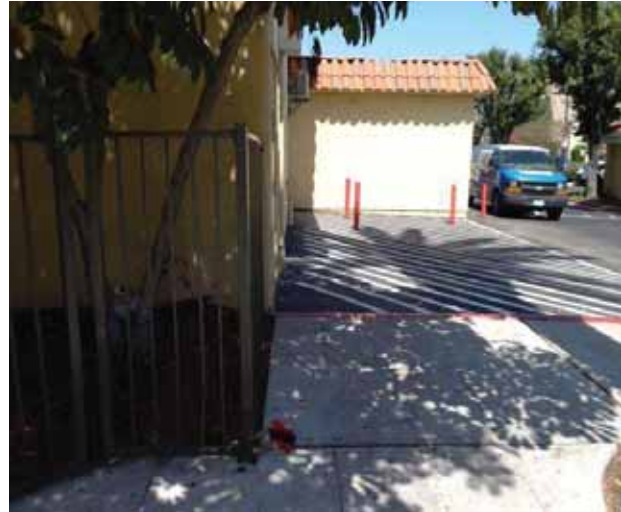
There is a change in elevation greater than recommended value.

Code Reference ADA 206, 302

Ensure that the change in elevation is within the recommended value.

Recommendation Up to 0.25 inches

Remove tripping hazards \$198

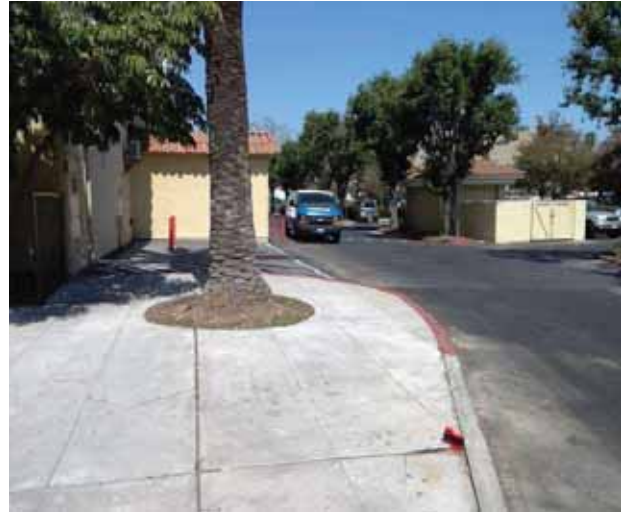
There is a change in elevation greater than recommended value.

Code Reference ADA 206, 302

Ensure that the change in elevation is within the recommended value.

Recommendation Up to 0.25 inches

Remove tripping hazards \$198

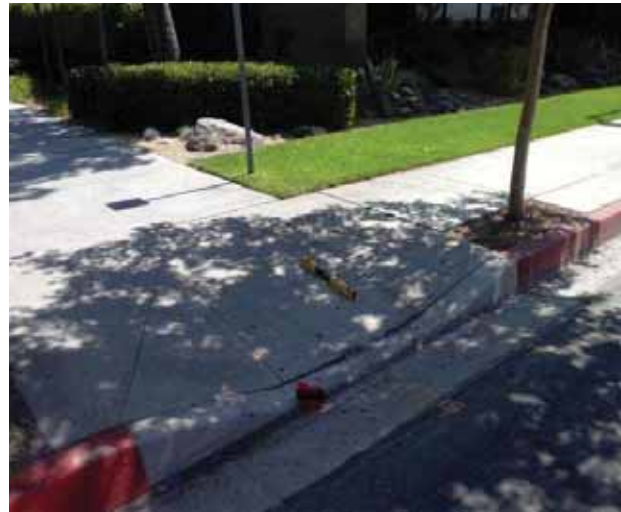
On-Site Finding Not Found

Code Reference CA 11B-406.5.12

Provide detectable warning to surface \$248

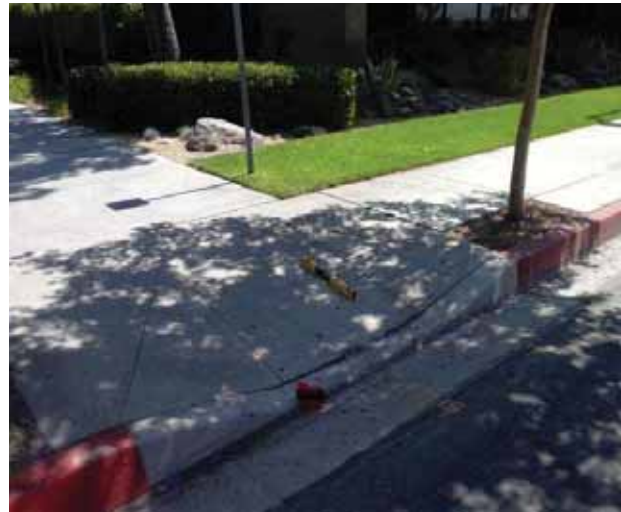
Code Reference ADA 406, 406.1, 405.2, CA 11B-406

Recommendation Up to 8.33 percent

Install curb ramp \$1,300

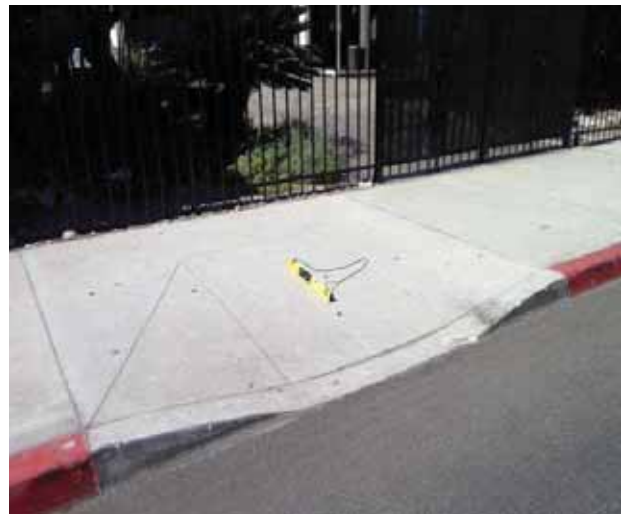
On-Site Finding Not Found

Code Reference CA 11B-406.5.12

Provide detectable warning to surface \$248

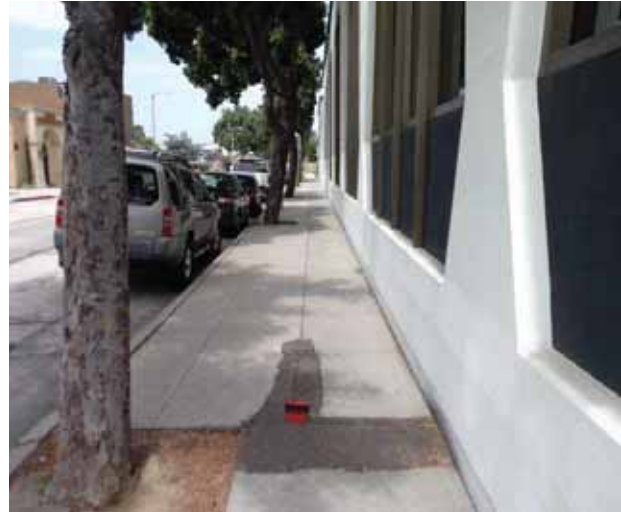
There is a change in elevation greater than recommended value.

Code Reference ADA 206, 302

Notes : Surface is Rough And Uneven

Ensure that the change in elevation is within the recommended value.

Recommendation Up to 0.25 inches

Remove tripping hazards \$198

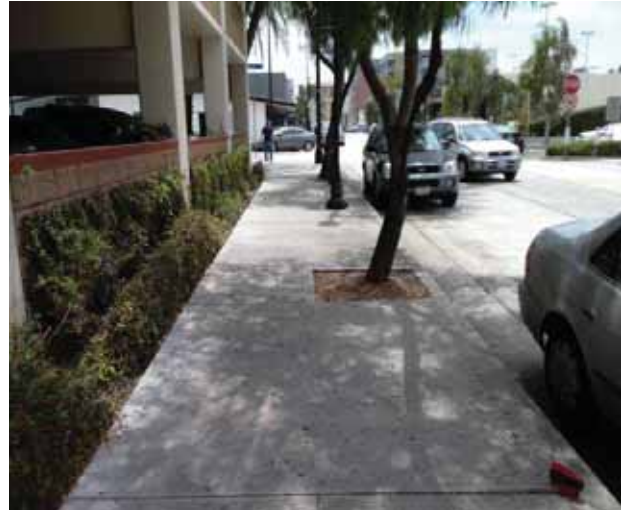
There is a change in elevation greater than recommended value.

Code Reference ADA 206, 302

Ensure that the change in elevation is within the recommended value.

Recommendation Up to 0.25 inches

Remove tripping hazards \$198

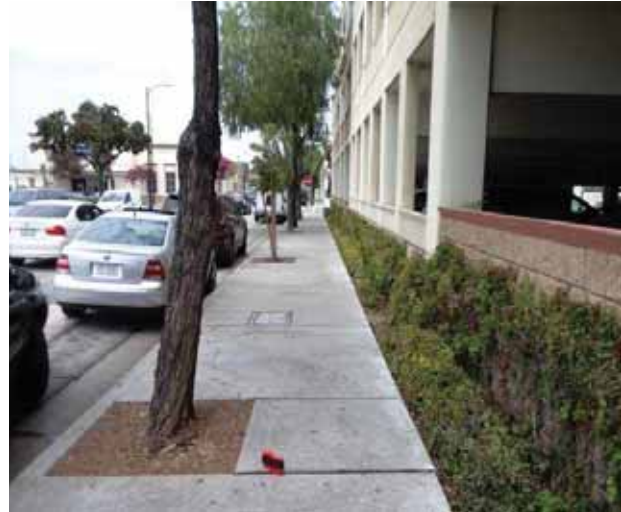
There is a change in elevation greater than recommended value.

Code Reference ADA 206, 302

Ensure that the change in elevation is within the recommended value.

Recommendation Up to 0.25 inches

Remove tripping hazards \$198

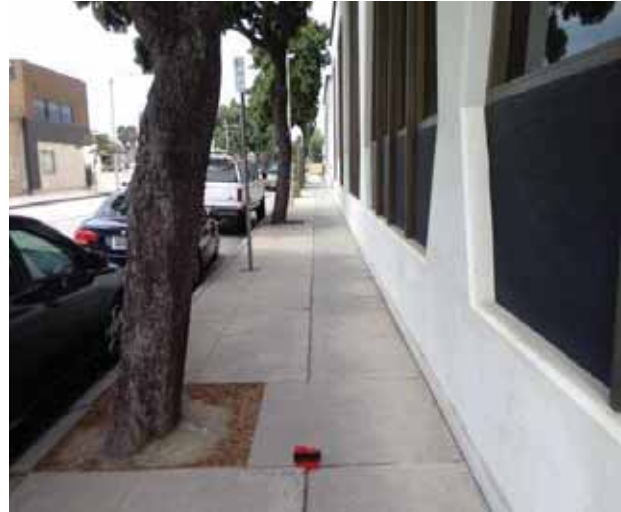
There is a change in elevation greater than recommended value.

Code Reference ADA 206, 302

Ensure that the change in elevation is within the recommended value.

Recommendation Up to 0.25 inches

Remove tripping hazards \$198

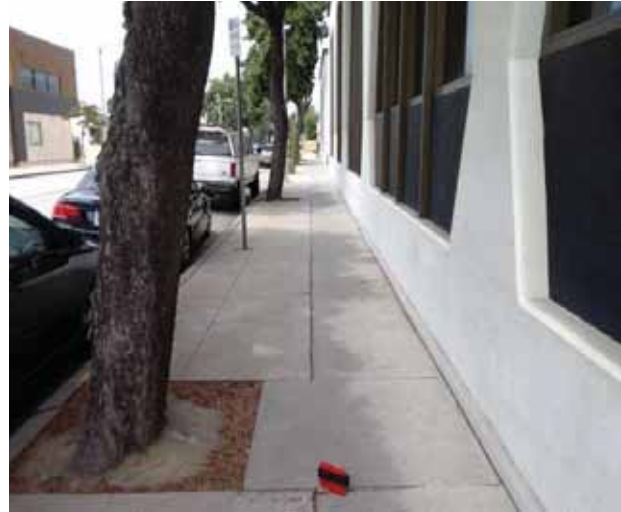
There is a change in elevation greater than recommended value.

Code Reference ADA 206, 302

Ensure that the change in elevation is within the recommended value.

Recommendation Up to 0.25 inches

Remove tripping hazards \$198

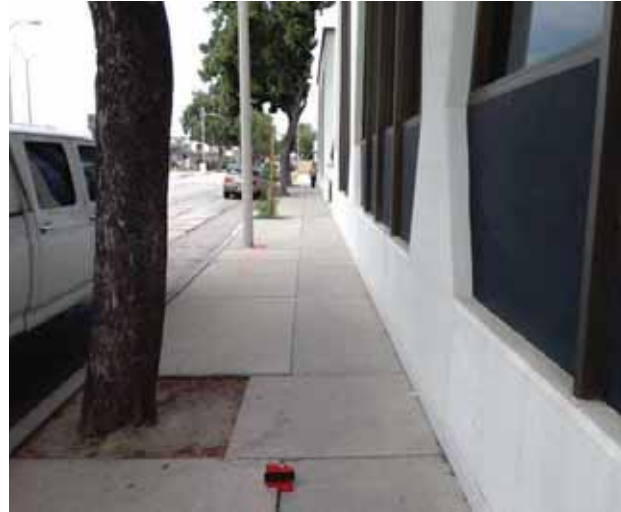
There is a change in elevation greater than recommended value.

Code Reference ADA 206, 302

Ensure that the change in elevation is within the recommended value.

Recommendation Up to 0.25 inches

Remove tripping hazards \$198

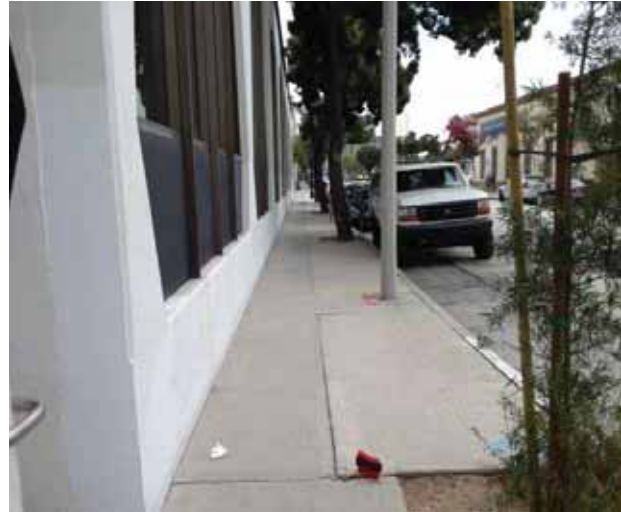
There is a change in elevation greater than recommended value.

Code Reference ADA 206, 302

Ensure that the change in elevation is within the recommended value.

Recommendation Up to 0.25 inches

Remove tripping hazards \$198

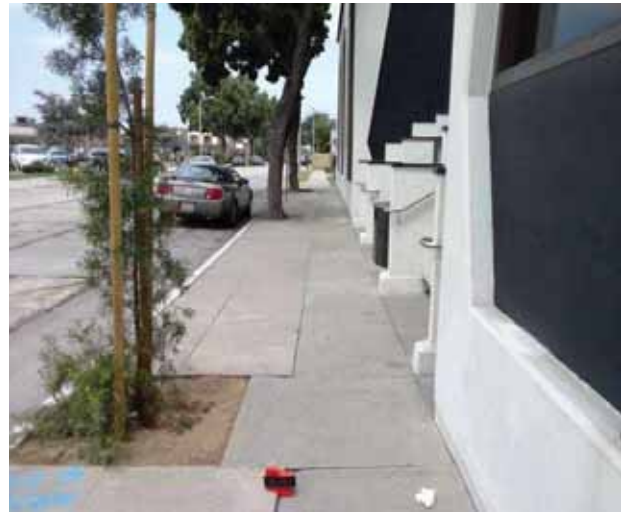
There is a change in elevation greater than recommended value.

Code Reference ADA 206, 302

Ensure that the change in elevation is within the recommended value.

Recommendation Up to 0.25 inches

Remove tripping hazards \$198

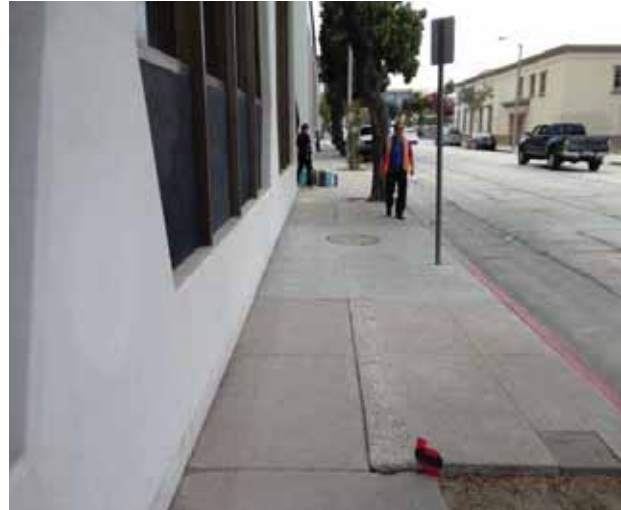
There is a change in elevation greater than recommended value.

Code Reference ADA 206, 302

Ensure that the change in elevation is within the recommended value.

Recommendation Up to 0.25 inches

Remove tripping hazards \$198

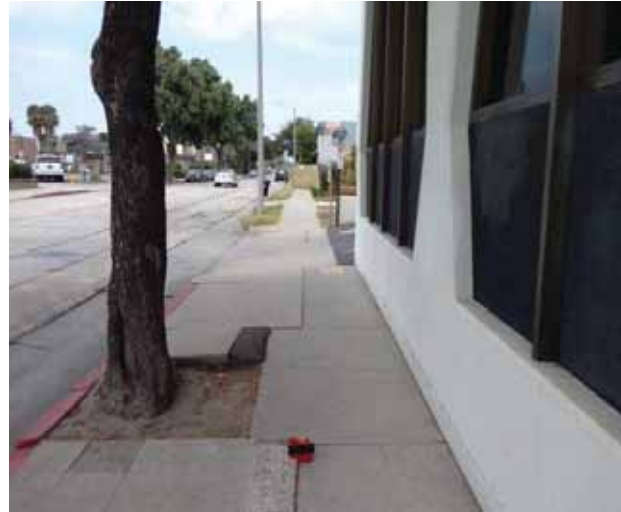
There is a change in elevation greater than recommended value.

Code Reference ADA 206, 302

Ensure that the change in elevation is within the recommended value.

Recommendation Up to 0.25 inches

Remove tripping hazards \$198

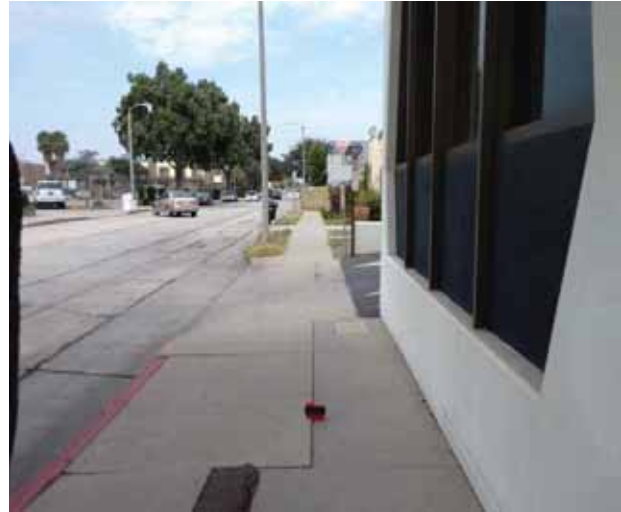
There is a change in elevation greater than recommended value.

Code Reference ADA 206, 302

Ensure that the change in elevation is within the recommended value.

Recommendation Up to 0.25 inches

Remove tripping hazards \$198

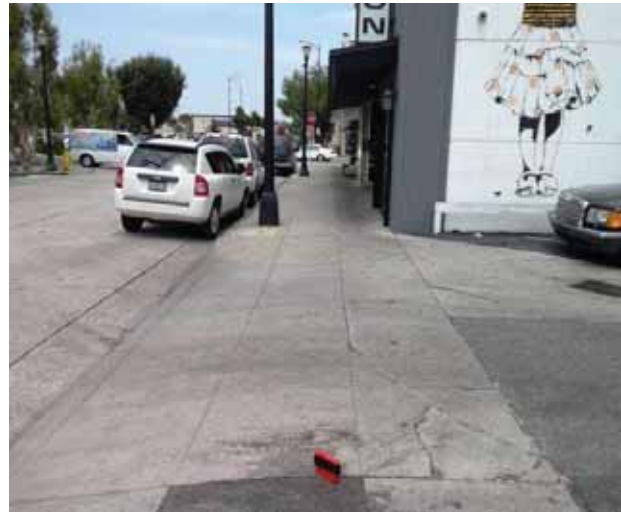
There is a change in elevation greater than recommended value.

Code Reference ADA 206, 302

Ensure that the change in elevation is within the recommended value.

Recommendation Up to 0.25 inches

Remove tripping hazards \$198

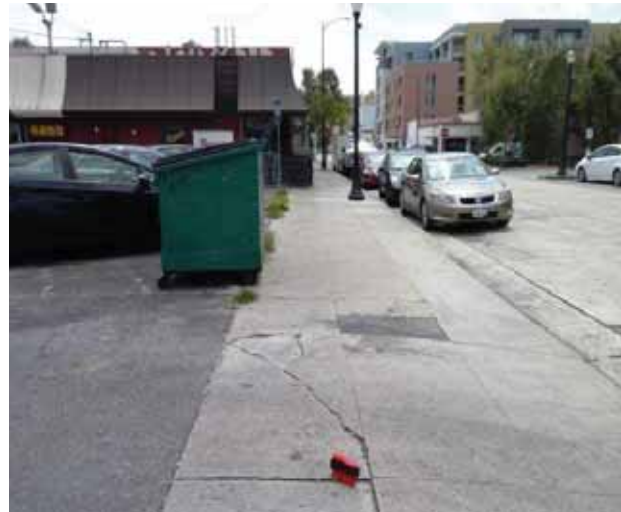
There is a change in elevation greater than recommended value.

Code Reference ADA 206, 302

Ensure that the change in elevation is within the recommended value.

Recommendation Up to 0.25 inches

Remove tripping hazards \$198

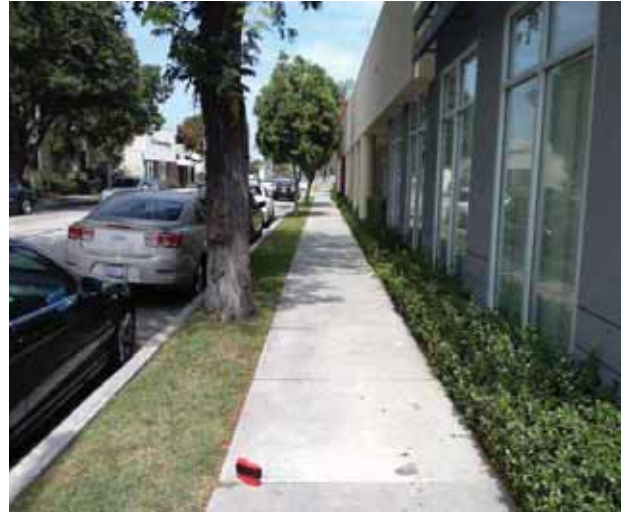
There is a change in elevation greater than recommended value.

Code Reference ADA 206, 302

Ensure that the change in elevation is within the recommended value.

Recommendation Up to 0.25 inches

Remove tripping hazards \$198

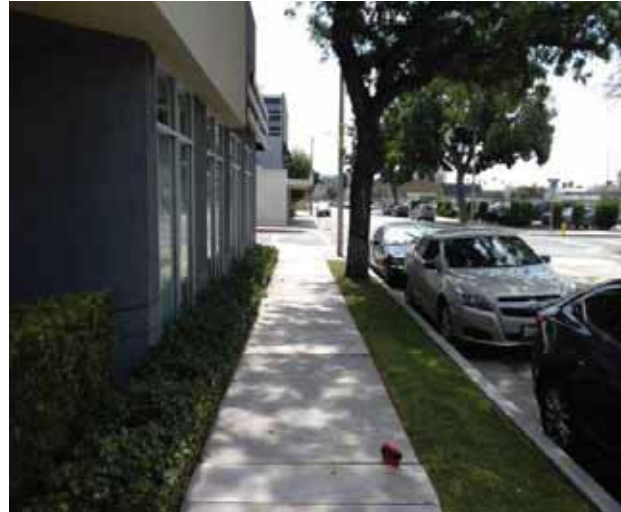
There is a change in elevation greater than recommended value.

Code Reference ADA 206, 302

Ensure that the change in elevation is within the recommended value.

Recommendation Up to 0.25 inches

Remove tripping hazards \$198

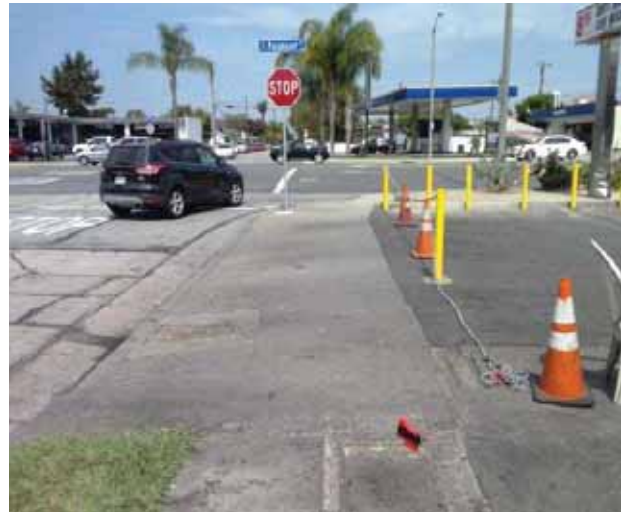
There is a change in elevation greater than recommended value.

Code Reference ADA 206, 302

Ensure that the change in elevation is within the recommended value.

Recommendation Up to 0.25 inches

Remove tripping hazards \$198

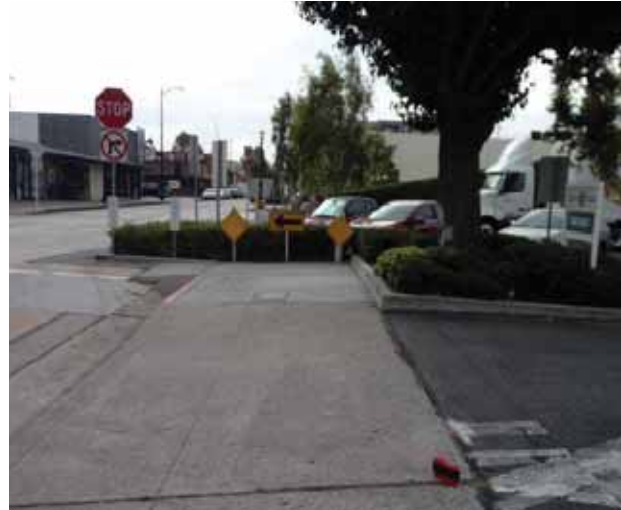
There is a change in elevation greater than recommended value.

Code Reference ADA 206, 302

Ensure that the change in elevation is within the recommended value.

Recommendation Up to 0.25 inches

Remove tripping hazards \$198

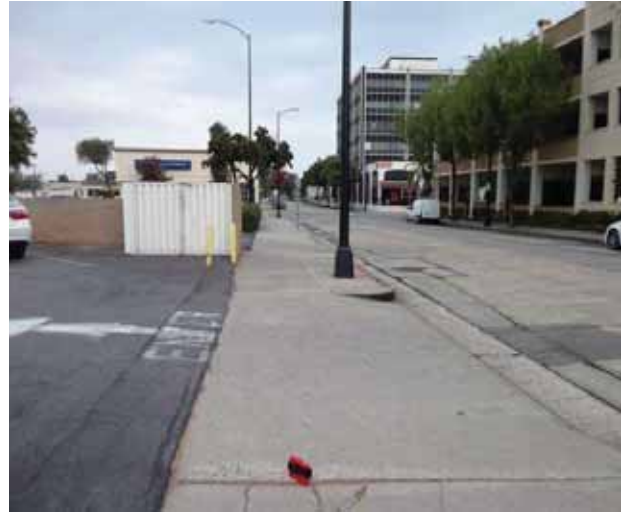
There is a change in elevation greater than recommended value.

Code Reference ADA 206, 302

Ensure that the change in elevation is within the recommended value.

Recommendation Up to 0.25 inches

Remove tripping hazards \$198

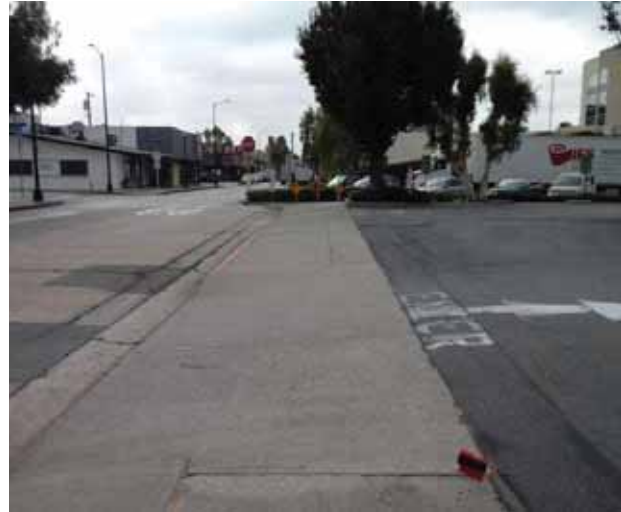
There is a change in elevation greater than recommended value.

Code Reference ADA 206, 302

Ensure that the change in elevation is within the recommended value.

Recommendation Up to 0.25 inches

Remove tripping hazards \$198

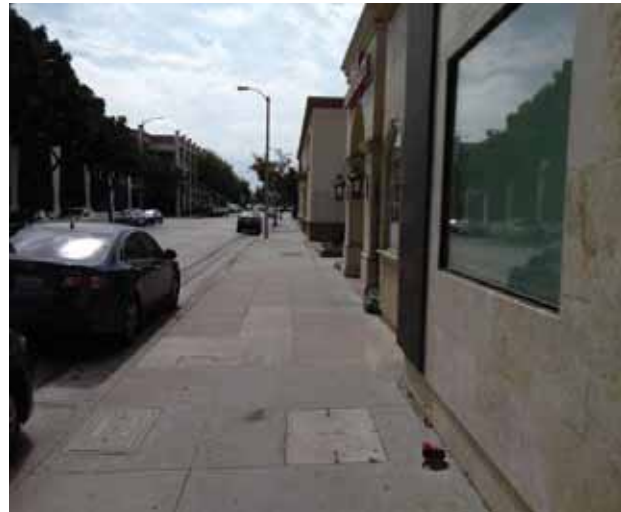
There is a change in elevation greater than recommended value.

Code Reference ADA 206, 302

Ensure that the change in elevation is within the recommended value.

Recommendation Up to 0.25 inches

Remove tripping hazards \$198

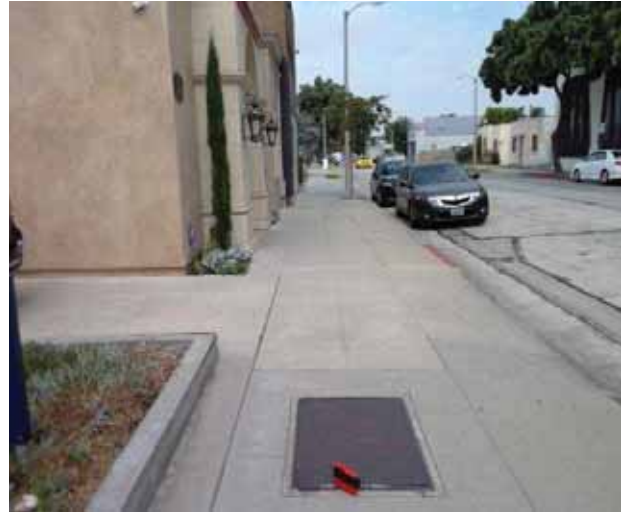
There is a change in elevation greater than recommended value.

Code Reference ADA 206, 302

Ensure that the change in elevation is within the recommended value.

Recommendation Up to 0.25 inches

Remove tripping hazards \$198

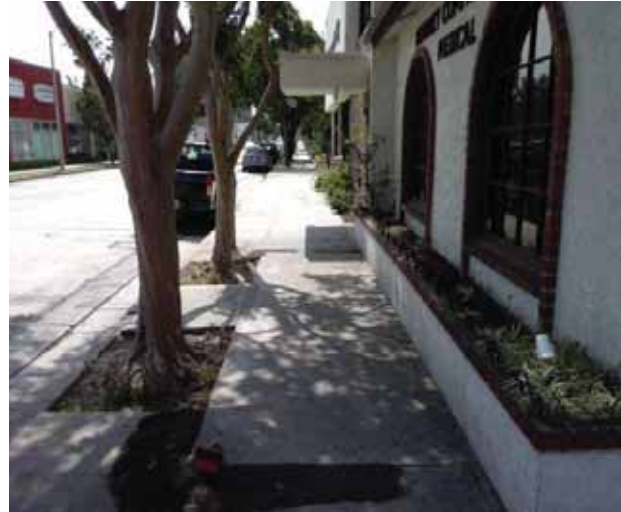
Code Reference ADA 206, 302

Notes : Tree upheaves concrete for 20 feet.

Remove tripping hazards \$198

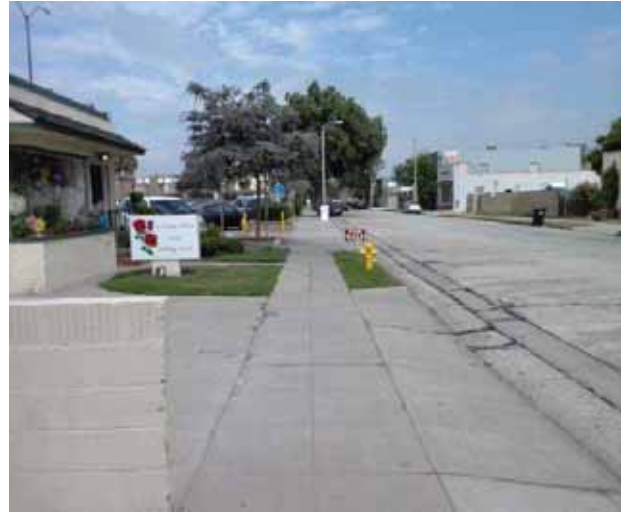
Code Reference ADA 705,CA 11B-705.1.2.5,CA 11B-247.1.2.5

Notes : Spalled Concrete Continues For 24 Feet

Install compliant detectable warnings \$190

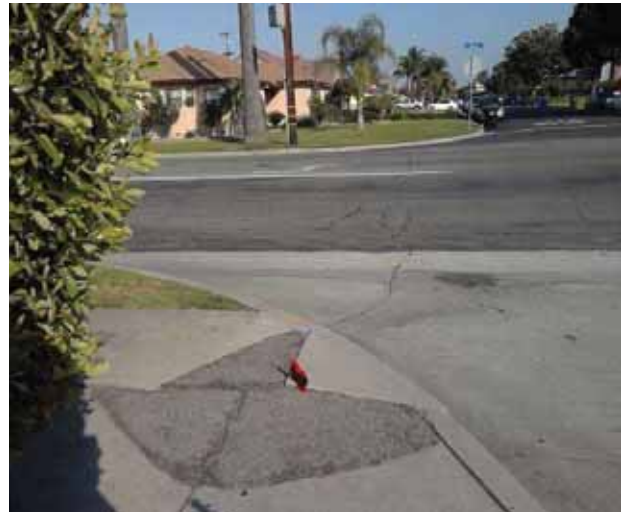
Code Reference ADA 206, 302

Notes : Surface is Rough And Uneven.

Remove tripping hazards \$198

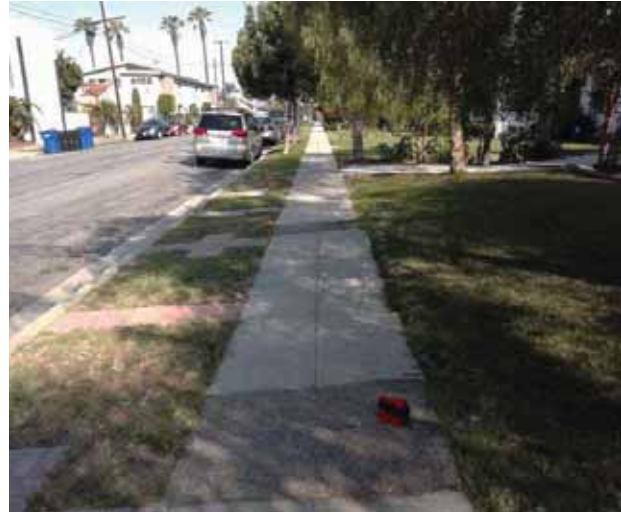
Code Reference ADA 206, 302

Notes : Surface is Rough And Uneven.

Remove tripping hazards \$198

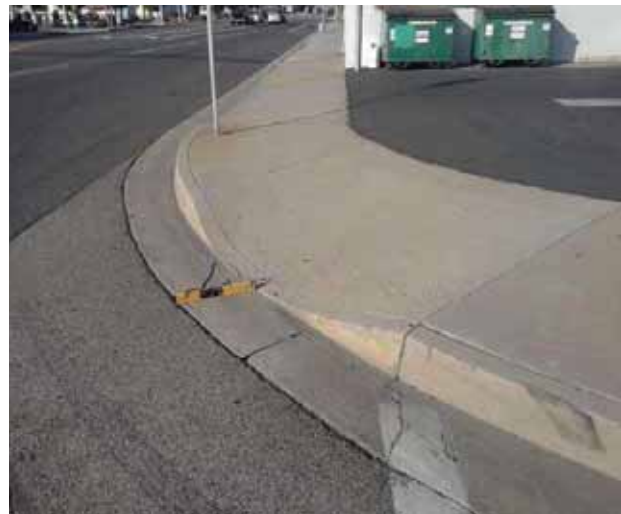
Code Reference ADA 402, 406.4, 403.3, 406.1, CA 11B-406.5.3

Provide compliant landing \$1,260

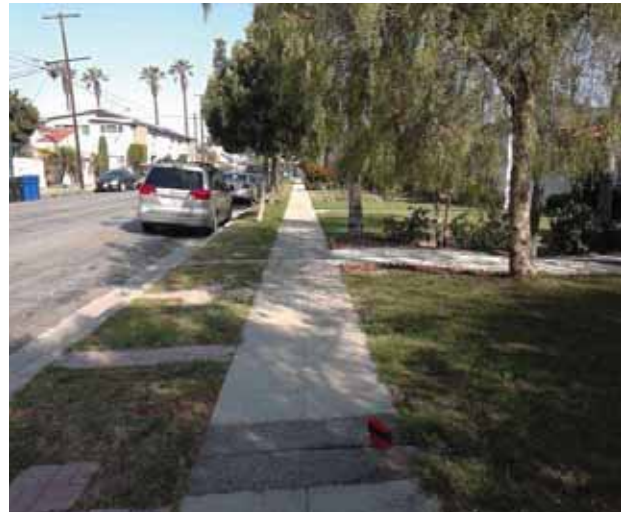
Code Reference ADA 206, 302

Notes : Surface is Rough And Uneven.

Remove tripping hazards \$198

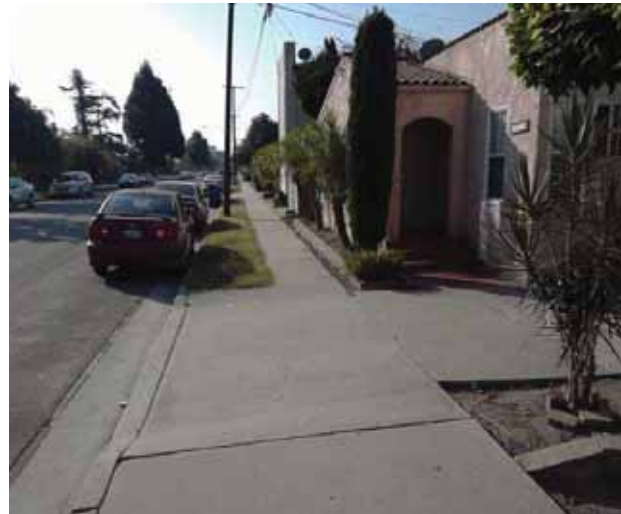
Code Reference ADA 206, 302, CA 11B-403.3

Repave surface \$1,092
