# **Accessibility Survey**

# 4th Street - Paramount Boulevard to Downey Avenue

Date of Inspection 7/21/2017

**Disability Access Consultants**

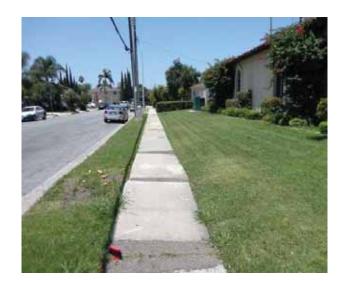
# Change in Level East of Myrtle Street @ 33.943737105901, -118.132999688387

Sidewalks , Change in Level : Change in Level Non Beveled

There is a change in elevation greater than recommended value.

On-Site Finding 2.00 inches

**Code Reference** ADA 206, 302 Notes: Surface is Rough And Uneven

Ensure that the change in elevation is within the recommended value.

Recommendation Up to 0.25 inches

Remove tripping hazards \$198

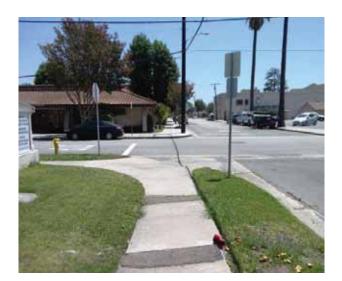
### Change in Level East of Myrtle Street @ 33.943770482751, -118.133039921522

Sidewalks , Change in Level : Change in Level Non Beveled

There is a change in elevation greater than recommended value.

On-Site Finding 1.50 inches

**Code Reference** ADA 206, 302 Notes: Surface is Rough And Uneven

Ensure that the change in elevation is within the recommended value.

Recommendation Up to 0.25 inches

Remove tripping hazards \$198

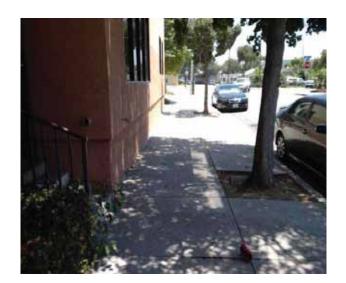
There is a change in elevation greater than recommended value.

Code Reference ADA 206, 302

Ensure that the change in elevation is within the recommended value.

Recommendation Up to 0.25 inches

Remove tripping hazards \$198

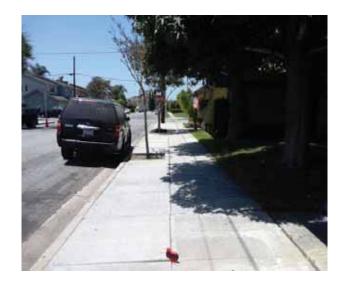
There is a change in elevation greater than recommended value.

Code Reference ADA 206, 302

Ensure that the change in elevation is within the recommended value.

Recommendation Up to 0.25 inches

Remove tripping hazards \$198

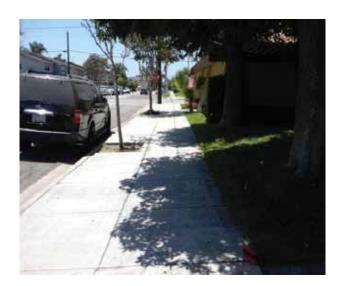
There is a change in elevation greater than recommended value.

Code Reference ADA 206, 302

Ensure that the change in elevation is within the recommended value.

Recommendation Up to 0.25 inches

Remove tripping hazards \$198

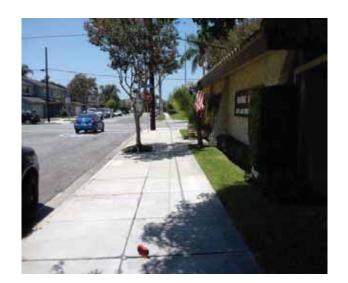
There is a change in elevation greater than recommended value.

Code Reference ADA 206, 302

Ensure that the change in elevation is within the recommended value.

Recommendation Up to 0.25 inches

Remove tripping hazards \$198

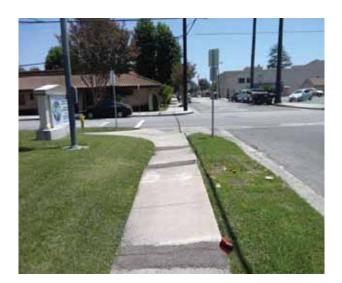
There is a change in elevation greater than recommended value.

**Code Reference** ADA 206, 302 Notes: Surface is Rough And Uneven

Ensure that the change in elevation is within the recommended value.

Recommendation Up to 0.25 inches

Remove tripping hazards \$198

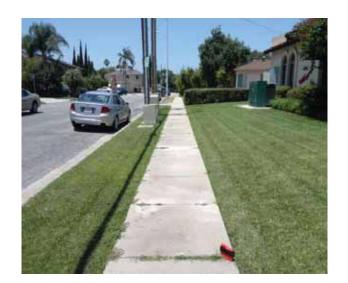
There is a change in elevation greater than recommended value.

Code Reference ADA 206, 302

Ensure that the change in elevation is within the recommended value.

Recommendation Up to 0.25 inches

Remove tripping hazards \$198

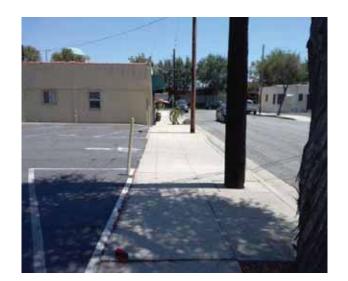
There is a change in elevation greater than recommended value.

Code Reference ADA 206, 302

Ensure that the change in elevation is within the recommended value.

Recommendation Up to 0.25 inches

Remove tripping hazards \$198

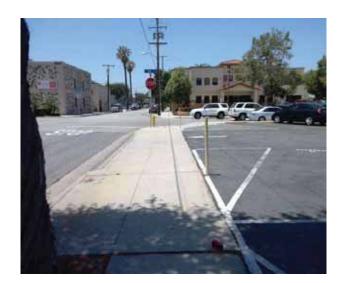
There is a change in elevation greater than recommended value.

Code Reference ADA 206, 302

Ensure that the change in elevation is within the recommended value.

Recommendation Up to 0.25 inches

Remove tripping hazards \$198

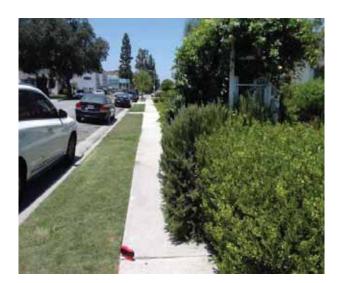
There is a change in elevation greater than recommended value.

Sidewalks , Change in Level : Change in Level Non Beveled

Code Reference ADA 206, 302

Ensure that the change in elevation is within the recommended value.

Recommendation Up to 0.25 inches

Remove tripping hazards \$198

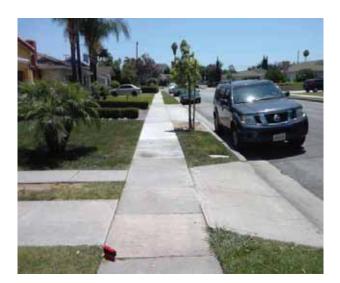
There is a change in elevation greater than recommended value.

Sidewalks , Change in Level : Change in Level Non Beveled

Code Reference ADA 206, 302

Ensure that the change in elevation is within the recommended value.

Recommendation Up to 0.25 inches

Remove tripping hazards \$198

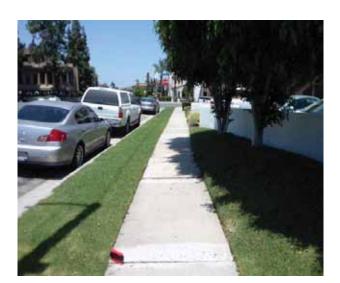
There is a change in elevation greater than recommended value.

Sidewalks , Change in Level : Change in Level Non Beveled

Code Reference ADA 206, 302

Ensure that the change in elevation is within the recommended value.

Recommendation Up to 0.25 inches

Remove tripping hazards \$198

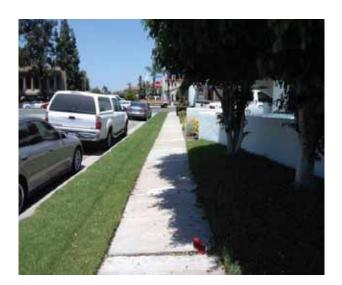
There is a change in elevation greater than recommended value.

Sidewalks , Change in Level : Change in Level Non Beveled

Code Reference ADA 206, 302

Ensure that the change in elevation is within the recommended value.

Recommendation Up to 0.25 inches

Remove tripping hazards \$198

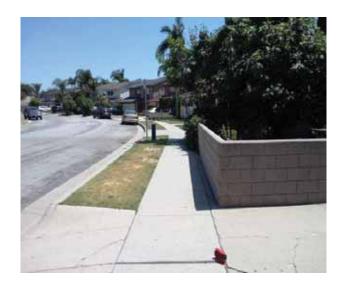
There is a change in elevation greater than recommended value.

Code Reference ADA 206, 302

Ensure that the change in elevation is within the recommended value.

Recommendation Up to 0.25 inches

Remove tripping hazards \$198

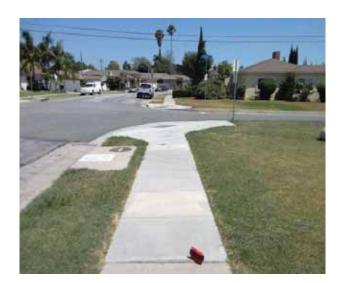
There is a change in elevation greater than recommended value.

Code Reference ADA 206, 302

Ensure that the change in elevation is within the recommended value.

Recommendation Up to 0.25 inches

Remove tripping hazards \$198

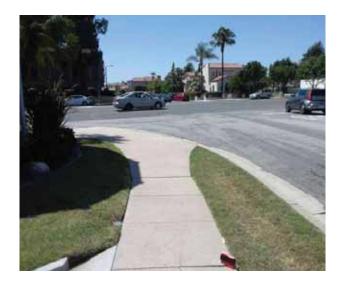
There is a change in elevation greater than recommended value.

Code Reference ADA 206, 302

Ensure that the change in elevation is within the recommended value.

Recommendation Up to 0.25 inches

Remove tripping hazards \$198

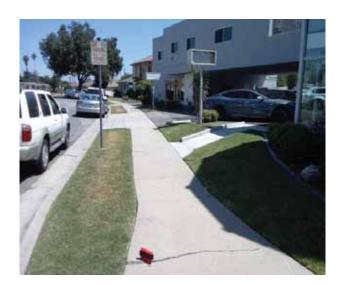
There is a change in elevation greater than recommended value.

Code Reference ADA 206, 302

Ensure that the change in elevation is within the recommended value.

Recommendation Up to 0.25 inches

Remove tripping hazards \$198

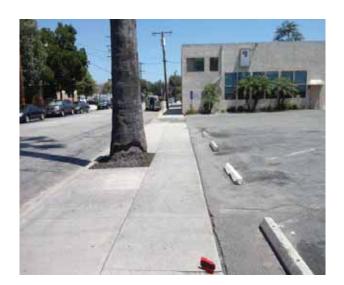
There is a change in elevation greater than recommended value.

Code Reference ADA 206, 302

Ensure that the change in elevation is within the recommended value.

Recommendation Up to 0.25 inches

Remove tripping hazards \$198

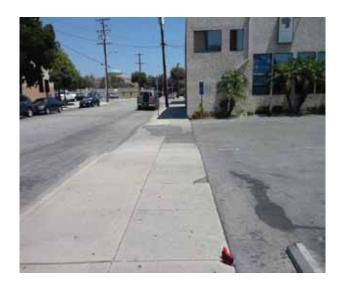
There is a change in elevation greater than recommended value.

Code Reference ADA 206, 302

Ensure that the change in elevation is within the recommended value.

Recommendation Up to 0.25 inches

Remove tripping hazards \$198

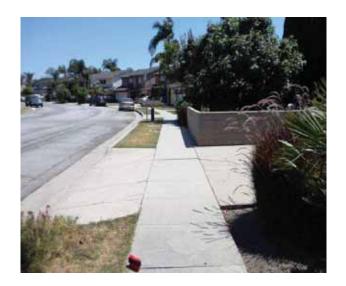
There is a change in elevation greater than recommended value.

Code Reference ADA 206, 302

Ensure that the change in elevation is within the recommended value.

Recommendation Up to 0.25 inches

Remove tripping hazards \$198

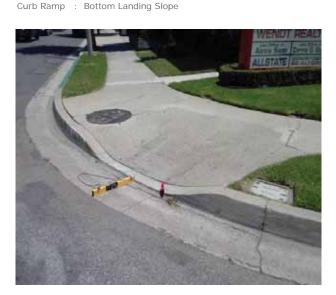
**Code Reference** ADA 406, 406.2,CA 11B-406.5.8

Recommendation Up to 5.00 percent

Repave landing \$1,260

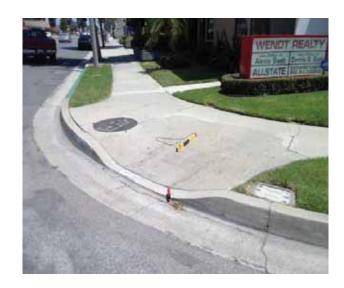
**Code Reference** ADA 406, 406.1, 405.2, CA 11B-406

Recommendation Up to 8.33 percent

Install curb ramp \$1,300

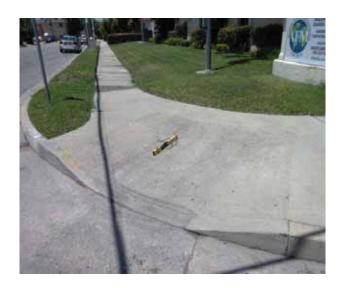
**Code Reference** ADA 406, 406.1, 405.2,CA 11B-406

Recommendation Up to 8.33 percent

Install curb ramp \$1,300

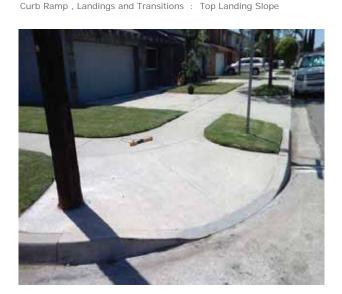
**Code Reference** ADA 402, 406.4, 403.3, 406.1,CA 11B-406.5.3

Recommendation Up to 2.08 percent

Provide compliant landing \$1,260

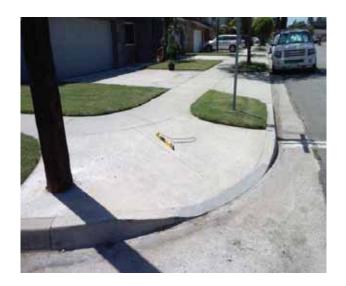
**Code Reference** ADA 406, 406.1, 405.2, CA 11B-406

Recommendation Up to 8.33 percent

Install curb ramp \$1,300

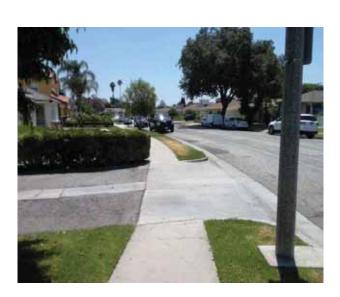
On-Site Finding Not Found

**Code Reference** ADA 705,CA 11B-705.1.2.5,CA 11B-247.1.2.5

Install compliant detectable \$190 warnings

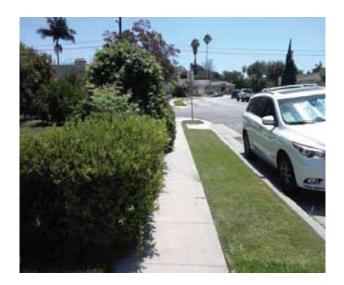
Sidewalks , Hazards & Gratings : Sidewalk Width at Obstruction

**Code Reference** ADA 206, 302, 403.5.1,CA 11B-403.5

Sidewalk width at the obstruction shall have the recommended value.

Recommendation At least 48.00 inches

\$1,260

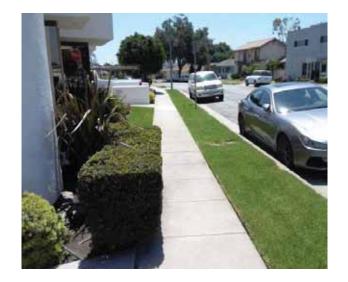
Sidewalks , Hazards & Gratings : Sidewalk Width at Obstruction

**Code Reference** ADA 206, 302, 403.5.1,CA 11B-403.5

Sidewalk width at the obstruction shall have the recommended value.

Recommendation At least 48.00 inches

\$1,260

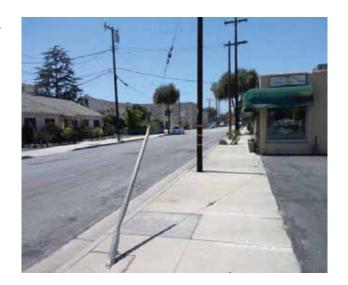
Sidewalks , Hazards & Gratings : Overhead Obstruction Height

**Code Reference** ADA 206, 307.4,CA 11B-307.4

Recommendation At least 80.00 inches

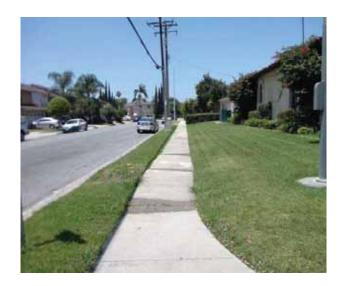
**Code Reference** ADA 206, 302,CA 11B-403.3

Repave the sidewalk surface with the recommended cross slope.

Recommendation Up to 2.08 percent

Repave surface \$1,092

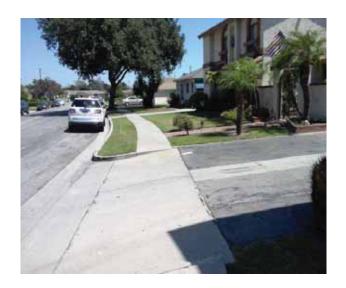
**Code Reference** ADA 705,CA 11B-705.1.2.5,CA 11B-247.1.2.5

Install compliant detectable \$190

warnings

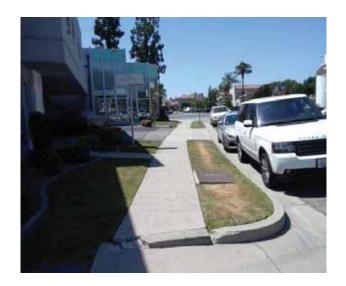
**Code Reference** ADA 402, 303, 406, 403.4, 303.4

Install curb ramp \$2,500

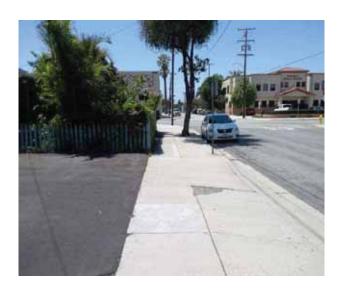
**Code Reference** ADA 705,CA 11B-705.1.2.5,CA 11B-247.1.2.5

Install compliant detectable \$190

warnings

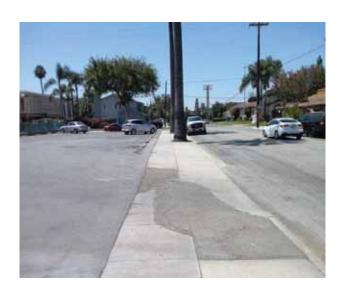
**Code Reference** ADA 705,CA 11B-705.1.2.5,CA 11B-247.1.2.5

Notes: Surface is Rough And Uneven

Install compliant detectable \$190

warnings
