# Accessibility Survey

## 5th Street & Brookshire Avenue

5th Street & Brookshire Avenue  
Downey, CA 90242

Date of Inspection  
4/18/2017

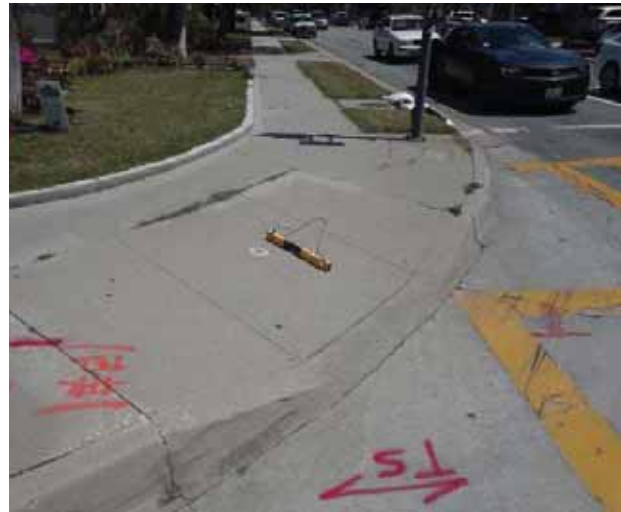
Northeast Corner @ 33.942195081132, -118.126471191645

Curb Ramp : No Detectable Warnings

The curb ramp does not provide a detectable warning surface which includes truncated domes.

**Code Reference** CA 11B-406.5.12

Provide compliant detectable warnings to surface.

Provide detectable warning to surface \$248

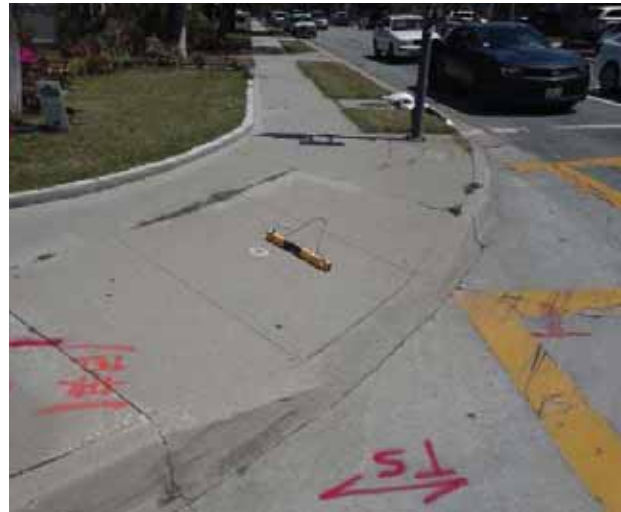
**Northeast Corner @ 33.942195081132, -118.126471191645**

Curb Ramp : Curb Ramp Slope

**Code Reference** ADA 406, 406.1, 405.2, CA 11B-406

Install curb ramp \$1,300

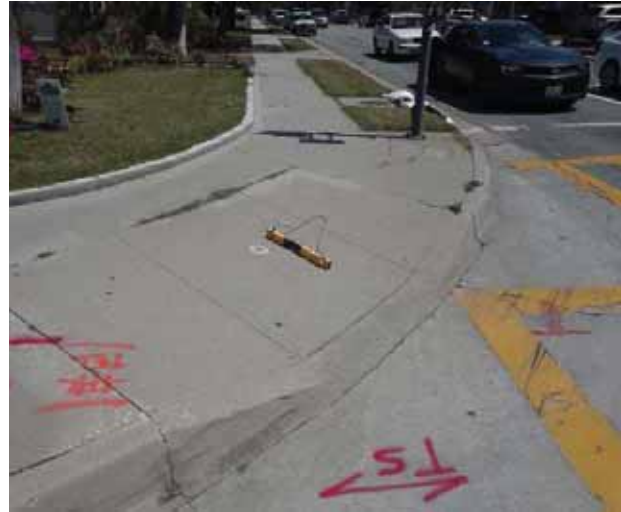
**Code Reference** ADA 406, 406.3, CA 11B-406.2.2

Install flared sides \$1,300

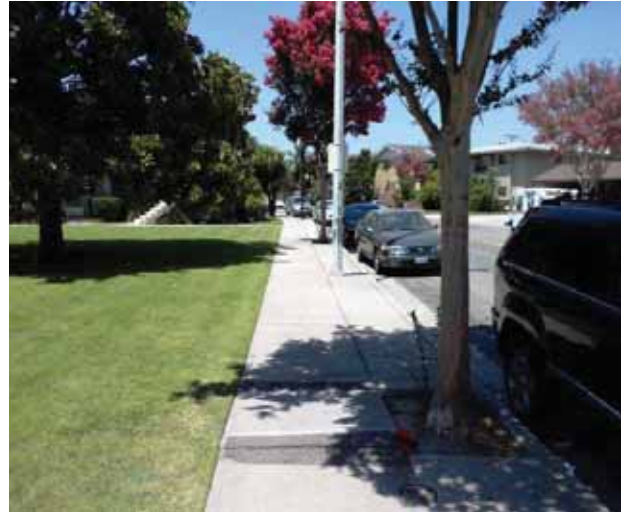
There is a change in elevation greater than recommended value.

**Code Reference** ADA 206, 302

Ensure that the change in elevation is within the recommended value.

Remove tripping hazards \$198

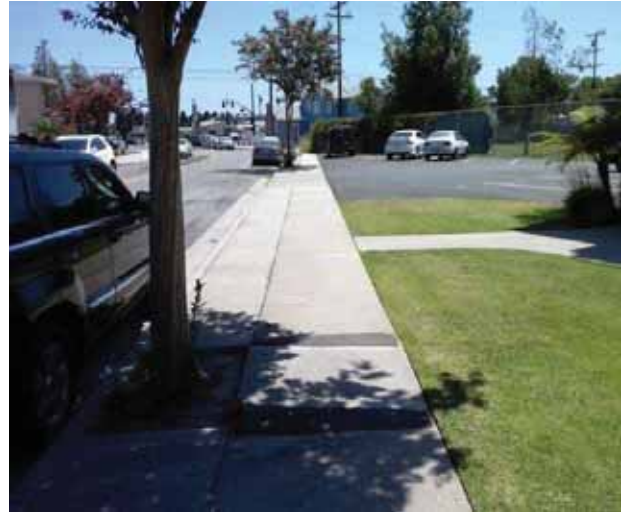
There is a change in elevation greater than recommended value.

**Code Reference** ADA 206, 302

Remove tripping hazards \$198

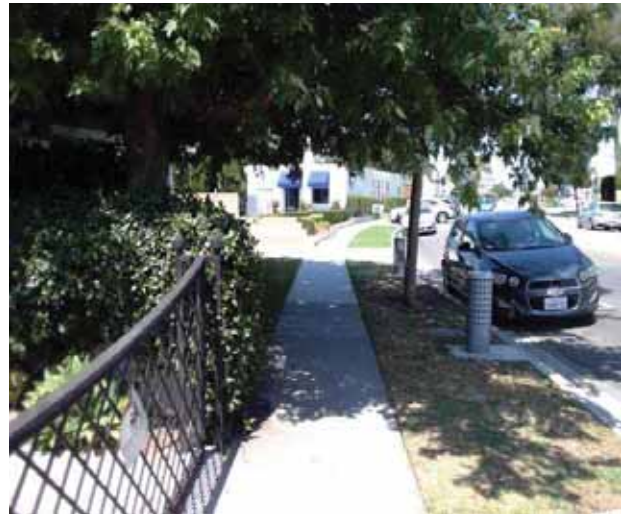
**Code Reference** ADA 206, 302,CA 11B-403.3

Repave surface \$1,092

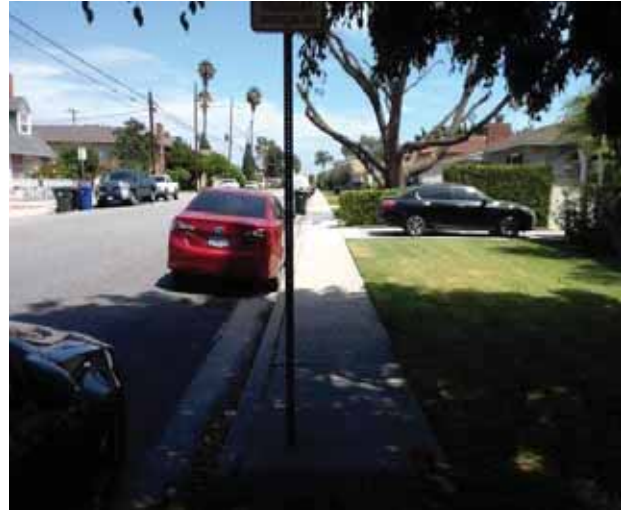
**Code Reference** ADA 206, 302

Notes : Surface is Rough And Uneven

Remove tripping hazards \$198
