# Accessibility Survey

## City of Downey Gallatin Road & Paramount Boulevard

Date of Inspection  
4/14/2017

Prepared By  
**Disability Access Consultants**  
(800) 743-7067

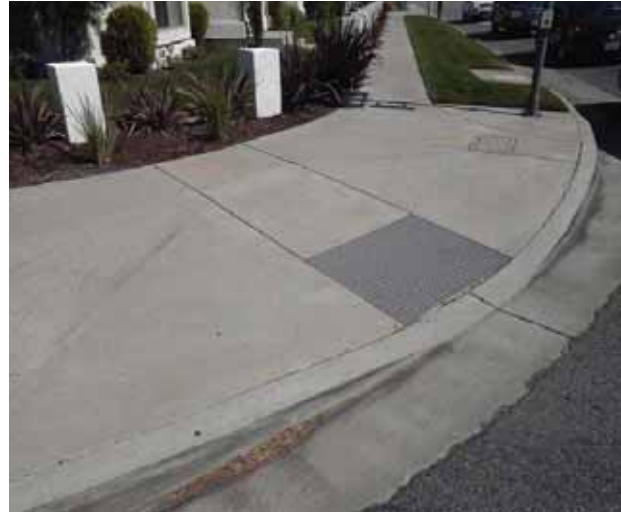
**Northeast Corner @ 33.962171372613, -118.122954815626**

Curb Ramp , Landings and Transitions : Top Landing Clear Length - Landings

There is not enough top landing clear length.

**On-Site Finding** 47.00 inches

**Code Reference** ADA 406, 406.4, CA 11B-406.5.3

Provide a level top landing with enough clear length.

Recommendation At least 48.00 inches

Provide compliant landing \$240

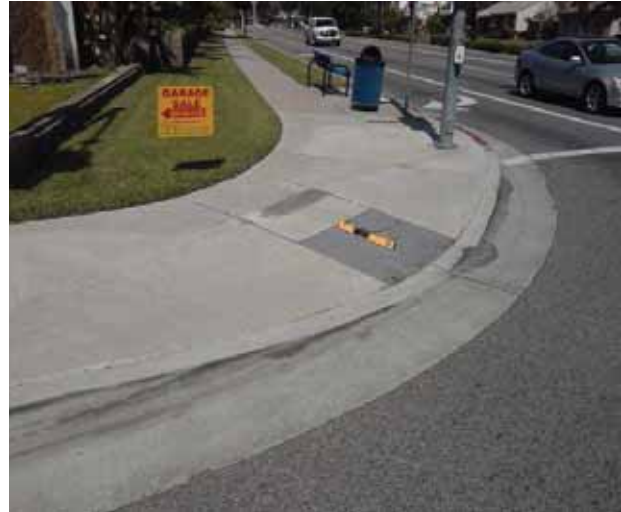
#### Northwest Corner @ 33.962348231455, -118.123208284378

Curb Ramp : Curb Ramp Slope

**Code Reference** ADA 406, 406.1, 405.2, CA 11B-406

Recommendation Up to 8.33 percent

Install curb ramp \$1,300

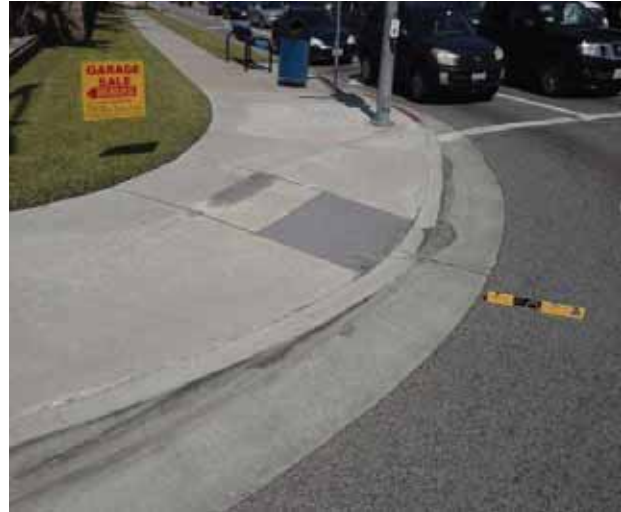
**Code Reference** ADA 406, 406.2, CA 11B-406.5.8

Recommendation Up to 5.00 percent

Repave landing \$1,260

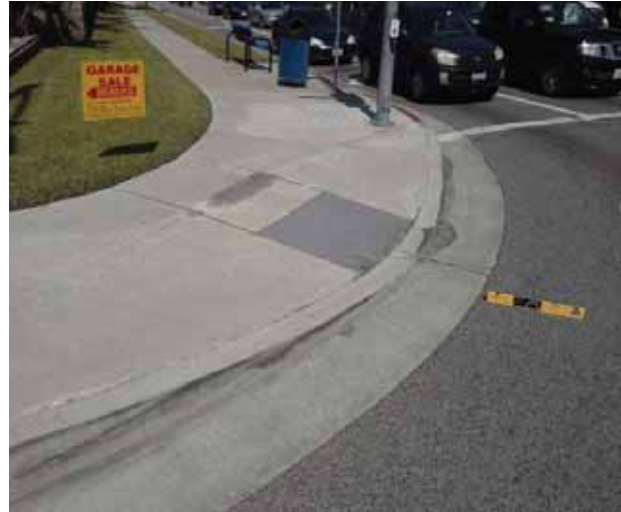
**Code Reference** ADA 406, 406.4, CA 11B-406.5.3

Recommendation At least 48.00 inches

Provide compliant landing \$240

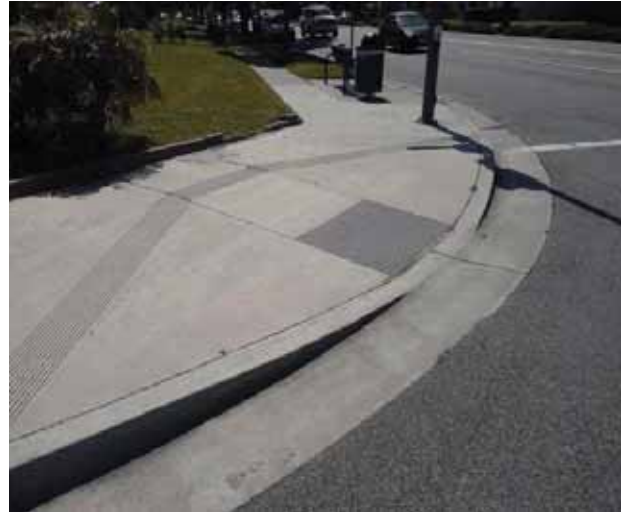
**Code Reference** ADA 406, 406.4, CA 11B-406.5.3

Recommendation At least 48.00 inches

Provide compliant landing \$240

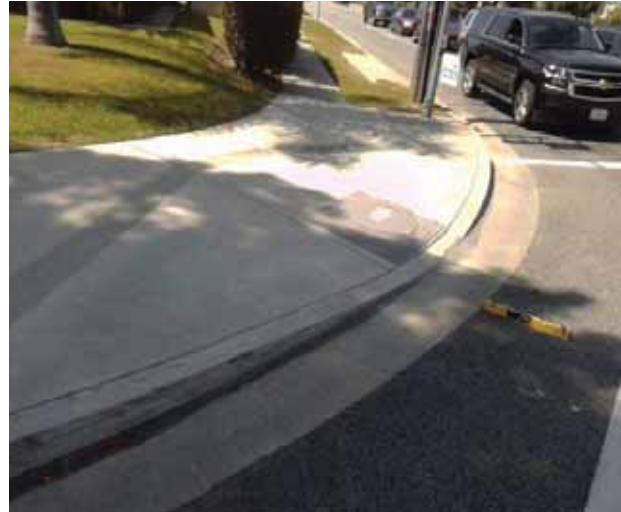
**Code Reference** ADA 406, 406.2, CA 11B-406.5.8

Recommendation Up to 5.00 percent

Repave landing \$1,260

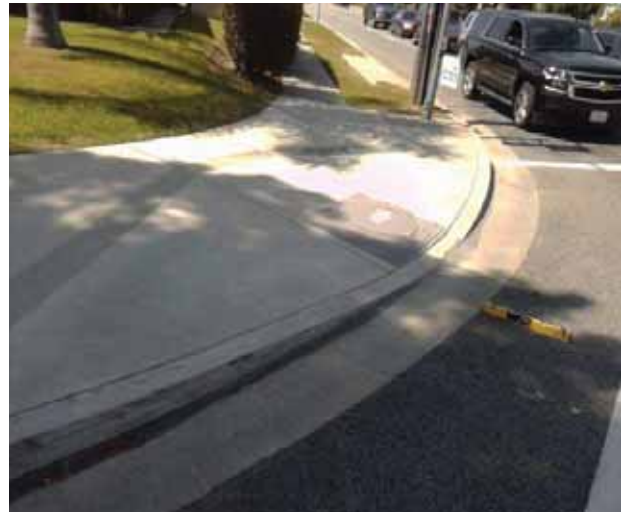
**Code Reference** ADA 406, 406.4, CA 11B-406.5.3

Recommendation At least 48.00 inches

Provide compliant landing \$240

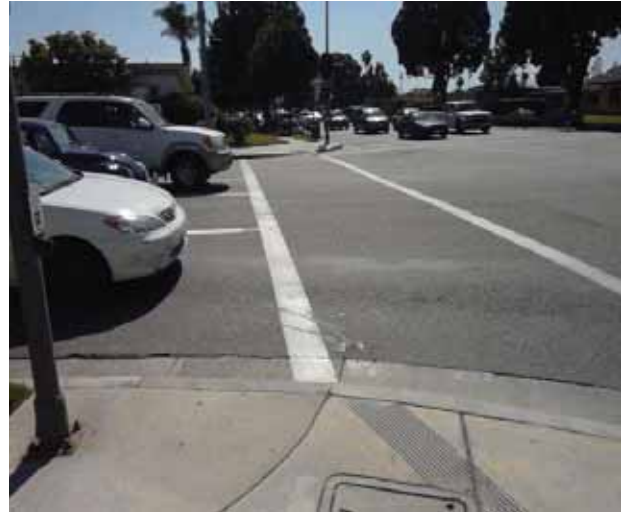
**Code Reference** CA MUTCD 4E.08

Recommendation Up to 60.00 inches

\$900

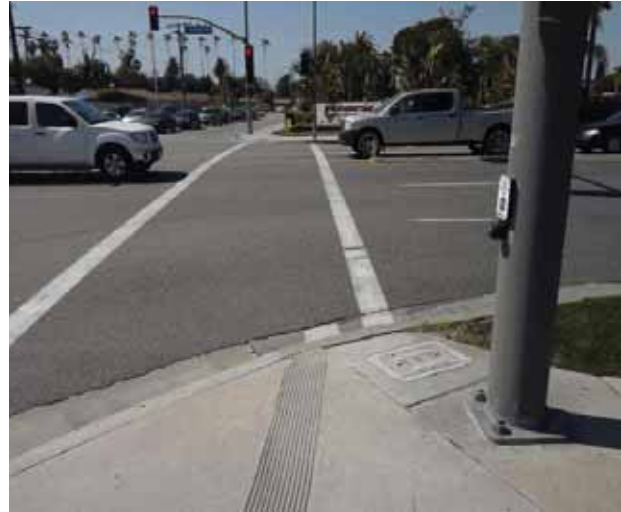
**Code Reference** CA MUTCD 4E.08

Recommendation Up to 60.00 inches

\$900

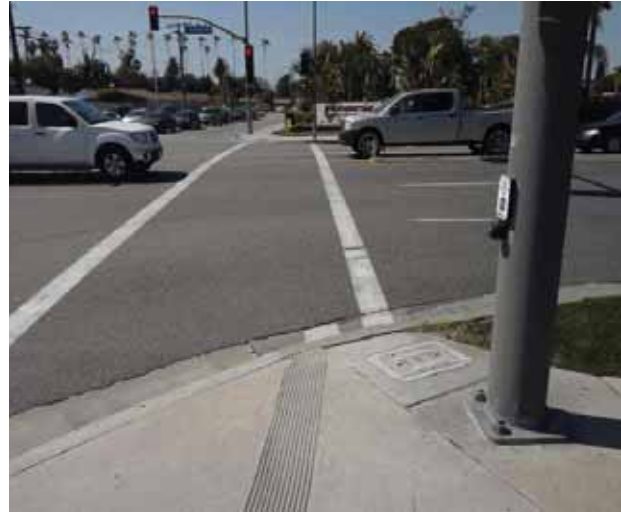
**Code Reference** CA MUTCD 4E.08

Recommendation At least 48.00 inches

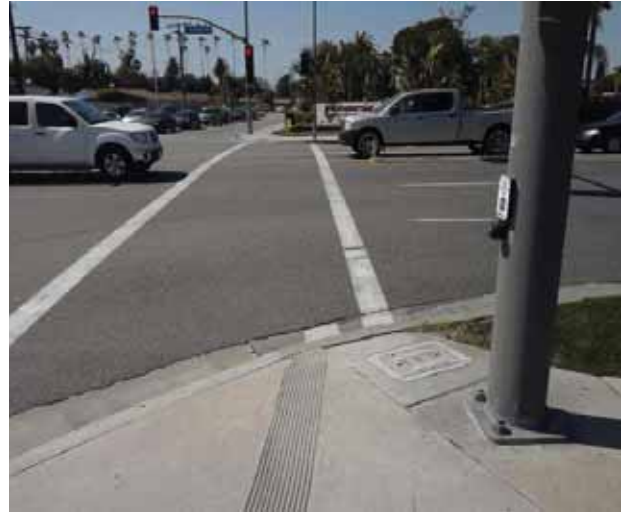
**Code Reference** CA 11B-305.2, CA MUTCD 4E.08

Recommendation Up to 2.08 percent

\$1,260

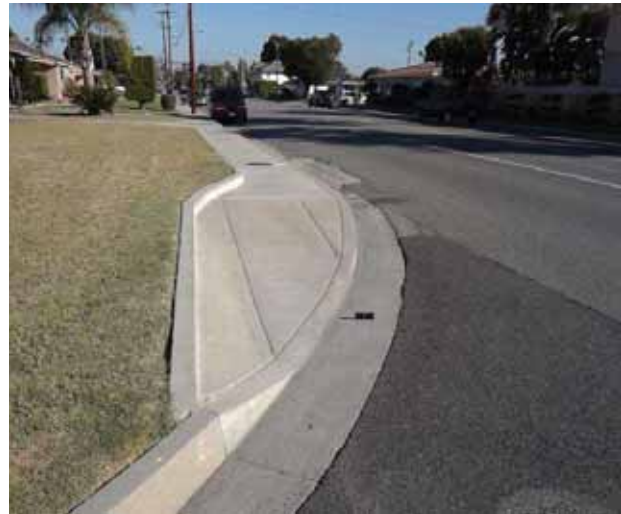
**Code Reference** ADA 402, 406.1, 405.3, CA 11B-406.5.7

Install curb ramp \$1,300

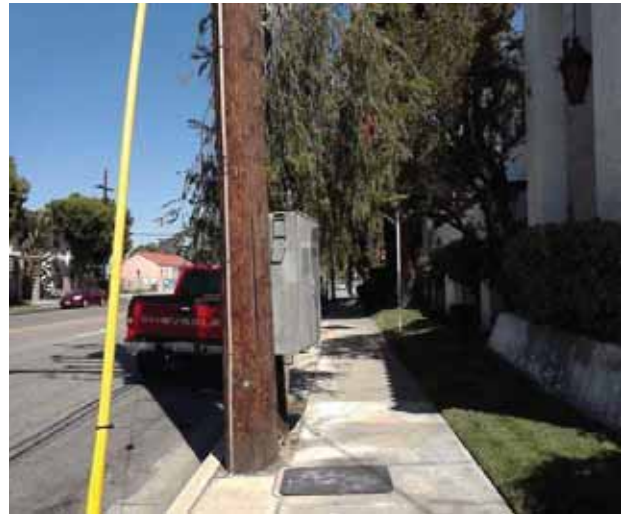
**Code Reference** ADA 307.2,CA 11B-307.2

Install wing walls or relocate object \$640

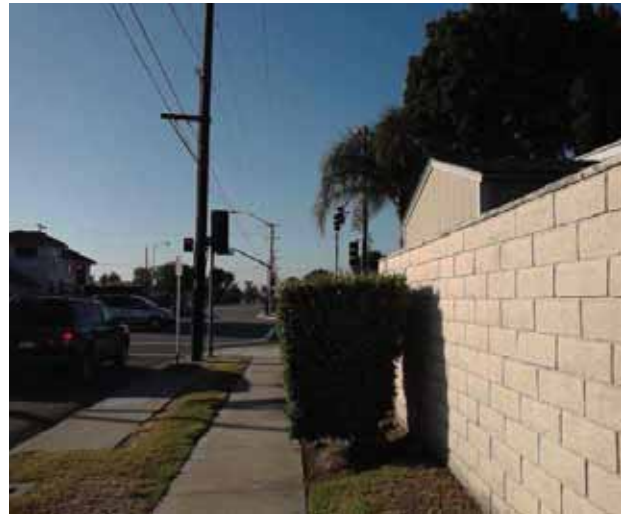
Code Reference ADA 206, 302, 403.5.1,CA 11B-403.5

\$1,260

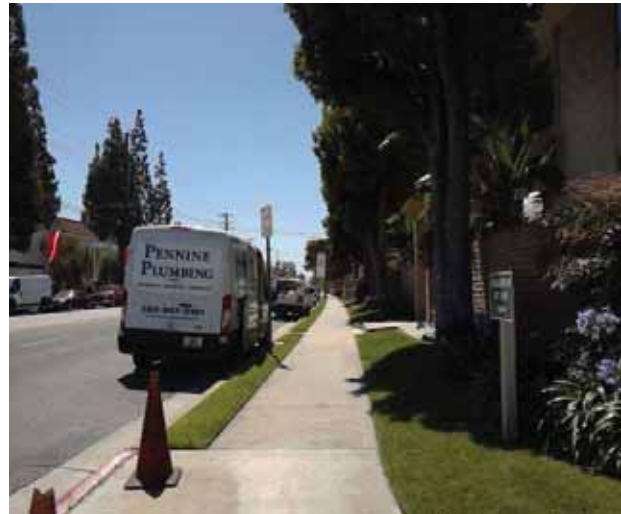
**Code Reference** ADA 206, 302,CA 11B-403.3

Repave surface \$1,092

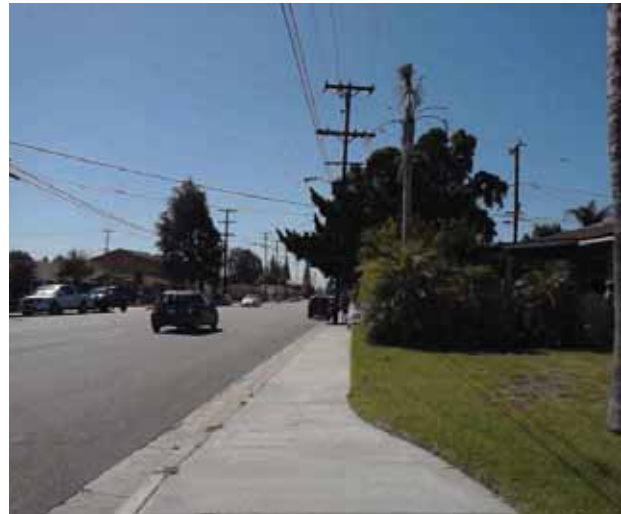
**Code Reference** ADA 206, 302,CA 11B-403.3

Repave surface \$1,092

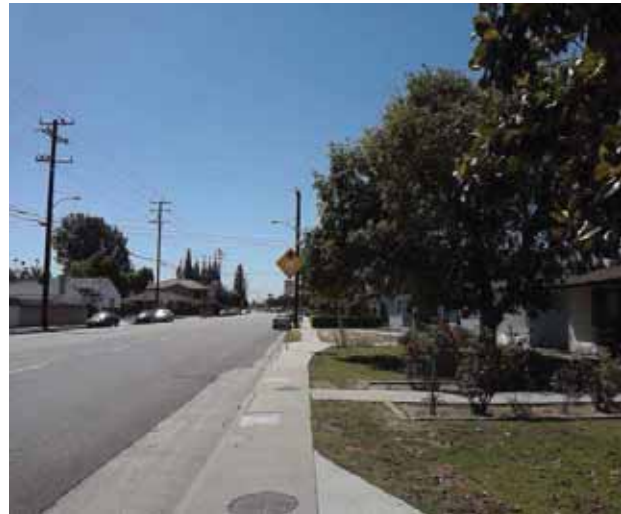
**Code Reference** ADA 206, 302,CA 11B-403.3

Repave surface \$1,092

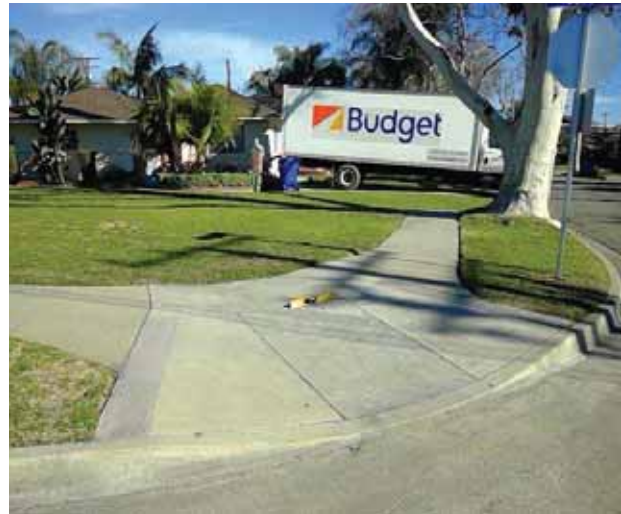
**Code Reference** ADA 402, 406.4, 403.3, 406.1, CA 11B-406.5.3

Provide compliant landing \$1,260

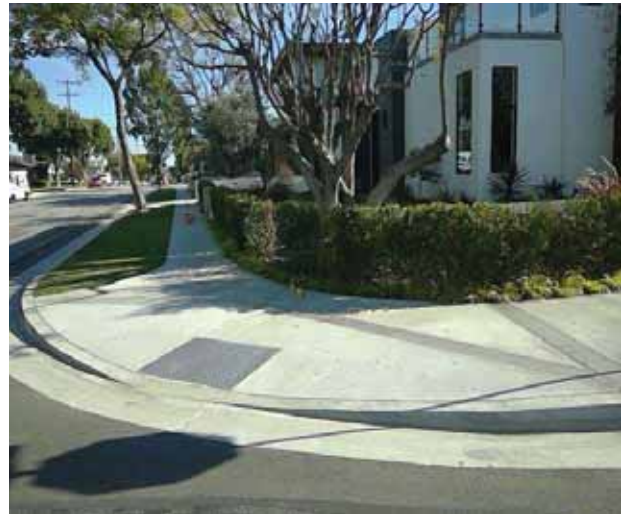
**Code Reference** ADA 406, 406.2, CA 11B-406.5.8

Repave landing \$1,260

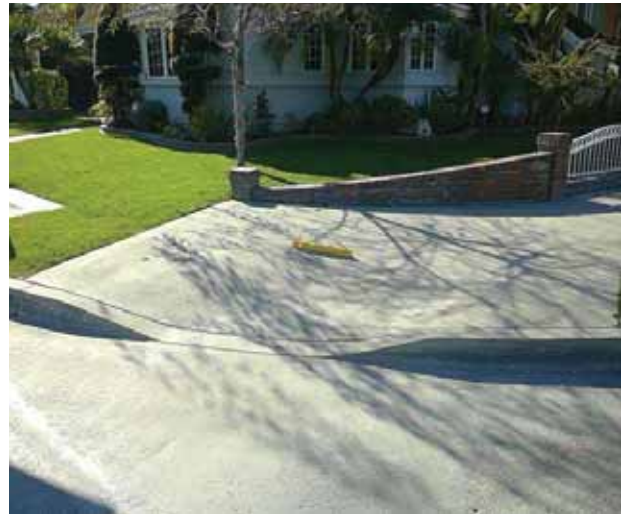
**Code Reference** ADA 402, 406.1, 405.3, CA 11B-406.5.7

Install curb ramp \$1,300
