Accessibility Survey

City of Downey Gardendale Street & Barlin Avenue

Date of Inspection
2/2/2017

Prepared By
Disability Access Consultants
(800) 743-7067

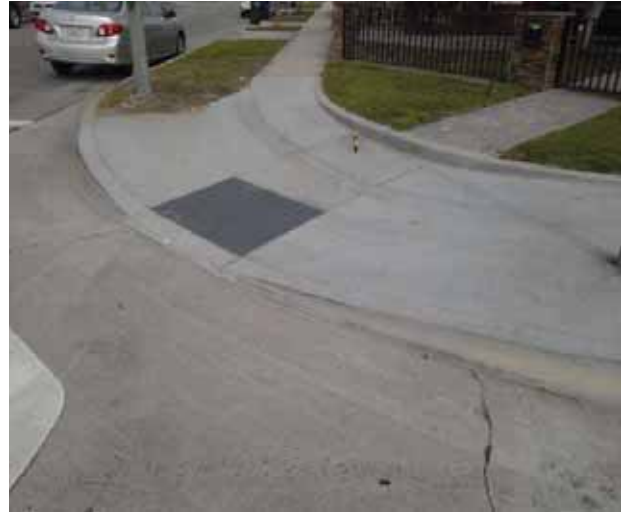
Northeast Corner @ 33.911974216051, -118.145278841257

Curb Ramp : No Detectable Warnings

The curb ramp does not provide a detectable warning surface which includes truncated domes.

Code Reference CA 11B-406.5.12

Provide compliant detectable warnings to surface.

Provide detectable warning to surface \$248

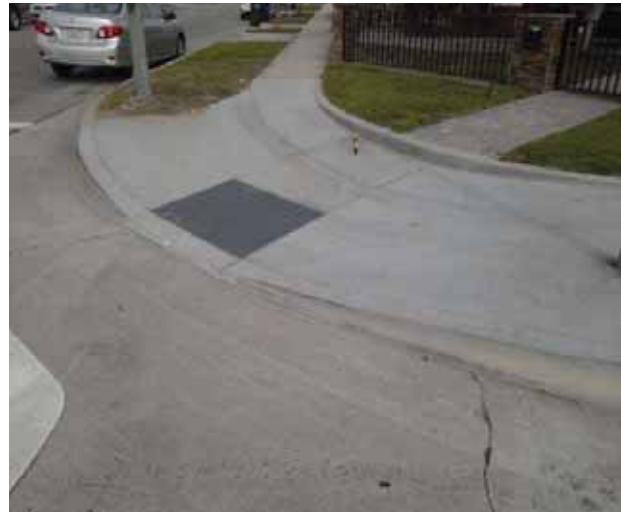
Northeast Corner @ 33.911974216051, -118.145278841257

Curb Ramp : Appurtenances

Utilities, gratings or other appurtenances are located on the curb ramp.

On-Site Finding Not Compliant

Code Reference ADA 303.3, CA 11B-303.3

Install curb ramp \$1,440

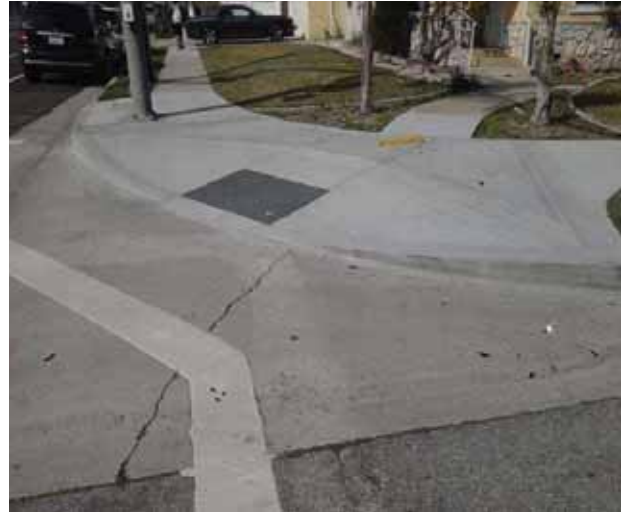
Code Reference CA 11B-705.1.2.2, ADA 705.1.2.2

Recommendation At least 36.00 inches

Install compliant detectable warnings \$190

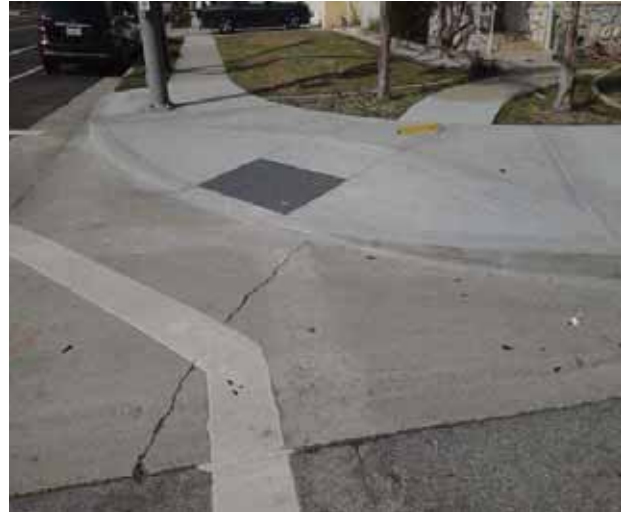
Code Reference ADA 402, 406.4, 403.3, 406.1, CA 11B-406.5.3

Recommendation Up to 2.08 percent

Provide compliant landing \$1,260

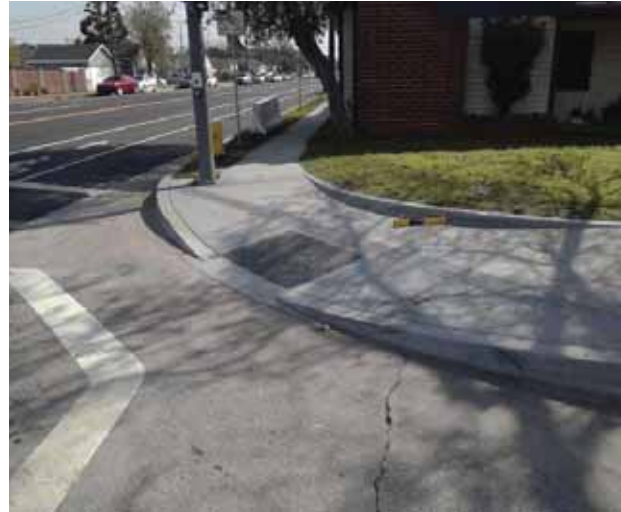
Code Reference ADA 402, 406.4, 403.3, 406.1, CA 11B-406.5.3

Recommendation Up to 2.08 percent

Provide compliant landing \$1,260

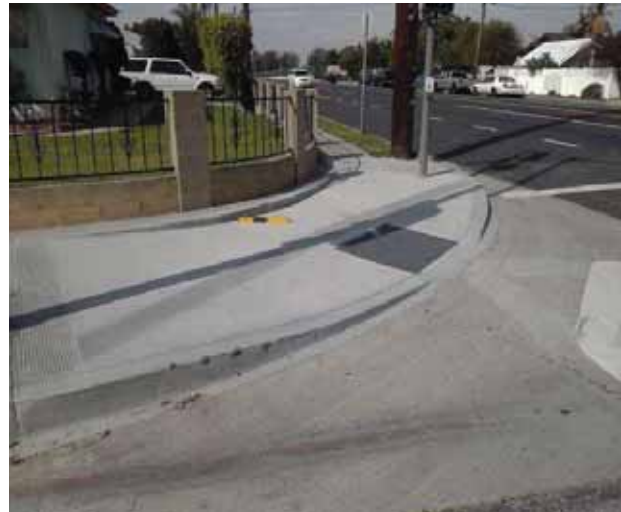
Code Reference ADA 402, 406.4, 403.3, 406.1, CA 11B-406.5.3

Recommendation Up to 2.08 percent

Provide compliant landing \$1,260

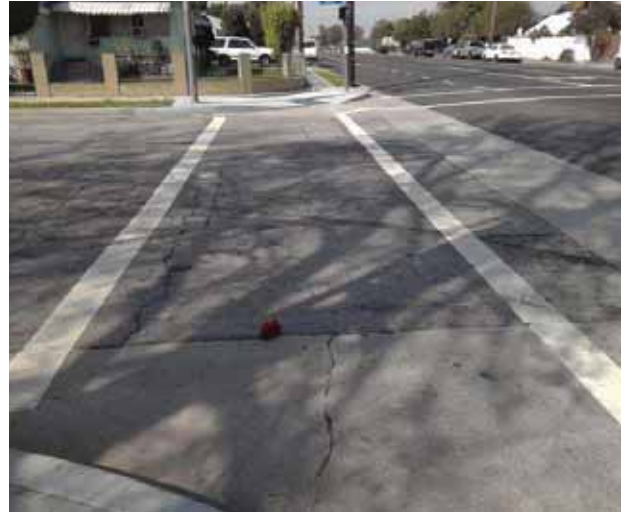
Code Reference ADA 303

Provide a compliant walking surface with recommended height.

Recommendation Up to 0.50 inches

\$1,260

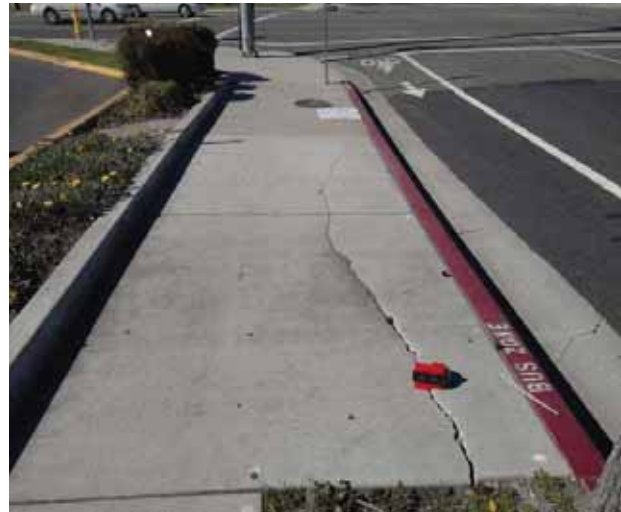
Code Reference ADA 206, 302

Notes : Change in level continues parallel to pedestrian traffic for 4 feet

Remove tripping hazards \$198

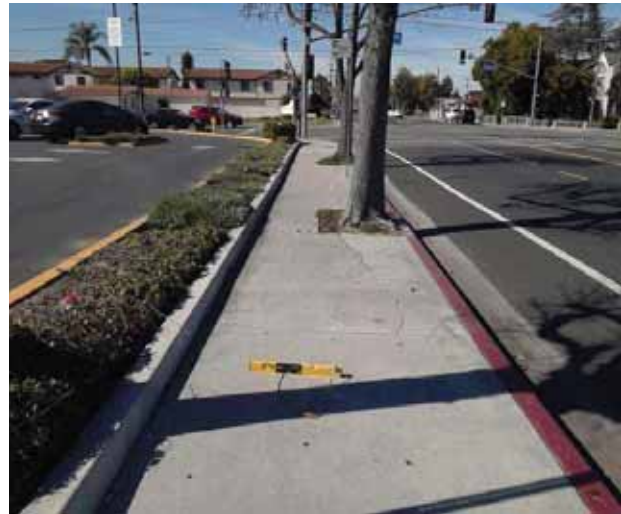
Code Reference ADA 206, 302,CA 11B-403.3

Repave surface \$1,092
