Accessibility Survey

City of Downey Patton Road - Alameda Street To Stewart & Gray Road

Date of Inspection 4/2/2017

Prepared By **Disability Access Consultants**(800) 743-7067

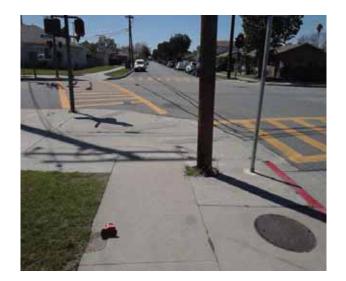
Change In Level South Of Cavel Street @ 33.925511391346, -118.136404752731

Sidewalks , Change in Level : Change in Level Non Beveled

There is a change in elevation greater than recommended value.

On-Site Finding 0.75 inches

Code Reference ADA 206, 302

Ensure that the change in elevation is within the recommended value.

Recommendation Up to 0.25 inches

Remove tripping hazards \$198

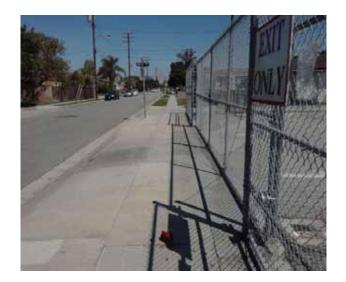
Change In Level South Of Cavel Street @ 33.926840064251, -118.135420382023

Sidewalks , Change in Level : Change in Level Non Beveled

There is a change in elevation greater than recommended value.

Code Reference ADA 206, 302

Ensure that the change in elevation is within the recommended value.

Recommendation Up to 0.25 inches

Remove tripping hazards \$198

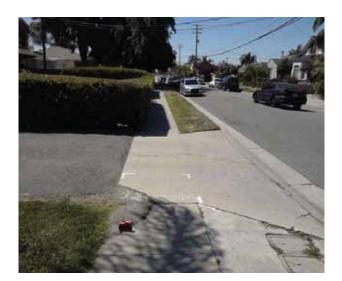
There is a change in elevation greater than recommended value.

Code Reference ADA 206, 302

Ensure that the change in elevation is within the recommended value.

Recommendation Up to 0.25 inches

Remove tripping hazards \$198

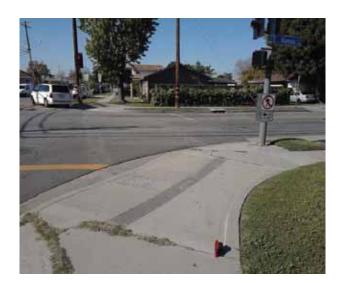
There is a change in elevation greater than recommended value.

Code Reference ADA 206, 302

Ensure that the change in elevation is within the recommended value.

Recommendation Up to 0.25 inches

Remove tripping hazards \$198

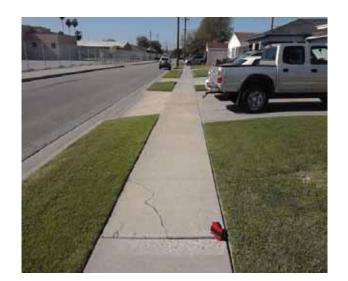
There is a change in elevation greater than recommended value.

Code Reference ADA 206, 302

Ensure that the change in elevation is within the recommended value.

Recommendation Up to 0.25 inches

Remove tripping hazards \$198

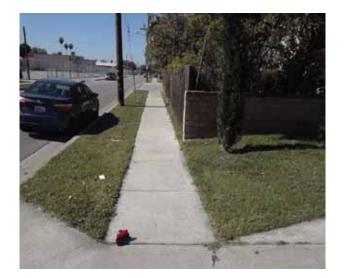
There is a change in elevation greater than recommended value.

Code Reference ADA 206, 302

Ensure that the change in elevation is within the recommended value.

Recommendation Up to 0.25 inches

Remove tripping hazards \$198

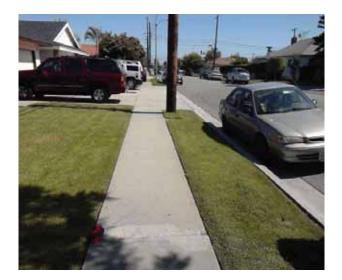
There is a change in elevation greater than recommended value.

Code Reference ADA 206, 302

Ensure that the change in elevation is within the recommended value.

Recommendation Up to 0.25 inches

Remove tripping hazards \$198

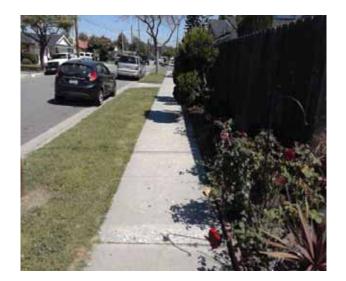
There is a change in elevation greater than recommended value.

Code Reference ADA 206, 302

Ensure that the change in elevation is within the recommended value.

Recommendation Up to 0.25 inches

Remove tripping hazards \$198

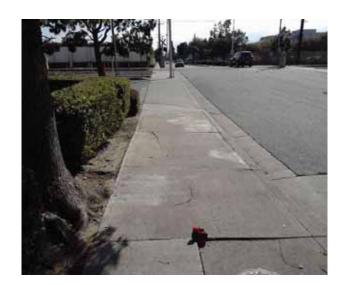
There is a change in elevation greater than recommended value.

Sidewalks , Change in Level : Change in Level Non Beveled

Code Reference ADA 206, 302

Ensure that the change in elevation is within the recommended value.

Recommendation Up to 0.25 inches

Remove tripping hazards \$198

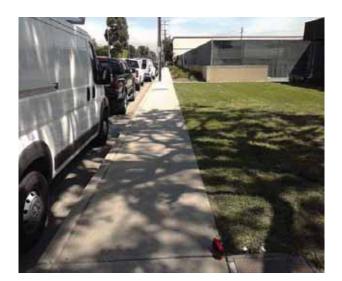
There is a change in elevation greater than recommended value.

Sidewalks , Change in Level : Change in Level Non Beveled

Code Reference ADA 206, 302

Ensure that the change in elevation is within the recommended value.

Recommendation Up to 0.25 inches

Remove tripping hazards \$198

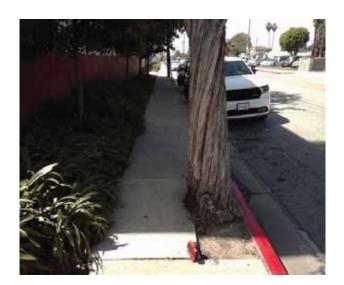
There is a change in elevation greater than recommended value.

Sidewalks , Change in Level : Change in Level Non Beveled

Code Reference ADA 206, 302

Ensure that the change in elevation is within the recommended value.

Recommendation Up to 0.25 inches

Remove tripping hazards \$198

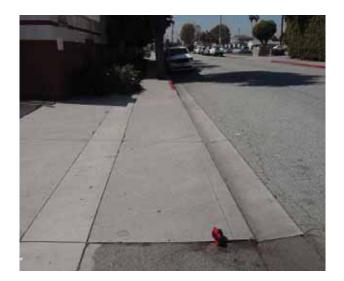
There is a change in elevation greater than recommended value.

Sidewalks , Change in Level : Change in Level Non Beveled

Code Reference ADA 206, 302

Ensure that the change in elevation is within the recommended value.

Recommendation Up to 0.25 inches

Remove tripping hazards \$198

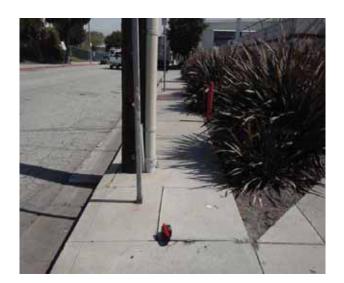
There is a change in elevation greater than recommended value.

Sidewalks , Change in Level : Change in Level Non Beveled

Code Reference ADA 206, 302

Ensure that the change in elevation is within the recommended value.

Up to 0.25 inches Recommendation

Remove tripping hazards \$198

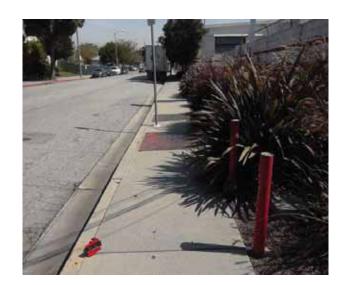
There is a change in elevation greater than recommended value.

Sidewalks , Change in Level : Change in Level Non Beveled

Code Reference ADA 206, 302

Ensure that the change in elevation is within the recommended value.

Recommendation Up to 0.25 inches

Remove tripping hazards \$198

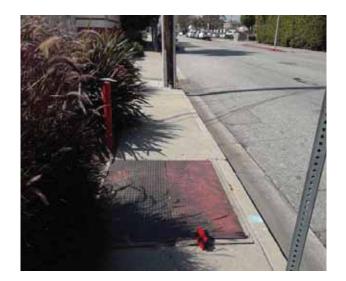
There is a change in elevation greater than recommended value.

Sidewalks , Change in Level : Change in Level Non Beveled

Code Reference ADA 206, 302

Ensure that the change in elevation is within the recommended value.

Recommendation Up to 0.25 inches

Remove tripping hazards \$198

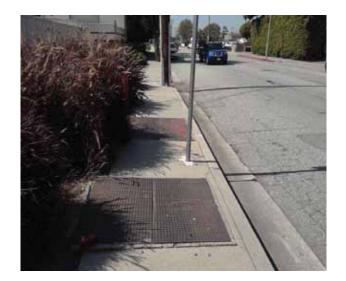
There is a change in elevation greater than recommended value.

Code Reference ADA 206, 302

Ensure that the change in elevation is within the recommended value.

Recommendation Up to 0.25 inches

Remove tripping hazards \$198

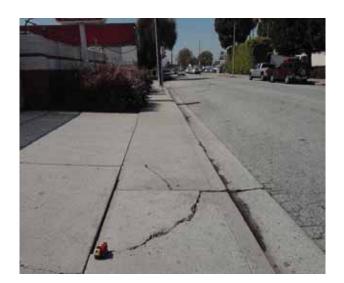
There is a change in elevation greater than recommended value.

Sidewalks , Change in Level : Change in Level Non Beveled

Code Reference ADA 206, 302

Ensure that the change in elevation is within the recommended value.

Recommendation Up to 0.25 inches

Remove tripping hazards \$198

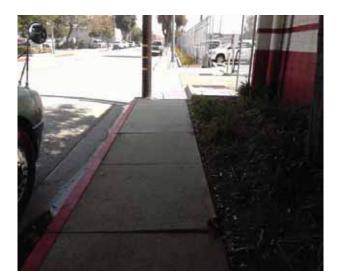
There is a change in elevation greater than recommended value.

Sidewalks , Change in Level : Change in Level Non Beveled

Code Reference ADA 206, 302

Ensure that the change in elevation is within the recommended value.

Recommendation Up to 0.25 inches

Remove tripping hazards \$198

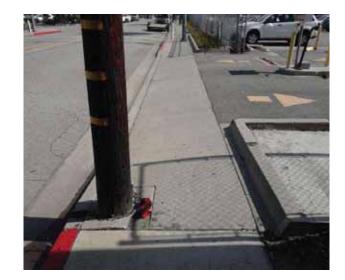
There is a change in elevation greater than recommended value.

Sidewalks , Change in Level : Change in Level Non Beveled

Code Reference ADA 206, 302

Ensure that the change in elevation is within the recommended value.

Recommendation Up to 0.25 inches

Remove tripping hazards \$198

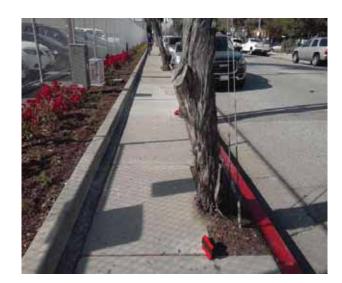
There is a change in elevation greater than recommended value.

Sidewalks , Change in Level : Change in Level Non Beveled

Code Reference ADA 206, 302

Ensure that the change in elevation is within the recommended value.

Recommendation Up to 0.25 inches

Remove tripping hazards \$198

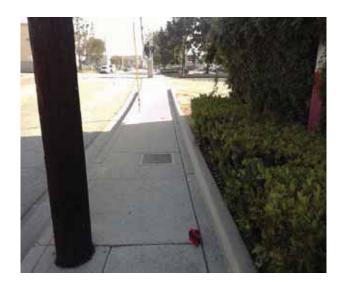
There is a change in elevation greater than recommended value.

Sidewalks , Change in Level : Change in Level Non Beveled

Code Reference ADA 206, 302

Ensure that the change in elevation is within the recommended value.

Recommendation Up to 0.25 inches

Remove tripping hazards \$198

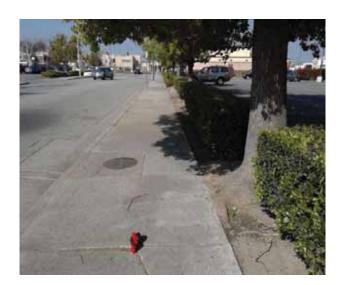
There is a change in elevation greater than recommended value.

Sidewalks , Change in Level : Change in Level Non Beveled

Code Reference ADA 206, 302

Ensure that the change in elevation is within the recommended value.

Recommendation Up to 0.25 inches

Remove tripping hazards \$198

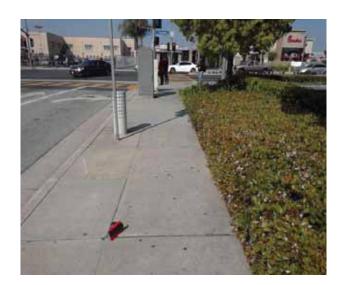
There is a change in elevation greater than recommended value.

Sidewalks , Change in Level : Change in Level Non Beveled

Code Reference ADA 206, 302

Ensure that the change in elevation is within the recommended value.

Recommendation Up to 0.25 inches

Remove tripping hazards \$198

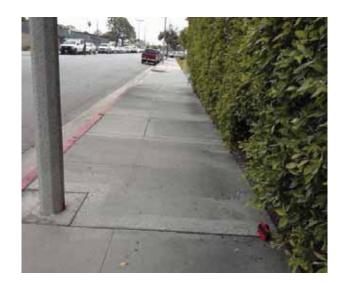
There is a change in elevation greater than recommended value.

Code Reference ADA 206, 302

Ensure that the change in elevation is within the recommended value.

Recommendation Up to 0.25 inches

Remove tripping hazards \$198

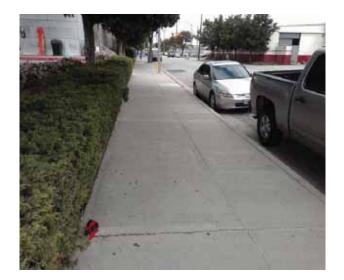
There is a change in elevation greater than recommended value.

Code Reference ADA 206, 302

Ensure that the change in elevation is within the recommended value.

Recommendation Up to 0.25 inches

Remove tripping hazards \$198

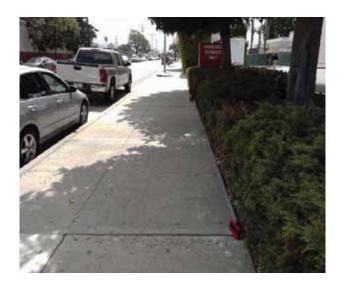
There is a change in elevation greater than recommended value.

Code Reference ADA 206, 302

Ensure that the change in elevation is within the recommended value.

Recommendation Up to 0.25 inches

Remove tripping hazards \$198

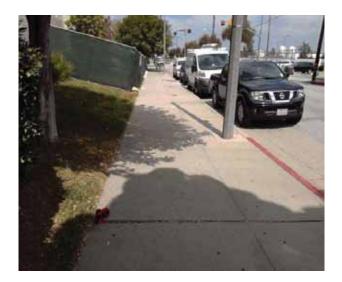
There is a change in elevation greater than recommended value.

Code Reference ADA 206, 302

Recommendation Up to 0.25 inches

Remove tripping hazards \$198

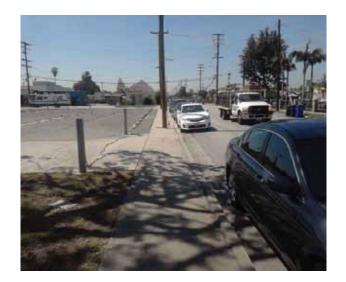
Code Reference ADA 206, 302,CA 11B-403.3

Notes: Spalled concrete continues for 41 feet.

Repave surface \$1,092

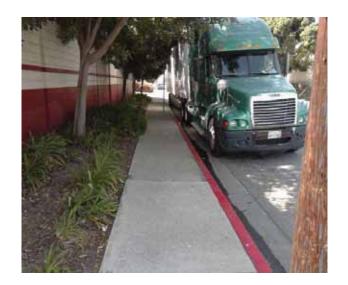
Code Reference ADA 206, 302

Notes: Spalled concrete continues for 5 feet.

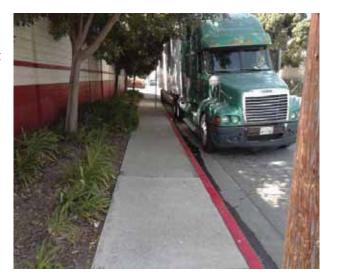
Code Reference ADA 206, 302,CA 11B-403.3

Notes: Spalled concrete continues for 5 feet.

Repave surface \$1,092

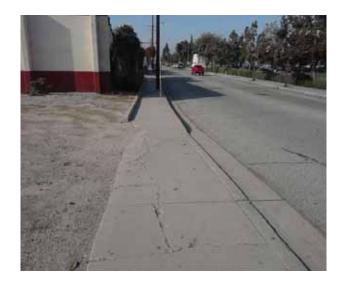
Code Reference ADA 206, 302 Notes: Spalled concrete continues for feet.

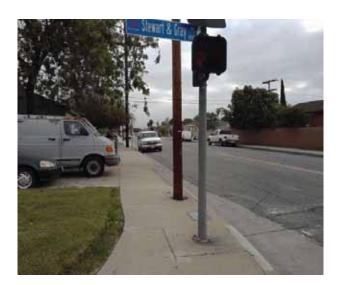
Sidewalks , Hazards & Gratings : Sidewalk Width at Obstruction

Code Reference ADA 206, 302, 403.5.1,CA 11B-403.5
