Accessibility Survey

City of Downey Suva Street & Bluff Road/ Foster Bridge Boulevard

Date of Inspection 6/23/2017

Disability Access Consultants

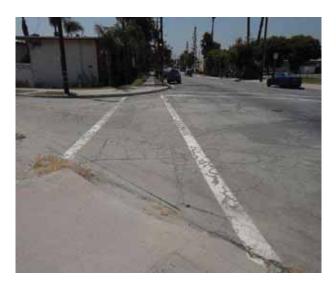
Notes: Crosswalk Missing, Faded And Or Damaged

Recommendation See Recommendation

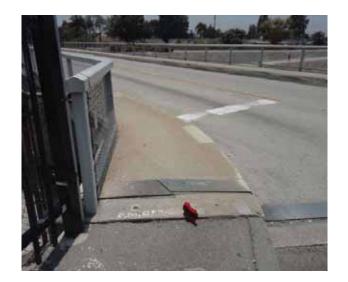
Code Reference ADA 206, 302 Notes: Surface is Rough And Uneven.

Remove tripping hazards \$198

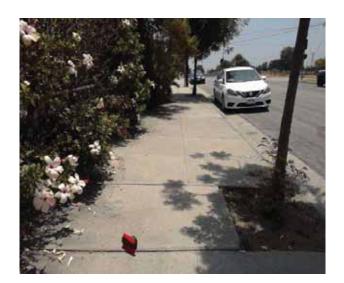
Sidewalks , Change in Level : Change in Level Non Beveled

Remove tripping hazards \$198

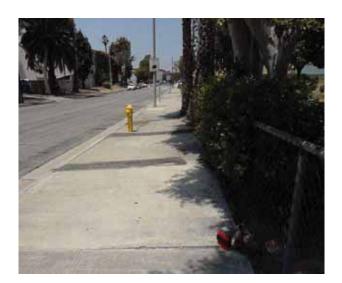
Sidewalks , Change in Level : Change in Level Non Beveled

Remove tripping hazards \$198

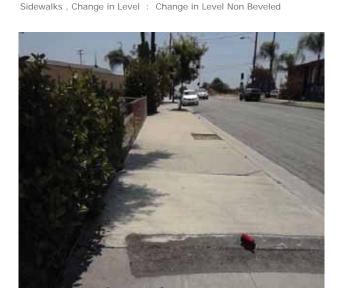
Code Reference ADA 206, 302 Notes: Surface is Rough And Uneven.

Remove tripping hazards \$198

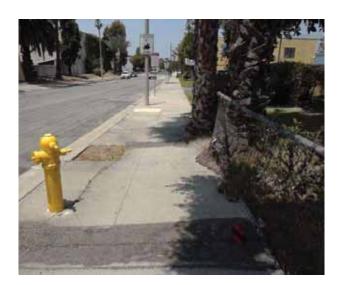
Sidewalks , Change in Level : Change in Level Non Beveled

Code Reference ADA 206, 302 Notes: Surface is Rough And Uneven.

Remove tripping hazards \$198

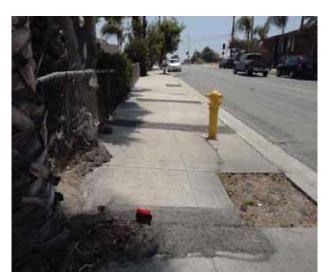
Code Reference ADA 206, 302 Notes: Surface is Rough And Uneven.

Remove tripping hazards \$198

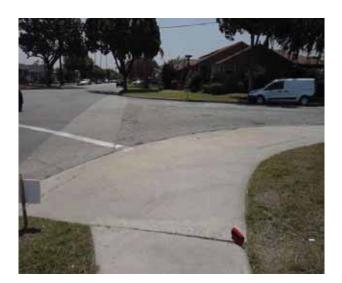
Sidewalks , Change in Level : Change in Level Non Beveled

Remove tripping hazards \$198

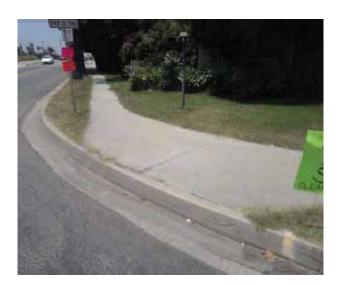
Sidewalks , Hazards & Gratings : Curb is on Path of Travel

Install curb ramp \$2,500

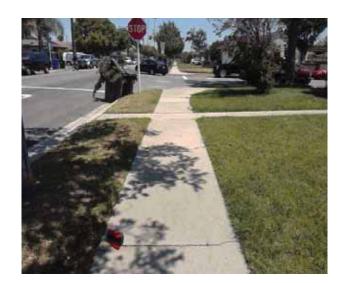
Sidewalks , Change in Level : Change in Level Non Beveled

Remove tripping hazards \$198

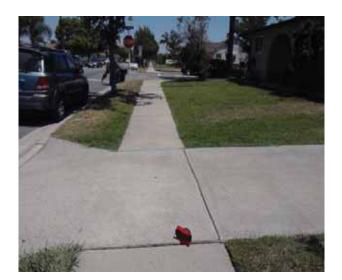
Sidewalks , Change in Level : Change in Level Non Beveled

Remove tripping hazards \$198

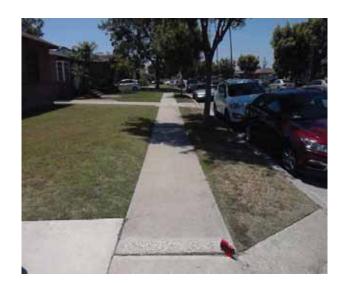
Sidewalks , Change in Level : Change in Level Non Beveled

Remove tripping hazards \$198

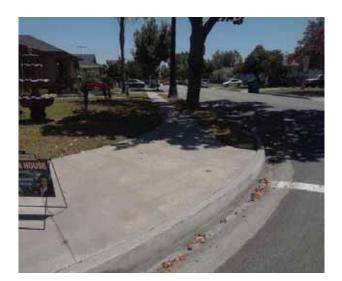
Sidewalks , Hazards & Gratings : Curb is on Path of Travel

Install curb ramp \$2,500

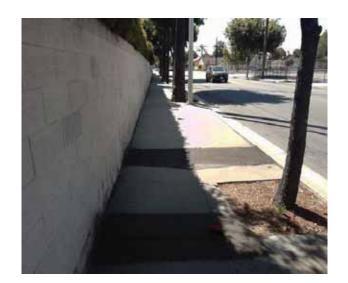
Code Reference ADA 206, 302 Notes: Surface is Rough And Uneven.

Remove tripping hazards \$198
