Accessibility Survey

City of Downey Telegraph Road & Birchbark Avenue

Date of Inspection 4/29/2017

Disability Access Consultants

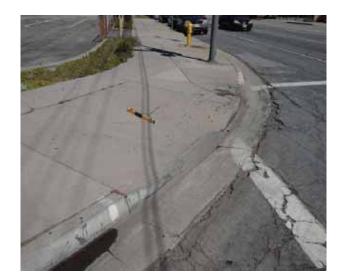
Code Reference CA 11B-406.5.12

Notes: Bottom landing spalled

Provide detectable warning to \$248 surface

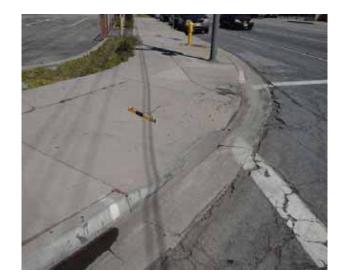
Code Reference ADA 406, 406.1, 405.2,CA 11B-406

Notes: Bottom landing spalled

Install curb ramp \$1,300

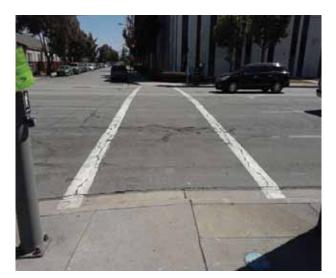
Notes: Curb on path of travel -- Spalled for 5 feet

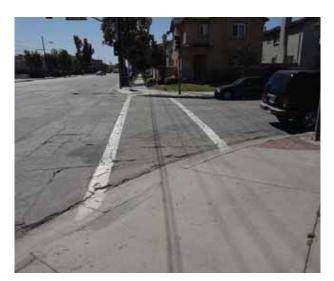
Notes: Spalled concrete continues for 61 feet.

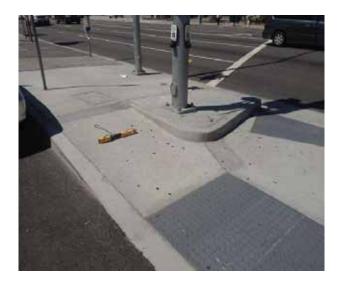
Code Reference ADA 402, 406.1, 405.3, CA 11B-406.5.7

Install curb ramp \$1,300

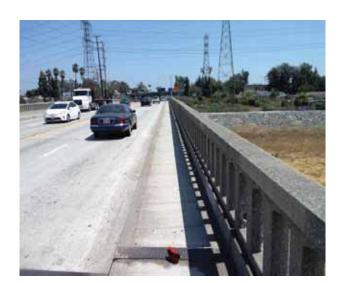
Sidewalks , Change in Level : Change in Level Non Beveled

Code Reference ADA 206, 302

Remove tripping hazards \$198

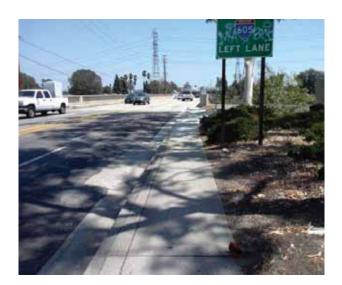
Sidewalks , Change in Level : Change in Level Non Beveled

Code Reference ADA 206, 302

Remove tripping hazards \$198

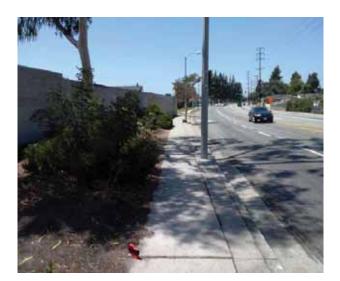
Sidewalks , Change in Level : Change in Level Non Beveled

Code Reference ADA 206, 302

Remove tripping hazards \$198

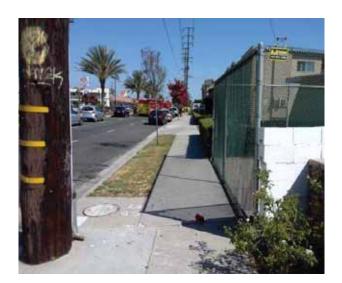
Sidewalks , Change in Level : Change in Level Non Beveled

Code Reference ADA 206, 302

Remove tripping hazards \$198

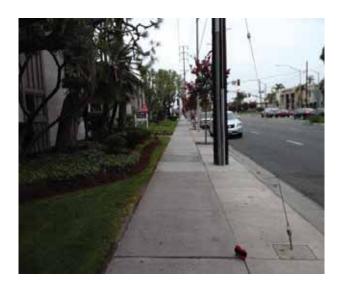
Sidewalks , Change in Level : Change in Level Non Beveled

Code Reference ADA 206, 302

Remove tripping hazards \$198

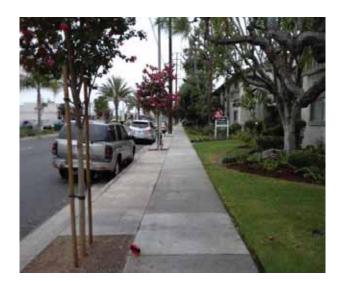
Sidewalks , Change in Level : Change in Level Non Beveled

Code Reference ADA 206, 302

Remove tripping hazards \$198

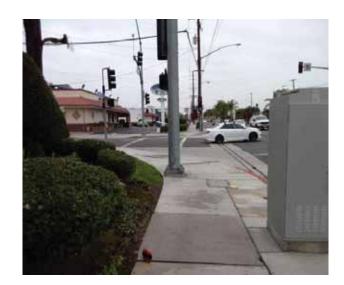
Sidewalks , Change in Level : Change in Level Non Beveled

Code Reference ADA 206, 302

Remove tripping hazards \$198

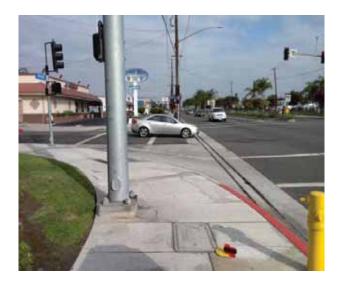
Sidewalks , Change in Level : Change in Level Non Beveled

Code Reference ADA 206, 302

Remove tripping hazards \$198

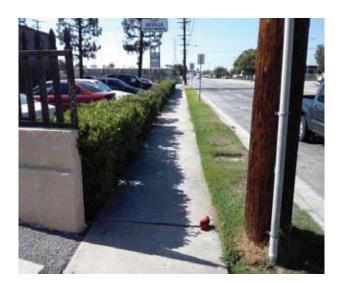
Sidewalks , Change in Level : Change in Level Non Beveled

Code Reference ADA 206, 302

Remove tripping hazards \$198

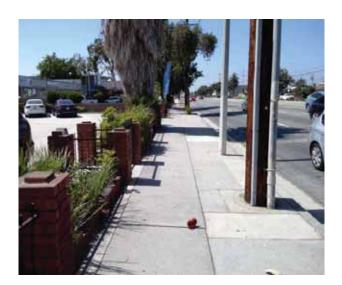
Sidewalks , Change in Level : Change in Level Non Beveled

Code Reference ADA 206, 302

Remove tripping hazards \$198

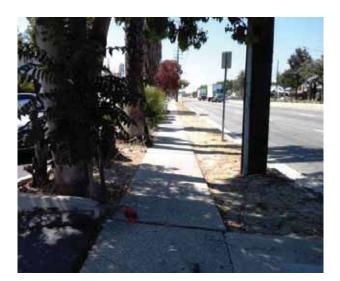
Sidewalks , Change in Level : Change in Level Non Beveled

Code Reference ADA 206, 302

Remove tripping hazards \$198

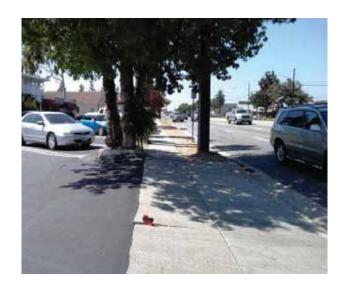
Sidewalks , Change in Level : Change in Level Non Beveled

Code Reference ADA 206, 302

Remove tripping hazards \$198

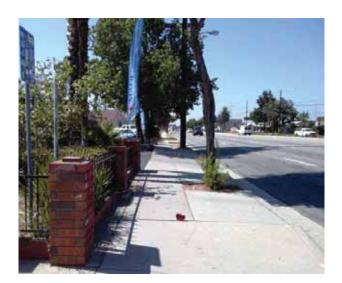
Sidewalks , Change in Level : Change in Level Non Beveled

Code Reference ADA 206, 302

Remove tripping hazards \$198

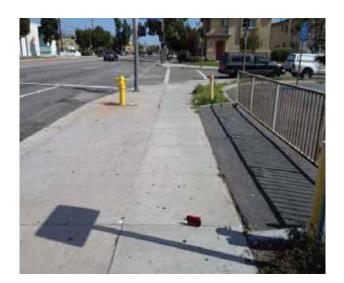
Sidewalks , Change in Level : Change in Level Non Beveled

Code Reference ADA 206, 302

Remove tripping hazards \$198

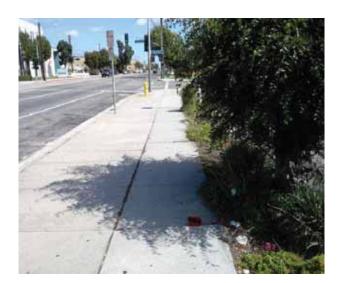
Sidewalks , Change in Level : Change in Level Non Beveled

Code Reference ADA 206, 302

Remove tripping hazards \$198

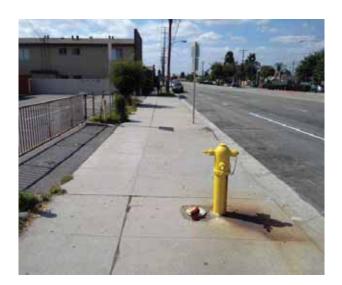
Sidewalks , Change in Level : Change in Level Non Beveled

Code Reference ADA 206, 302

Remove tripping hazards \$198

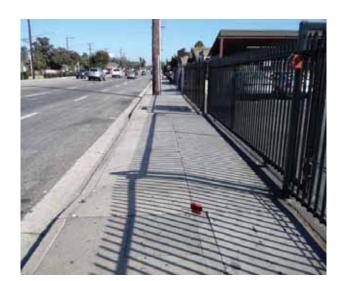
Sidewalks , Change in Level : Change in Level Non Beveled

Code Reference ADA 206, 302

Remove tripping hazards \$198
