Accessibility Survey

Adoree Street & Columbia Way
Downey, CA 90242

Date of Inspection
4/10/2017

Disability Access Consultants

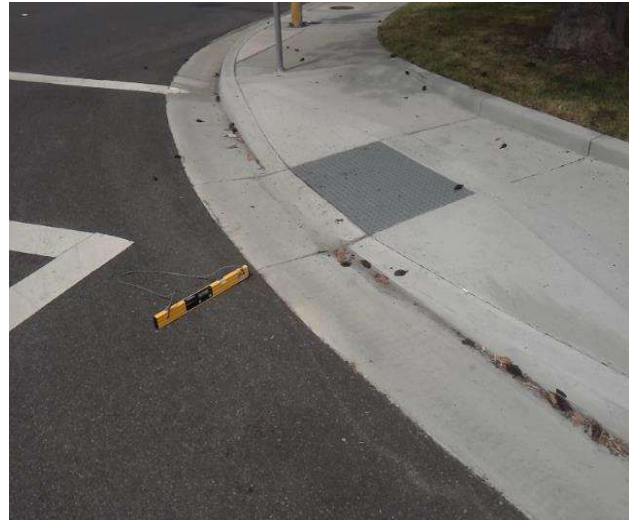
Curb Ramp , Landings and Transitions : Top Landing Slope

The slope at the top landing is greater than allowed.

On-Site Finding 3.10 percent

Code Reference ADA 402, 406.4, 403.3, 406.1, CA 11B-406.5.3

Provide a top landing surface that does not exceed the maximum slope and cross slope. Provide a sufficient maneuvering clearance that does not accumulate water.

Recommendation Up to 2.08 percent

Provide compliant landing \$1,260

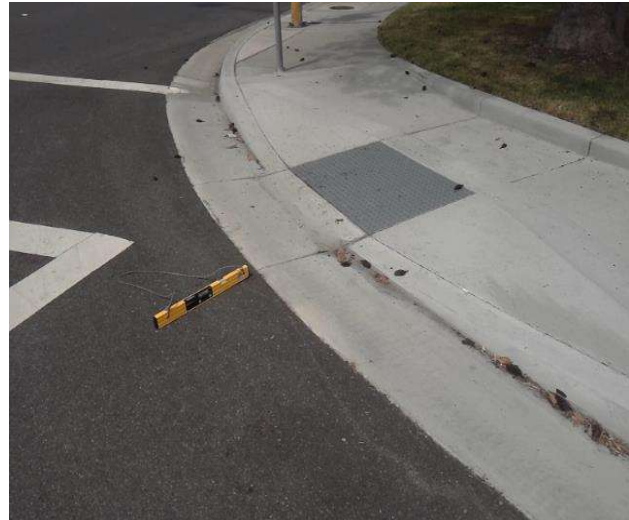
Curb Ramp , Landings and Transitions : Top Landing Clear Length - Landings

Code Reference ADA 406, 406.4,CA 11B-406.5.3

Recommendation At least 48.00 inches

Provide compliant landing \$240

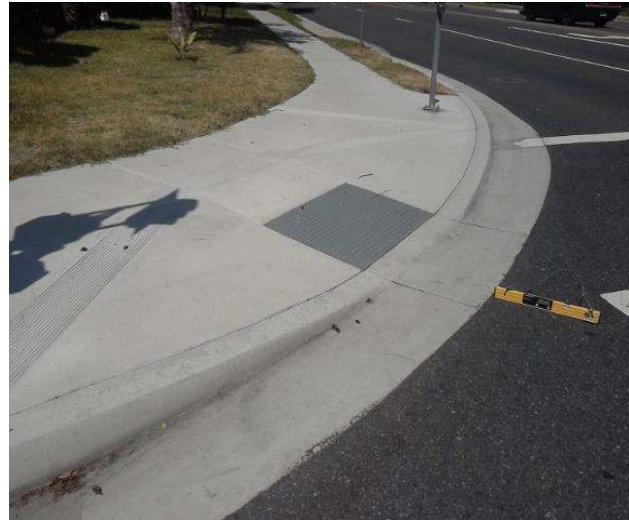
Code Reference ADA 406, 406.4, CA 11B-406.5.3

Recommendation At least 48.00 inches

Provide compliant landing \$240

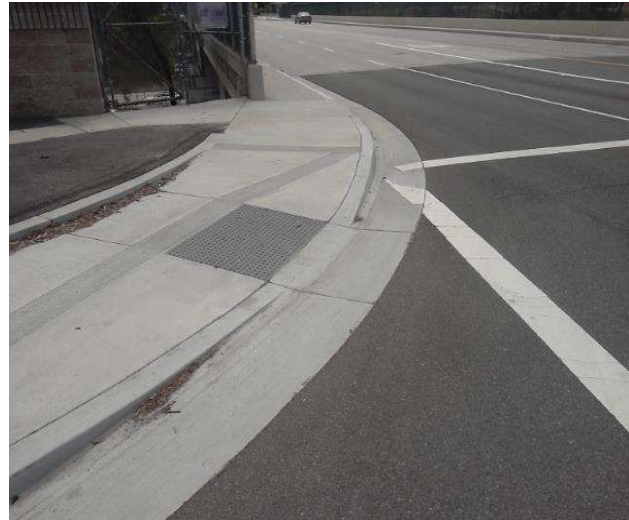
Code Reference ADA 406, 406.6, 406.1, 405.10

Recommendation At least 48.00 inches

Provide compliant landing \$255

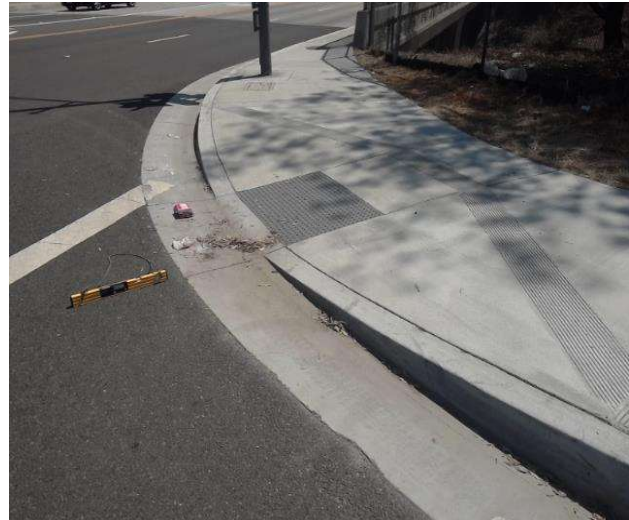
Code Reference ADA 406, 406.4,CA 11B-406.5.3

Recommendation At least 48.00 inches

Provide compliant landing \$240

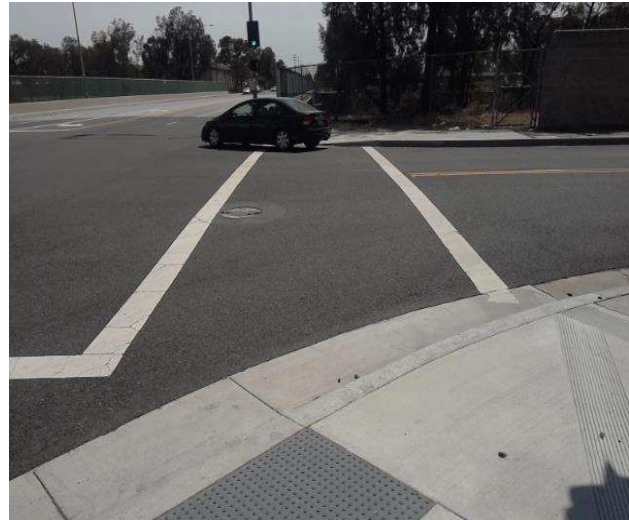
Code Reference ADA 303

Provide a compliant walking surface with recommended height.

Recommendation Up to 0.25 inches

\$1,260

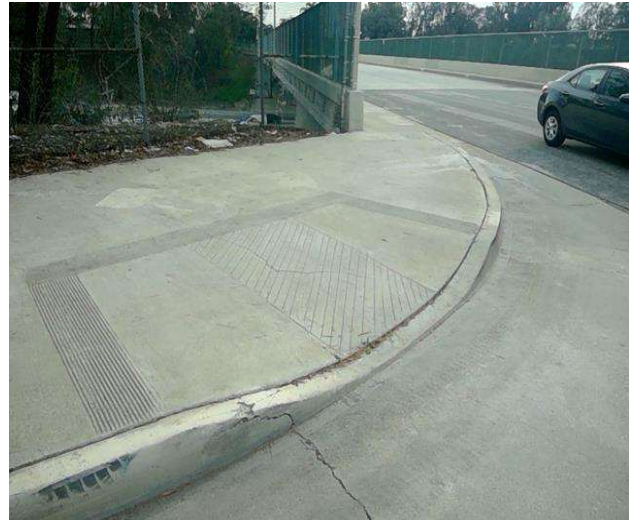
Curb Ramp , Landings And Transitions : Bottom Landing Change in Level

Code Reference ADA 302, 303, 406.2, 303.1

Recommendation Up to 0.50 inches

Patch lip at curb ramp \$255

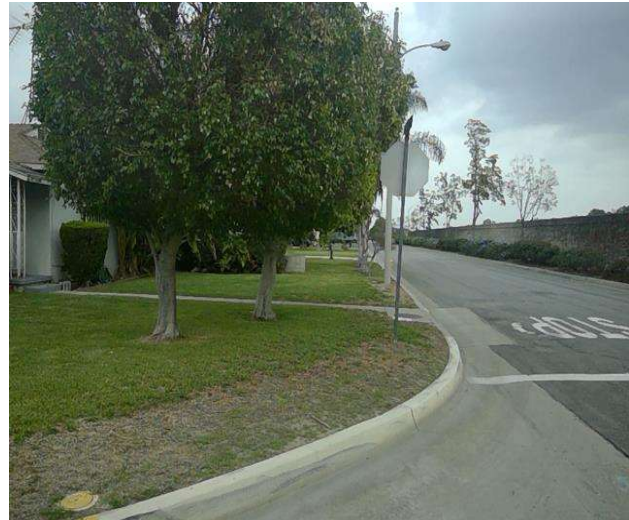
Sidewalks : Missing Sidewalk

Section of sidewalk is missing and consists of dirt, grass or gravel.

Code Reference ADA 206, 302,CA 11B-302,CA 11B-206

Provide a compliant sidewalk for the missing section.

\$1,260

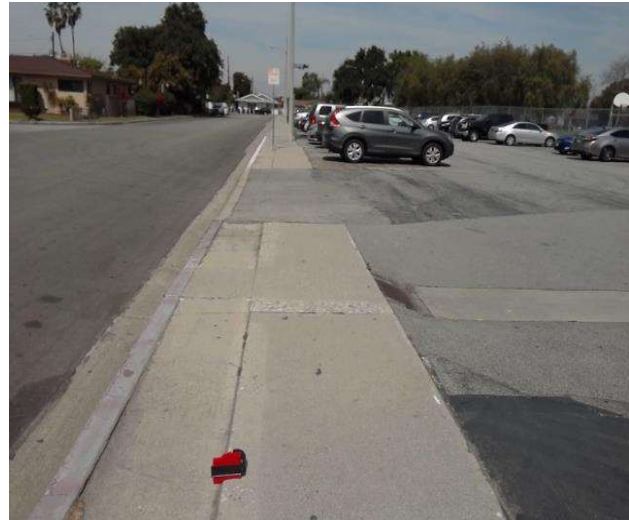
There is a change in elevation greater than recommended value.

Code Reference ADA 206, 302

Notes : On going for 26 feet

Ensure that the change in elevation is within the recommended value.

Recommendation Up to 0.25 inches

Remove tripping hazards \$198

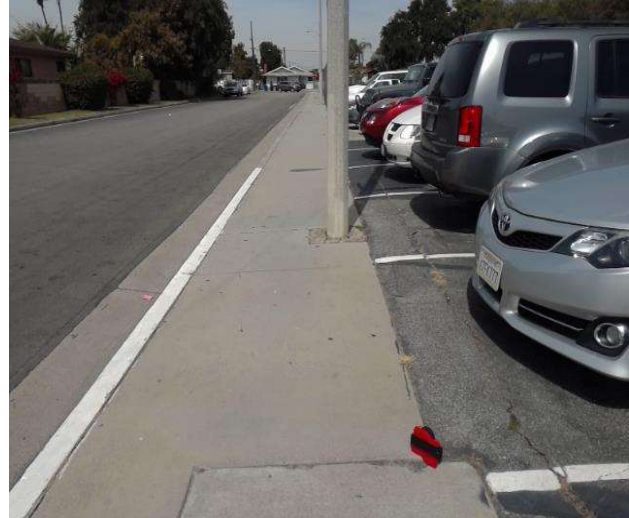
There is a change in elevation greater than recommended value.

Code Reference ADA 206, 302

Ensure that the change in elevation is within the recommended value.

Recommendation Up to 0.25 inches

Remove tripping hazards \$198

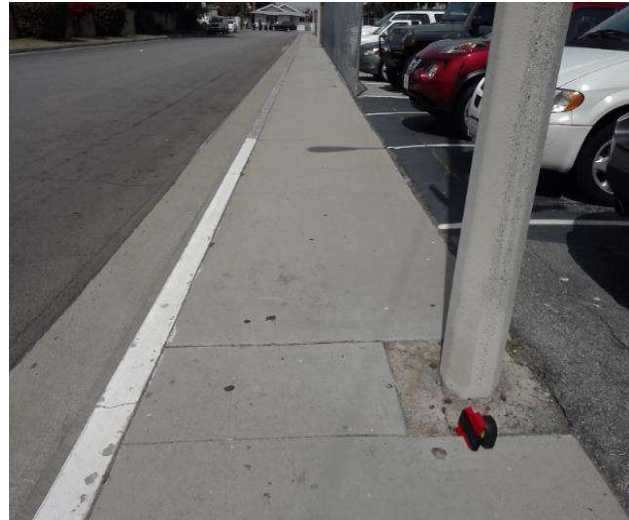
There is a change in elevation greater than recommended value.

Code Reference ADA 206, 302

Ensure that the change in elevation is within the recommended value.

Recommendation Up to 0.25 inches

Remove tripping hazards \$198

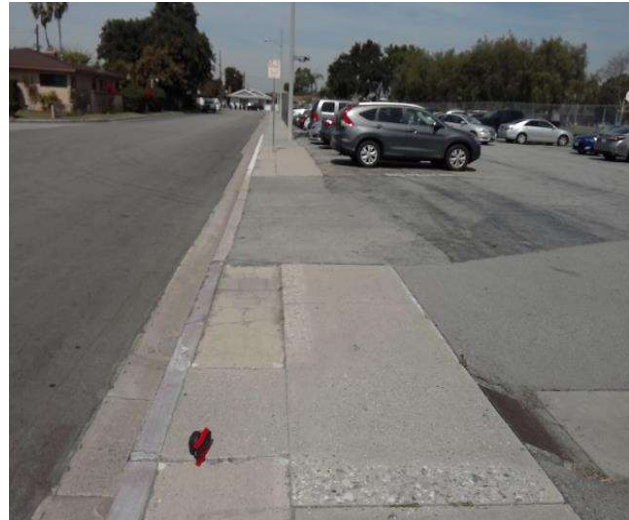
There is a change in elevation greater than recommended value.

Code Reference ADA 206, 302

Ensure that the change in elevation is within the recommended value.

Recommendation Up to 0.25 inches

Remove tripping hazards \$198

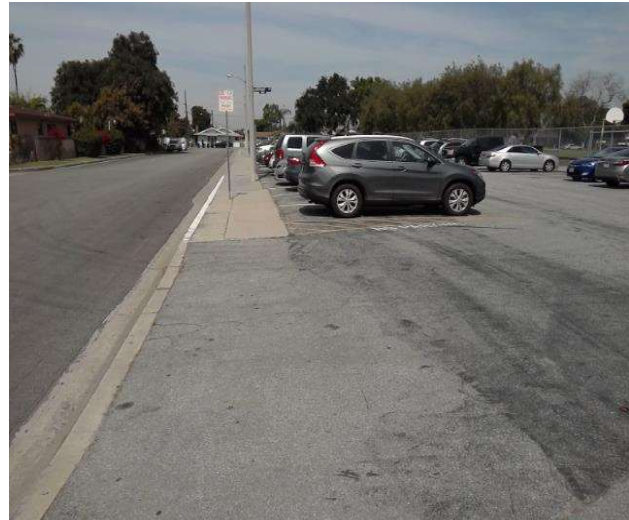
Code Reference ADA 705,CA 11B-705.1.2.5,CA 11B-247.1.2.5

Notes : Surface is rough and uneven.

Install compliant detectable warnings \$190

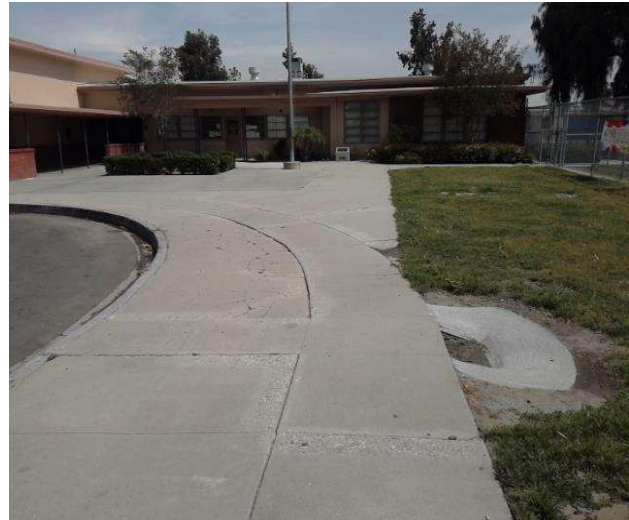
Code Reference ADA 206, 302

Notes : Spalled concrete continues for 43 feet.

\$1,260

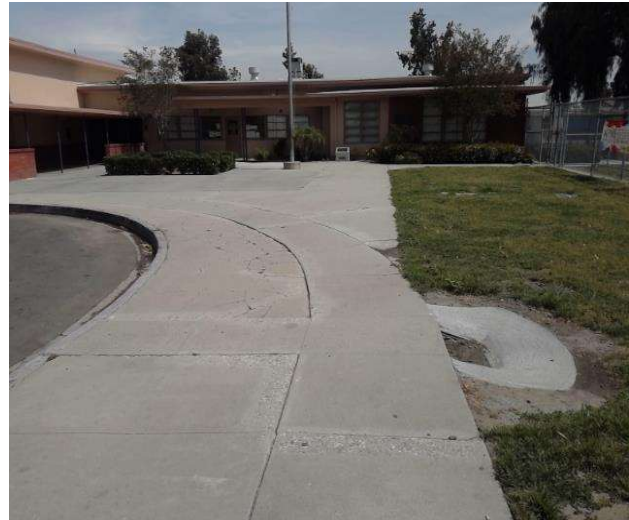
Code Reference ADA 206, 302,CA 11B-403.3

Notes : Spalled concrete continues for 43 feet.

Repave the sidewalk surface with the recommended cross slope.

Recommendation Up to 2.08 percent

Repave surface \$1,092

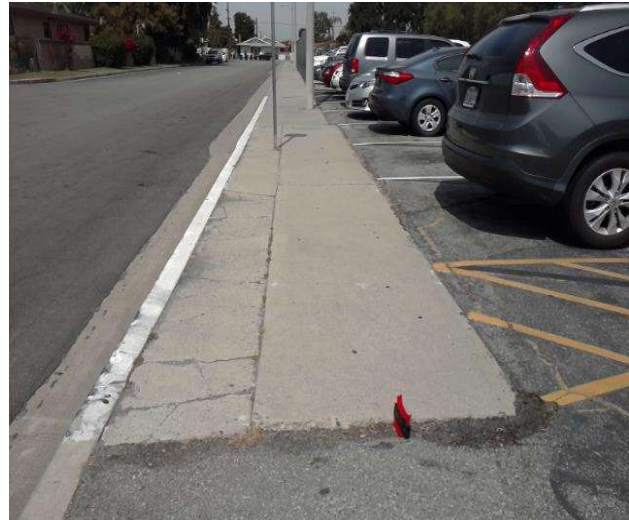
Code Reference ADA 206, 302,CA 11B-403.3

Repave the sidewalk surface with the recommended cross slope.

Recommendation Up to 2.08 percent

Repave surface \$1,092

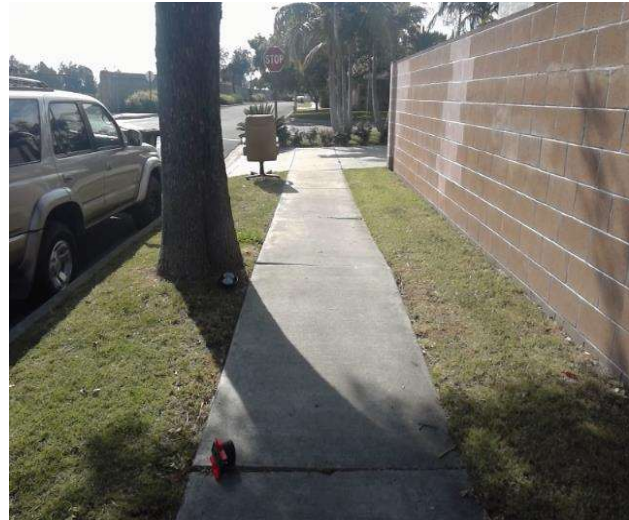
There is a change in elevation greater than recommended value.

Code Reference ADA 206, 302

Ensure that the change in elevation is within the recommended value.

Recommendation Up to 0.25 inches

Remove tripping hazards \$198

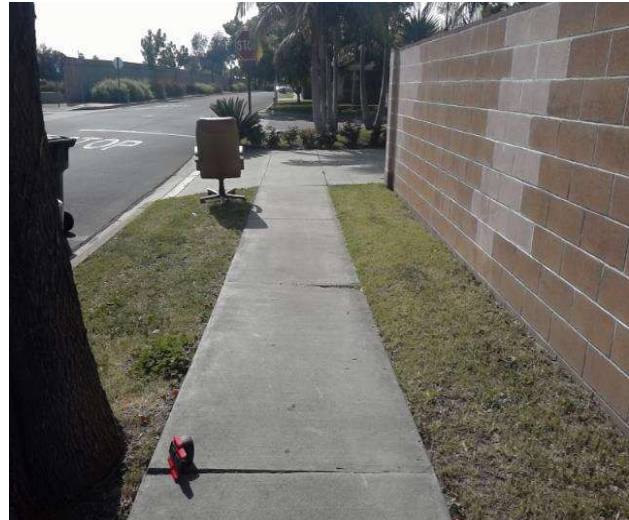
There is a change in elevation greater than recommended value.

Code Reference ADA 206, 302

Ensure that the change in elevation is within the recommended value.

Recommendation Up to 0.25 inches

Remove tripping hazards \$198

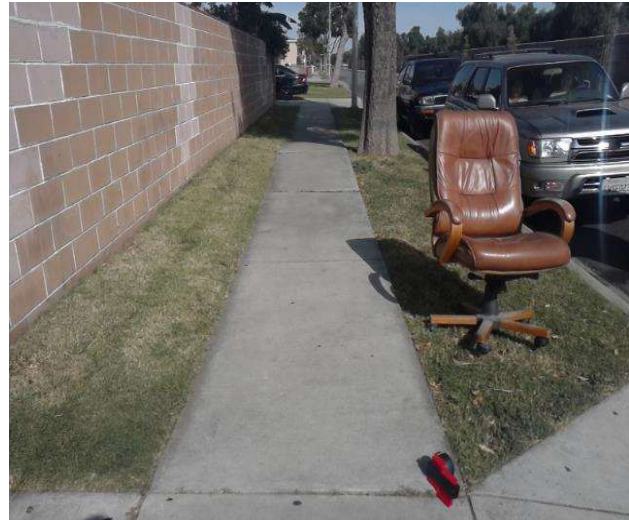
There is a change in elevation greater than recommended value.

Code Reference ADA 206, 302

Ensure that the change in elevation is within the recommended value.

Recommendation Up to 0.25 inches

Remove tripping hazards \$198

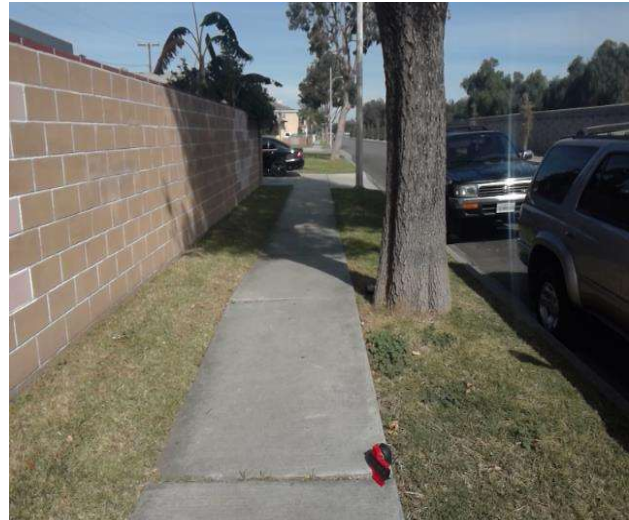
There is a change in elevation greater than recommended value.

Code Reference ADA 206, 302

Ensure that the change in elevation is within the recommended value.

Recommendation Up to 0.25 inches

Remove tripping hazards \$198

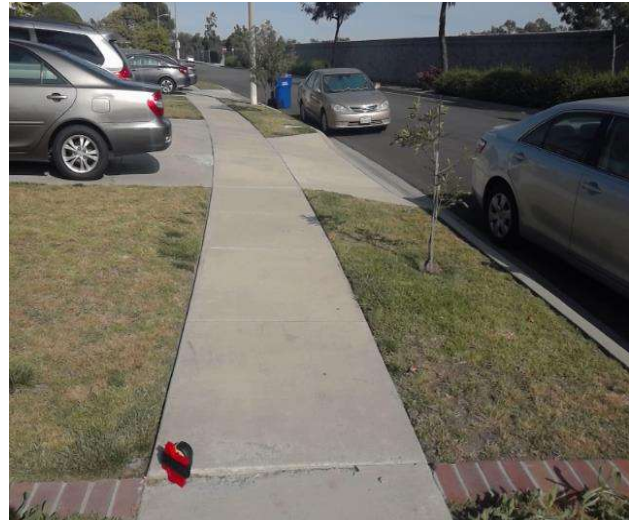
There is a change in elevation greater than recommended value.

Code Reference ADA 206, 302

Ensure that the change in elevation is within the recommended value.

Recommendation Up to 0.25 inches

Remove tripping hazards \$198

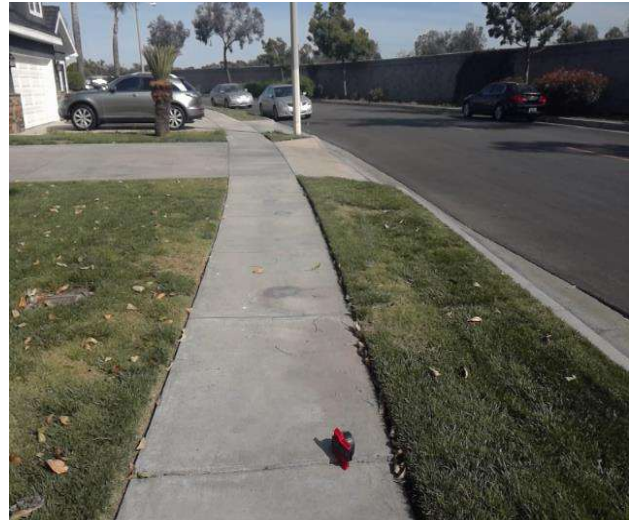
There is a change in elevation greater than recommended value.

Code Reference ADA 206, 302

Ensure that the change in elevation is within the recommended value.

Recommendation Up to 0.25 inches

Remove tripping hazards \$198
