Accessibility Survey

Alameda Street & Birchdale Avenue

Date of Inspection
3/17/2017

Disability Access Consultants

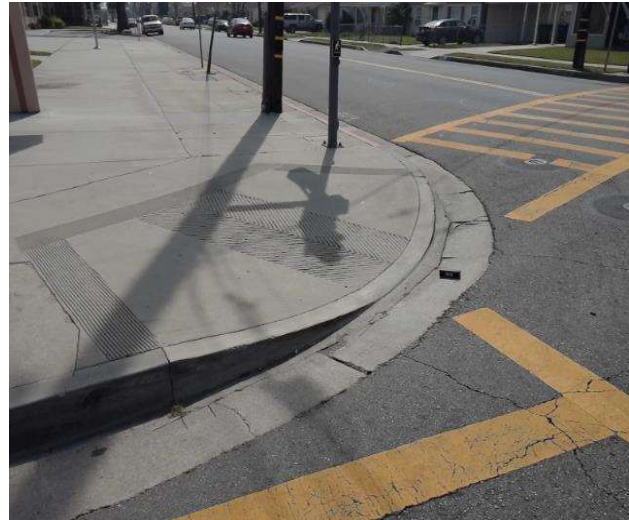
Northeast Corner @ 33.925457976927, -118.136438280344

Curb Ramp : No Detectable Warnings

The curb ramp does not provide a detectable warning surface which includes truncated domes.

Code Reference CA 11B-406.5.12

Provide compliant detectable warnings to surface.

Provide detectable warning to surface \$248

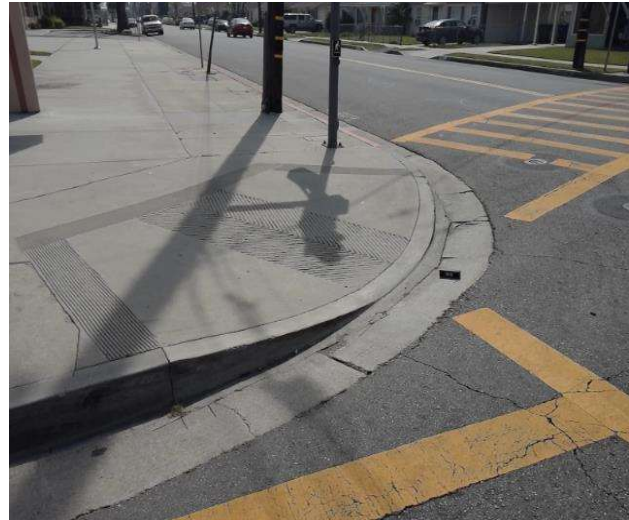
Code Reference ADA 406, 406.3, CA 11B-406.2.2

Recommendation Up to 10.00 percent

Install flared sides \$1,300

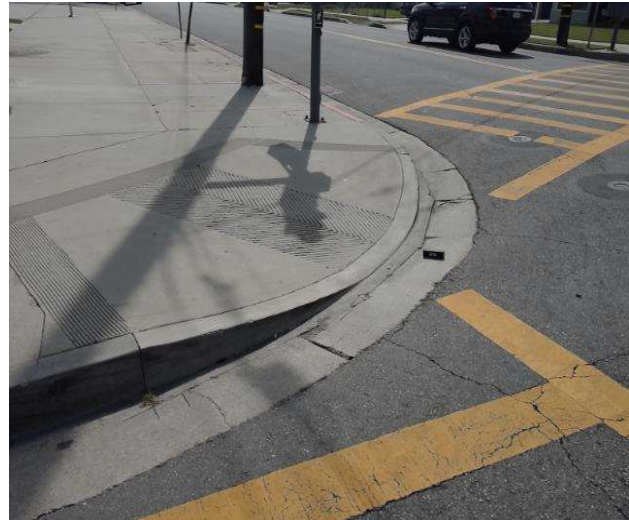
Code Reference ADA 406, 406.2, CA 11B-406.5.8

Recommendation Up to 5.00 percent

Repave landing \$1,260

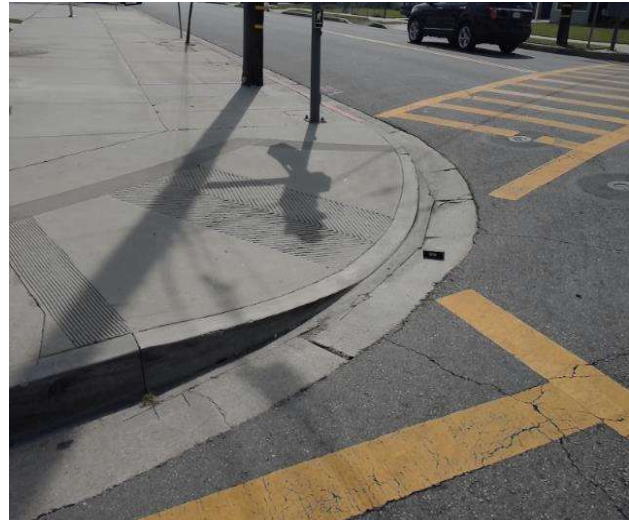
Code Reference ADA 302, 303, 406.2, 303.1

Recommendation Up to 0.50 inches

Patch lip at curb ramp \$255

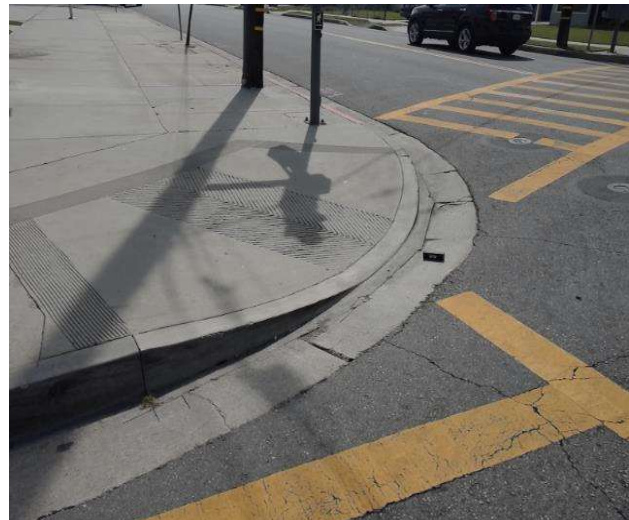
Code Reference ADA 402, 406.4, 403.3, 406.1, CA 11B-406.5.3

Recommendation Up to 2.08 percent

Provide compliant landing \$1,260

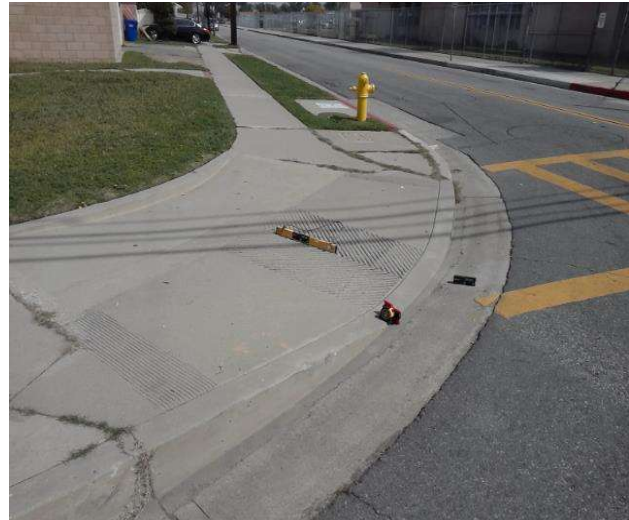
Code Reference CA 11B-406.5.12

Provide detectable warning to surface \$248

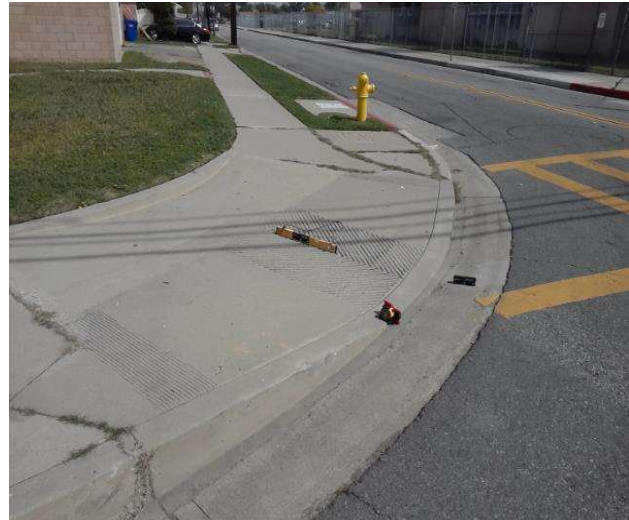
Code Reference ADA 406, 406.1, 405.2, CA 11B-406

Recommendation Up to 8.33 percent

Install curb ramp \$1,300

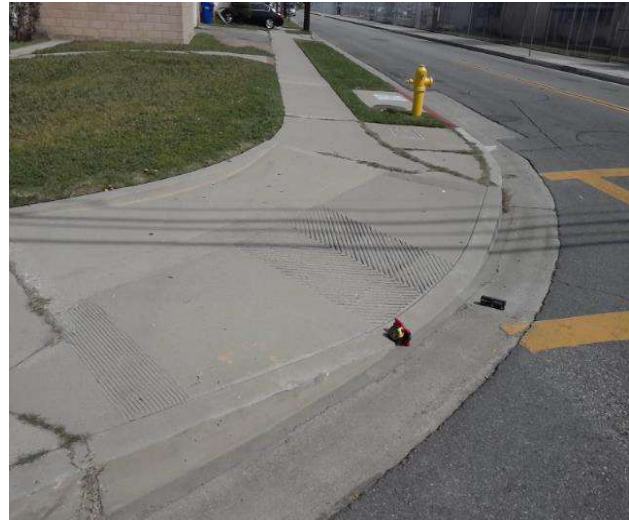
Code Reference ADA 406, 406.2, CA 11B-406.5.8

Recommendation Up to 5.00 percent

Repave landing \$1,260

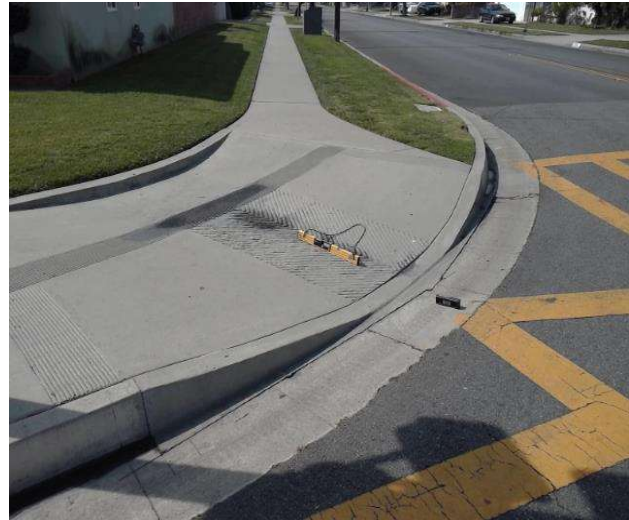
Code Reference CA 11B-406.5.12

Provide detectable warning to surface \$248

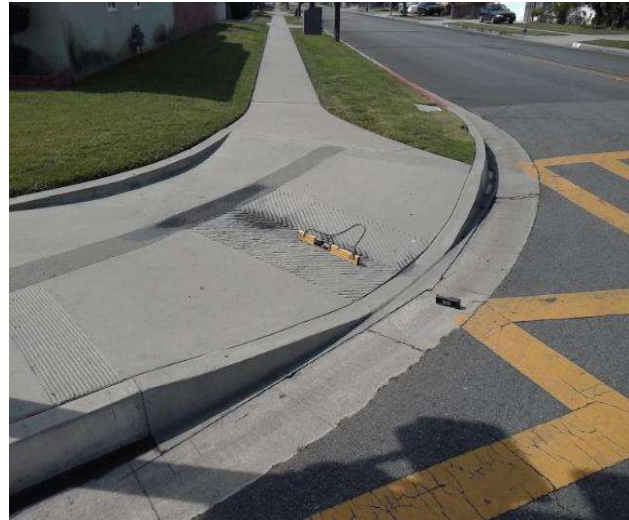
Code Reference ADA 406, 406.1, 405.5, CA 11B-406.5.2

Recommendation At least 48.00 inches

Install curb ramp \$1,300

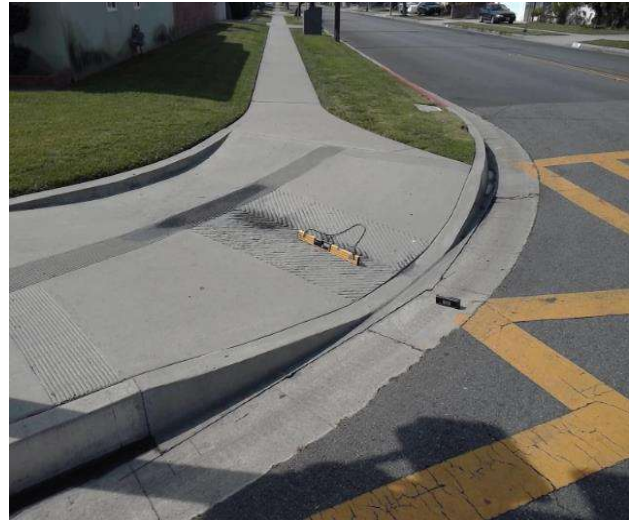
Code Reference CA 11B-406.5.6

Install curb ramp \$1,440

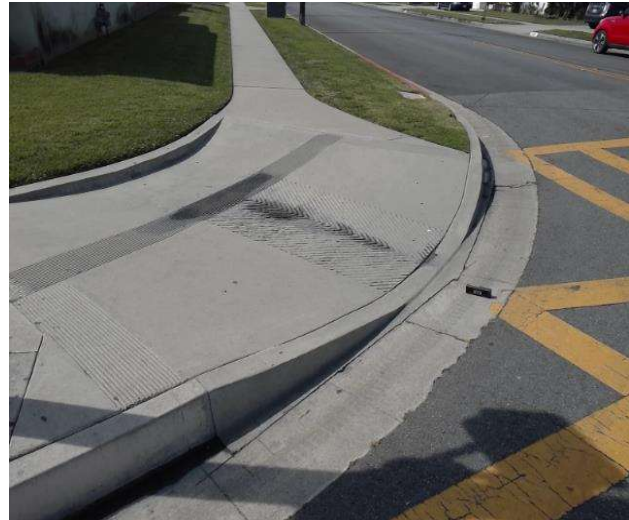
Code Reference ADA 406, 406.6, 406.1, 405.10

Recommendation At least 48.00 inches

Provide compliant landing \$255

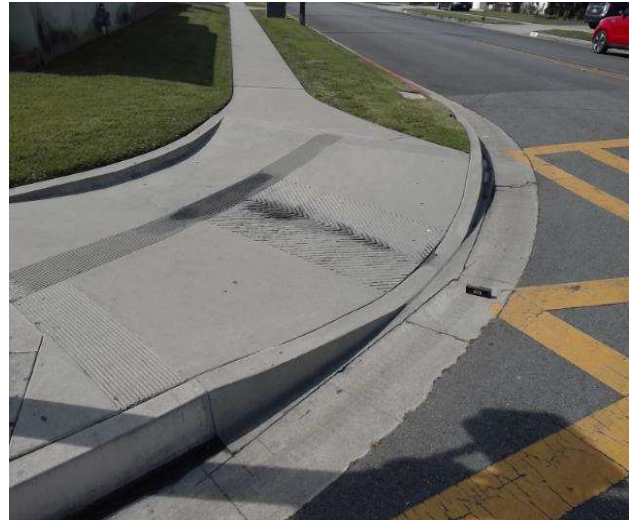
Code Reference ADA 406, 406.2, CA 11B-406.5.8

Recommendation Up to 5.00 percent

Repave landing \$1,260

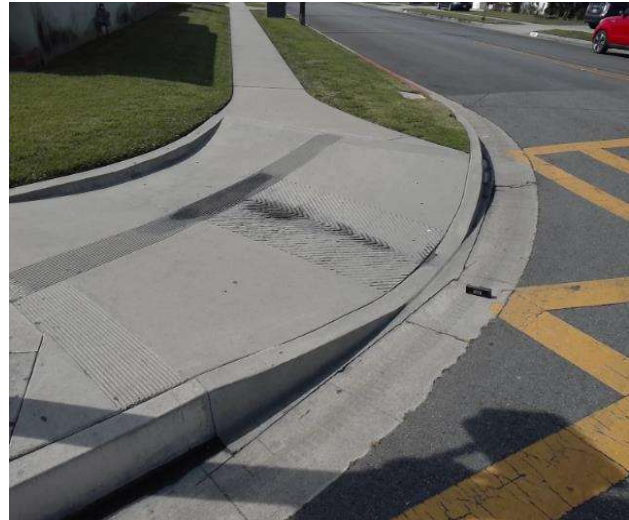
Code Reference ADA 406, 406.4, CA 11B-406.5.3

Recommendation At least 48.00 inches

Provide compliant landing \$240

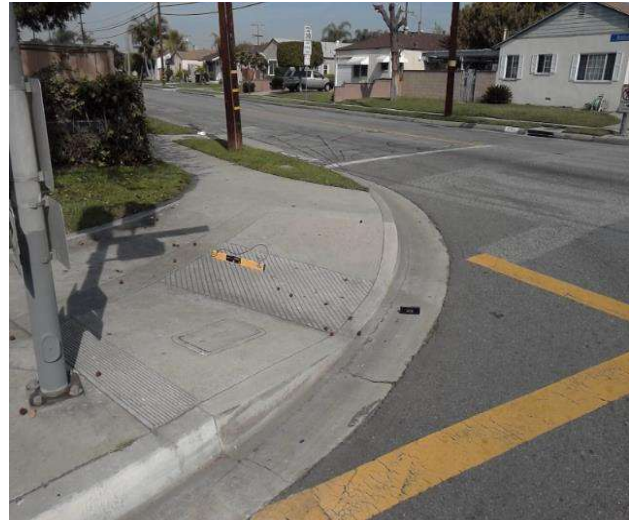
Code Reference CA 11B-406.5.12

Provide detectable warning to surface \$248

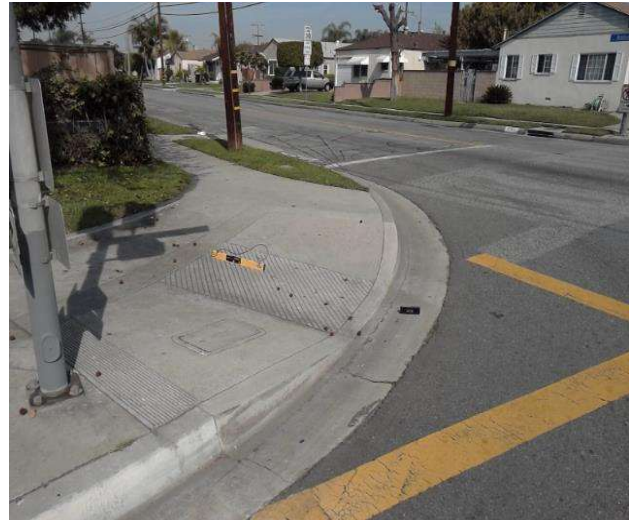
Code Reference ADA 406, 406.1, 405.2, CA 11B-406

Recommendation Up to 8.33 percent

Install curb ramp \$1,300

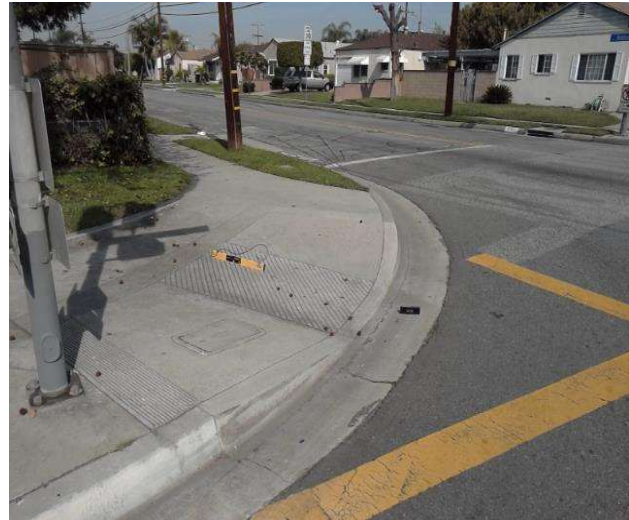
Code Reference ADA 406, 406.3, CA 11B-406.2.2

Recommendation Up to 10.00 percent

Install flared sides \$1,300

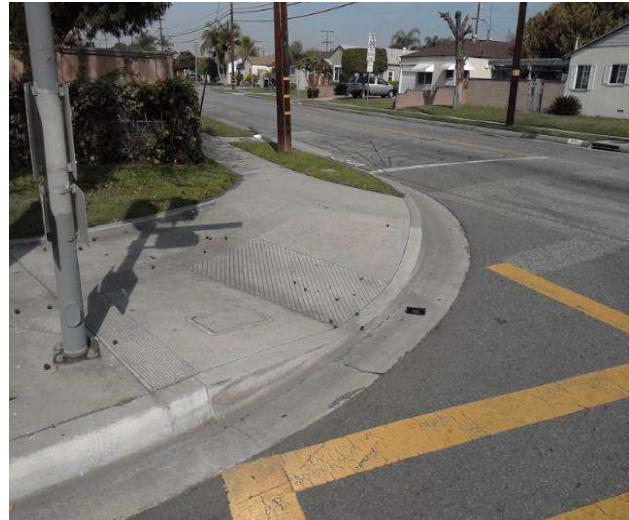
Code Reference ADA 406, 406.2,CA 11B-406.5.8

Recommendation Up to 5.00 percent

Repave landing \$1,260

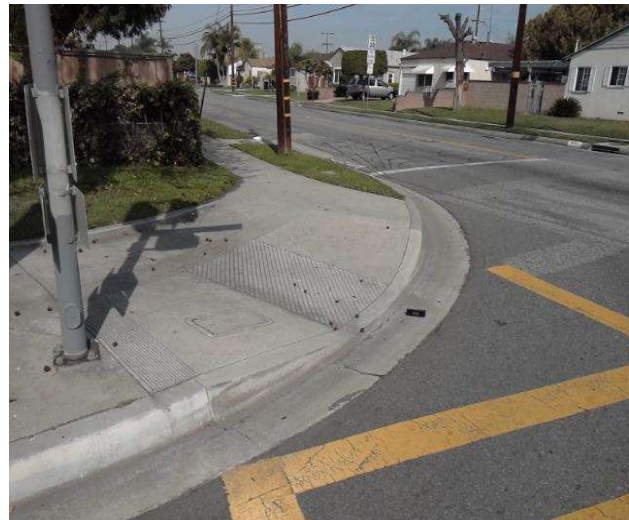
Code Reference ADA 402, 406.4, 403.3, 406.1, CA 11B-406.5.3

Recommendation Up to 2.08 percent

Provide compliant landing \$1,260

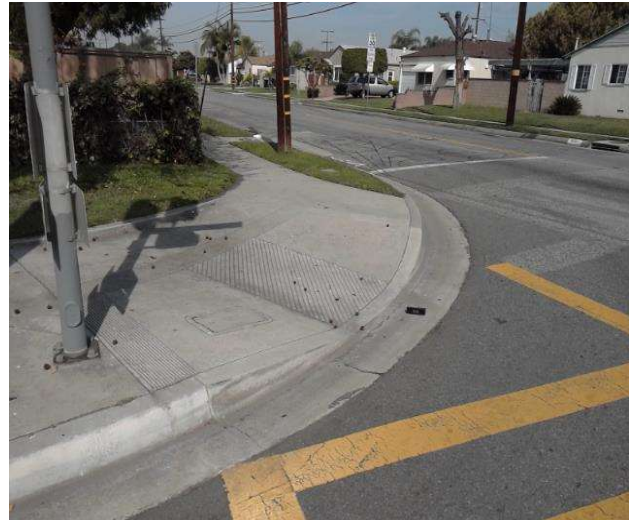
Code Reference ADA 406, 406.4, CA 11B-406.5.3

Recommendation At least 48.00 inches

Provide compliant landing \$240

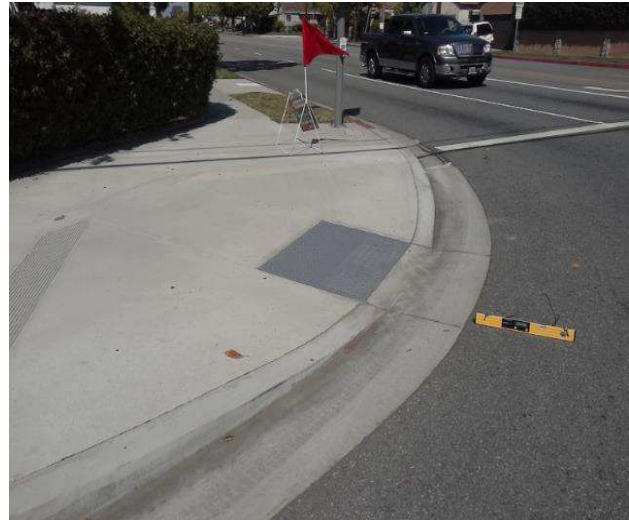
Code Reference ADA 406, 406.2,CA 11B-406.5.8

Recommendation Up to 5.00 percent

Repave landing \$1,260

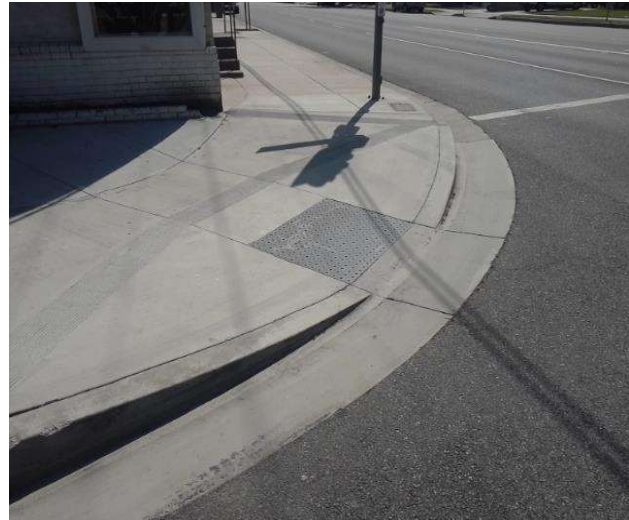
Code Reference ADA 406, 406.5

Install crosswalk \$800

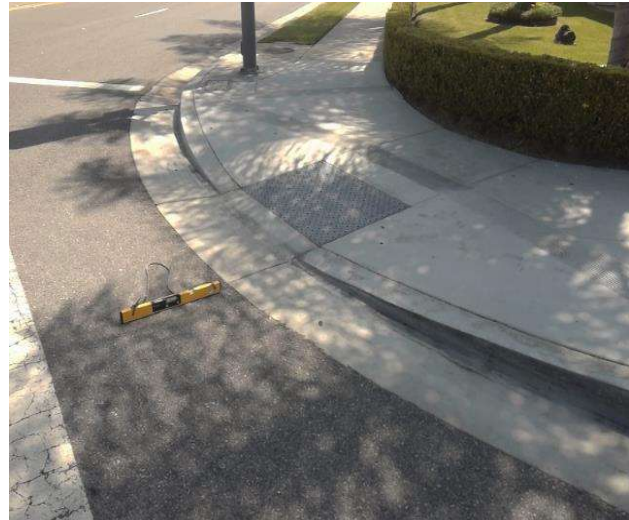
Code Reference ADA 406, 406.2, CA 11B-406.5.8

Recommendation Up to 5.00 percent

Repave landing \$1,260

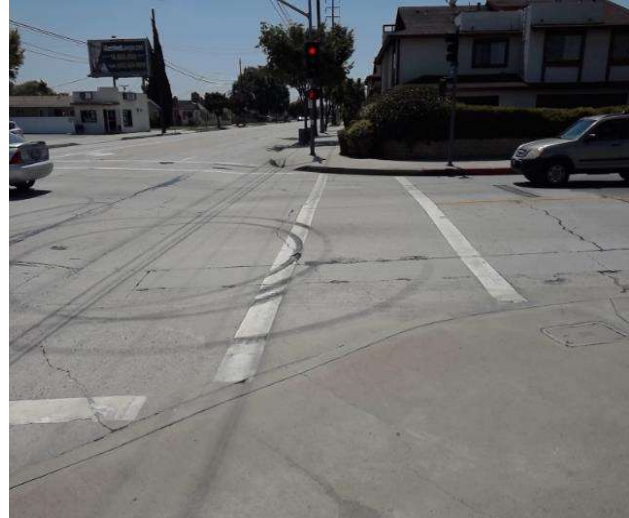
Notes : Spalled concrete continues for 10 feet.

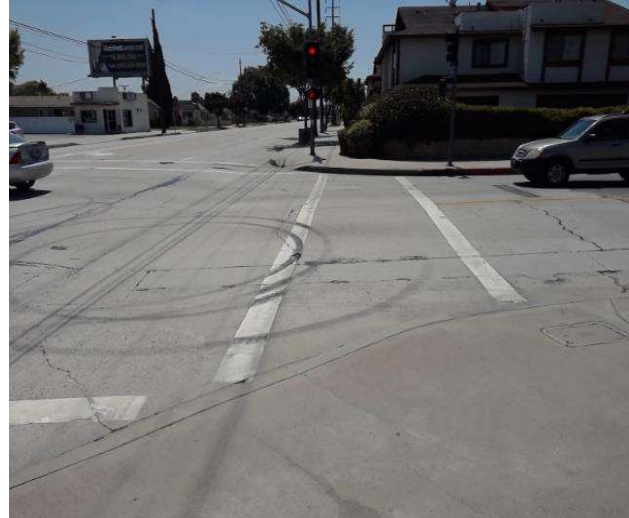
Notes : Spalled concrete continues for 10 feet.

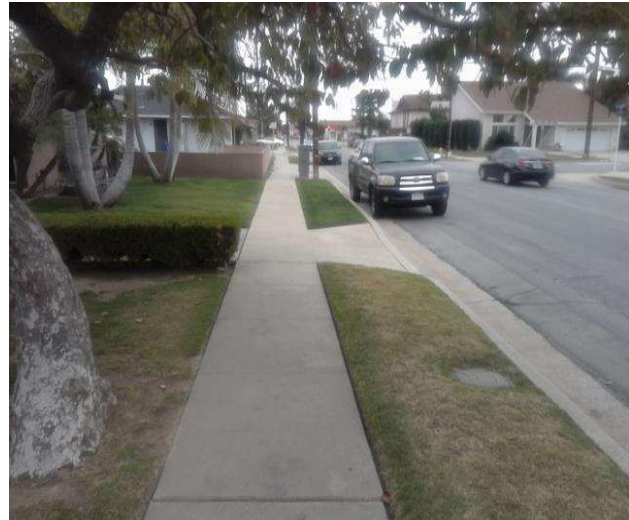
Code Reference ADA 206, 302

Remove tripping hazards \$198

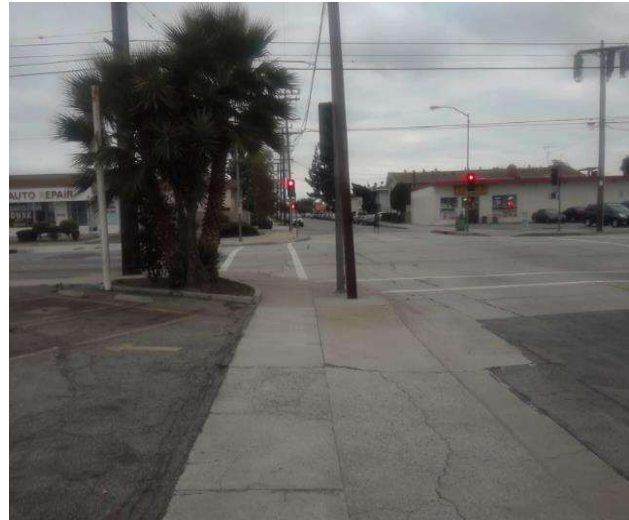
Code Reference ADA 206, 302

Remove tripping hazards \$198

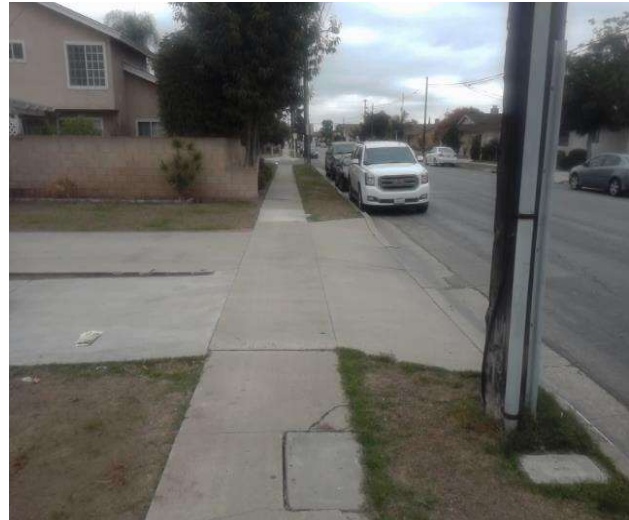
Code Reference ADA 206, 302

Remove tripping hazards \$198

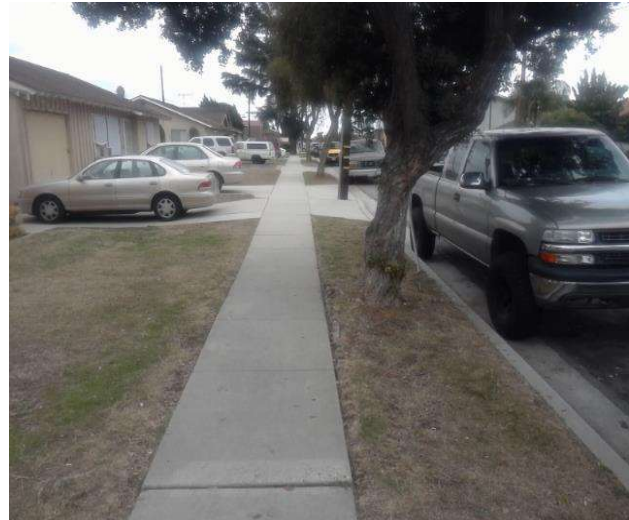
Code Reference ADA 206, 302

Remove tripping hazards \$198

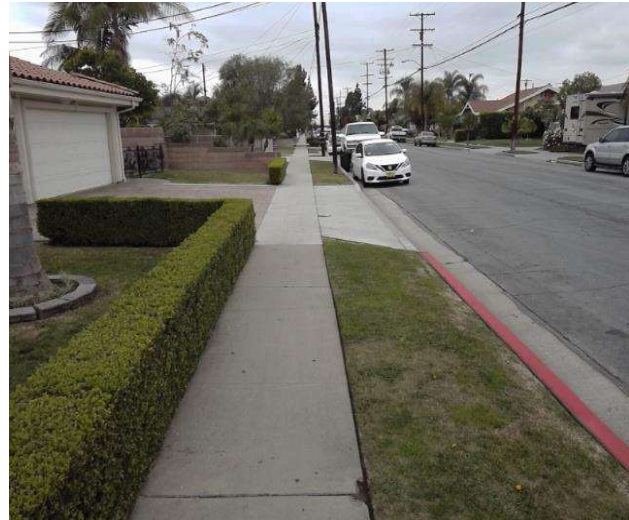
Code Reference ADA 206, 302

Remove tripping hazards \$198

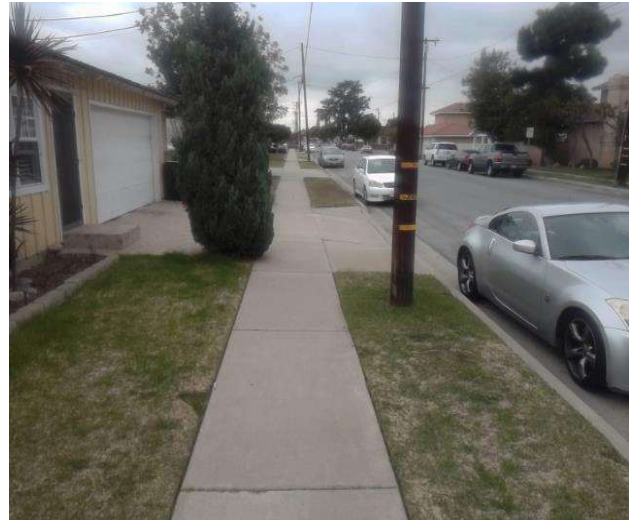
Code Reference ADA 206, 302

Remove tripping hazards \$198

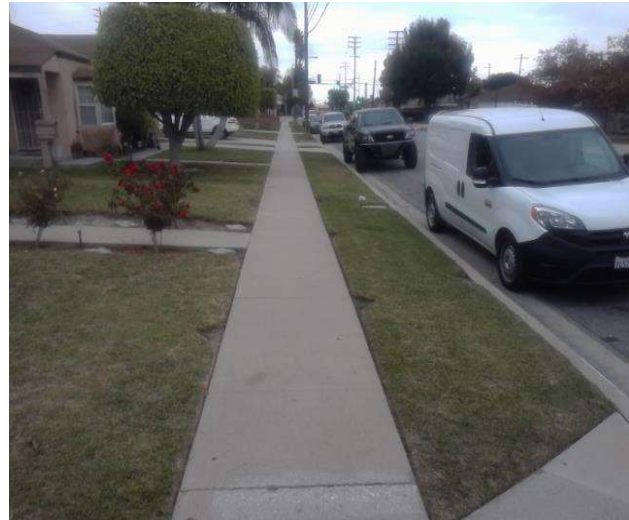
Code Reference ADA 206, 302

Remove tripping hazards \$198

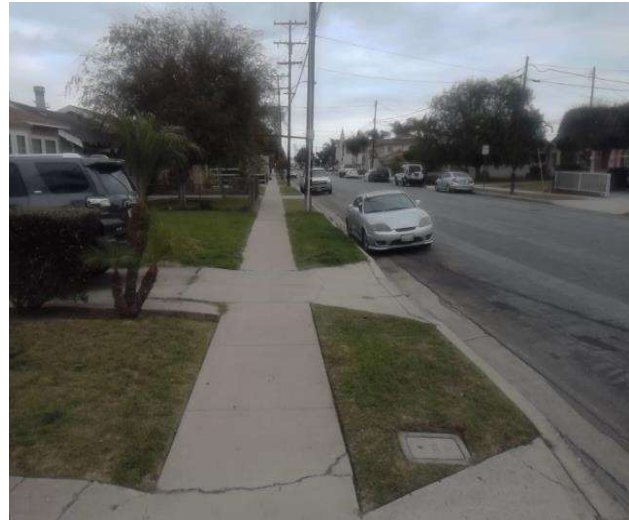
Code Reference ADA 206, 302

Remove tripping hazards \$198

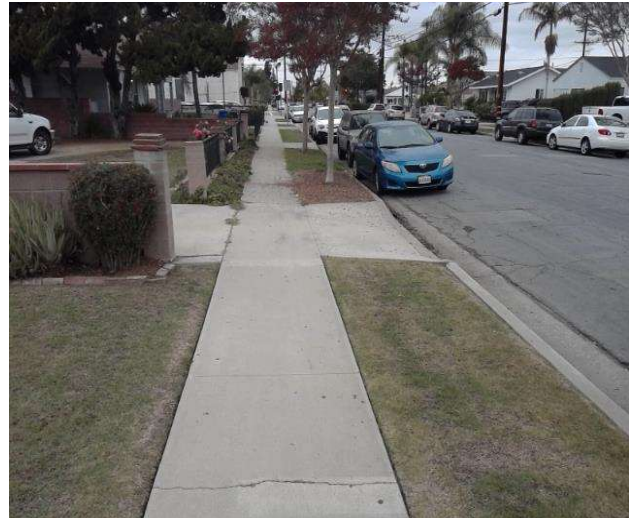
Code Reference ADA 206, 302

Remove tripping hazards \$198

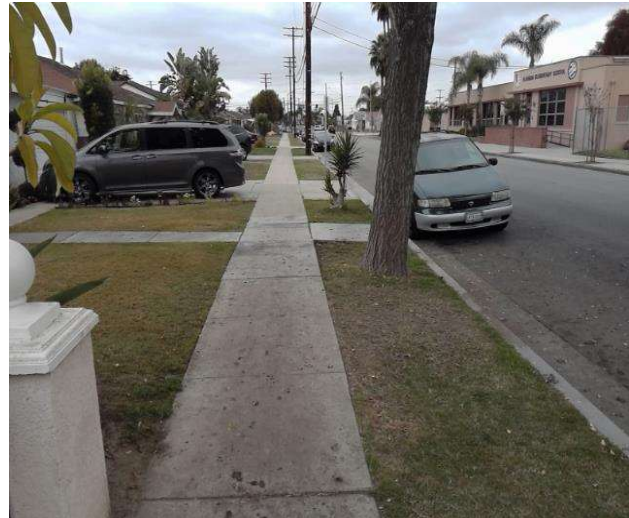
Code Reference ADA 206, 302

Remove tripping hazards \$198

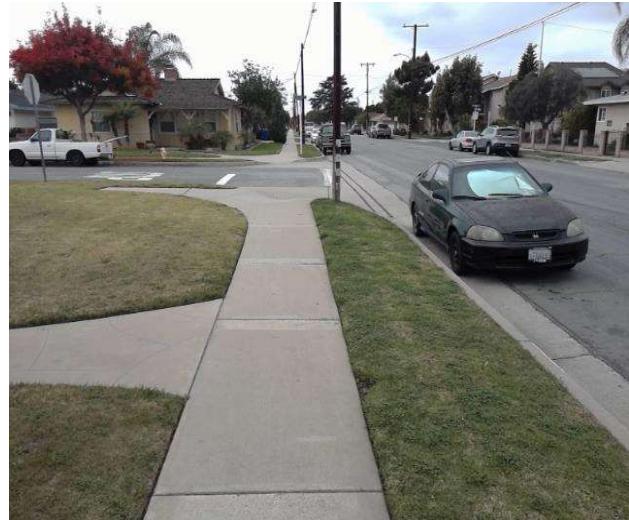
Code Reference ADA 206, 302

Remove tripping hazards \$198

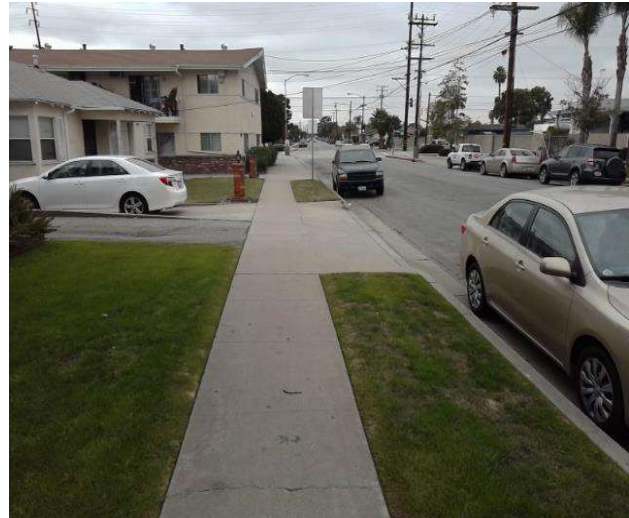
Code Reference ADA 206, 302

Remove tripping hazards \$198

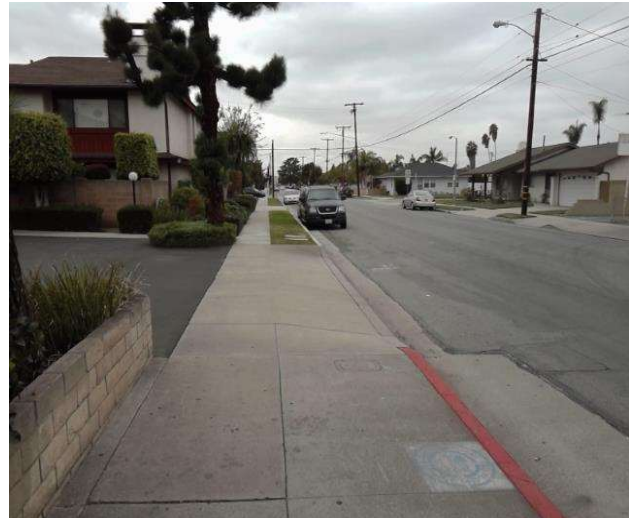
Code Reference ADA 206, 302

Remove tripping hazards \$198

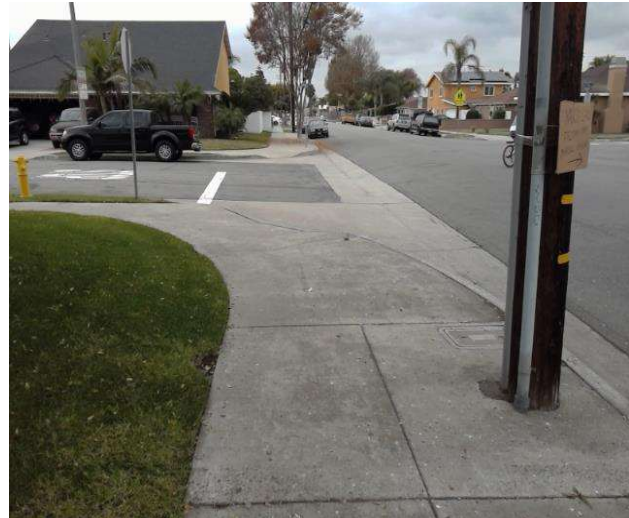
Code Reference ADA 206, 302

Remove tripping hazards \$198

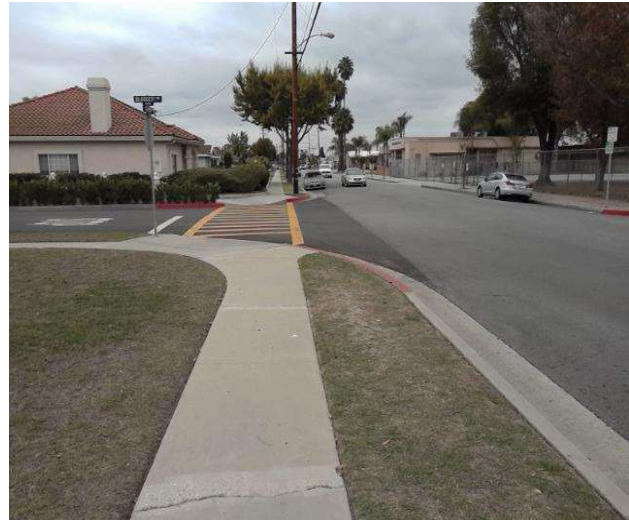
Code Reference ADA 206, 302

Remove tripping hazards \$198
