Accessibility Survey

City of Downey Amigos Avenue - Amigos Avenue to Erickson Avenue

Date of Inspection 8/30/2017

Disability Access Consultants

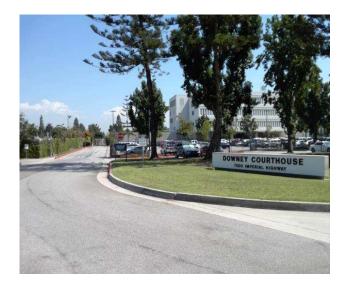
East Side @ 33.926542950752, -118.161456584930

Sidewalks : No Sidewalk

No sidewalk exists at the location.

No action necessary until a sidewalk is provided.

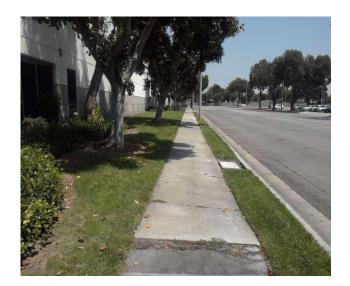
There is a change in elevation greater than recommended value.

Ensure that the change in elevation is within the recommended value.

Recommendation Up to 0.25 inches

Remove tripping hazards \$198

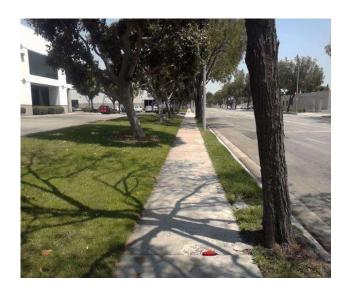
There is a change in elevation greater than recommended value.

Ensure that the change in elevation is within the recommended value.

Recommendation Up to 0.25 inches

Remove tripping hazards \$198

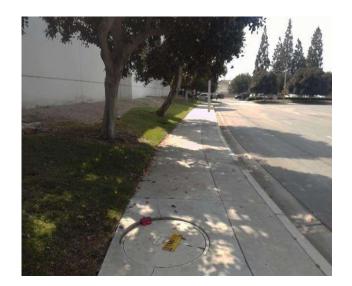
There is a change in elevation greater than recommended value.

Ensure that the change in elevation is within the recommended value.

Recommendation Up to 0.25 inches

Remove tripping hazards \$198

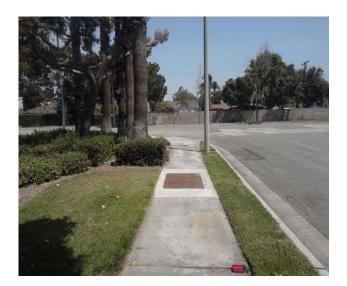
There is a change in elevation greater than recommended value.

Ensure that the change in elevation is within the recommended value.

Recommendation Up to 0.25 inches

Remove tripping hazards \$198

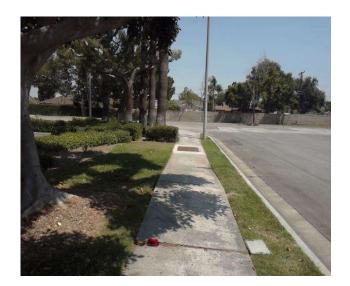
There is a change in elevation greater than recommended value.

Ensure that the change in elevation is within the recommended value.

Recommendation Up to 0.25 inches

Remove tripping hazards \$198

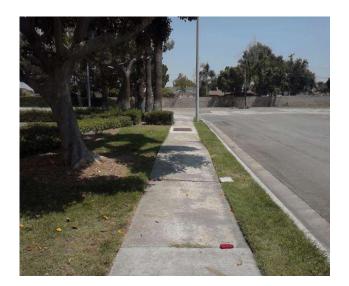
There is a change in elevation greater than recommended value.

Ensure that the change in elevation is within the recommended value.

Recommendation Up to 0.25 inches

Remove tripping hazards \$198

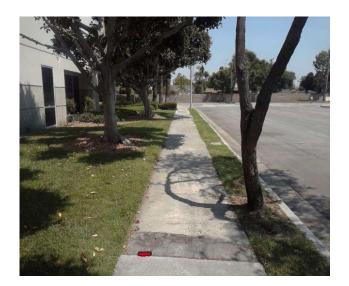
There is a change in elevation greater than recommended value.

Ensure that the change in elevation is within the recommended value.

Recommendation Up to 0.25 inches

Remove tripping hazards \$198

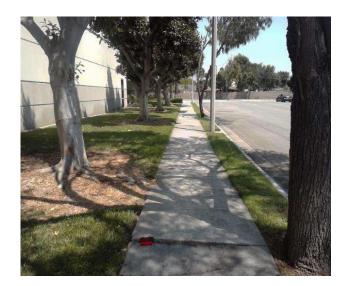
There is a change in elevation greater than recommended value.

Ensure that the change in elevation is within the recommended value.

Recommendation Up to 0.25 inches

Remove tripping hazards \$198

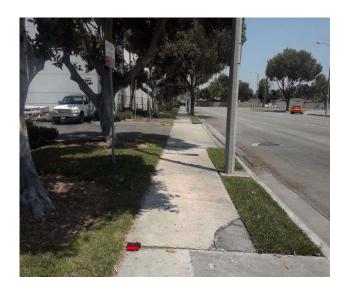
There is a change in elevation greater than recommended value.

Ensure that the change in elevation is within the recommended value.

Recommendation Up to 0.25 inches

Remove tripping hazards \$198

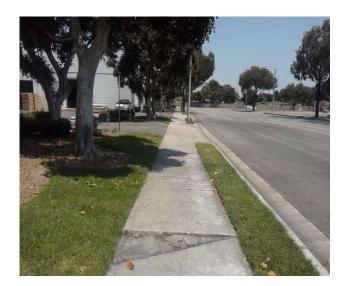
There is a change in elevation greater than recommended value.

Ensure that the change in elevation is within the recommended value.

Recommendation Up to 0.25 inches

Remove tripping hazards \$198

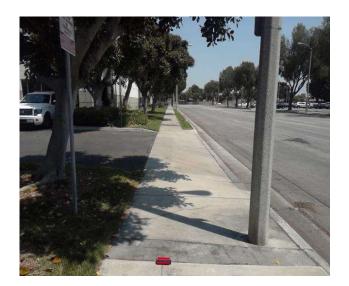
There is a change in elevation greater than recommended value.

Ensure that the change in elevation is within the recommended value.

Recommendation Up to 0.25 inches

Remove tripping hazards \$198

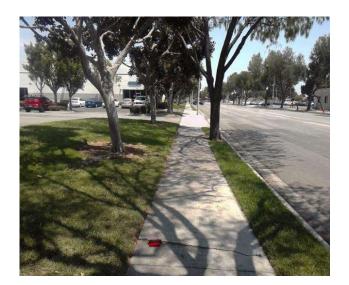
There is a change in elevation greater than recommended value.

Ensure that the change in elevation is within the recommended value.

Recommendation Up to 0.25 inches

Remove tripping hazards \$198

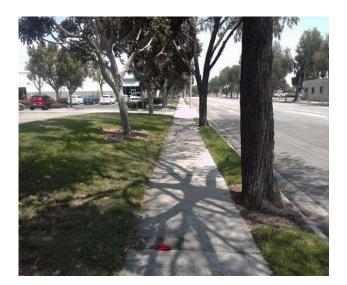
There is a change in elevation greater than recommended value.

Ensure that the change in elevation is within the recommended value.

Recommendation Up to 0.25 inches

Remove tripping hazards \$198

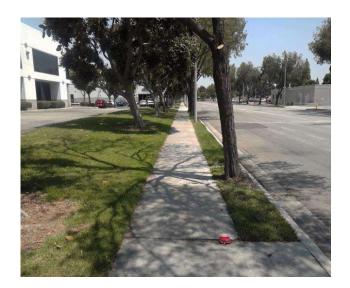
There is a change in elevation greater than recommended value.

Ensure that the change in elevation is within the recommended value.

Recommendation Up to 0.25 inches

Remove tripping hazards \$198

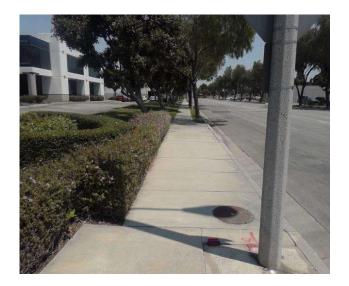
There is a change in elevation greater than recommended value.

Ensure that the change in elevation is within the recommended value.

Recommendation Up to 0.25 inches

Remove tripping hazards \$198

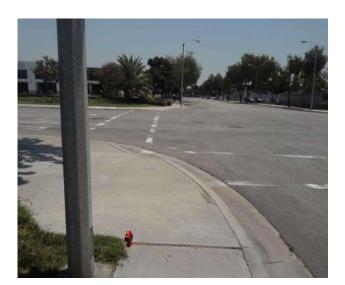
There is a change in elevation greater than recommended value.

Ensure that the change in elevation is within the recommended value.

Recommendation Up to 0.25 inches

Remove tripping hazards \$198

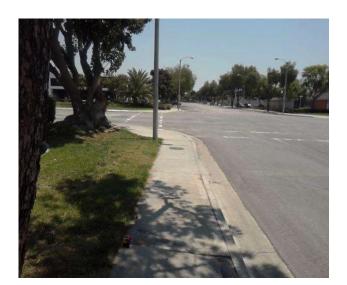
There is a change in elevation greater than recommended value.

Ensure that the change in elevation is within the recommended value.

Recommendation Up to 0.25 inches

Remove tripping hazards \$198

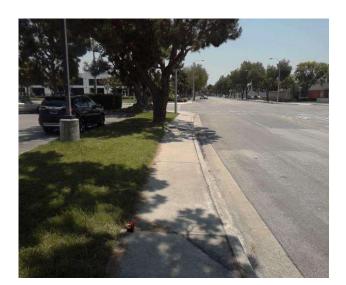
There is a change in elevation greater than recommended value.

Ensure that the change in elevation is within the recommended value.

Recommendation Up to 0.25 inches

Remove tripping hazards \$198

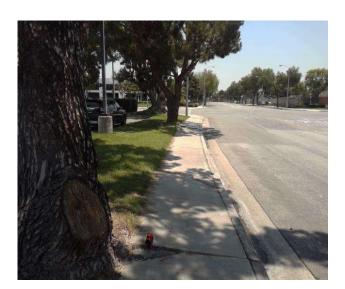
There is a change in elevation greater than recommended value.

Ensure that the change in elevation is within the recommended value.

Recommendation Up to 0.25 inches

Remove tripping hazards \$198

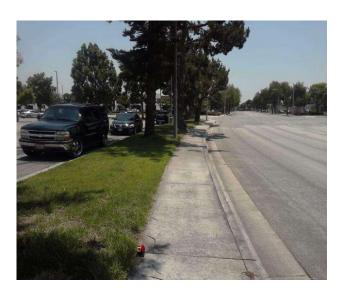
There is a change in elevation greater than recommended value.

Ensure that the change in elevation is within the recommended value.

Recommendation Up to 0.25 inches

Remove tripping hazards \$198

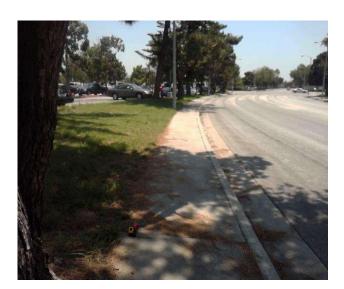
There is a change in elevation greater than recommended value.

Ensure that the change in elevation is within the recommended value.

Recommendation Up to 0.25 inches

Remove tripping hazards \$198

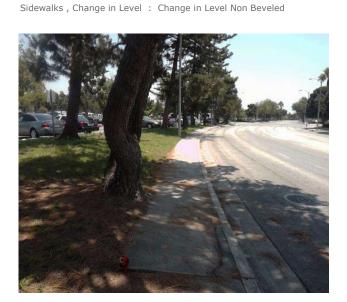
There is a change in elevation greater than recommended value.

Ensure that the change in elevation is within the recommended value.

Recommendation Up to 0.25 inches

Remove tripping hazards \$198

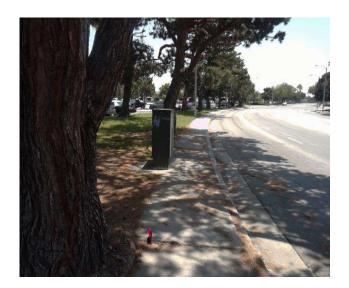
There is a change in elevation greater than recommended value.

Ensure that the change in elevation is within the recommended value.

Recommendation Up to 0.25 inches

Remove tripping hazards \$198

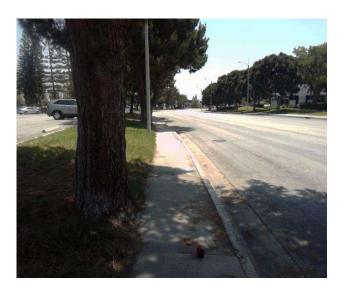
There is a change in elevation greater than recommended value.

Ensure that the change in elevation is within the recommended value.

Recommendation Up to 0.25 inches

Remove tripping hazards \$198

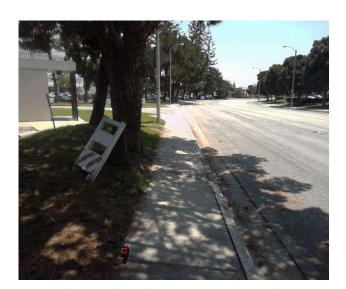
There is a change in elevation greater than recommended value.

Ensure that the change in elevation is within the recommended value.

Recommendation Up to 0.25 inches

Remove tripping hazards \$198

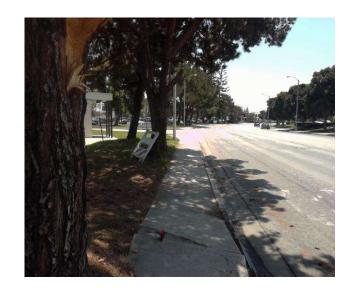
There is a change in elevation greater than recommended value.

Ensure that the change in elevation is within the recommended value.

Recommendation Up to 0.25 inches

Remove tripping hazards \$198

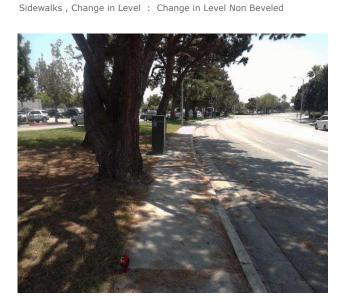
There is a change in elevation greater than recommended value.

Ensure that the change in elevation is within the recommended value.

Recommendation Up to 0.25 inches

Remove tripping hazards \$198

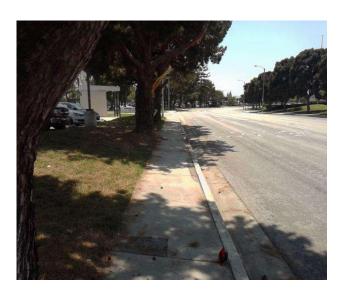
There is a change in elevation greater than recommended value.

Ensure that the change in elevation is within the recommended value.

Recommendation Up to 0.25 inches

Remove tripping hazards \$198

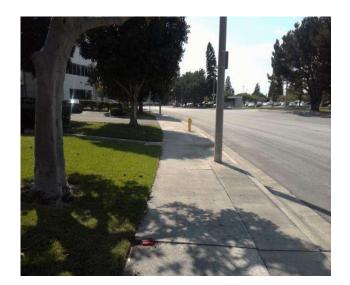
There is a change in elevation greater than recommended value.

Ensure that the change in elevation is within the recommended value.

Recommendation Up to 0.25 inches

Remove tripping hazards \$198

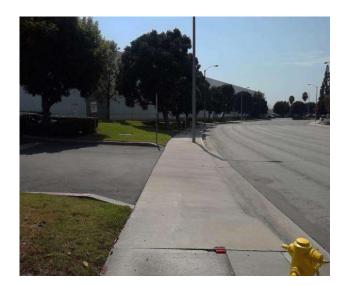
There is a change in elevation greater than recommended value.

Ensure that the change in elevation is within the recommended value.

Recommendation Up to 0.25 inches

Remove tripping hazards \$198

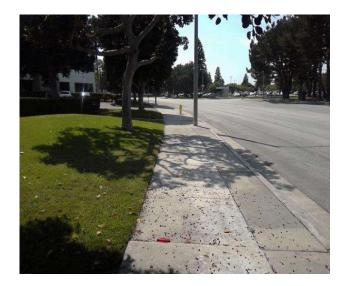
There is a change in elevation greater than recommended value.

Ensure that the change in elevation is within the recommended value.

Recommendation Up to 0.25 inches

Remove tripping hazards \$198

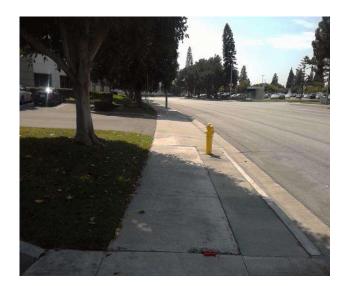
There is a change in elevation greater than recommended value.

Ensure that the change in elevation is within the recommended value.

Recommendation Up to 0.25 inches

Remove tripping hazards \$198

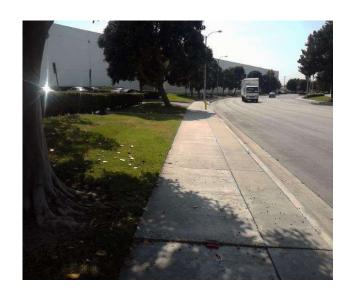
There is a change in elevation greater than recommended value.

Ensure that the change in elevation is within the recommended value.

Recommendation Up to 0.25 inches

Remove tripping hazards \$198

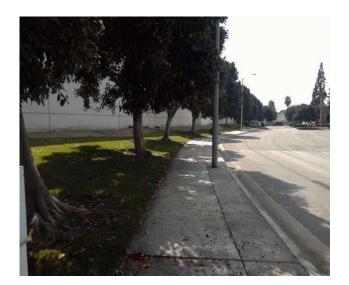
There is a change in elevation greater than recommended value.

Ensure that the change in elevation is within the recommended value.

Recommendation Up to 0.25 inches

Remove tripping hazards \$198

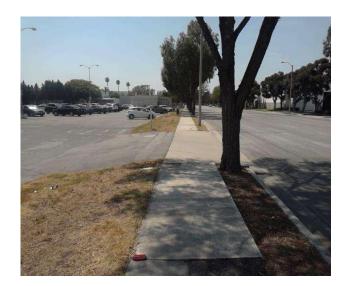
There is a change in elevation greater than recommended value.

Ensure that the change in elevation is within the recommended value.

Recommendation Up to 0.25 inches

Remove tripping hazards \$198

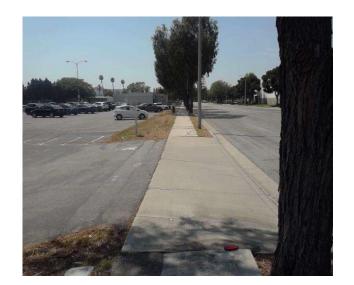
There is a change in elevation greater than recommended value.

Ensure that the change in elevation is within the recommended value.

Recommendation Up to 0.25 inches

Remove tripping hazards \$198

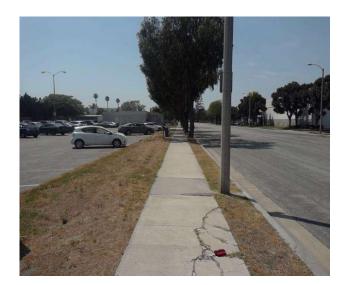
There is a change in elevation greater than recommended value.

Ensure that the change in elevation is within the recommended value.

Recommendation Up to 0.25 inches

Remove tripping hazards \$198

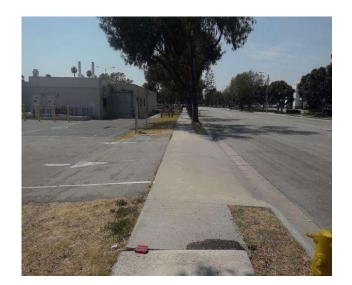
There is a change in elevation greater than recommended value.

Ensure that the change in elevation is within the recommended value.

Recommendation Up to 0.25 inches

Remove tripping hazards \$198

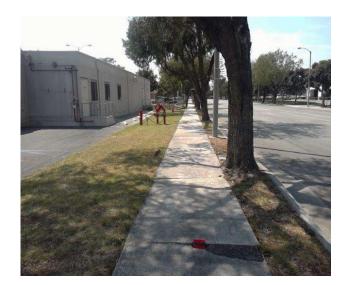
There is a change in elevation greater than recommended value.

Ensure that the change in elevation is within the recommended value.

Recommendation Up to 0.25 inches

Remove tripping hazards \$198

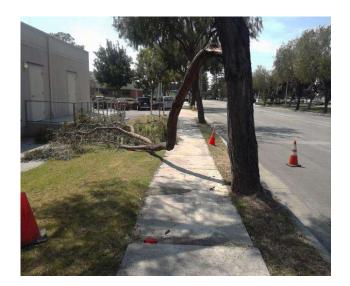
There is a change in elevation greater than recommended value.

Ensure that the change in elevation is within the recommended value.

Recommendation Up to 0.25 inches

Remove tripping hazards \$198

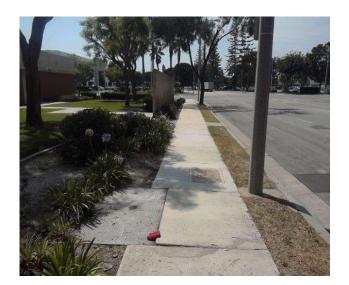
There is a change in elevation greater than recommended value.

Ensure that the change in elevation is within the recommended value.

Recommendation Up to 0.25 inches

Remove tripping hazards \$198

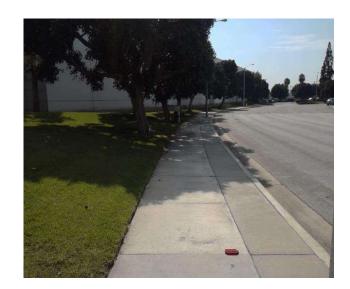
There is a change in elevation greater than recommended value.

Ensure that the change in elevation is within the recommended value.

Recommendation Up to 0.25 inches

Remove tripping hazards \$198

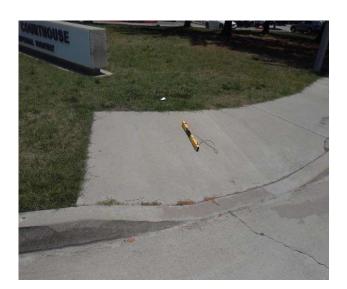
On-Site Finding Not Found

Provide detectable warning to \$248 surface
