Accessibility Survey

City of Downey Iowa Steet & Brookshire Avenue

Date of Inspection
4/30/2017

Disability Access Consultants

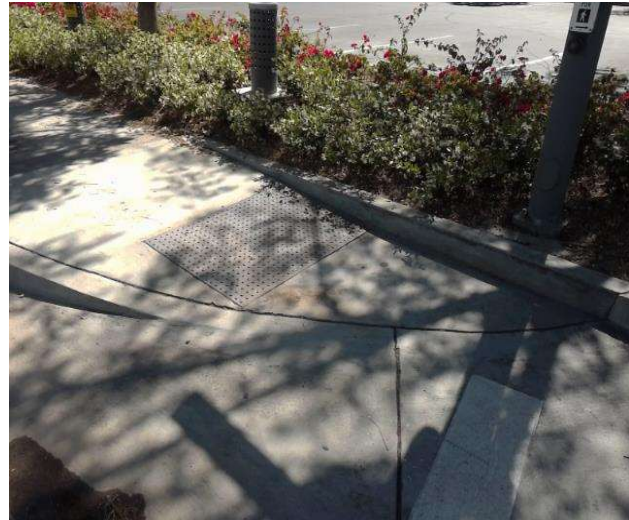
Northeast Corner @ 33.936084561179, -118.131161034107

Curb Ramp : Curb Ramp - Cross Slope

The cross slope is greater than allowed.

On-Site Finding 38.00 percent

Code Reference ADA 402, 406.1, 405.3, CA 11B-406.5.7

Provide a compliant curb ramp.

Recommendation Up to 2.08 percent

Install curb ramp \$1,300

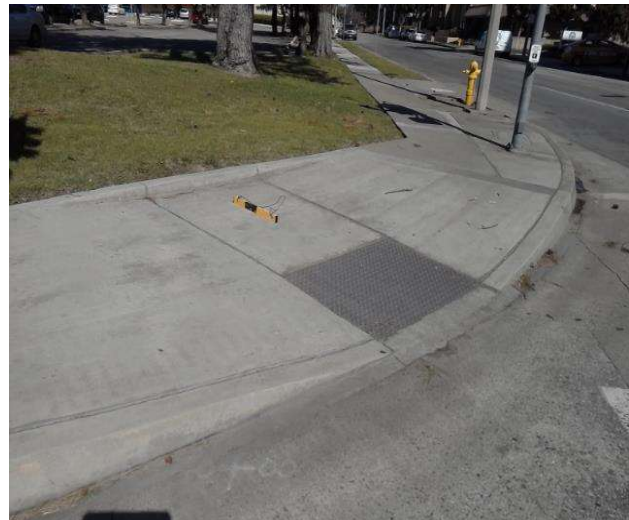
Code Reference ADA 402, 406.4, 403.3, 406.1,CA 11B-406.5.3

Recommendation Up to 2.08 percent

Provide compliant landing \$1,260

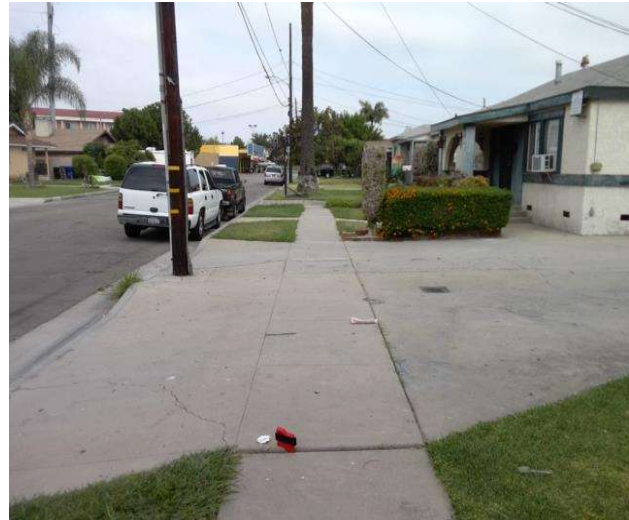
There is a change in elevation greater than recommended value.

Code Reference ADA 206, 302

Ensure that the change in elevation is within the recommended value.

Recommendation Up to 0.25 inches

Remove tripping hazards \$198

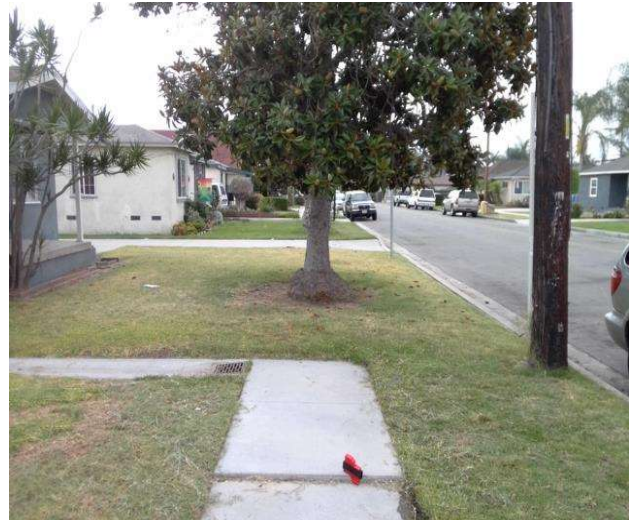
There is a change in elevation greater than recommended value.

Code Reference ADA 206, 302

Ensure that the change in elevation is within the recommended value.

Recommendation Up to 0.25 inches

Remove tripping hazards \$198

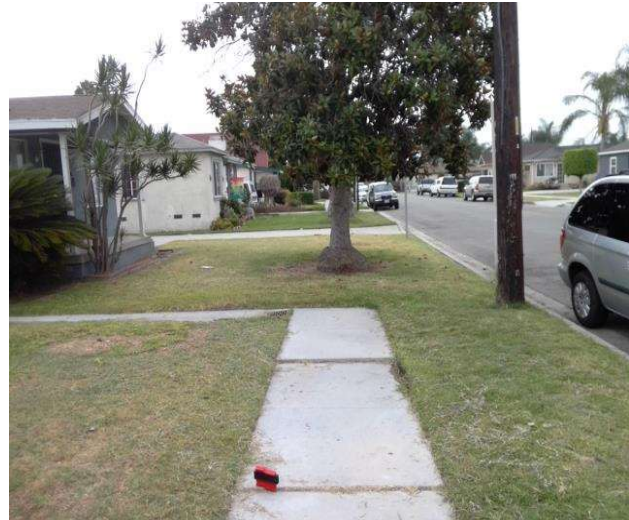
There is a change in elevation greater than recommended value.

Code Reference ADA 206, 302

Ensure that the change in elevation is within the recommended value.

Recommendation Up to 0.25 inches

Remove tripping hazards \$198

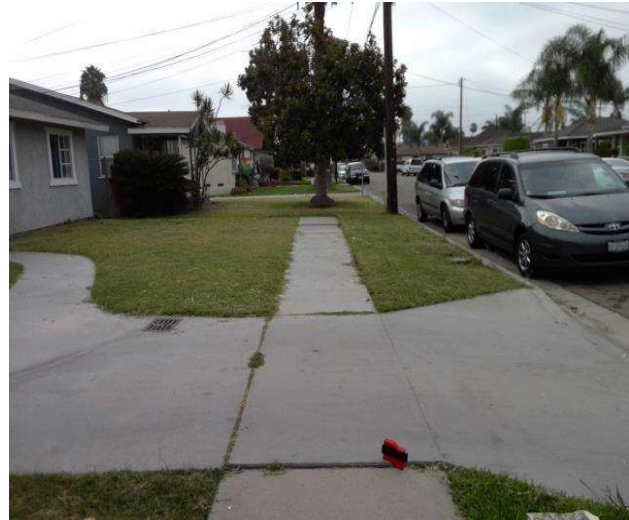
There is a change in elevation greater than recommended value.

Code Reference ADA 206, 302

Ensure that the change in elevation is within the recommended value.

Recommendation Up to 0.25 inches

Remove tripping hazards \$198

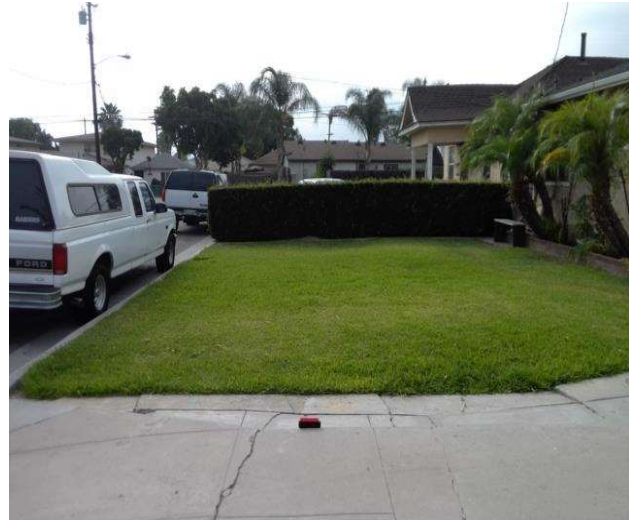
There is a change in elevation greater than recommended value.

Code Reference ADA 206, 302

Ensure that the change in elevation is within the recommended value.

Recommendation Up to 0.25 inches

Remove tripping hazards \$198

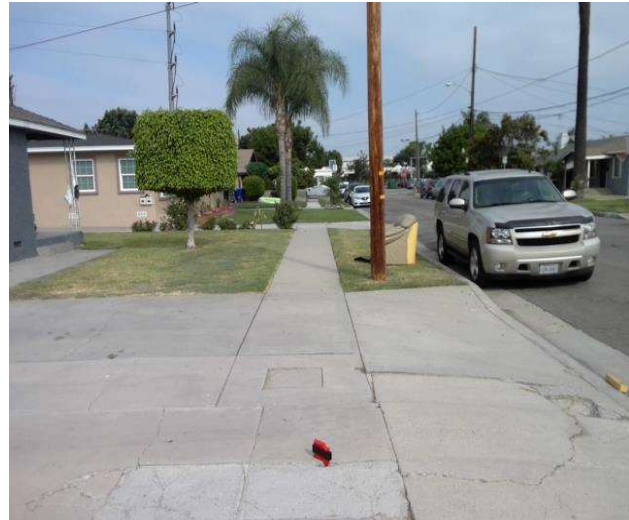
There is a change in elevation greater than recommended value.

Code Reference ADA 206, 302

Ensure that the change in elevation is within the recommended value.

Recommendation Up to 0.25 inches

Remove tripping hazards \$198

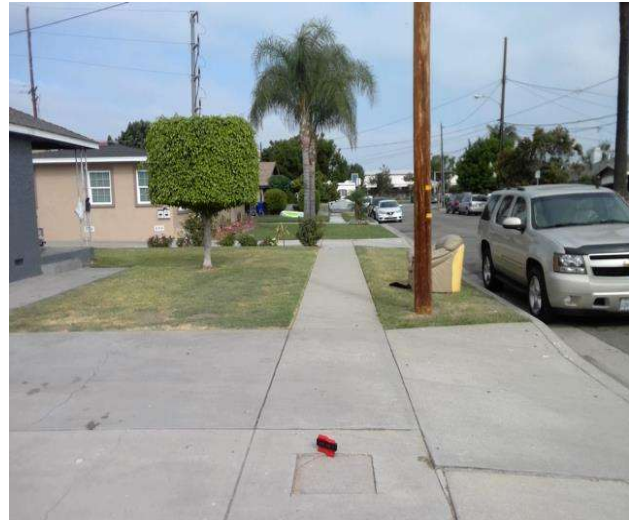
There is a change in elevation greater than recommended value.

Code Reference ADA 206, 302

Ensure that the change in elevation is within the recommended value.

Recommendation Up to 0.25 inches

Remove tripping hazards \$198

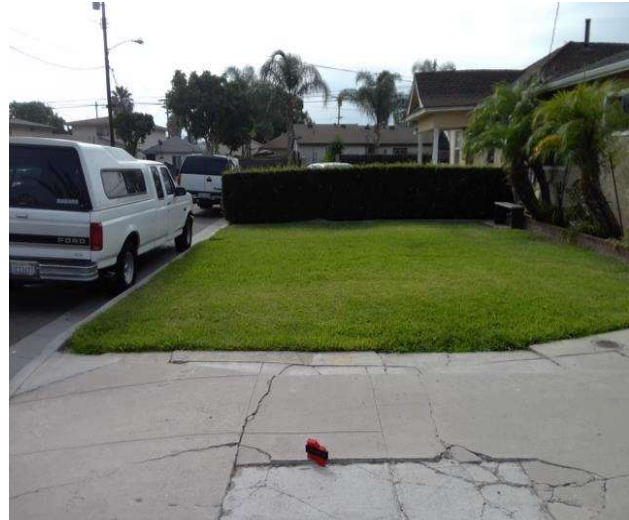
There is a change in elevation greater than recommended value.

Code Reference ADA 206, 302

Ensure that the change in elevation is within the recommended value.

Recommendation Up to 0.25 inches

Remove tripping hazards \$198

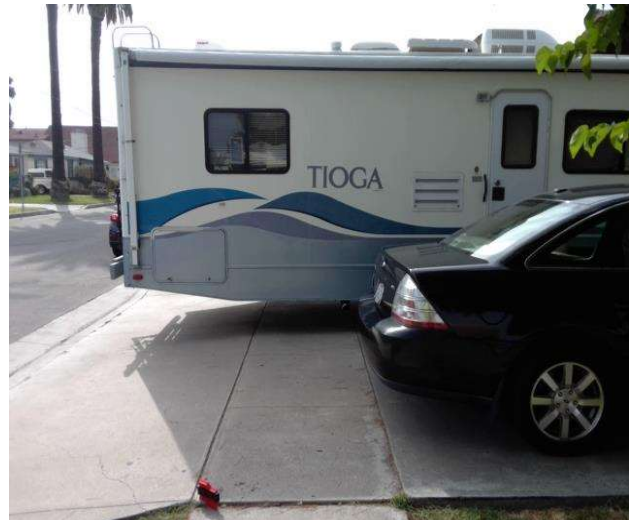
There is a change in elevation greater than recommended value.

Code Reference ADA 206, 302

Ensure that the change in elevation is within the recommended value.

Recommendation Up to 0.25 inches

Remove tripping hazards \$198
