Accessibility Survey

City of Downey Western Avenue - 7th Street to 5th Street

7th Street to 5th Street Downey, CA 90242

Date of Inspection 7/11/2017

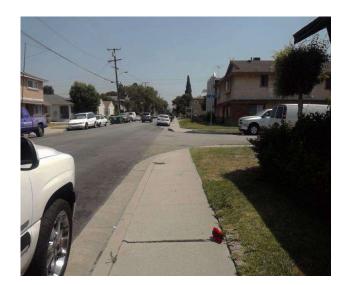
Change in Level South of 6th Street @ 33.946146880879, -118.132372051477

Sidewalks , Change in Level : Change in Level Non Beveled

There is a change in elevation greater than recommended value.

On-Site Finding 0.87 inches

Ensure that the change in elevation is within the recommended value.

Recommendation Up to 0.25 inches

Remove tripping hazards \$198

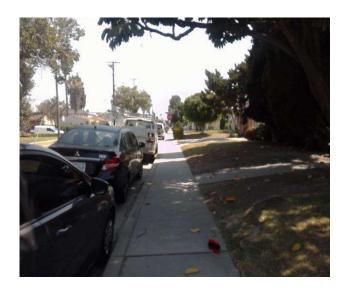
There is a change in elevation greater than recommended value.

Ensure that the change in elevation is within the recommended value.

Recommendation Up to 0.25 inches

Remove tripping hazards \$198

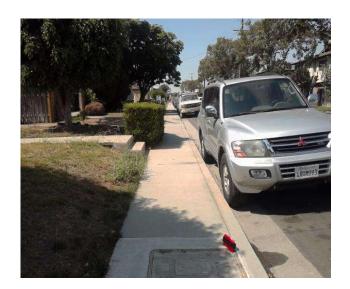
There is a change in elevation greater than recommended value.

Ensure that the change in elevation is within the recommended value.

Recommendation Up to 0.25 inches

Remove tripping hazards \$198

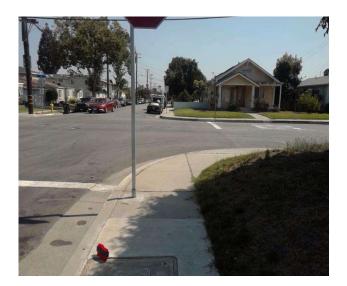
There is a change in elevation greater than recommended value.

Ensure that the change in elevation is within the recommended value.

Recommendation Up to 0.25 inches

Remove tripping hazards \$198

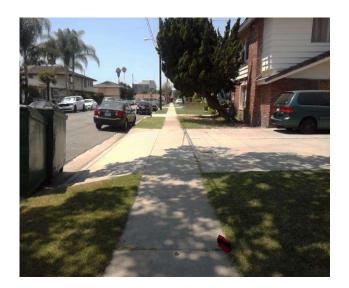
There is a change in elevation greater than recommended value.

Ensure that the change in elevation is within the recommended value.

Recommendation Up to 0.25 inches

Remove tripping hazards \$198

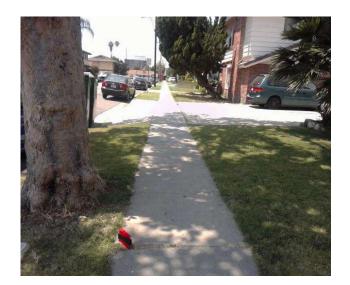
There is a change in elevation greater than recommended value.

Ensure that the change in elevation is within the recommended value.

Recommendation Up to 0.25 inches

Remove tripping hazards \$198

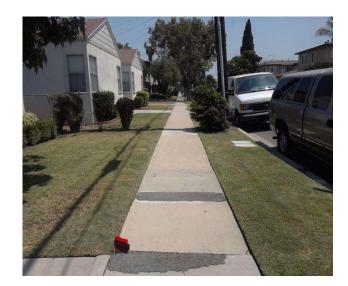
There is a change in elevation greater than recommended value.

Ensure that the change in elevation is within the recommended value.

Recommendation Up to 0.25 inches

Remove tripping hazards \$198

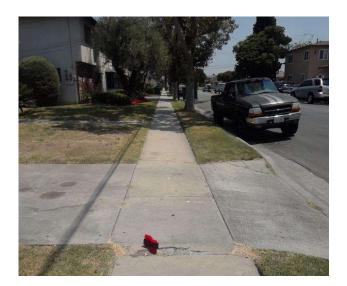
There is a change in elevation greater than recommended value.

Ensure that the change in elevation is within the recommended value.

Recommendation Up to 0.25 inches

Remove tripping hazards \$198

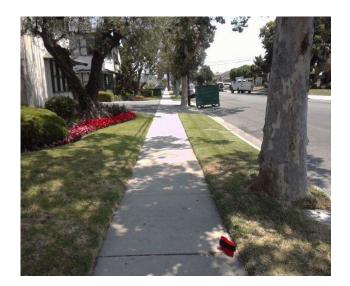
There is a change in elevation greater than recommended value.

Ensure that the change in elevation is within the recommended value.

Recommendation Up to 0.25 inches

Remove tripping hazards \$198

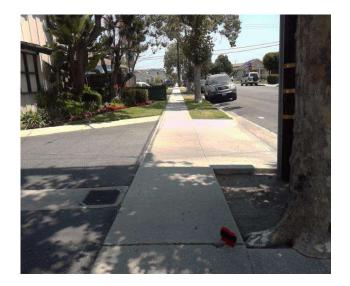
There is a change in elevation greater than recommended value.

Ensure that the change in elevation is within the recommended value.

Recommendation Up to 0.25 inches

Remove tripping hazards \$198

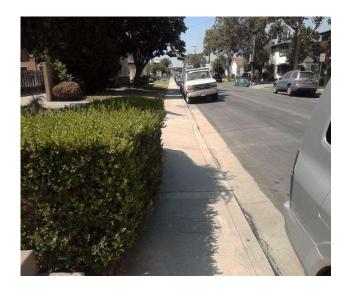
Sidewalks , Hazards & Gratings : Sidewalk Width at Obstruction

Sidewalk width at the obstruction shall have the recommended value.

Recommendation At least 48.00 inches

\$1,260

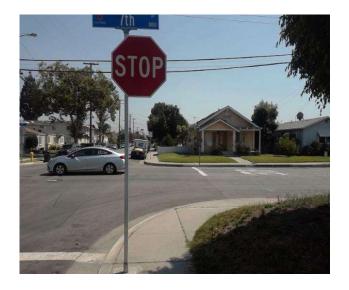
Sidewalks , Hazards & Gratings : Sidewalk Width at Obstruction

Sidewalk width at the obstruction shall have the recommended value.

Recommendation At least 48.00 inches

\$1,260

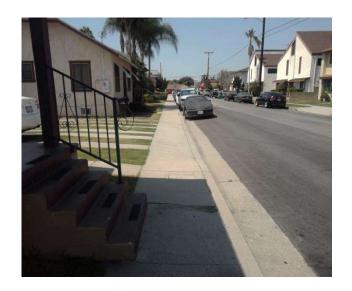
Sidewalks , Hazards & Gratings : Sidewalk Width at Obstruction

Sidewalk width at the obstruction shall have the recommended value.

Recommendation At least 48.00 inches

\$1,260

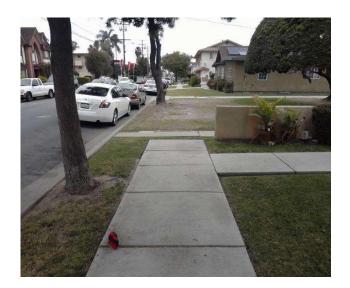
There is a change in elevation greater than recommended value.

Ensure that the change in elevation is within the recommended value.

Recommendation Up to 0.25 inches

Remove tripping hazards \$198

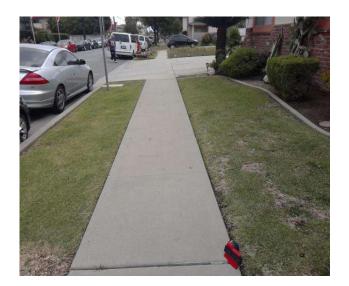
There is a change in elevation greater than recommended value.

Ensure that the change in elevation is within the recommended value.

Recommendation Up to 0.25 inches

Remove tripping hazards \$198

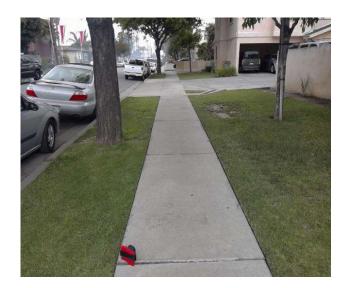
There is a change in elevation greater than recommended value.

Ensure that the change in elevation is within the recommended value.

Recommendation Up to 0.25 inches

Remove tripping hazards \$198

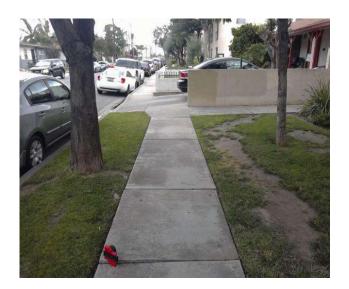
There is a change in elevation greater than recommended value.

Ensure that the change in elevation is within the recommended value.

Recommendation Up to 0.25 inches

Remove tripping hazards \$198

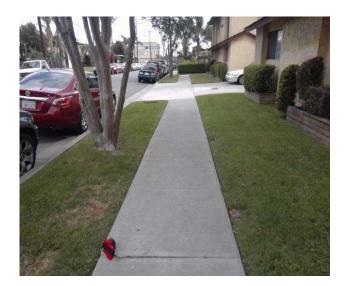
There is a change in elevation greater than recommended value.

Ensure that the change in elevation is within the recommended value.

Recommendation Up to 0.25 inches

Remove tripping hazards \$198

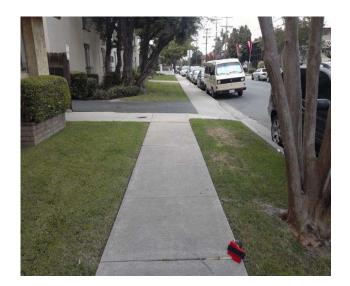
There is a change in elevation greater than recommended value.

Ensure that the change in elevation is within the recommended value.

Recommendation Up to 0.25 inches

Remove tripping hazards \$198

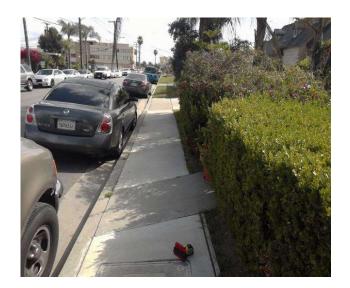
There is a change in elevation greater than recommended value.

Ensure that the change in elevation is within the recommended value.

Recommendation Up to 0.25 inches

Remove tripping hazards \$198

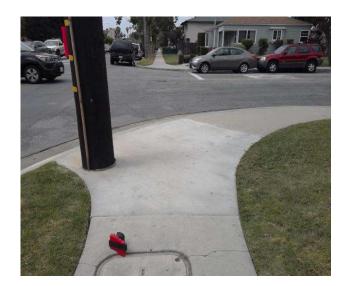
There is a change in elevation greater than recommended value.

Ensure that the change in elevation is within the recommended value.

Recommendation Up to 0.25 inches

Remove tripping hazards \$198

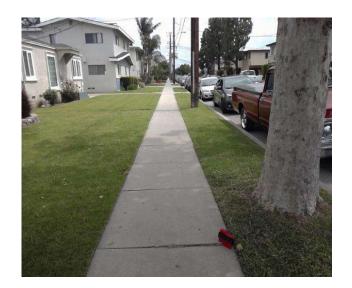
There is a change in elevation greater than recommended value.

Ensure that the change in elevation is within the recommended value.

Recommendation Up to 0.25 inches

Remove tripping hazards \$198

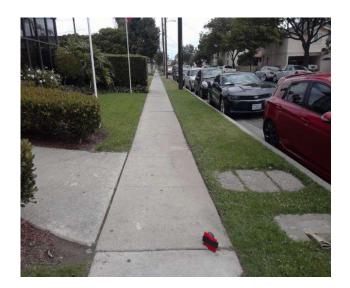
There is a change in elevation greater than recommended value.

Ensure that the change in elevation is within the recommended value.

Recommendation Up to 0.25 inches

Remove tripping hazards \$198

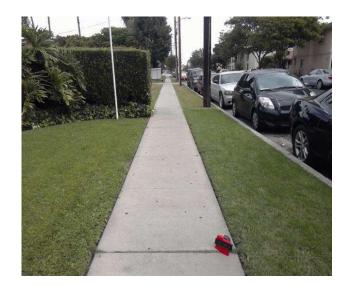
There is a change in elevation greater than recommended value.

Ensure that the change in elevation is within the recommended value.

Recommendation Up to 0.25 inches

Remove tripping hazards \$198

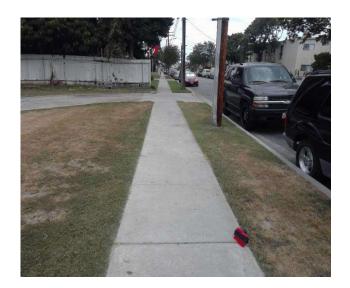
There is a change in elevation greater than recommended value.

Ensure that the change in elevation is within the recommended value.

Recommendation Up to 0.25 inches

Remove tripping hazards \$198

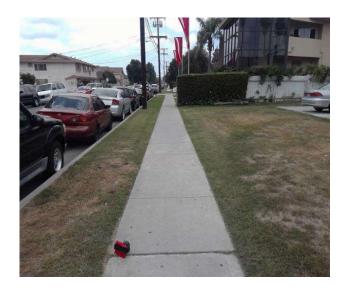
There is a change in elevation greater than recommended value.

Ensure that the change in elevation is within the recommended value.

Recommendation Up to 0.25 inches

Remove tripping hazards \$198

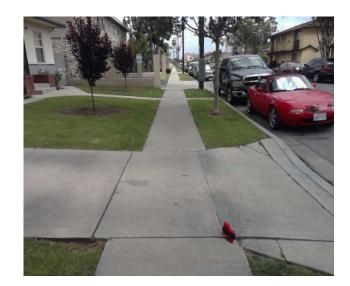
There is a change in elevation greater than recommended value.

Ensure that the change in elevation is within the recommended value.

Recommendation Up to 0.25 inches

Remove tripping hazards \$198

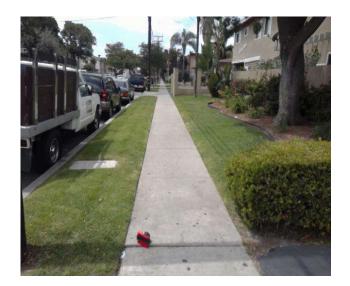
There is a change in elevation greater than recommended value.

Ensure that the change in elevation is within the recommended value.

Recommendation Up to 0.25 inches

Remove tripping hazards \$198

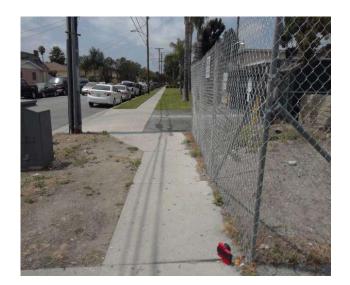
There is a change in elevation greater than recommended value.

Ensure that the change in elevation is within the recommended value.

Recommendation Up to 0.25 inches

Remove tripping hazards \$198

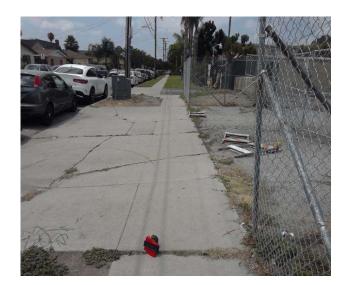
There is a change in elevation greater than recommended value.

Ensure that the change in elevation is within the recommended value.

Recommendation Up to 0.25 inches

Remove tripping hazards \$198

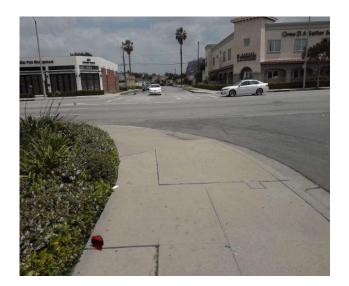
There is a change in elevation greater than recommended value.

Ensure that the change in elevation is within the recommended value.

Recommendation Up to 0.25 inches

Remove tripping hazards \$198

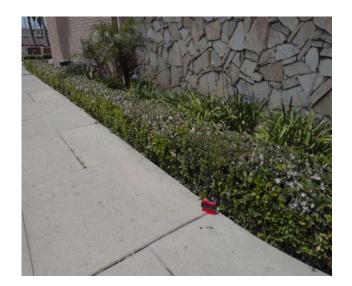
There is a change in elevation greater than recommended value.

Ensure that the change in elevation is within the recommended value.

Recommendation Up to 0.25 inches

Remove tripping hazards \$198

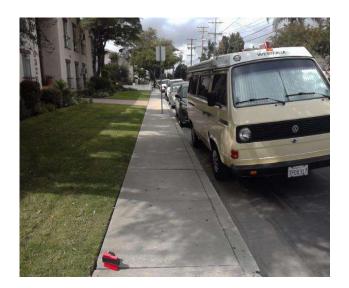
There is a change in elevation greater than recommended value.

Ensure that the change in elevation is within the recommended value.

Recommendation Up to 0.25 inches

Remove tripping hazards \$198
