Accessibility Survey

City of Downey Allengrove Street - Parrot Avenue to Brock Avenue

Date of Inspection
6/23/2017

Disability Access Consultants

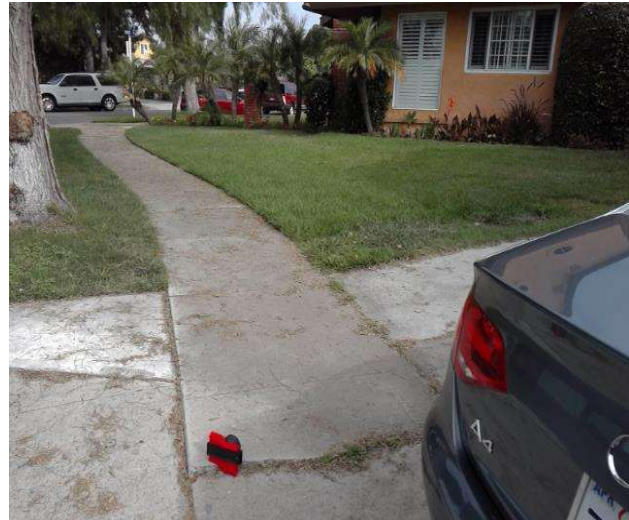
Change in Level East of Parrot Avenue @ 33.962849885666, -118.120473772287

Sidewalks , Change in Level : Change in Level Non Beveled

There is a change in elevation greater than recommended value.

On-Site Finding 0.87 inches

Code Reference ADA 206, 302

Ensure that the change in elevation is within the recommended value.

Recommendation Up to 0.25 inches

Remove tripping hazards \$198

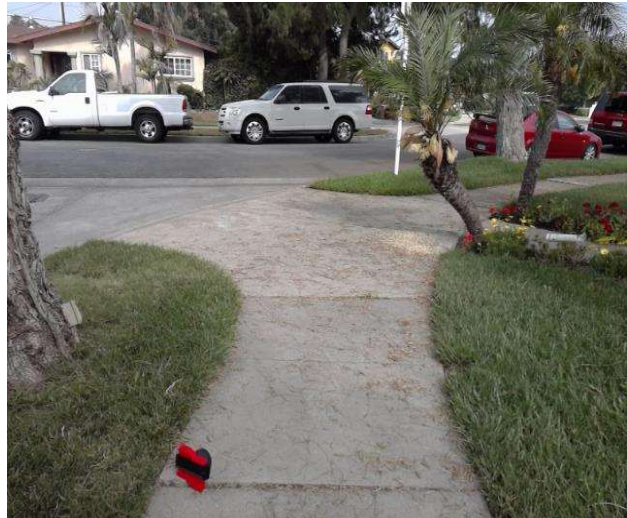
Change in Level East of Parrot Avenue @ 33.962882142709, -118.120603859425

Sidewalks , Change in Level : Change in Level Non Beveled

There is a change in elevation greater than recommended value.

Code Reference ADA 206, 302

Ensure that the change in elevation is within the recommended value.

Recommendation Up to 0.25 inches

Remove tripping hazards \$198

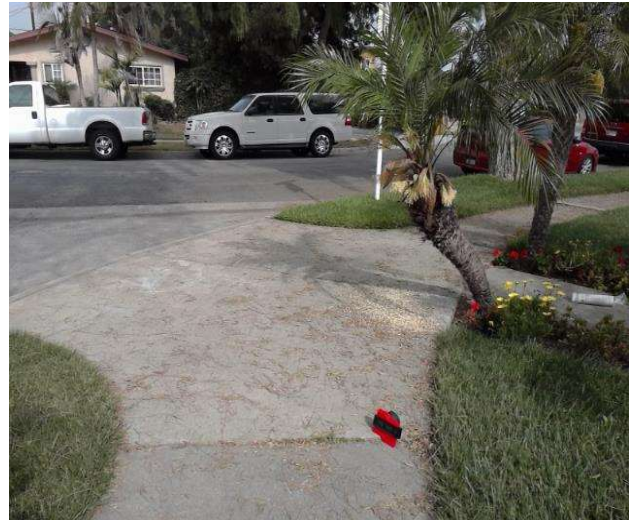
There is a change in elevation greater than recommended value.

Code Reference ADA 206, 302

Ensure that the change in elevation is within the recommended value.

Recommendation Up to 0.25 inches

Remove tripping hazards \$198

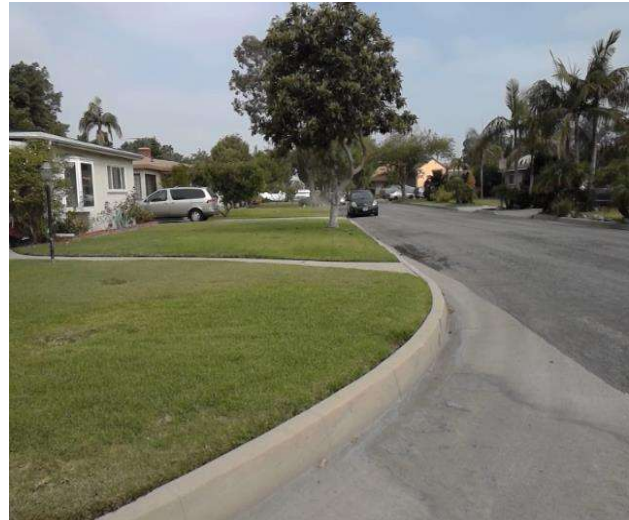
Sidewalks : Missing Sidewalk

Section of sidewalk is missing and consists of dirt, grass or gravel.

Code Reference ADA 206, 302,CA 11B-302,CA 11B-206

Provide a compliant sidewalk for the missing section.

\$1,260

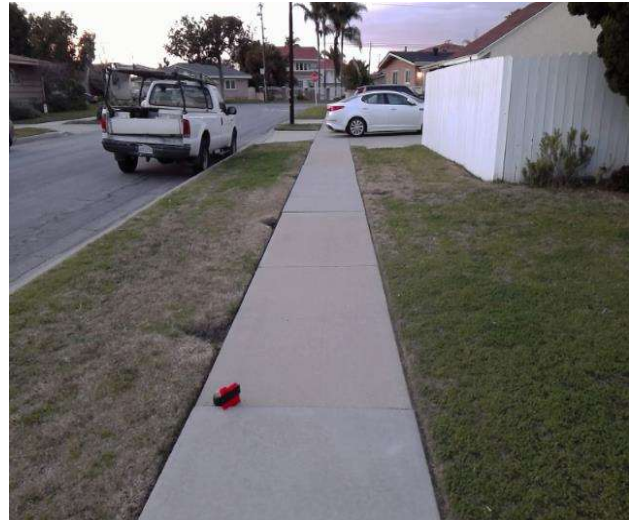
There is a change in elevation greater than recommended value.

Code Reference ADA 206, 302

Ensure that the change in elevation is within the recommended value.

Recommendation Up to 0.25 inches

Remove tripping hazards \$198

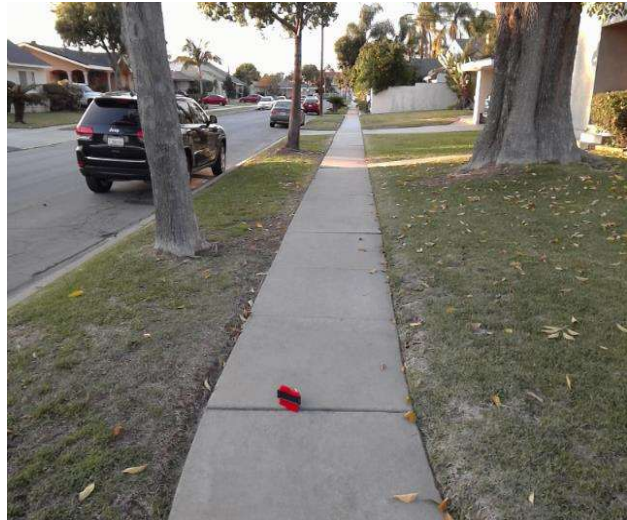
There is a change in elevation greater than recommended value.

Code Reference ADA 206, 302

Ensure that the change in elevation is within the recommended value.

Recommendation Up to 0.25 inches

Remove tripping hazards \$198

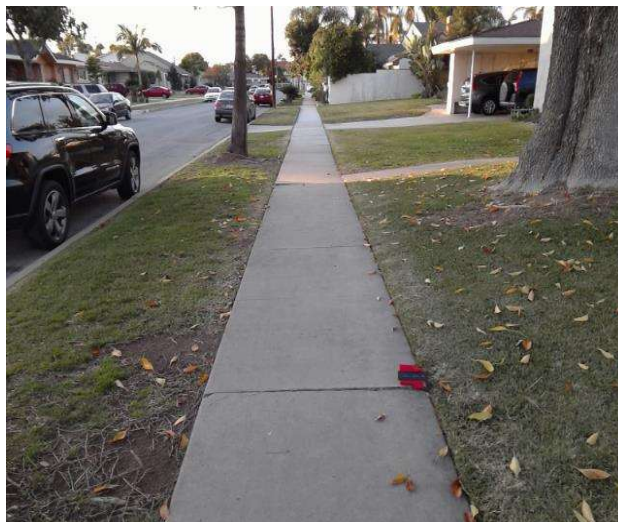
There is a change in elevation greater than recommended value.

Code Reference ADA 206, 302

Ensure that the change in elevation is within the recommended value.

Recommendation Up to 0.25 inches

Remove tripping hazards \$198

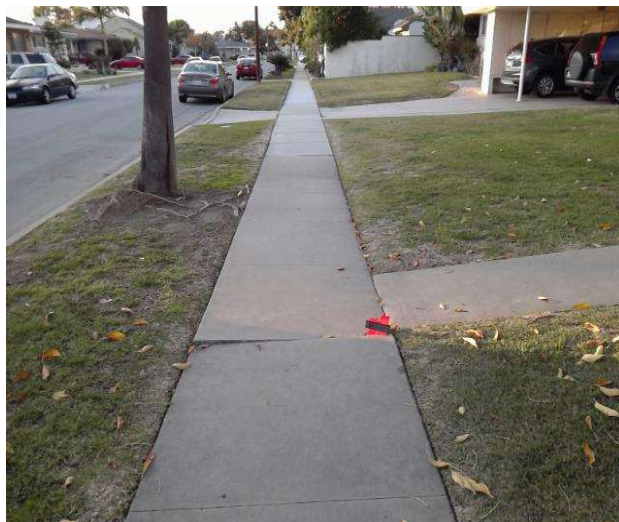
There is a change in elevation greater than recommended value.

Code Reference ADA 206, 302

Ensure that the change in elevation is within the recommended value.

Recommendation Up to 0.25 inches

Remove tripping hazards \$198

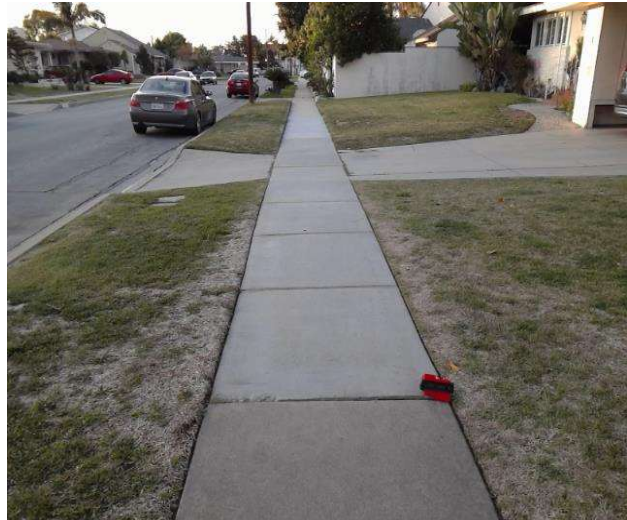
There is a change in elevation greater than recommended value.

Code Reference ADA 206, 302

Ensure that the change in elevation is within the recommended value.

Recommendation Up to 0.25 inches

Remove tripping hazards \$198

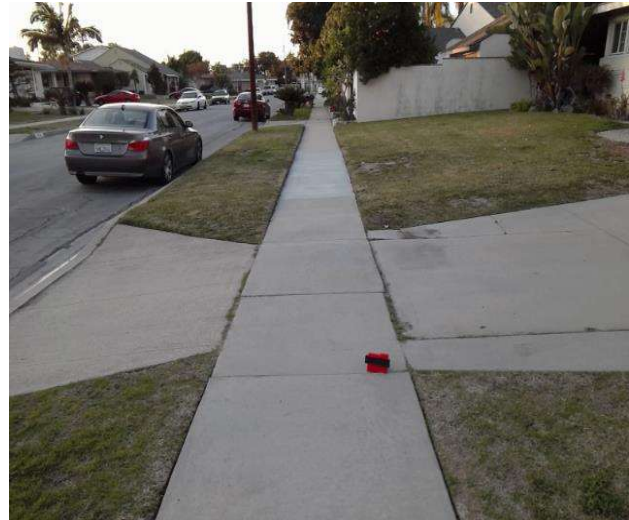
There is a change in elevation greater than recommended value.

Code Reference ADA 206, 302

Ensure that the change in elevation is within the recommended value.

Recommendation Up to 0.25 inches

Remove tripping hazards \$198

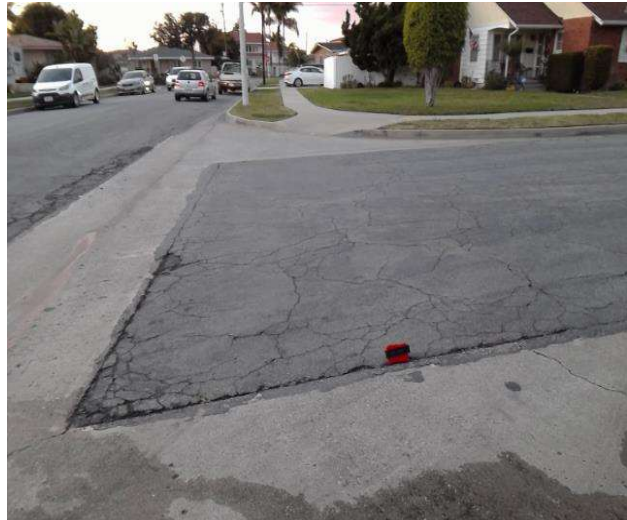
There is a change in elevation greater than recommended value.

Code Reference ADA 206, 302

Ensure that the change in elevation is within the recommended value.

Recommendation Up to 0.25 inches

Remove tripping hazards \$198

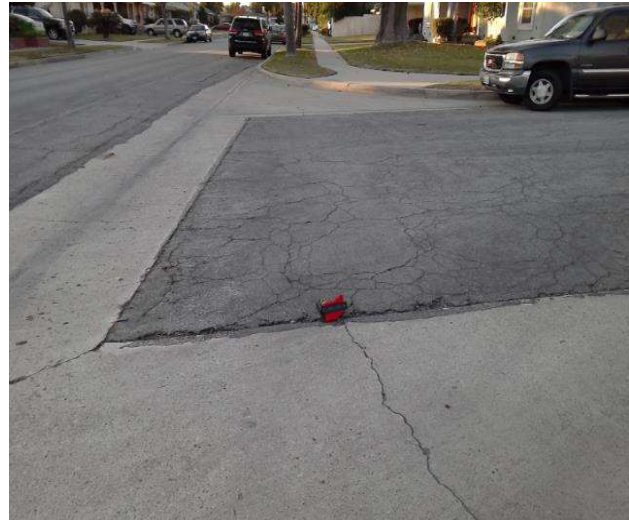
There is a change in elevation greater than recommended value.

Code Reference ADA 206, 302

Ensure that the change in elevation is within the recommended value.

Recommendation Up to 0.25 inches

Remove tripping hazards \$198

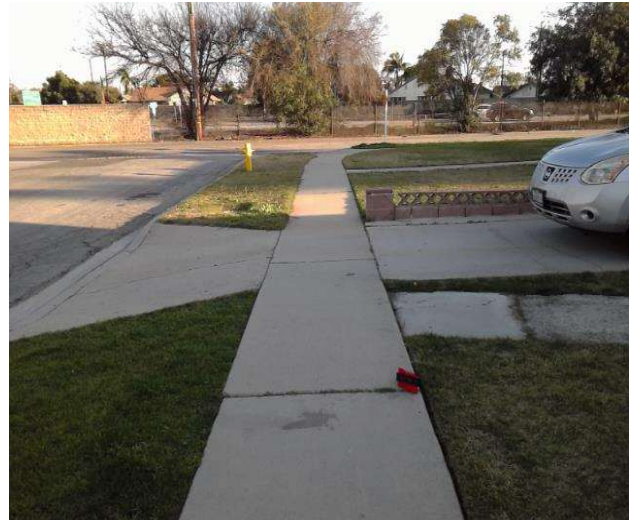
There is a change in elevation greater than recommended value.

Code Reference ADA 206, 302

Ensure that the change in elevation is within the recommended value.

Recommendation Up to 0.25 inches

Remove tripping hazards \$198

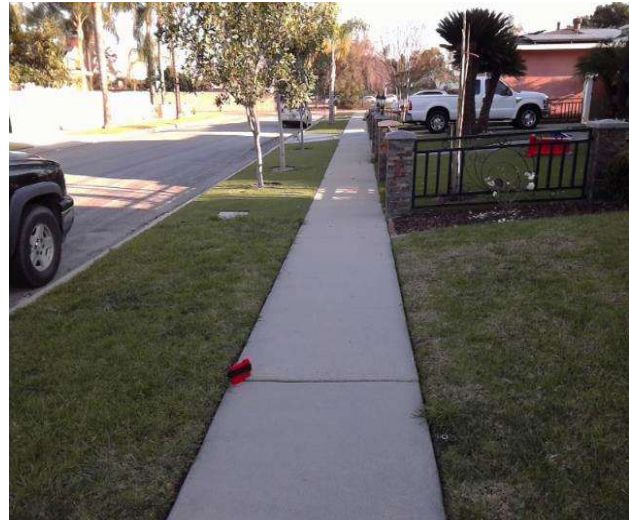
There is a change in elevation greater than recommended value.

Code Reference ADA 206, 302

Ensure that the change in elevation is within the recommended value.

Recommendation Up to 0.25 inches

Remove tripping hazards \$198

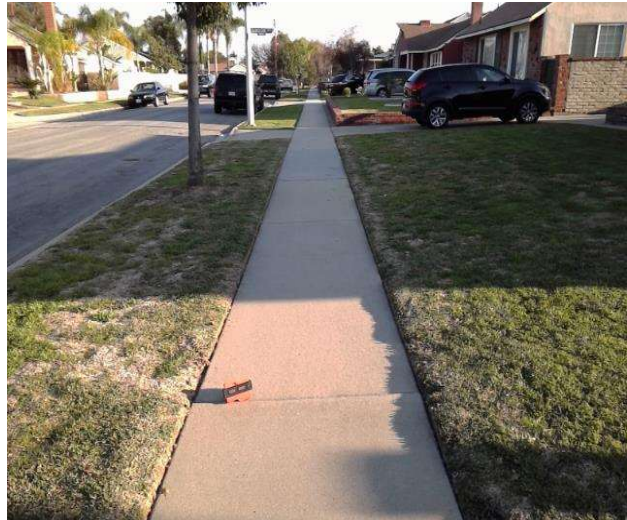
There is a change in elevation greater than recommended value.

Code Reference ADA 206, 302

Ensure that the change in elevation is within the recommended value.

Recommendation Up to 0.25 inches

Remove tripping hazards \$198

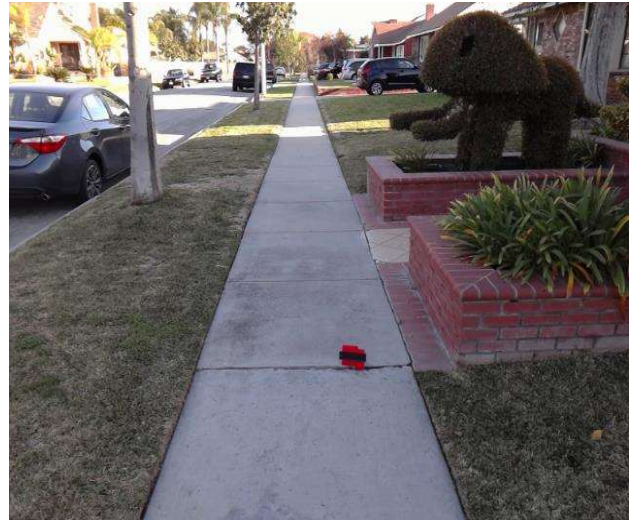
There is a change in elevation greater than recommended value.

Code Reference ADA 206, 302

Ensure that the change in elevation is within the recommended value.

Recommendation Up to 0.25 inches

Remove tripping hazards \$198

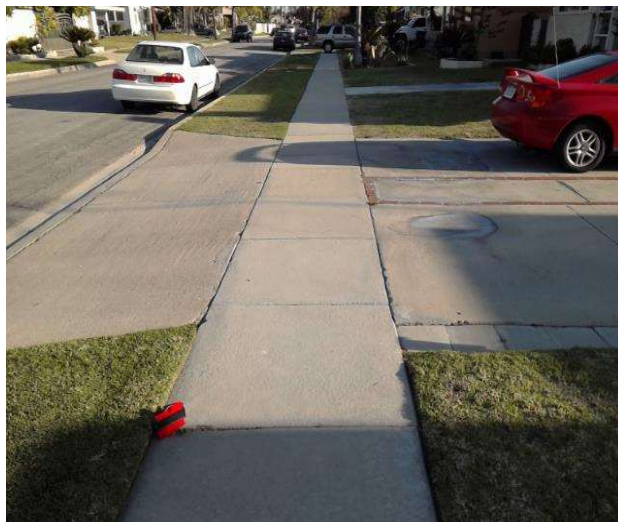
There is a change in elevation greater than recommended value.

Code Reference ADA 206, 302

Ensure that the change in elevation is within the recommended value.

Recommendation Up to 0.25 inches

Remove tripping hazards \$198

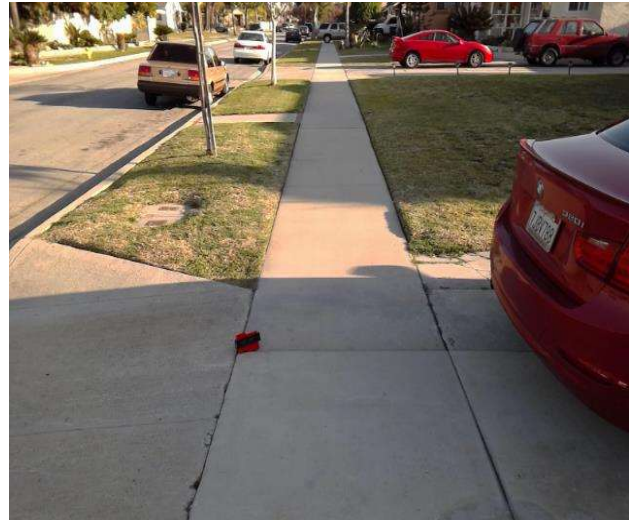
There is a change in elevation greater than recommended value.

Code Reference ADA 206, 302

Ensure that the change in elevation is within the recommended value.

Recommendation Up to 0.25 inches

Remove tripping hazards \$198

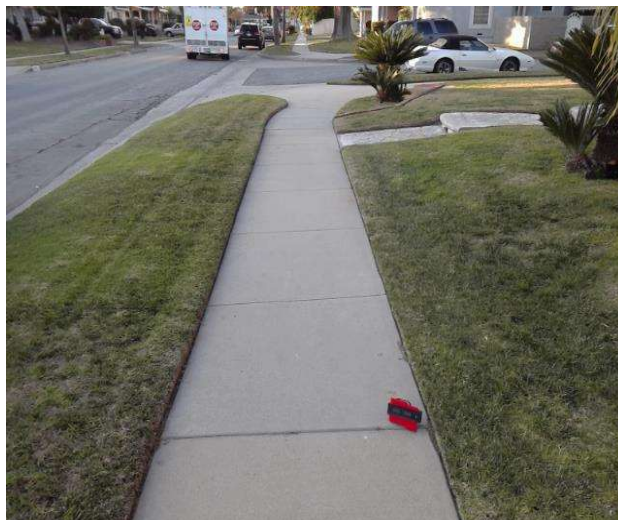
There is a change in elevation greater than recommended value.

Code Reference ADA 206, 302

Ensure that the change in elevation is within the recommended value.

Recommendation Up to 0.25 inches

Remove tripping hazards \$198

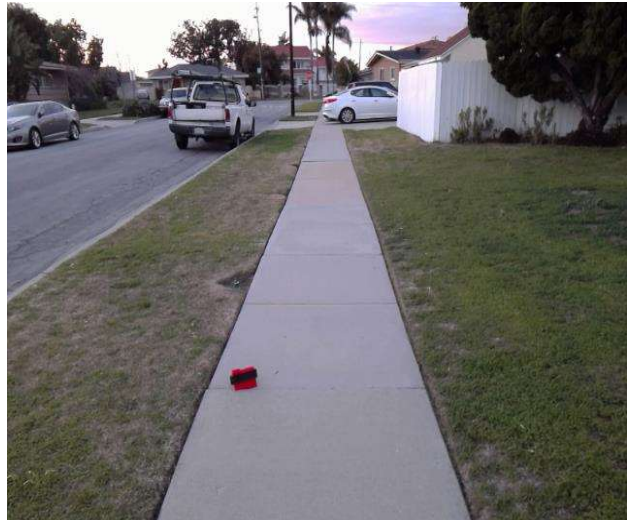
There is a change in elevation greater than recommended value.

Code Reference ADA 206, 302

Ensure that the change in elevation is within the recommended value.

Recommendation Up to 0.25 inches

Remove tripping hazards \$198

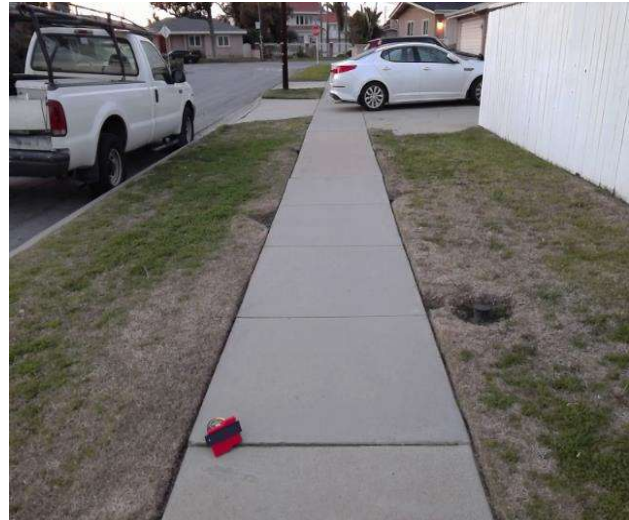
There is a change in elevation greater than recommended value.

Code Reference ADA 206, 302

Ensure that the change in elevation is within the recommended value.

Recommendation Up to 0.25 inches

Remove tripping hazards \$198

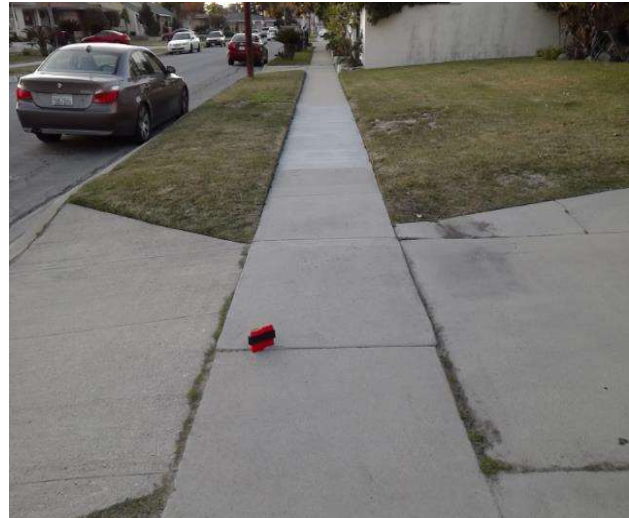
There is a change in elevation greater than recommended value.

Code Reference ADA 206, 302

Ensure that the change in elevation is within the recommended value.

Recommendation Up to 0.25 inches

Remove tripping hazards \$198

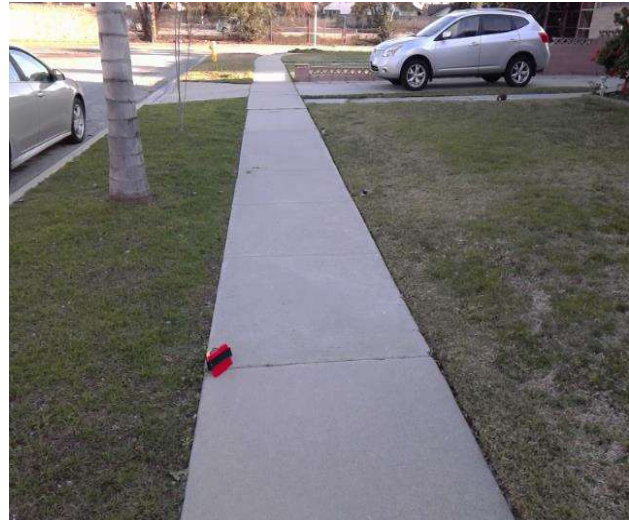
There is a change in elevation greater than recommended value.

Code Reference ADA 206, 302

Ensure that the change in elevation is within the recommended value.

Recommendation Up to 0.25 inches

Remove tripping hazards \$198

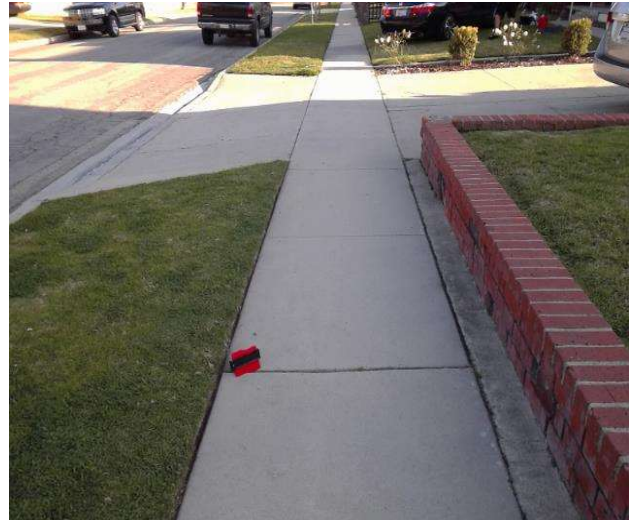
There is a change in elevation greater than recommended value.

Code Reference ADA 206, 302

Ensure that the change in elevation is within the recommended value.

Recommendation Up to 0.25 inches

Remove tripping hazards \$198

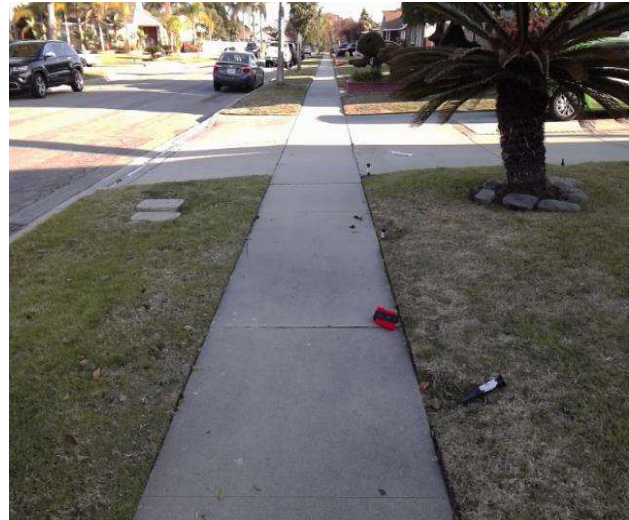
There is a change in elevation greater than recommended value.

Code Reference ADA 206, 302

Ensure that the change in elevation is within the recommended value.

Recommendation Up to 0.25 inches

Remove tripping hazards \$198

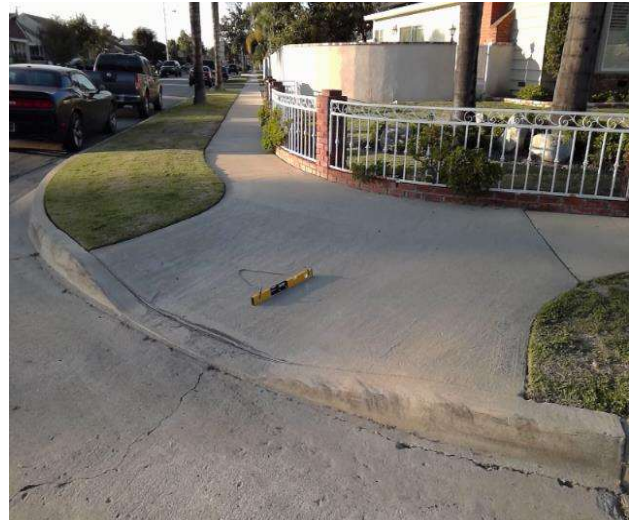
On-Site Finding Not Found

Code Reference CA 11B-406.5.12

Recommendation See Recommendation

Provide detectable warning to surface \$248

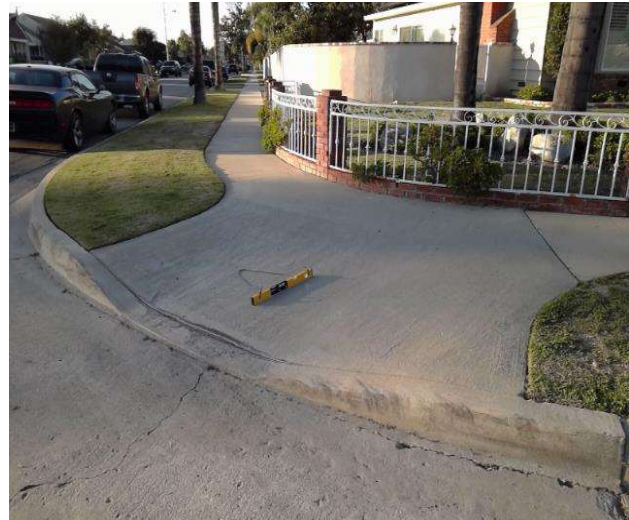
Code Reference ADA 406, 406.1, 405.2, CA 11B-406

Recommendation Up to 8.33 percent

Install curb ramp \$1,300

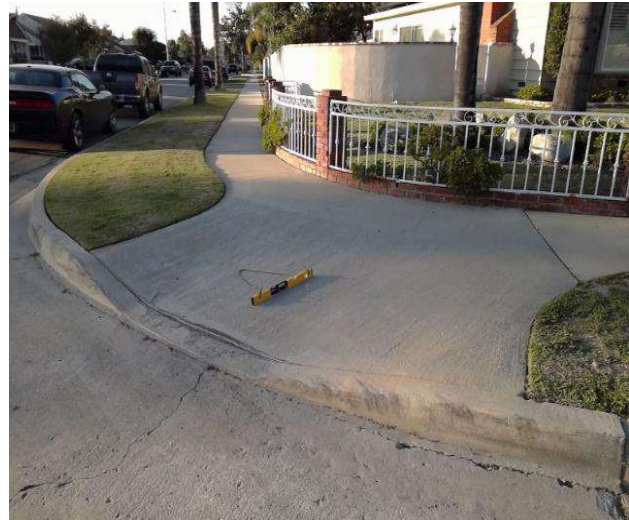
Code Reference ADA 406, 406.3, CA 11B-406.2.2

Recommendation Up to 10.00 percent

Install flared sides \$1,300

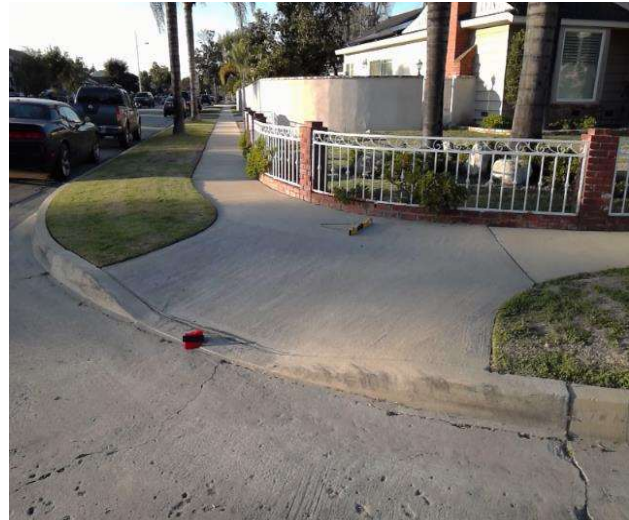
Code Reference ADA 402, 406.4, 403.3, 406.1, CA 11B-406.5.3

Recommendation Up to 2.08 percent

Provide compliant landing \$1,260

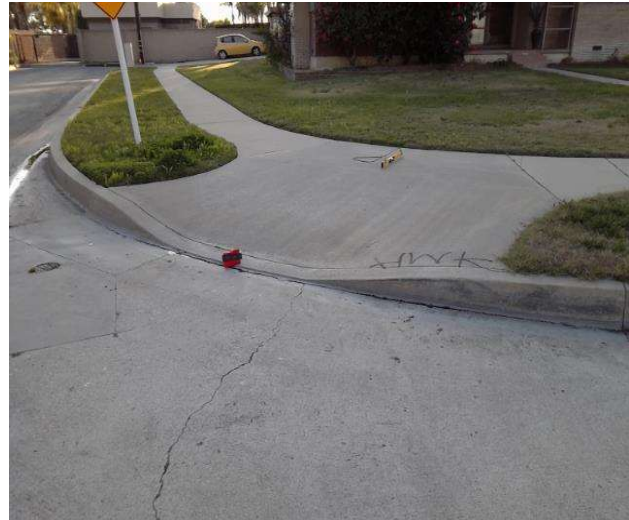
Curb Ramp , Landings And Transitions : Bottom Landing Change in Level

Code Reference ADA 302, 303, 406.2, 303.1

Recommendation Up to 0.50 inches

Patch lip at curb ramp \$255

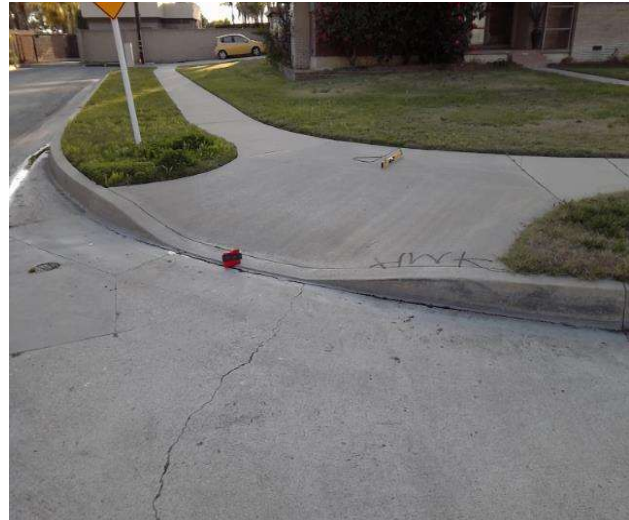
Code Reference ADA 402, 406.4, 403.3, 406.1, CA 11B-406.5.3

Recommendation Up to 2.08 percent

Provide compliant landing \$1,260

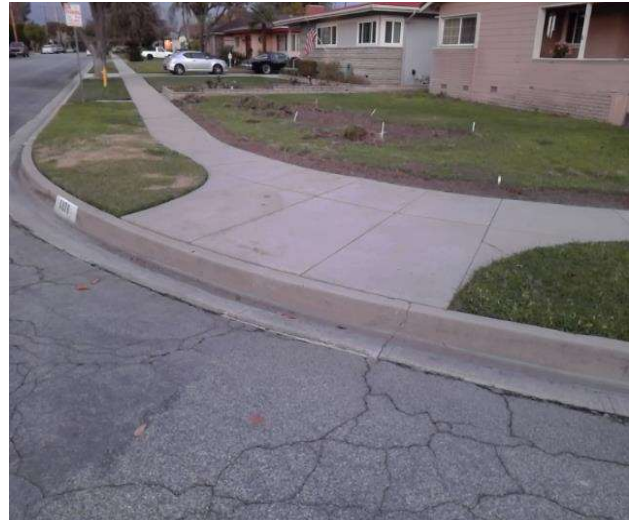
Sidewalks , Hazards & Gratings : Curb is on Path of Travel

Code Reference ADA 402, 303, 406, 403.4, 303.4

Recommendation See Recommendation

Install curb ramp \$2,500

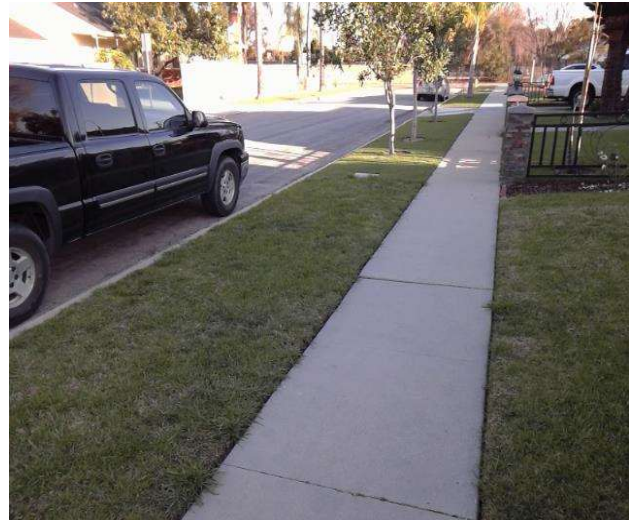
Code Reference ADA 206, 302,CA 11B-403.3

Repave the sidewalk surface with the recommended cross slope.

Recommendation Up to 2.08 percent

Repave surface \$1,092

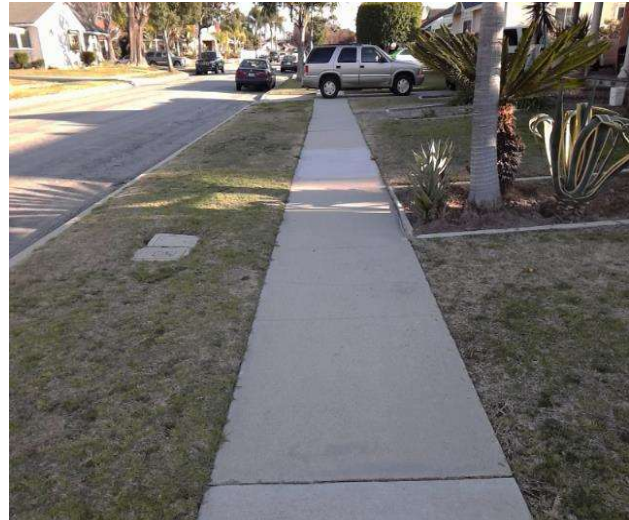
Code Reference ADA 206, 302,CA 11B-403.3

Repave the sidewalk surface with the recommended cross slope.

Recommendation Up to 2.08 percent

Repave surface \$1,092

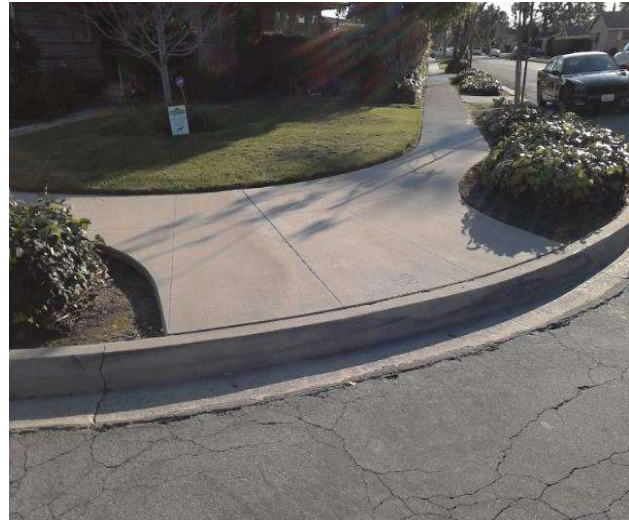
Sidewalks , Hazards & Gratings : Curb is on Path of Travel

Code Reference ADA 402, 303, 406, 403.4, 303.4

Recommendation See Recommendation

Install curb ramp \$2,500

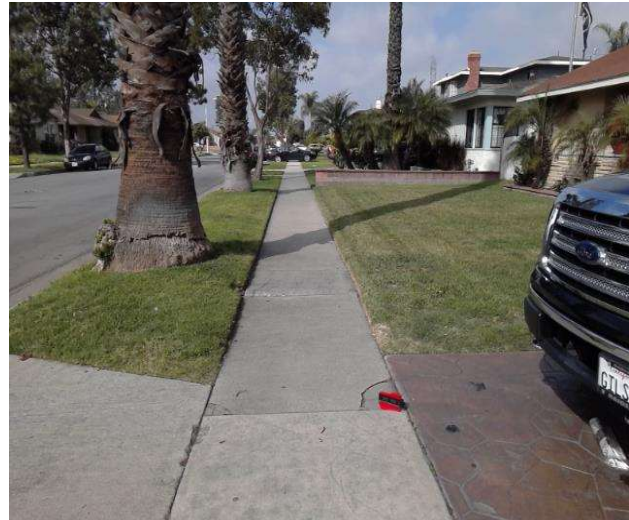
There is a change in elevation greater than recommended value.

Code Reference ADA 206, 302

Ensure that the change in elevation is within the recommended value.

Recommendation Up to 0.25 inches

Remove tripping hazards \$198

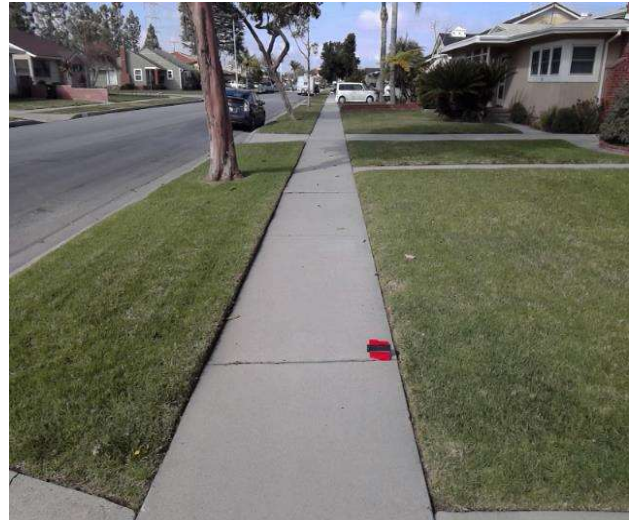
There is a change in elevation greater than recommended value.

Code Reference ADA 206, 302

Ensure that the change in elevation is within the recommended value.

Recommendation Up to 0.25 inches

Remove tripping hazards \$198

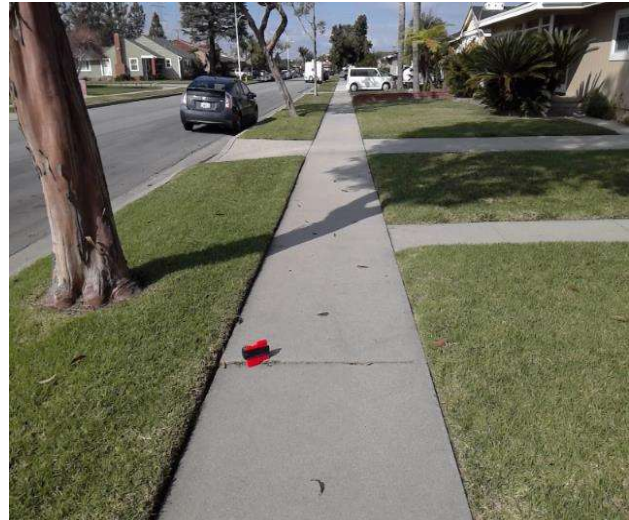
There is a change in elevation greater than recommended value.

Code Reference ADA 206, 302

Ensure that the change in elevation is within the recommended value.

Recommendation Up to 0.25 inches

Remove tripping hazards \$198

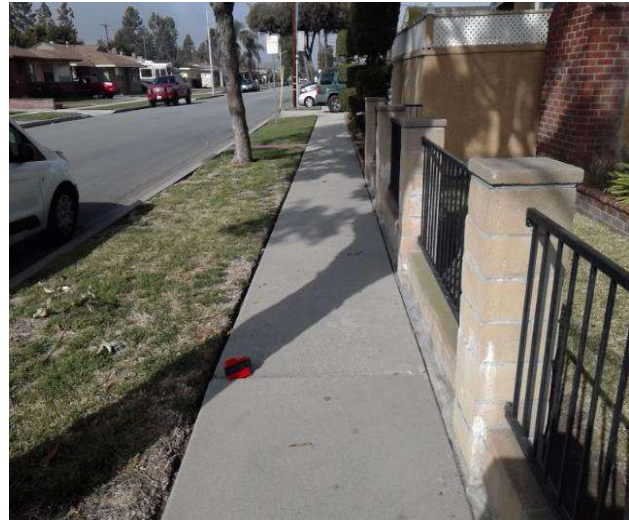
There is a change in elevation greater than recommended value.

Code Reference ADA 206, 302

Ensure that the change in elevation is within the recommended value.

Recommendation Up to 0.25 inches

Remove tripping hazards \$198

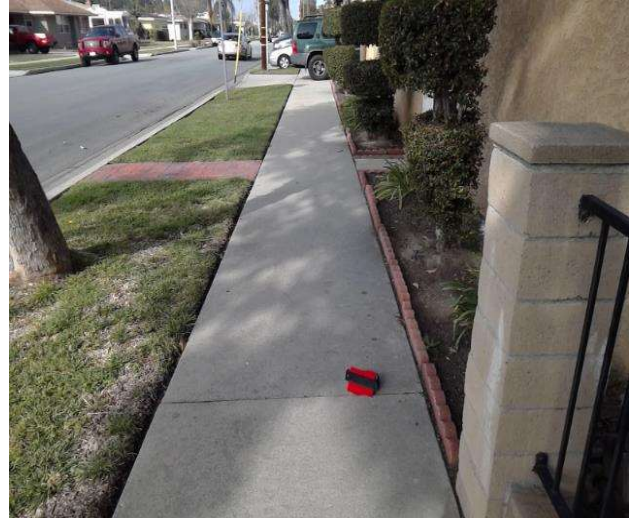
There is a change in elevation greater than recommended value.

Code Reference ADA 206, 302

Ensure that the change in elevation is within the recommended value.

Recommendation Up to 0.25 inches

Remove tripping hazards \$198

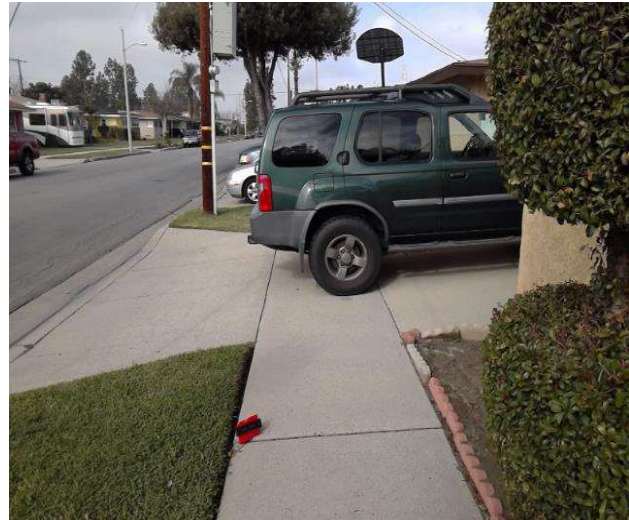
There is a change in elevation greater than recommended value.

Code Reference ADA 206, 302

Ensure that the change in elevation is within the recommended value.

Recommendation Up to 0.25 inches

Remove tripping hazards \$198

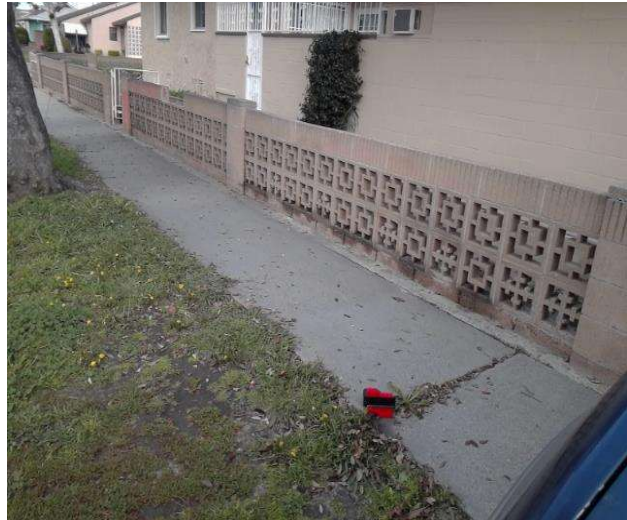
There is a change in elevation greater than recommended value.

Code Reference ADA 206, 302

Ensure that the change in elevation is within the recommended value.

Recommendation Up to 0.25 inches

Remove tripping hazards \$198

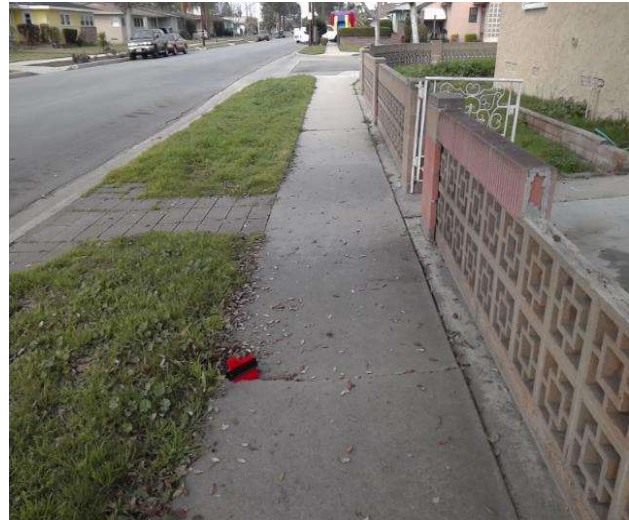
There is a change in elevation greater than recommended value.

Code Reference ADA 206, 302

Ensure that the change in elevation is within the recommended value.

Recommendation Up to 0.25 inches

Remove tripping hazards \$198

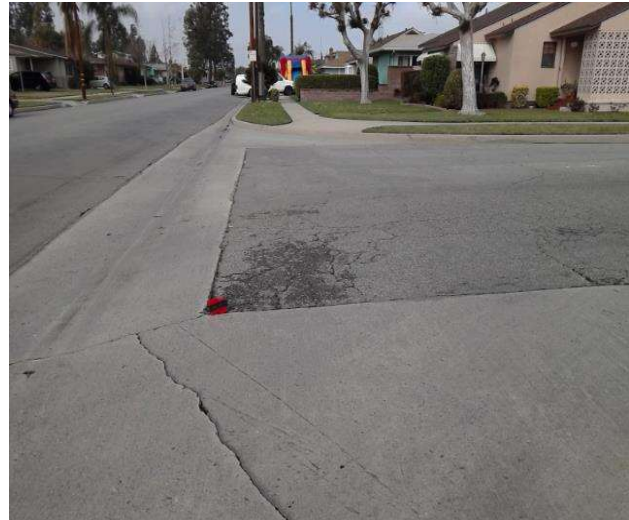
There is a change in elevation greater than recommended value.

Code Reference ADA 206, 302

Ensure that the change in elevation is within the recommended value.

Recommendation Up to 0.25 inches

Remove tripping hazards \$198

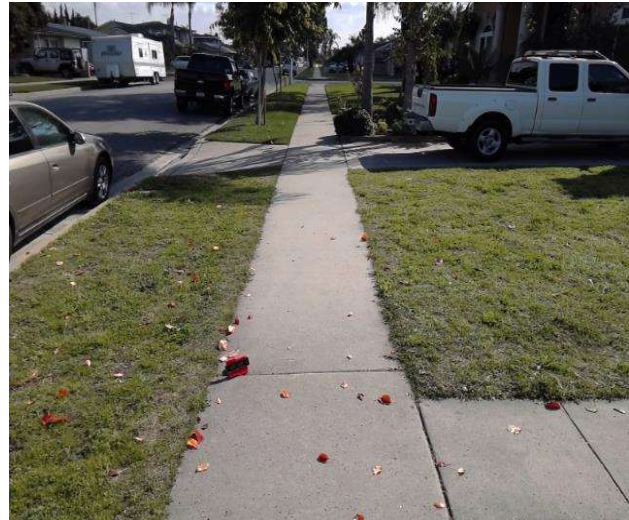
There is a change in elevation greater than recommended value.

Code Reference ADA 206, 302

Ensure that the change in elevation is within the recommended value.

Recommendation Up to 0.25 inches

Remove tripping hazards \$198

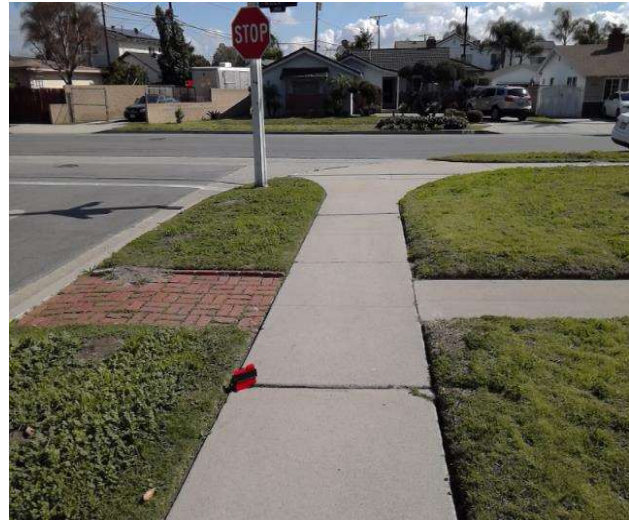
There is a change in elevation greater than recommended value.

Code Reference ADA 206, 302

Ensure that the change in elevation is within the recommended value.

Recommendation Up to 0.25 inches

Remove tripping hazards \$198

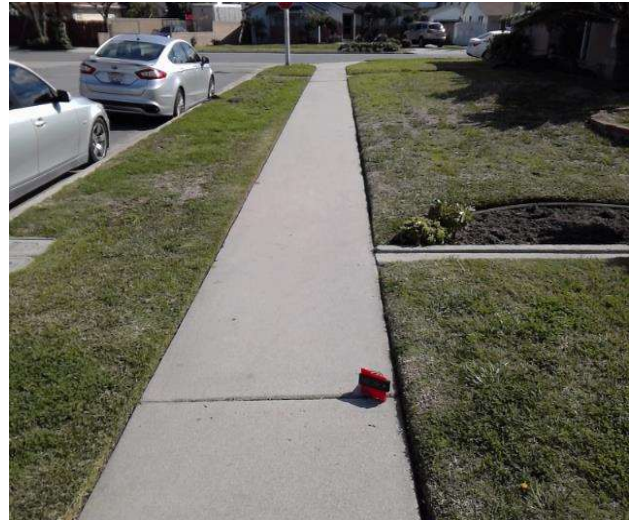
There is a change in elevation greater than recommended value.

Code Reference ADA 206, 302

Ensure that the change in elevation is within the recommended value.

Recommendation Up to 0.25 inches

Remove tripping hazards \$198

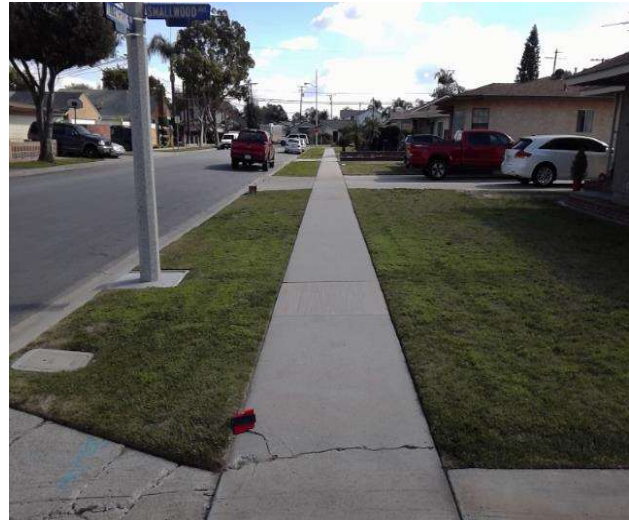
There is a change in elevation greater than recommended value.

Code Reference ADA 206, 302

Ensure that the change in elevation is within the recommended value.

Recommendation Up to 0.25 inches

Remove tripping hazards \$198

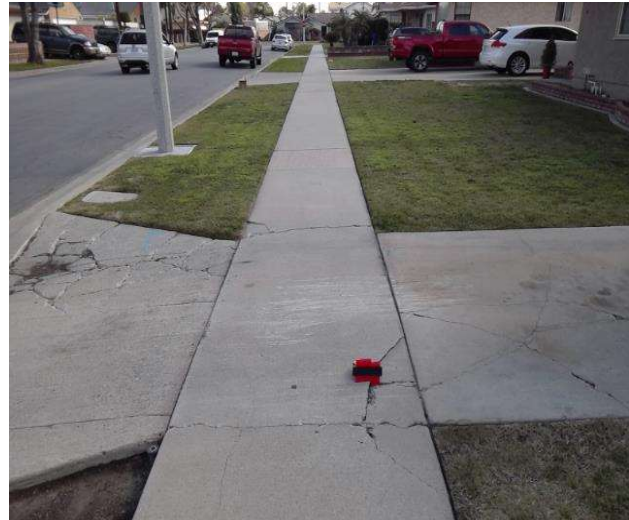
There is a change in elevation greater than recommended value.

Code Reference ADA 206, 302

Ensure that the change in elevation is within the recommended value.

Recommendation Up to 0.25 inches

Remove tripping hazards \$198

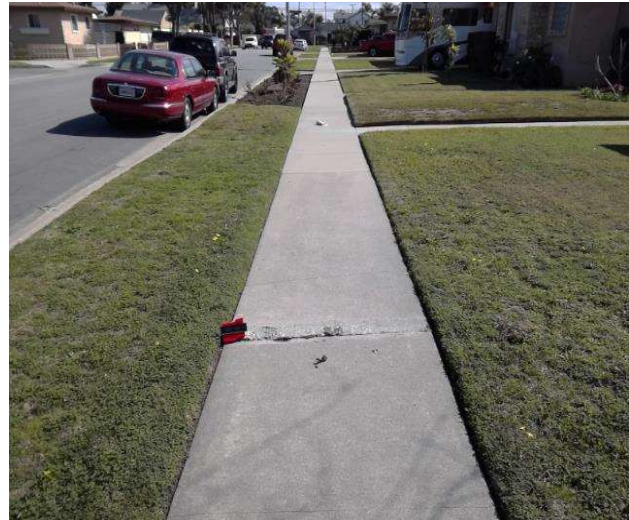
There is a change in elevation greater than recommended value.

Code Reference ADA 206, 302

Ensure that the change in elevation is within the recommended value.

Recommendation Up to 0.25 inches

Remove tripping hazards \$198

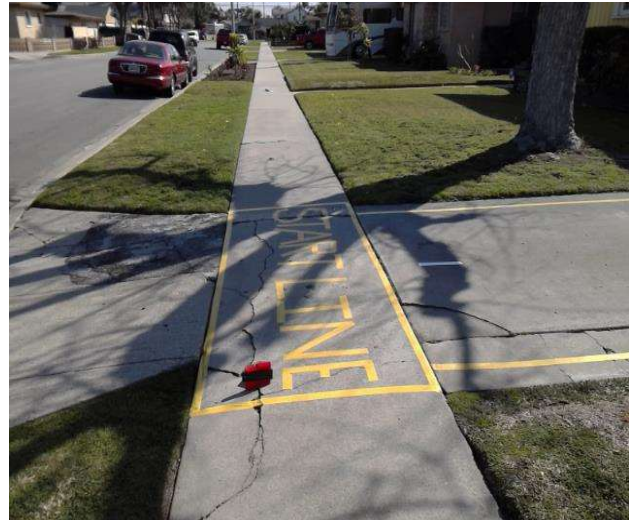
There is a change in elevation greater than recommended value.

Code Reference ADA 206, 302

Ensure that the change in elevation is within the recommended value.

Recommendation Up to 0.25 inches

Remove tripping hazards \$198

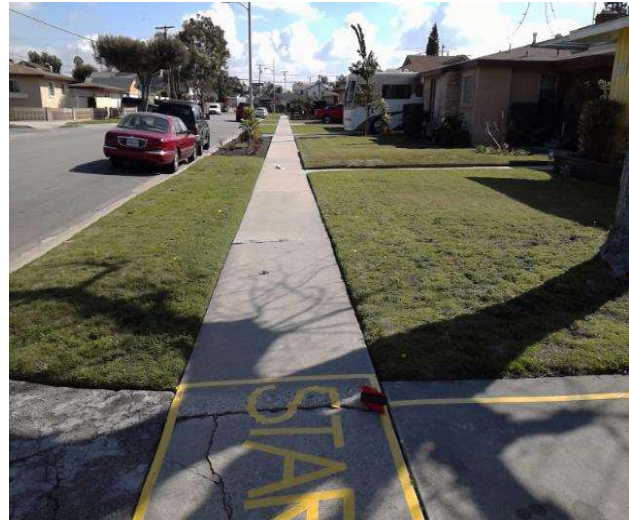
There is a change in elevation greater than recommended value.

Code Reference ADA 206, 302

Ensure that the change in elevation is within the recommended value.

Recommendation Up to 0.25 inches

Remove tripping hazards \$198

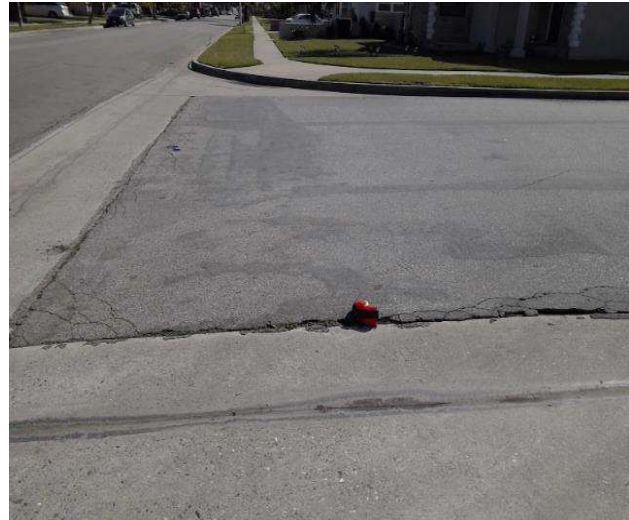
There is a change in elevation greater than recommended value.

Code Reference ADA 206, 302

Ensure that the change in elevation is within the recommended value.

Recommendation Up to 0.25 inches

Remove tripping hazards \$198

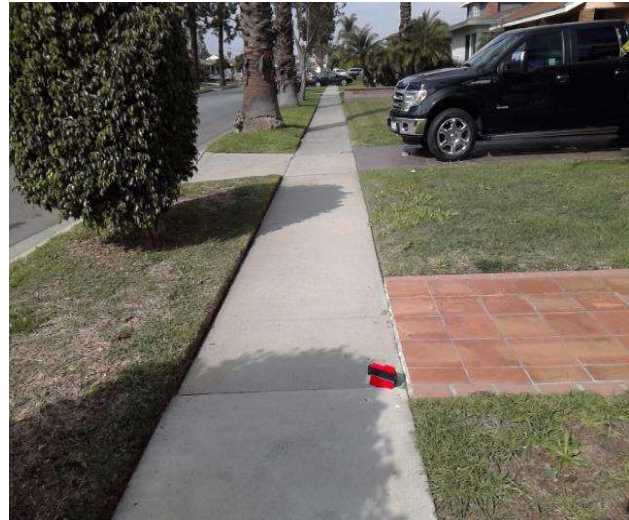
There is a change in elevation greater than recommended value.

Code Reference ADA 206, 302

Ensure that the change in elevation is within the recommended value.

Recommendation Up to 0.25 inches

Remove tripping hazards \$198

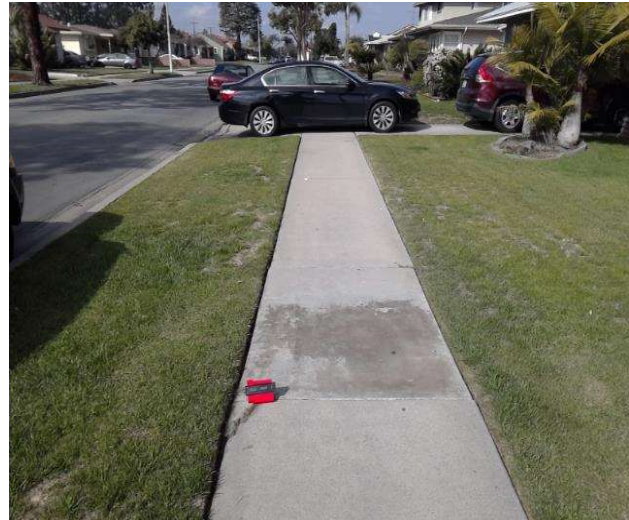
There is a change in elevation greater than recommended value.

Code Reference ADA 206, 302

Ensure that the change in elevation is within the recommended value.

Recommendation Up to 0.25 inches

Remove tripping hazards \$198

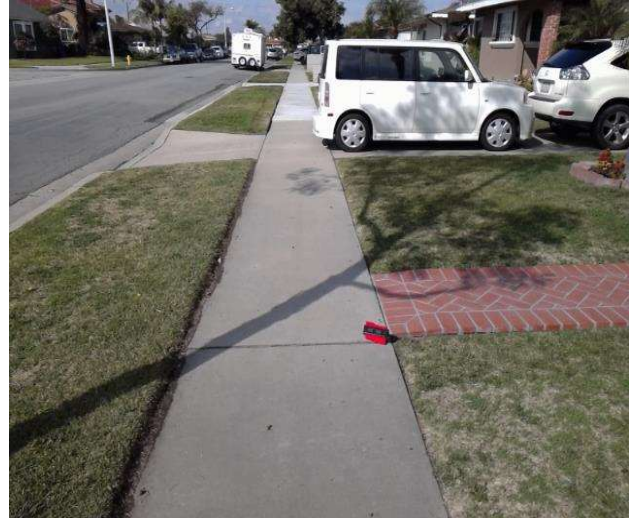
There is a change in elevation greater than recommended value.

Code Reference ADA 206, 302

Ensure that the change in elevation is within the recommended value.

Recommendation Up to 0.25 inches

Remove tripping hazards \$198

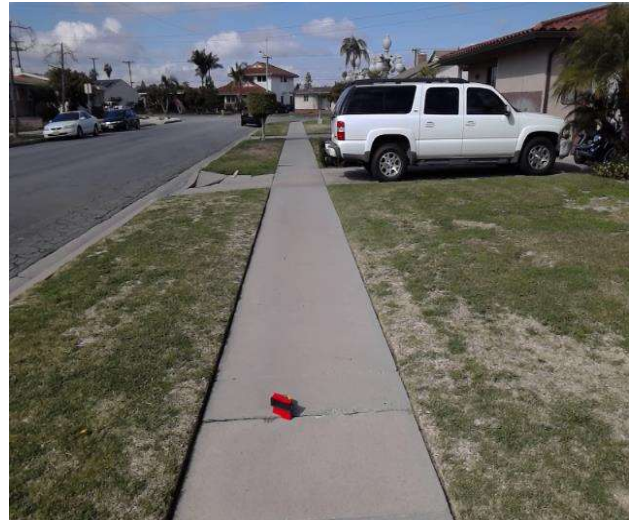
Code Reference ADA 206, 302

Remove tripping hazards \$198

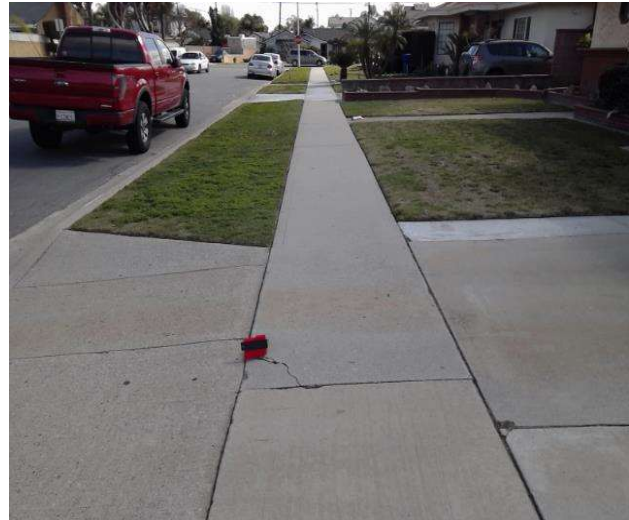
Code Reference ADA 206, 302

Remove tripping hazards \$198

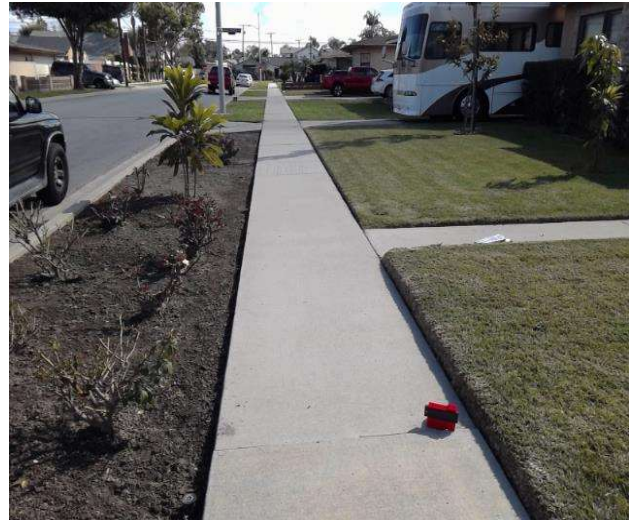
Code Reference ADA 206, 302

Remove tripping hazards \$198
