Accessibility Survey

City of Downey Allengrove Street - Parrot Avenue to Brock Avenue

Date of Inspection
6/23/2017

Disability Access Consultants

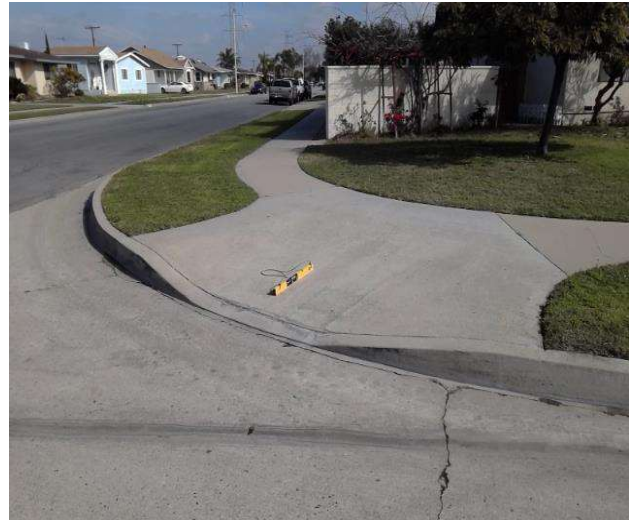
Code Reference CA 11B-406.5.12

Provide detectable warning to surface \$248

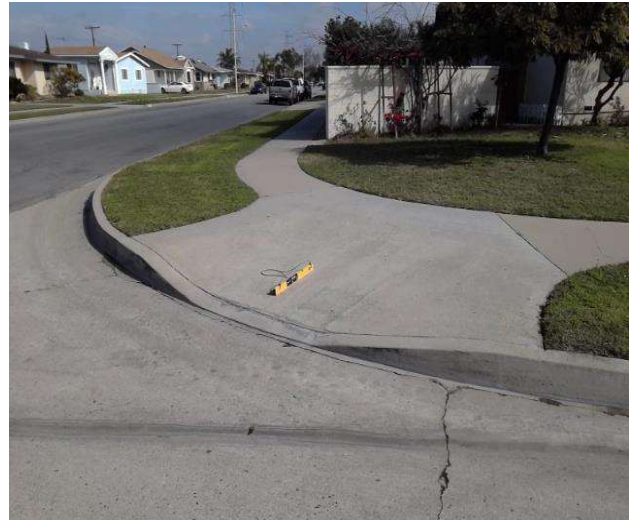
Code Reference ADA 406, 406.3, CA 11B-406.2.2

Install flared sides \$1,300

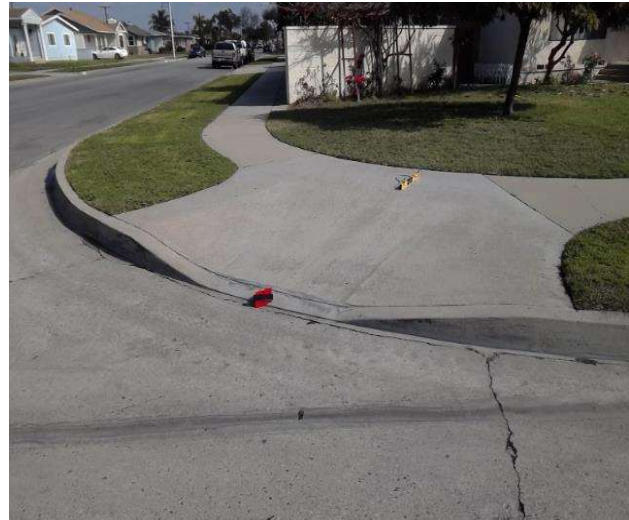
Curb Ramp , Landings and Transitions : Top Landing Slope

Code Reference ADA 402, 406.4, 403.3, 406.1, CA 11B-406.5.3

Provide compliant landing \$1,260

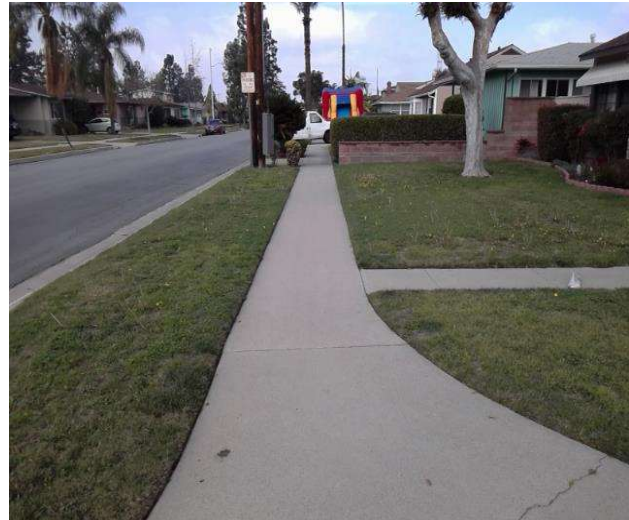
Code Reference ADA 206, 302, CA 11B-403.5.1

\$1,260

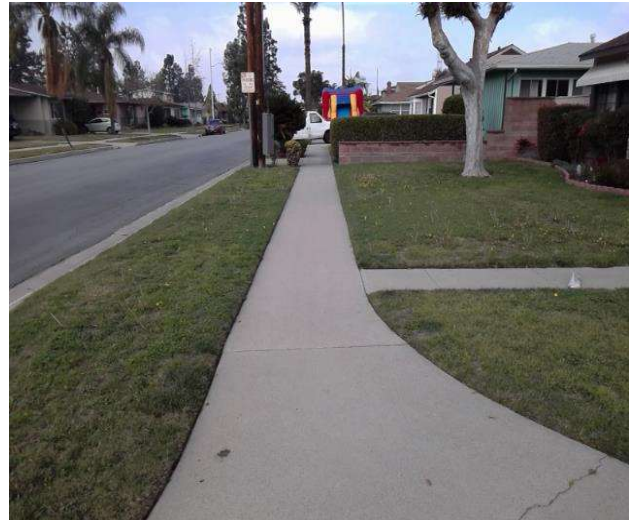
Code Reference ADA 206, 302,CA 11B-403.3

Repave surface \$1,092
