Accessibility Survey

City of Downey Cheyenne Street - Barlin Avenue To Blodgett Avenue

Date of Inspection
4/7/2017

Disability Access Consultants

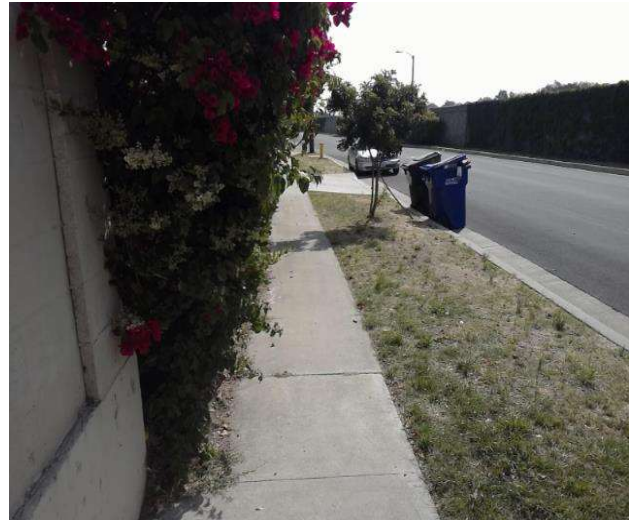
Bush East Of Barlin Avenue @ 33.913740492039, -118.143441528082

Sidewalks , Hazards & Gratings : Sidewalk Width at Obstruction

Sidewalk width at the obstruction is not compliant.

On-Site Finding 32.00 inches

Code Reference ADA 206, 302, 403.5.1, CA 11B-403.5

Sidewalk width at the obstruction shall have the recommended value.

Recommendation At least 48.00 inches

\$1,260

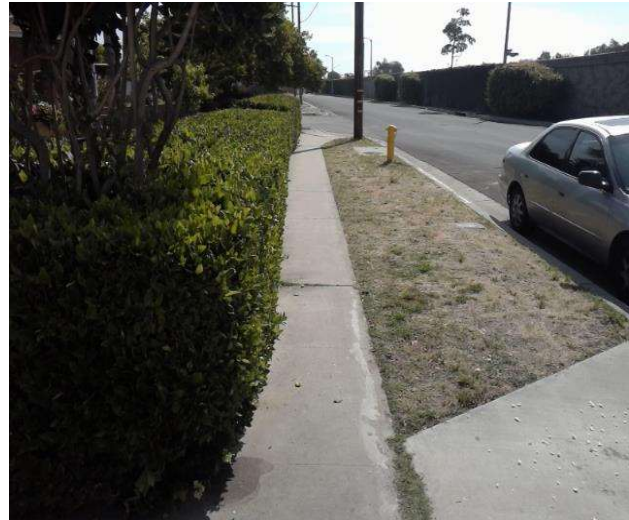
Bush East Of Barlin Avenue @ 33.913744943854, -118.143260478973

Sidewalks , Hazards & Gratings : Sidewalk Width at Obstruction

Code Reference ADA 206, 302, 403.5.1, CA 11B-403.5

Sidewalk width at the obstruction shall have the recommended value.

Recommendation At least 48.00 inches

\$1,260

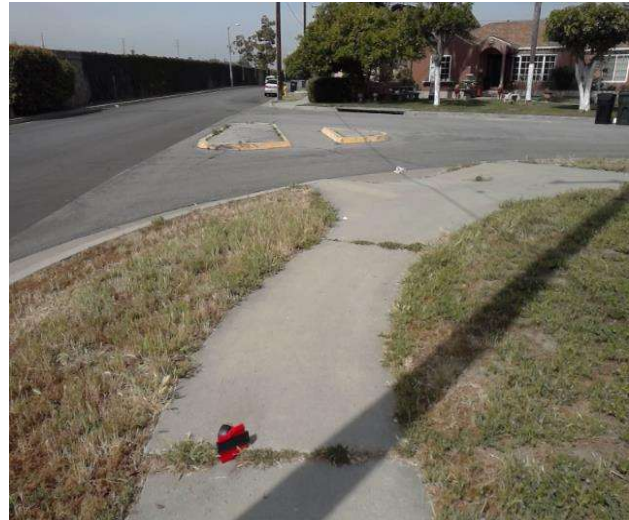
There is a change in elevation greater than recommended value.

Code Reference ADA 206, 302

Ensure that the change in elevation is within the recommended value.

Recommendation Up to 0.25 inches

Remove tripping hazards \$198

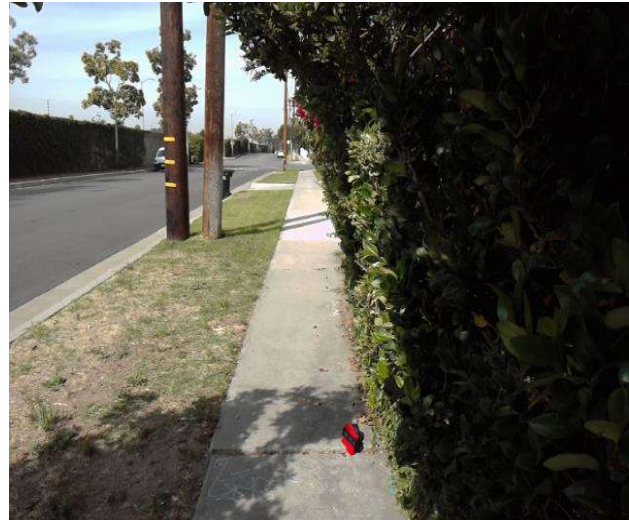
There is a change in elevation greater than recommended value.

Code Reference ADA 206, 302

Ensure that the change in elevation is within the recommended value.

Recommendation Up to 0.25 inches

Remove tripping hazards \$198

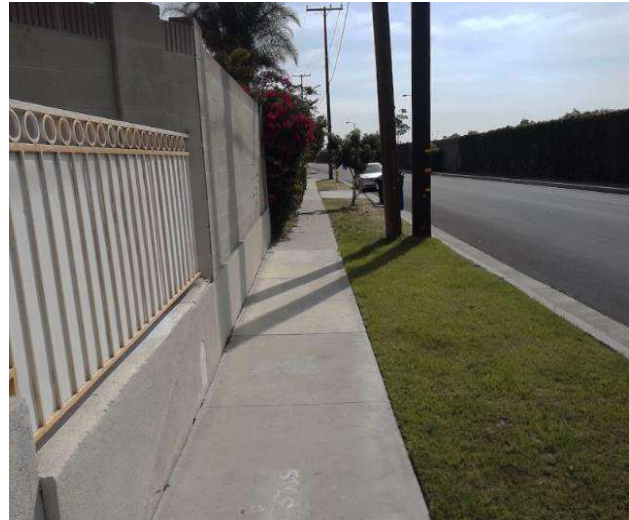
Code Reference ADA 206, 302, CA 11B-403.3

Repave the sidewalk surface with the recommended cross slope.

Recommendation Up to 2.08 percent

Repave surface \$1,092

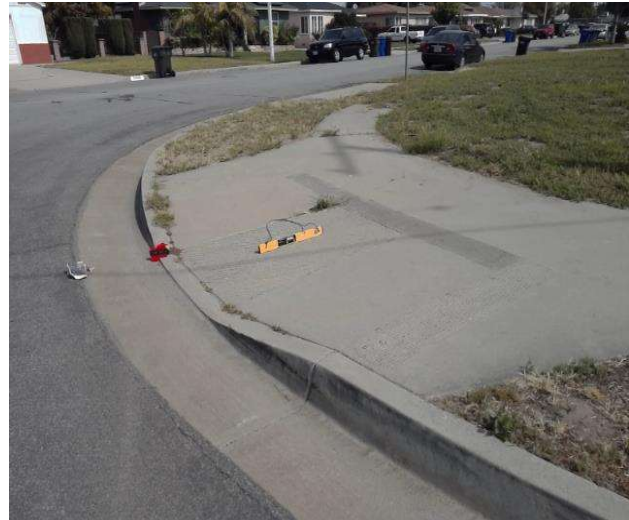
Code Reference ADA 406, 406.3, CA 11B-406.2.2

Recommendation Up to 10.00 percent

Install flared sides \$1,300

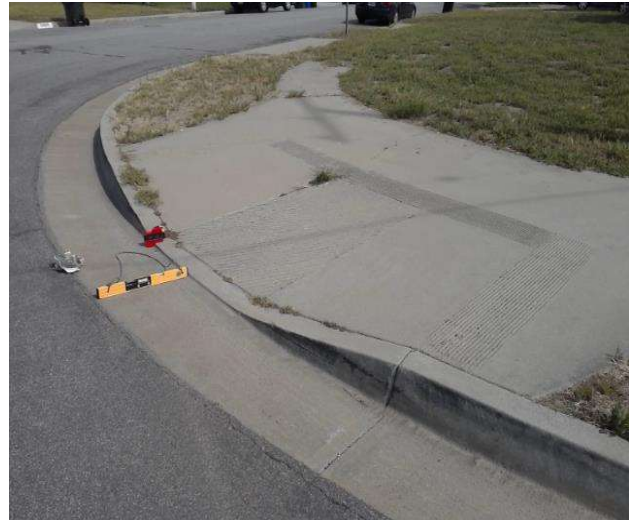
Curb Ramp , Landings And Transitions : Bottom Landing Change in Level

Code Reference ADA 302, 303, 406.2, 303.1

Recommendation Up to 0.50 inches

Patch lip at curb ramp \$255

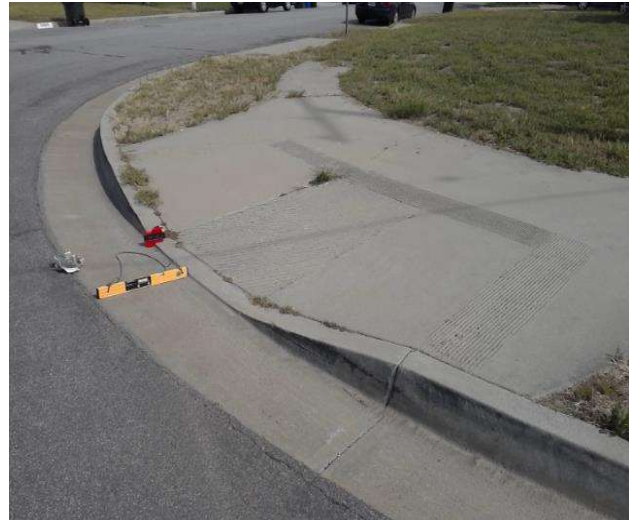
Code Reference ADA 402, 406.4, 403.3, 406.1, CA 11B-406.5.3

Recommendation Up to 2.08 percent

Provide compliant landing \$1,260

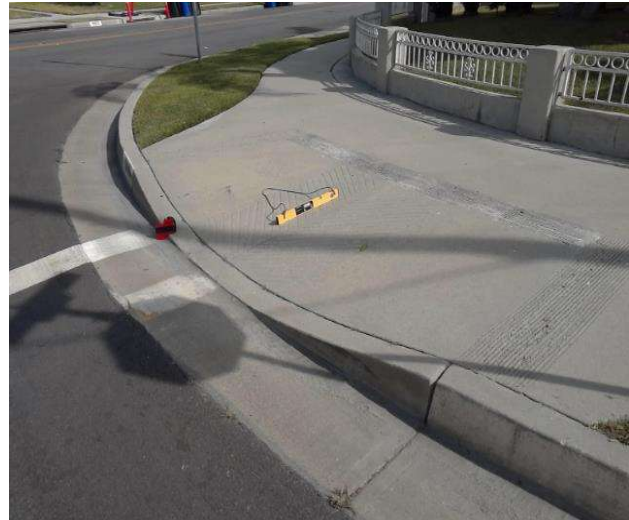
On-Site Finding Not Found

Code Reference CA 11B-406.5.12

Provide detectable warning to surface \$248

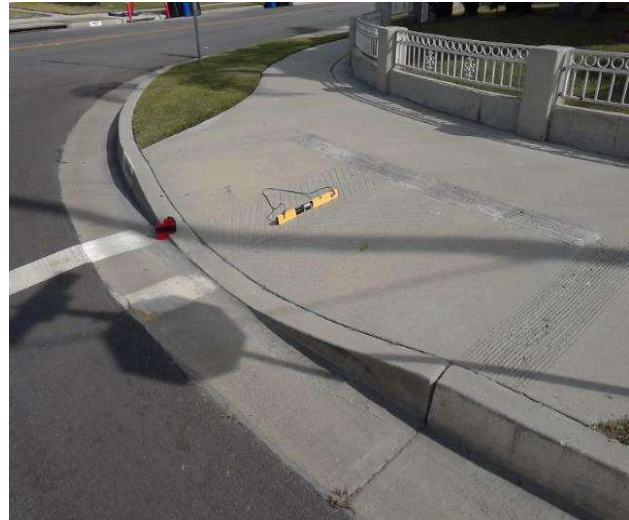
Code Reference ADA 406, 406.1, 405.2, CA 11B-406

Recommendation Up to 8.33 percent

Install curb ramp \$1,300

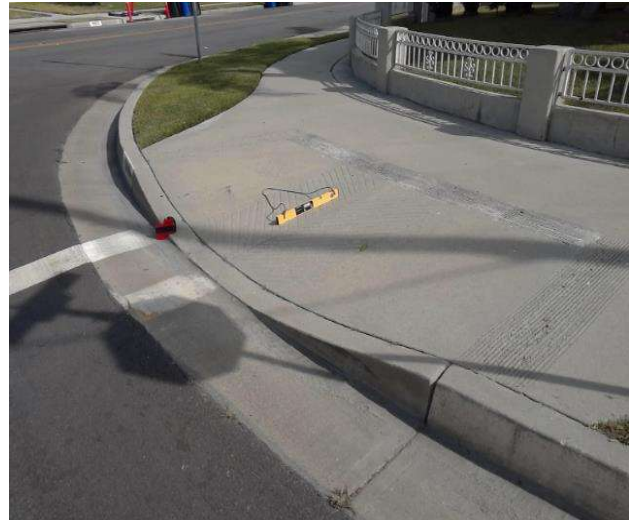
Code Reference ADA 406, 406.3, CA 11B-406.2.2

Recommendation Up to 10.00 percent

Install flared sides \$1,300

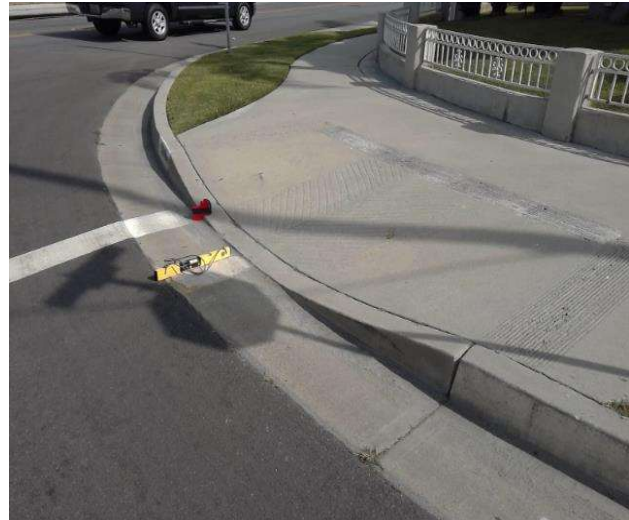
Code Reference ADA 406, 406.2, CA 11B-406.5.8

Recommendation Up to 5.00 percent

Repave landing \$1,260

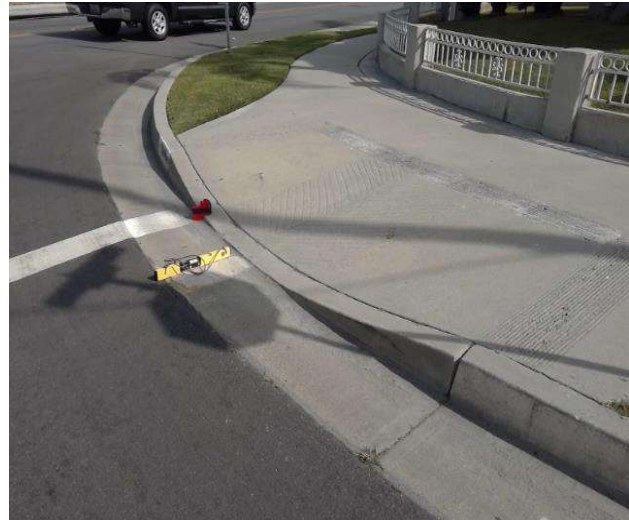
Curb Ramp , Landings And Transitions : Bottom Landing Change in Level

Code Reference ADA 302, 303, 406.2, 303.1

Recommendation Up to 0.50 inches

Patch lip at curb ramp \$255

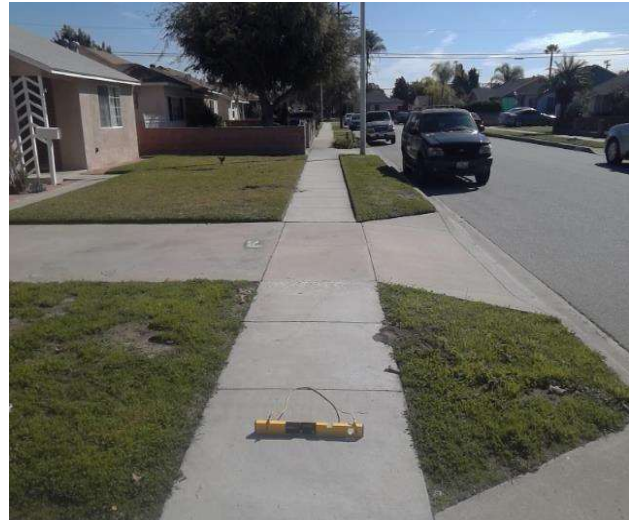
Code Reference ADA 206, 302, CA 11B-403.3

Repave the sidewalk surface with the recommended cross slope.

Recommendation Up to 2.08 percent

Repave surface \$1,092

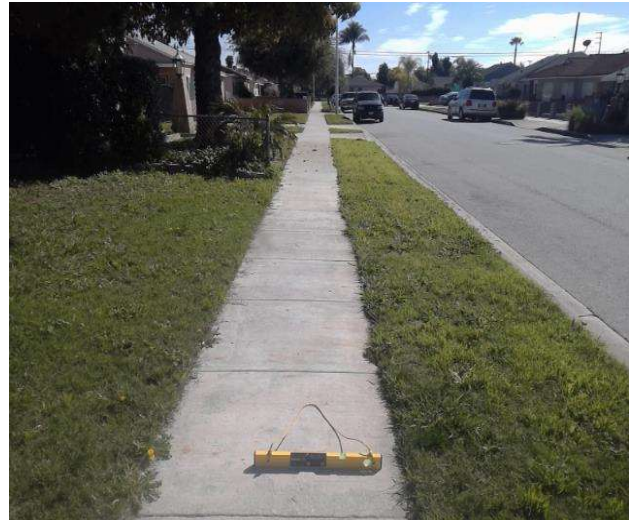
Code Reference ADA 206, 302, CA 11B-403.3

Repave the sidewalk surface with the recommended cross slope.

Recommendation Up to 2.08 percent

Repave surface \$1,092

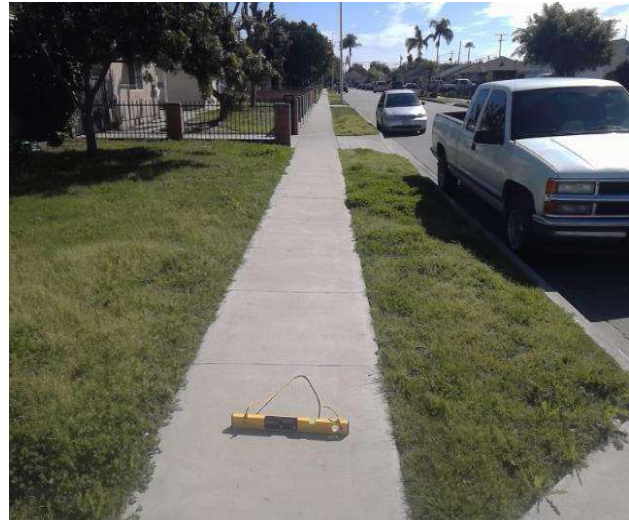
Code Reference ADA 206, 302, CA 11B-403.3

Repave the sidewalk surface with the recommended cross slope.

Recommendation Up to 2.08 percent

Repave surface \$1,092

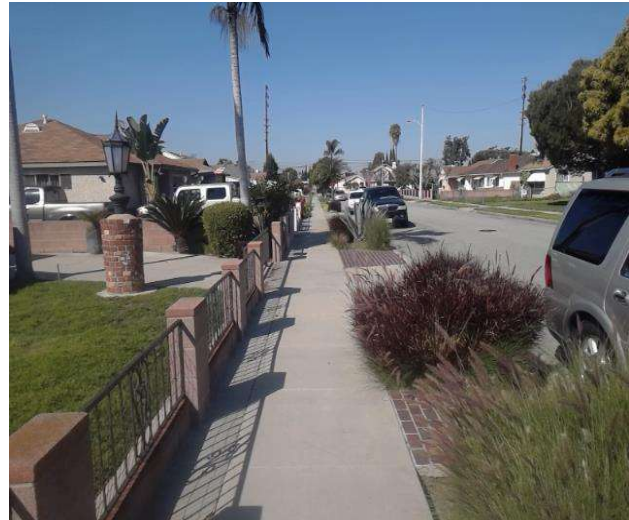
Sidewalks , Hazards & Gratings : Sidewalk Width at Obstruction

Code Reference ADA 206, 302, 403.5.1,CA 11B-403.5

Sidewalk width at the obstruction shall have the recommended value.

Recommendation At least 48.00 inches

\$1,260

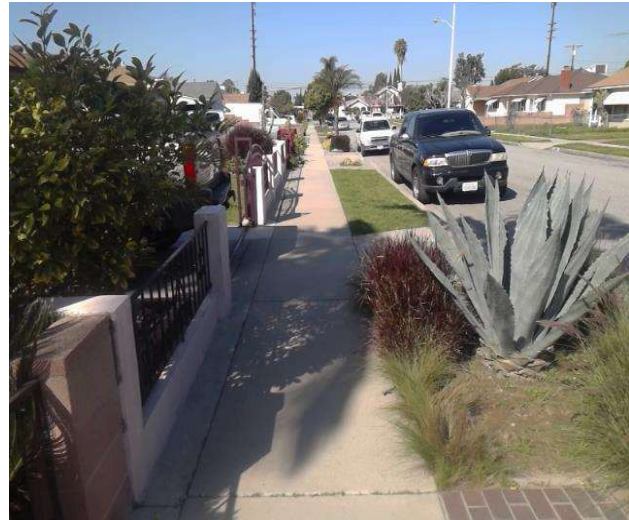
Sidewalks , Hazards & Gratings : Sidewalk Width at Obstruction

Code Reference ADA 206, 302, 403.5.1, CA 11B-403.5

Sidewalk width at the obstruction shall have the recommended value.

Recommendation At least 48.00 inches

\$1,260

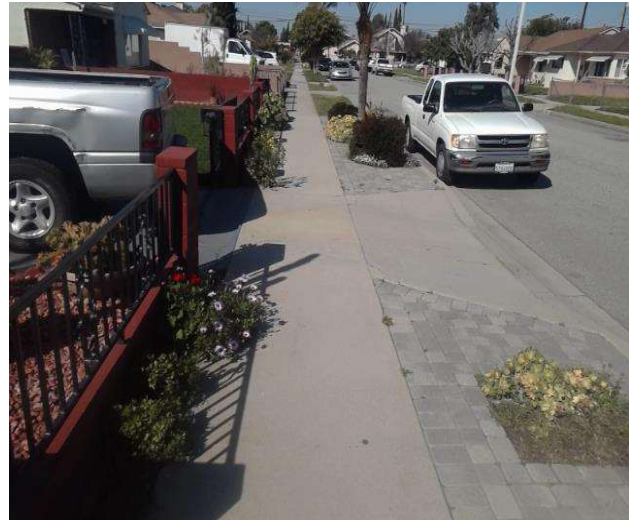
Sidewalks , Hazards & Gratings : Sidewalk Width at Obstruction

Code Reference ADA 206, 302, 403.5.1, CA 11B-403.5

Sidewalk width at the obstruction shall have the recommended value.

Recommendation At least 48.00 inches

\$1,260

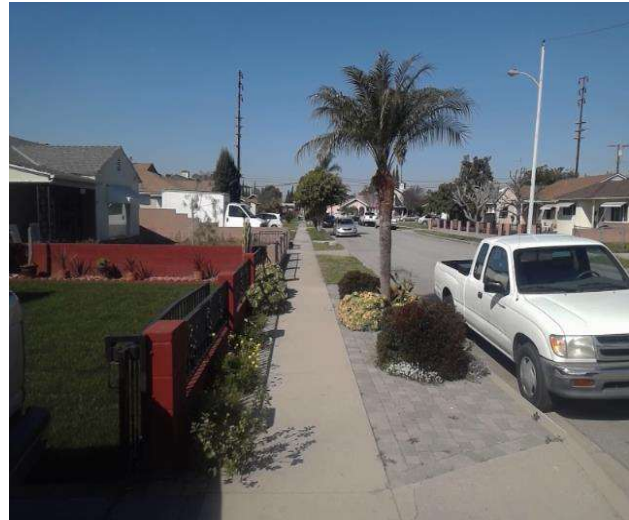
Sidewalks , Hazards & Gratings : Sidewalk Width at Obstruction

Code Reference ADA 206, 302, 403.5.1, CA 11B-403.5

Sidewalk width at the obstruction shall have the recommended value.

Recommendation At least 48.00 inches

\$1,260

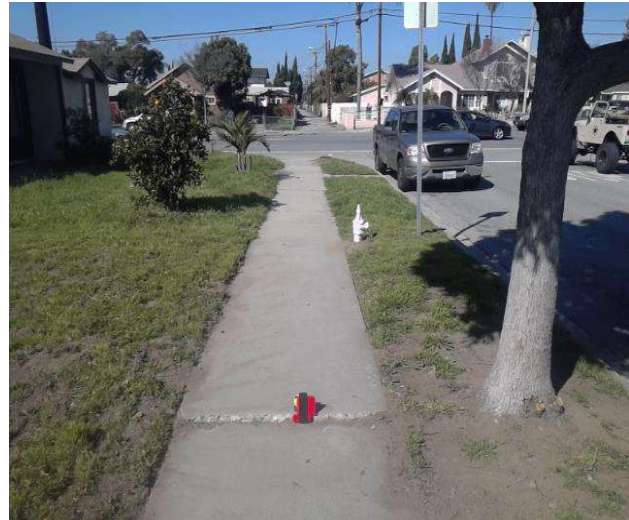
There is a change in elevation greater than recommended value.

Code Reference ADA 206, 302

Ensure that the change in elevation is within the recommended value.

Recommendation Up to 0.25 inches

Remove tripping hazards \$198

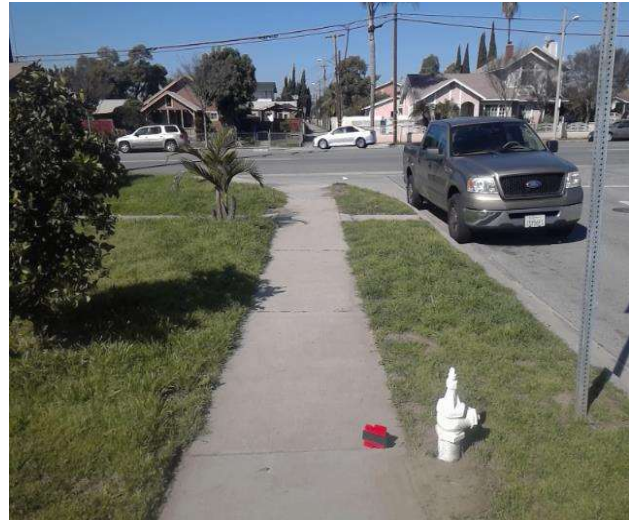
There is a change in elevation greater than recommended value.

Code Reference ADA 206, 302

Recommendation Up to 0.50 inches

Remove tripping hazards \$198

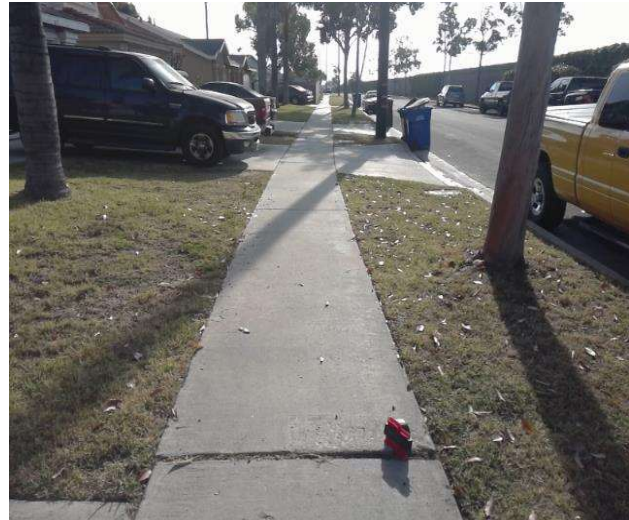
There is a change in elevation greater than recommended value.

Code Reference ADA 206, 302

Ensure that the change in elevation is within the recommended value.

Recommendation Up to 0.25 inches

Remove tripping hazards \$198

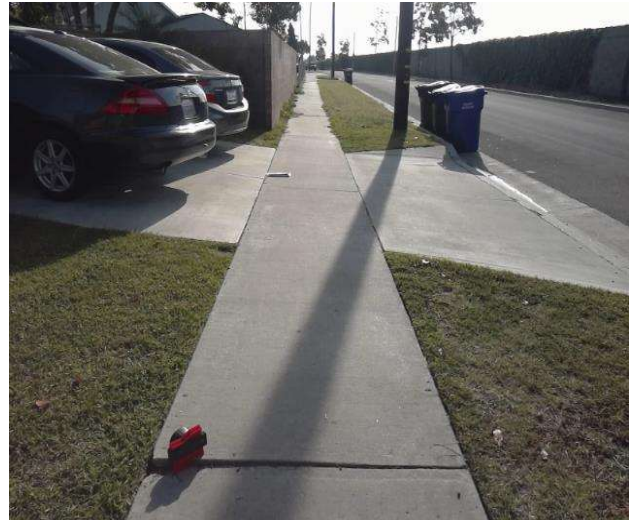
There is a change in elevation greater than recommended value.

Code Reference ADA 206, 302

Ensure that the change in elevation is within the recommended value.

Recommendation Up to 0.25 inches

Remove tripping hazards \$198

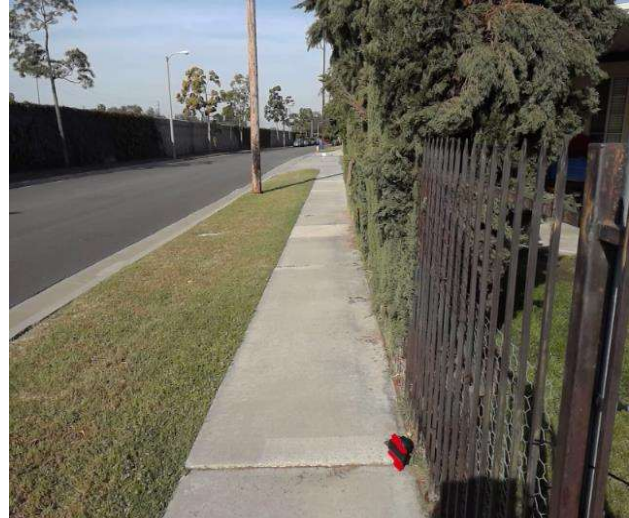
There is a change in elevation greater than recommended value.

Code Reference ADA 206, 302

Ensure that the change in elevation is within the recommended value.

Recommendation Up to 0.25 inches

Remove tripping hazards \$198

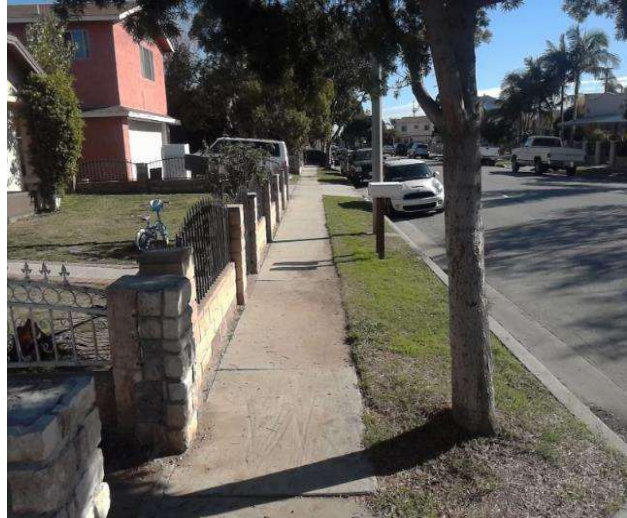
There is a change in elevation greater than recommended value.

Code Reference ADA 206, 302

Ensure that the change in elevation is within the recommended value.

Recommendation Up to 0.25 inches

Remove tripping hazards \$198

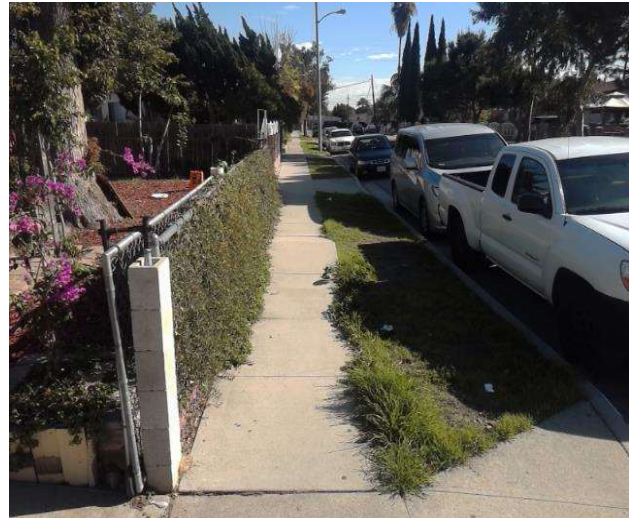
There is a change in elevation greater than recommended value.

Code Reference ADA 206, 302

Ensure that the change in elevation is within the recommended value.

Recommendation Up to 0.25 inches

Remove tripping hazards \$198

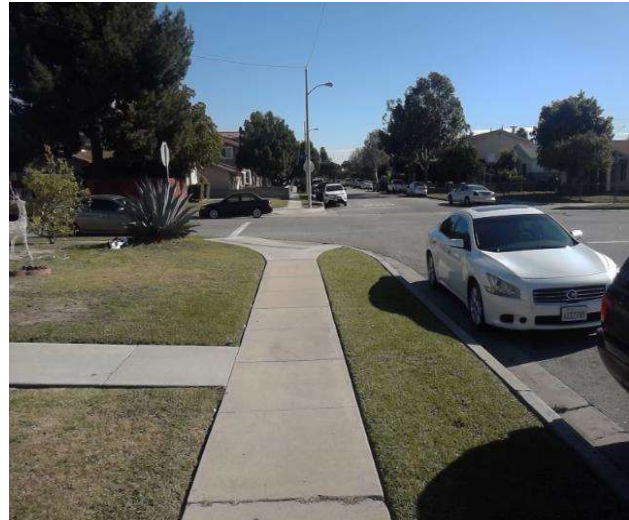
There is a change in elevation greater than recommended value.

Code Reference ADA 206, 302

Ensure that the change in elevation is within the recommended value.

Recommendation Up to 0.25 inches

Remove tripping hazards \$198
