Accessibility Survey

City of Downey Myrtle Street - 2nd Street to Firestone Boulevard

Date of Inspection 7/20/2017

Disability Access Consultants

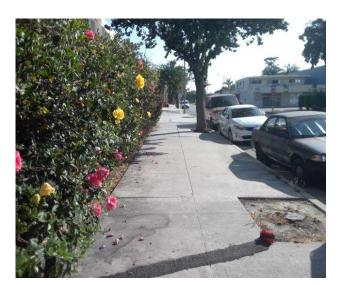
Change in Level North of Firestone Boulevard @ 33.942556669534, - 118.136317580938

Sidewalks , Change in Level : Change in Level Non Beveled

There is a change in elevation greater than recommended value.

On-Site Finding 1.00 inches

Code Reference ADA 206, 302

Ensure that the change in elevation is within the recommended value.

Recommendation Up to 0.25 inches

Remove tripping hazards \$198

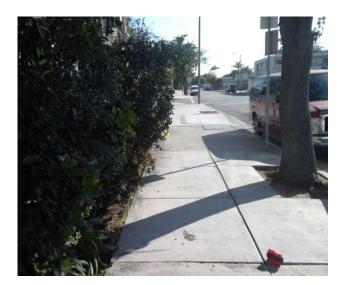
Change in Level North of Firestone Boulevard @ 33.942689066133, - 118.136215656996

Sidewalks , Change in Level : Change in Level Non Beveled

There is a change in elevation greater than recommended value.

On-Site Finding 0.50 inches

Code Reference ADA 206, 302

Ensure that the change in elevation is within the recommended value.

Recommendation Up to 0.25 inches

Remove tripping hazards \$198

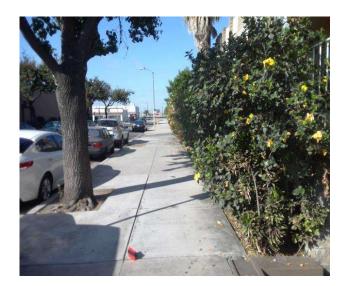
There is a change in elevation greater than recommended value.

Code Reference ADA 206, 302

Ensure that the change in elevation is within the recommended value.

Recommendation Up to 0.25 inches

Remove tripping hazards \$198

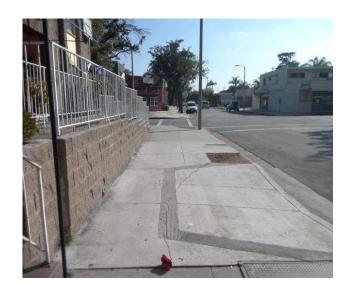
There is a change in elevation greater than recommended value.

Code Reference ADA 206, 302

Ensure that the change in elevation is within the recommended value.

Recommendation Up to 0.25 inches

Remove tripping hazards \$198

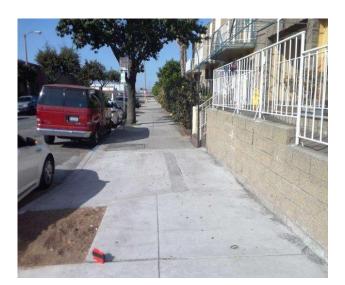
There is a change in elevation greater than recommended value.

Code Reference ADA 206, 302

Ensure that the change in elevation is within the recommended value.

Recommendation Up to 0.25 inches

Remove tripping hazards \$198

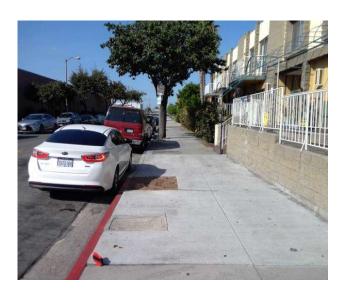
There is a change in elevation greater than recommended value.

Code Reference ADA 206, 302

Ensure that the change in elevation is within the recommended value.

Recommendation Up to 0.25 inches

Remove tripping hazards \$198

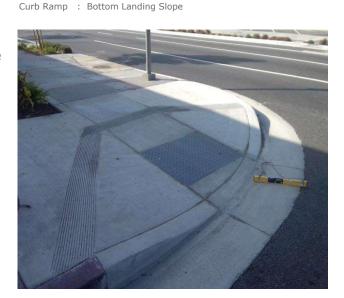
Code Reference ADA 406, 406.2,CA 11B-406.5.8

Recommendation Up to 5.00 percent

Repave landing \$1,260

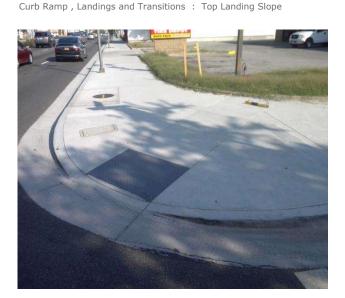
Code Reference ADA 402, 406.4, 403.3, 406.1,CA 11B-406.5.3

Recommendation Up to 2.08 percent

Provide compliant landing \$1,260

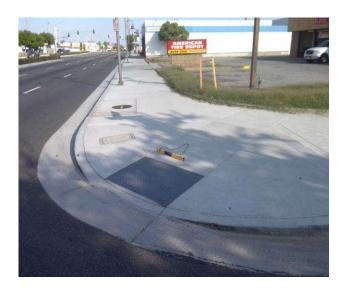
Code Reference ADA 402, 406.1, 405.3,CA 11B-406.5.7

Recommendation Up to 2.08 percent

Install curb ramp \$1,300

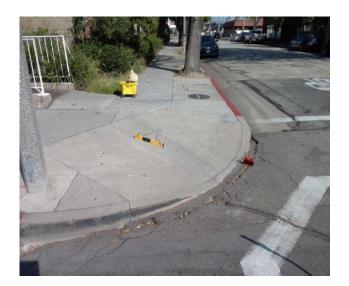
On-Site Finding Not Found

Code Reference CA 11B-406.5.12

Provide detectable warning to \$248 surface

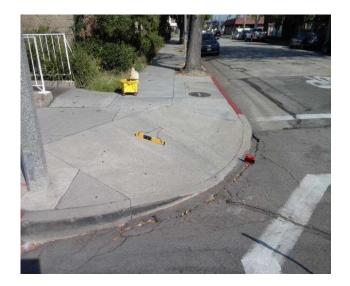
Code Reference ADA 406, 406.1, 405.2,CA 11B-406

Recommendation Up to 8.33 percent

Install curb ramp \$1,300

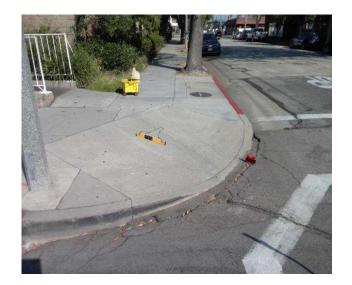
Code Reference ADA 402, 406.1, 405.3,CA 11B-406.5.7

Recommendation Up to 2.08 percent

Install curb ramp \$1,300

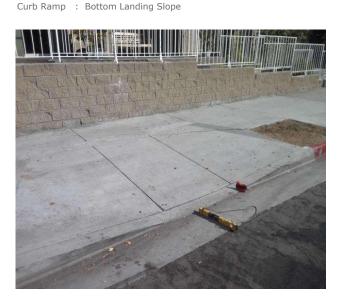
Code Reference ADA 406, 406.2,CA 11B-406.5.8

Recommendation Up to 5.00 percent

Repave landing \$1,260

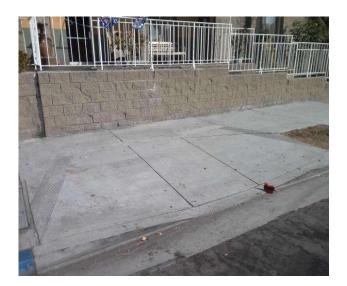
On-Site Finding Not Found

Code Reference CA 11B-406.5.12

Provide detectable warning to \$248 surface

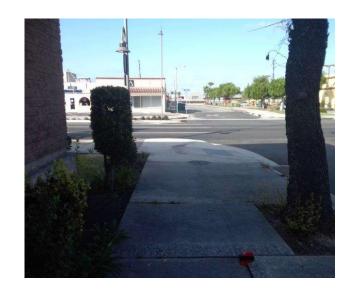
There is a change in elevation greater than recommended value.

Code Reference ADA 206, 302

Ensure that the change in elevation is within the recommended value.

Recommendation Up to 0.25 inches

Remove tripping hazards \$198

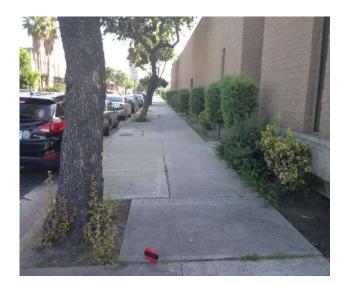
There is a change in elevation greater than recommended value.

Code Reference ADA 206, 302

Ensure that the change in elevation is within the recommended value.

Recommendation Up to 0.25 inches

Remove tripping hazards \$198

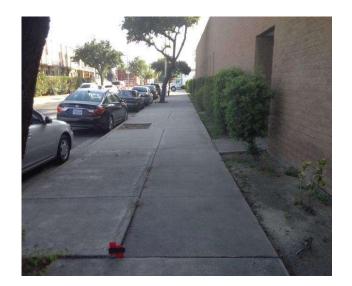
There is a change in elevation greater than recommended value.

Code Reference ADA 206, 302

Ensure that the change in elevation is within the recommended value.

Recommendation Up to 0.25 inches

Remove tripping hazards \$198

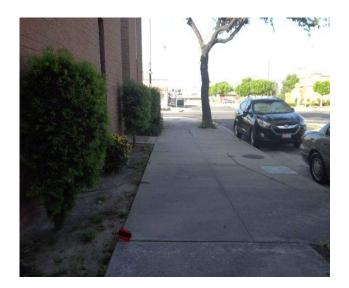
There is a change in elevation greater than recommended value.

Code Reference ADA 206, 302

Ensure that the change in elevation is within the recommended value.

Recommendation Up to 0.25 inches

Remove tripping hazards \$198

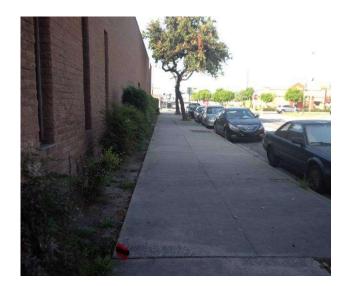
There is a change in elevation greater than recommended value.

Code Reference ADA 206, 302

Ensure that the change in elevation is within the recommended value.

Recommendation Up to 0.25 inches

Remove tripping hazards \$198

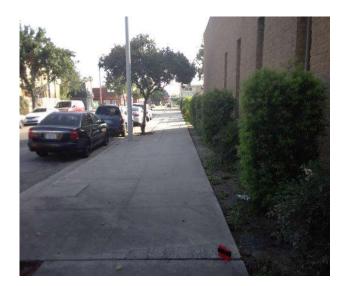
There is a change in elevation greater than recommended value.

Code Reference ADA 206, 302

Ensure that the change in elevation is within the recommended value.

Recommendation Up to 0.25 inches

Remove tripping hazards \$198

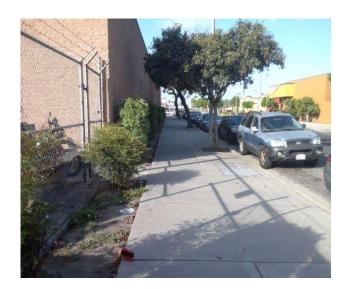
There is a change in elevation greater than recommended value.

Code Reference ADA 206, 302

Ensure that the change in elevation is within the recommended value.

Recommendation Up to 0.25 inches

Remove tripping hazards \$198

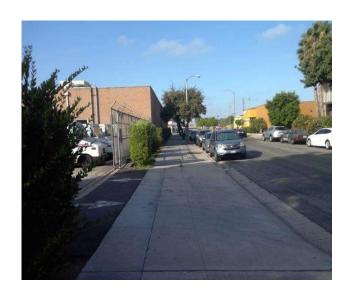
On-Site Finding Not Found

Code Reference ADA 705,CA 11B-705.1.2.5,CA 11B-247.1.2.5

Install compliant detectable \$190

warnings

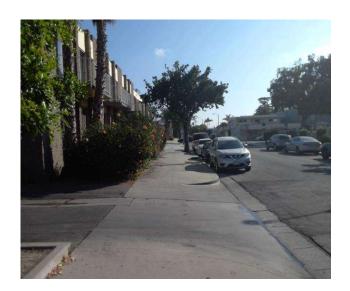
On-Site Finding Not Found

Code Reference ADA 705,CA 11B-705.1.2.5,CA 11B-247.1.2.5

Install compliant detectable \$190

warnings

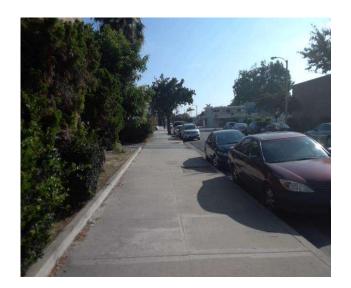
Code Reference ADA 206, 302,CA 11B-403.3

Repave the sidewalk surface with the recommended cross slope.

Recommendation Up to 2.08 percent

Repave surface \$1,092

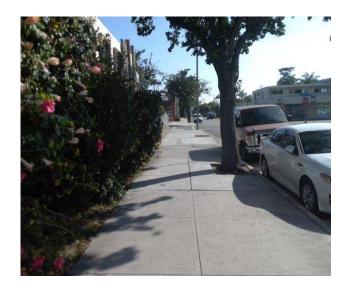
Code Reference ADA 206, 302,CA 11B-403.3

Repave the sidewalk surface with the recommended cross slope.

Recommendation Up to 2.08 percent

Repave surface \$1,092

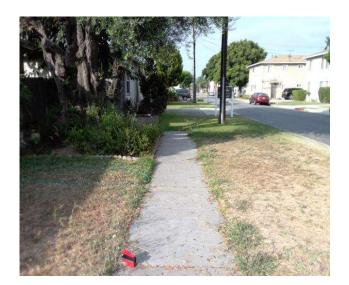
There is a change in elevation greater than recommended value.

Code Reference ADA 206, 302

Ensure that the change in elevation is within the recommended value.

Recommendation Up to 0.25 inches

Remove tripping hazards \$198

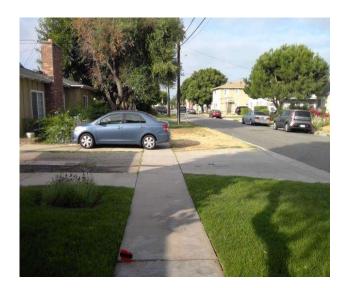
There is a change in elevation greater than recommended value.

Code Reference ADA 206, 302

Ensure that the change in elevation is within the recommended value.

Recommendation Up to 0.25 inches

Remove tripping hazards \$198

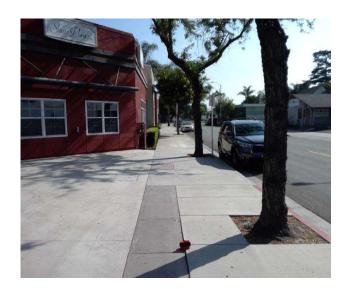
There is a change in elevation greater than recommended value.

Code Reference ADA 206, 302

Ensure that the change in elevation is within the recommended value.

Recommendation Up to 0.25 inches

Remove tripping hazards \$198

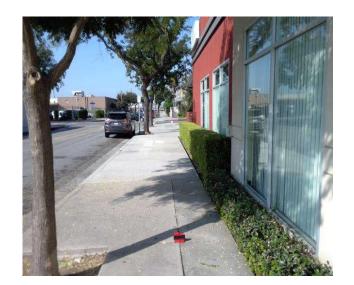
There is a change in elevation greater than recommended value.

Code Reference ADA 206, 302

Ensure that the change in elevation is within the recommended value.

Recommendation Up to 0.25 inches

Remove tripping hazards \$198

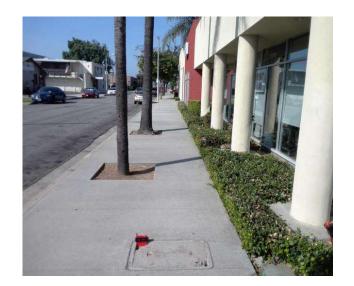
There is a change in elevation greater than recommended value.

Code Reference ADA 206, 302

Ensure that the change in elevation is within the recommended value.

Recommendation Up to 0.25 inches

Remove tripping hazards \$198

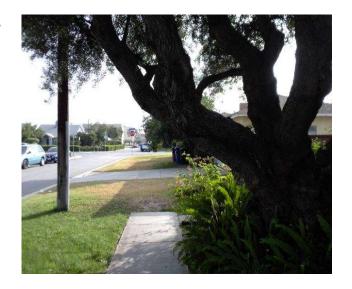
Sidewalks , Hazards & Gratings : Overhead Obstruction Height

Code Reference ADA 206, 307.4,CA 11B-307.4

Recommendation At least 80.00 inches

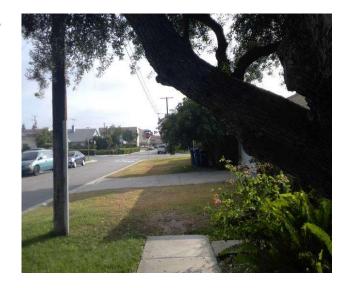
Sidewalks , Hazards & Gratings : Overhead Obstruction Height

Code Reference ADA 206, 307.4,CA 11B-307.4

Recommendation At least 80.00 inches

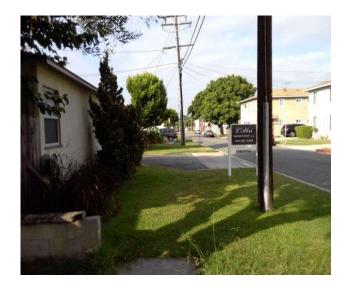
Sidewalks : Missing Sidewalk

Section of sidewalk is missing and consists of dirt, grass or gravel.

Code Reference ADA 206, 302,CA 11B-302,CA 11B-206

Provide a compliant sidewalk for the missing section.

\$1,260

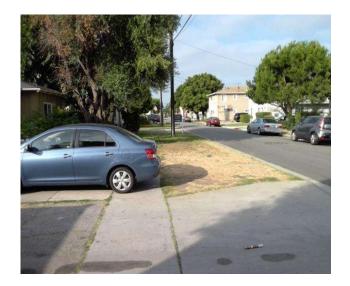
Code Reference ADA 206, 302,CA 11B-403.3

Repave the sidewalk surface with the recommended cross slope.

Recommendation Up to 2.08 percent

Repave surface \$1,092

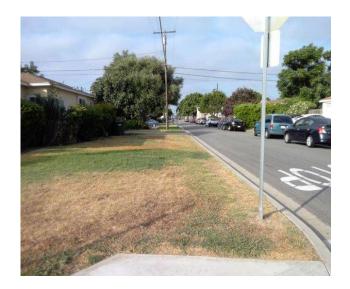
Sidewalks : Missing Sidewalk

Section of sidewalk is missing and consists of dirt, grass or gravel.

Code Reference ADA 206, 302,CA 11B-302,CA 11B-206

Provide a compliant sidewalk for the missing section.

\$1,260

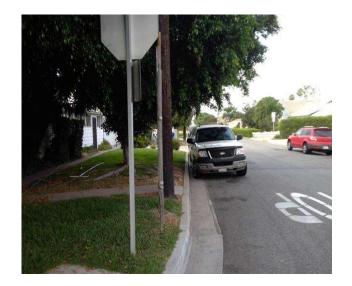
Sidewalks : Missing Sidewalk

Section of sidewalk is missing and consists of dirt, grass or gravel.

Code Reference ADA 206, 302,CA 11B-302,CA 11B-206

Provide a compliant sidewalk for the missing section.

\$1,260

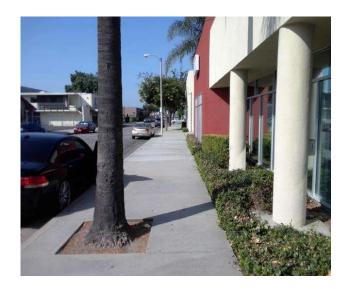
Code Reference ADA 206, 302,CA 11B-403.5.1

Widen the sidewalk to the recommended value.

Recommendation At least 48.00 inches

\$1,260

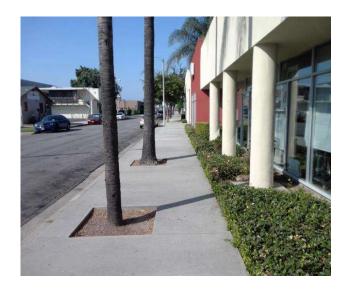
Code Reference ADA 206, 302,CA 11B-403.5.1

Widen the sidewalk to the recommended value.

Recommendation At least 48.00 inches

\$1,260

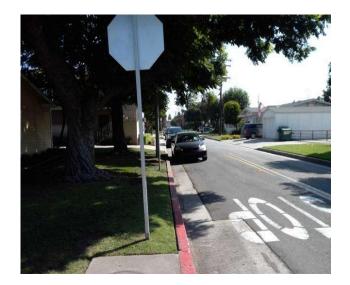
Sidewalks : Missing Sidewalk

Section of sidewalk is missing and consists of dirt, grass or gravel.

Code Reference ADA 206, 302,CA 11B-302,CA 11B-206

Provide a compliant sidewalk for the missing section.

\$1,260

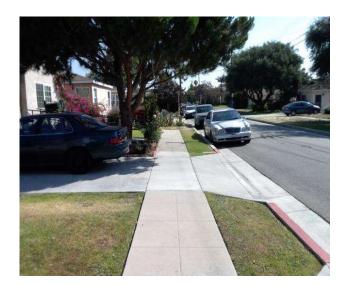
Code Reference ADA 206, 302,CA 11B-403.3

Repave the sidewalk surface with the recommended cross slope.

Recommendation Up to 2.08 percent

Repave surface \$1,092

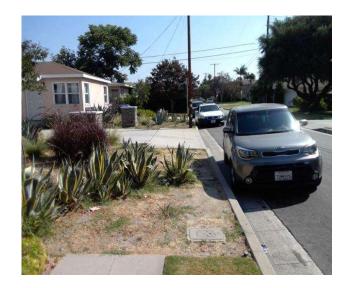
Sidewalks : Missing Sidewalk

Section of sidewalk is missing and consists of dirt, grass or gravel.

Code Reference ADA 206, 302,CA 11B-302,CA 11B-206

Recommendation See Recommendation

\$1,260
