Accessibility Survey

City of Downey New Street - 6th Street to 2nd Street

6th Street to 2nd Street Downey, CA 90242

Date of Inspection 7/19/2017

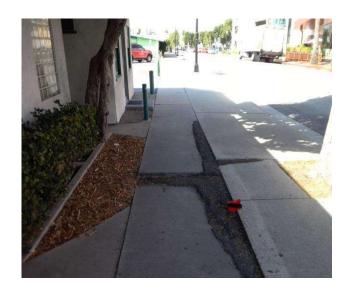
Change in Level South of 3rd Street @ 33.942098286438, -118.132724761963

Sidewalks , Change in Level : Change in Level Non Beveled

There is a change in elevation greater than recommended value.

On-Site Finding 2.00 inches

Code Reference ADA 206, 302 Notes: Surface is Rough And Uneven

Ensure that the change in elevation is within the recommended value.

Recommendation Up to 0.25 inches

Remove tripping hazards \$198

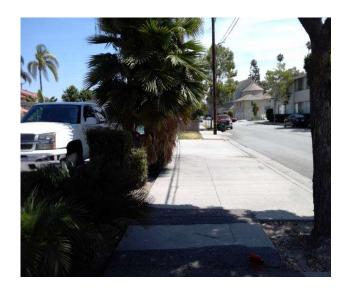
Change in Level North of 4th Street @ 33.943698166225, -118.131551295519

Sidewalks , Change in Level : Change in Level Non Beveled

There is a change in elevation greater than recommended value.

Code Reference ADA 206, 302 Notes: Surface is Rough And Uneven

Ensure that the change in elevation is within the recommended value.

Recommendation Up to 0.25 inches

Remove tripping hazards \$198

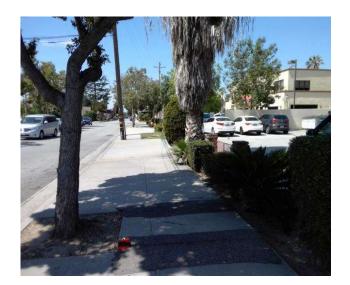
There is a change in elevation greater than recommended value.

Code Reference ADA 206, 302 Notes: Surface is Rough And Uneven

Ensure that the change in elevation is within the recommended value.

Recommendation Up to 0.25 inches

Remove tripping hazards \$198

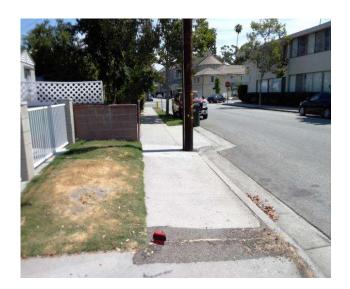
There is a change in elevation greater than recommended value.

Code Reference ADA 206, 302 Notes: Surface is Rough And Uneven

Ensure that the change in elevation is within the recommended value.

Recommendation Up to 0.25 inches

Remove tripping hazards \$198

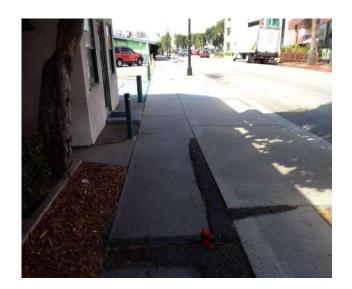
There is a change in elevation greater than recommended value.

Code Reference ADA 206, 302

Ensure that the change in elevation is within the recommended value.

Recommendation Up to 0.25 inches

Remove tripping hazards \$198

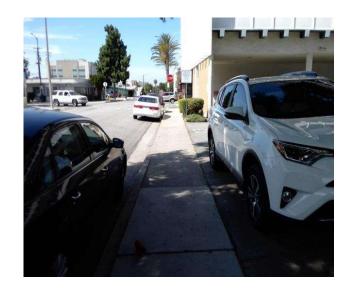
There is a change in elevation greater than recommended value.

Code Reference ADA 206, 302

Ensure that the change in elevation is within the recommended value.

Recommendation Up to 0.25 inches

Remove tripping hazards \$198

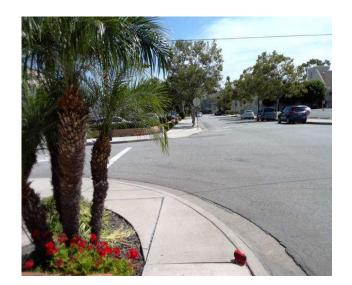
There is a change in elevation greater than recommended value.

Code Reference ADA 206, 302

Ensure that the change in elevation is within the recommended value.

Recommendation Up to 0.25 inches

Remove tripping hazards \$198

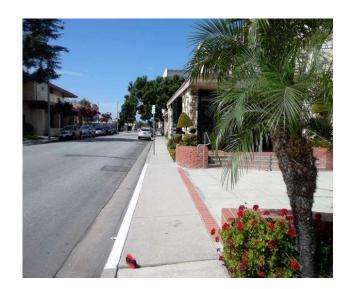
There is a change in elevation greater than recommended value.

Code Reference ADA 206, 302

Ensure that the change in elevation is within the recommended value.

Recommendation Up to 0.25 inches

Remove tripping hazards \$198

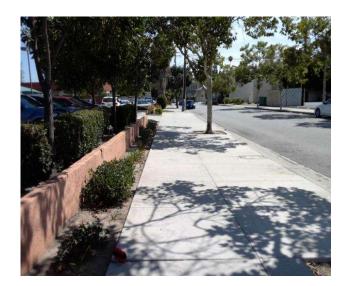
There is a change in elevation greater than recommended value.

Code Reference ADA 206, 302

Ensure that the change in elevation is within the recommended value.

Recommendation Up to 0.25 inches

Remove tripping hazards \$198

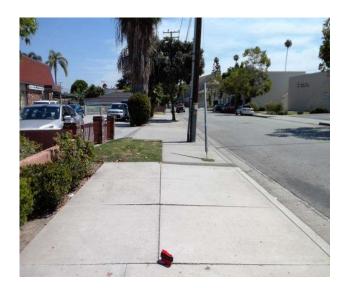
There is a change in elevation greater than recommended value.

Code Reference ADA 206, 302

Ensure that the change in elevation is within the recommended value.

Recommendation Up to 0.25 inches

Remove tripping hazards \$198

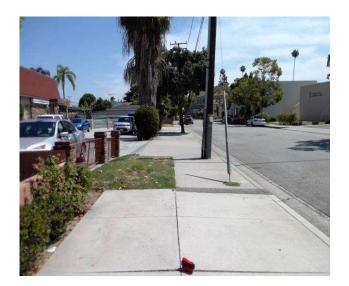
There is a change in elevation greater than recommended value.

Code Reference ADA 206, 302

Ensure that the change in elevation is within the recommended value.

Recommendation Up to 0.25 inches

Remove tripping hazards \$198

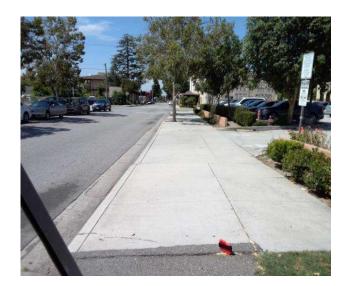
There is a change in elevation greater than recommended value.

Code Reference ADA 206, 302 Notes: Surface is Rough And Uneven

Ensure that the change in elevation is within the recommended value.

Recommendation Up to 0.25 inches

Remove tripping hazards \$198

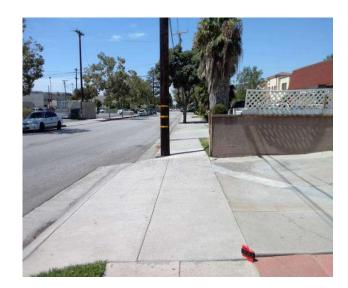
There is a change in elevation greater than recommended value.

Code Reference ADA 206, 302

Ensure that the change in elevation is within the recommended value.

Recommendation Up to 0.25 inches

Remove tripping hazards \$198

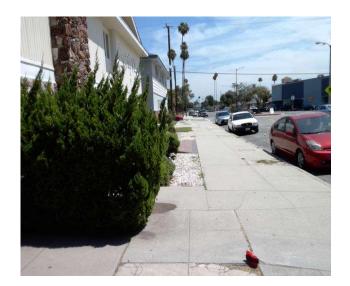
There is a change in elevation greater than recommended value.

Code Reference ADA 206, 302

Ensure that the change in elevation is within the recommended value.

Recommendation Up to 0.25 inches

Remove tripping hazards \$198

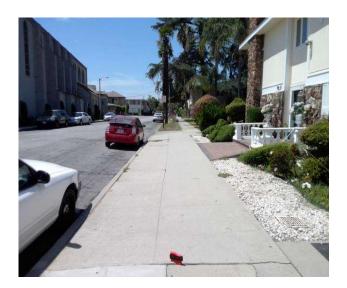
There is a change in elevation greater than recommended value.

Code Reference ADA 206, 302

Ensure that the change in elevation is within the recommended value.

Recommendation Up to 0.25 inches

Remove tripping hazards \$198

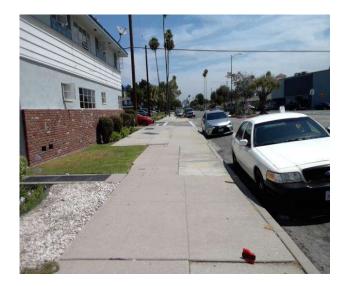
There is a change in elevation greater than recommended value.

Code Reference ADA 206, 302

Ensure that the change in elevation is within the recommended value.

Recommendation Up to 0.25 inches

Remove tripping hazards \$198

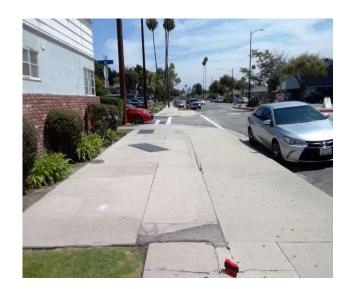
There is a change in elevation greater than recommended value.

Code Reference ADA 206, 302

Ensure that the change in elevation is within the recommended value.

Recommendation Up to 0.25 inches

Remove tripping hazards \$198

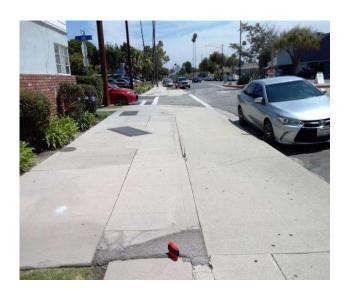
There is a change in elevation greater than recommended value.

Code Reference ADA 206, 302 Notes: Surface is Rough And Uneven

Ensure that the change in elevation is within the recommended value.

Recommendation Up to 0.25 inches

Remove tripping hazards \$198

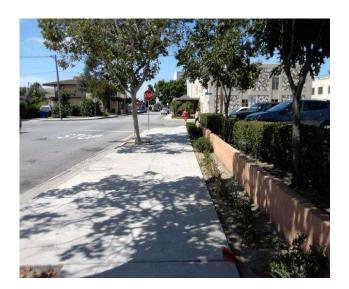
There is a change in elevation greater than recommended value.

Code Reference ADA 206, 302

Ensure that the change in elevation is within the recommended value.

Recommendation Up to 0.25 inches

Remove tripping hazards \$198

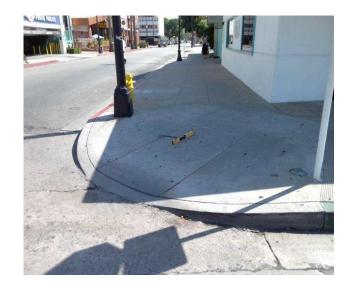
On-Site Finding Not Found

Code Reference CA 11B-406.5.12

Provide detectable warning to \$248 surface

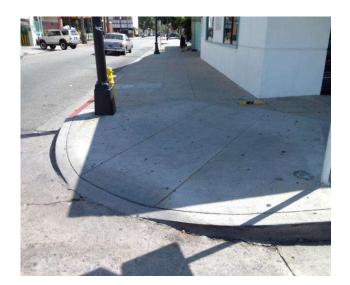
Code Reference ADA 402, 406.4, 403.3, 406.1,CA 11B-406.5.3

Recommendation Up to 2.08 percent

Provide compliant landing \$1,260

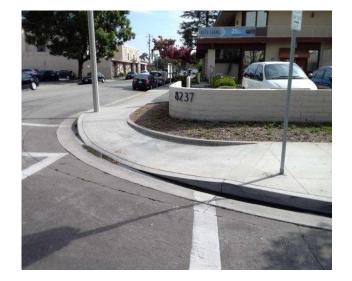
Code Reference ADA 406.1, 405.2,CA 11B-406

Recommendation Up to 8.33 percent

Install curb ramp \$1,300

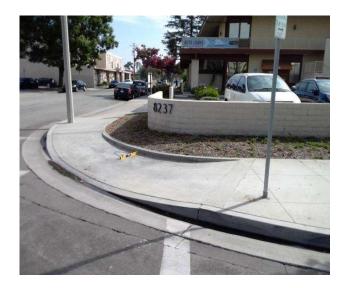
ADA 402, 406.4, 403.3, 406.1, CA 11B-406.5.3 **Code Reference**

Recommendation Up to 2.08 percent

Provide compliant landing \$1,260

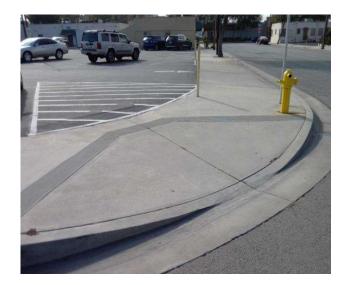
On-Site Finding Not Found

Code Reference CA 11B-406.5.12

Provide detectable warning to \$248 surface

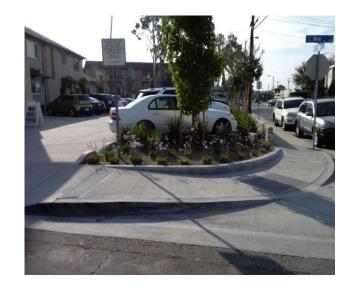
Code Reference ADA 406.1, 405.2,CA 11B-406

Recommendation Up to 8.33 percent

Install curb ramp \$1,300

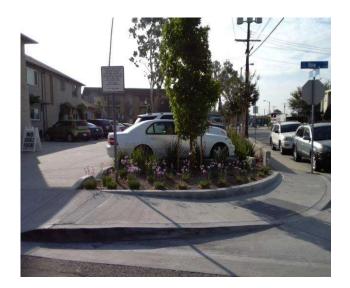
Code Reference ADA 402, 406.4, 403.3, 406.1,CA 11B-406.5.3

Recommendation Up to 2.08 percent

Provide compliant landing \$1,260

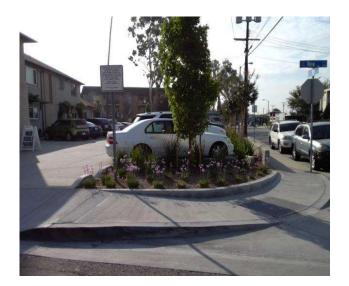
Curb Ramp , Landings and Transitions : Top Landing Right Side Clear

Code Reference ADA 406.4,CA 11B-406.5.3

Recommendation At least 48.00 inches

Provide compliant landing \$240

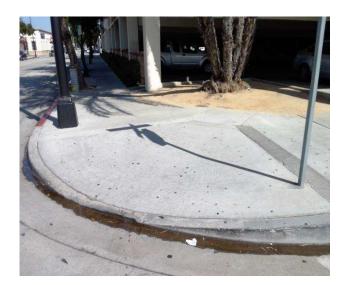
On-Site Finding Not Found

Code Reference CA 11B-406.5.12

Provide detectable warning to \$248 surface

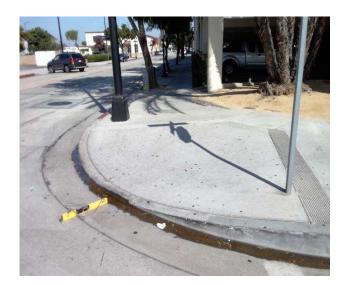
Code Reference ADA 402, 406.4, 403.3, 406.1,CA 11B-406.5.3

Recommendation Up to 2.08 percent

Provide compliant landing \$1,260

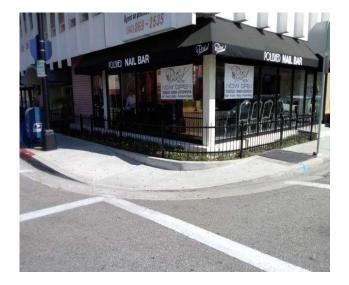
Code Reference ADA 406.1,CA 11B-406.5.2,CA 11B-406

Recommendation At least 48.00 inches

Install curb ramp \$1,300

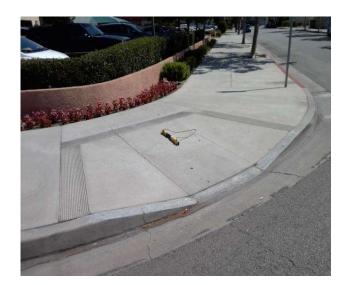
On-Site Finding Not Found

Code Reference CA 11B-406.5.12

Provide detectable warning to \$248 surface

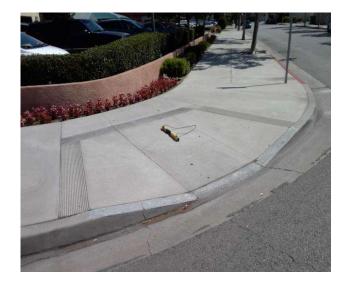
Code Reference ADA 406, 406.1, 405.2,CA 11B-406

Recommendation Up to 8.33 percent

Install curb ramp \$1,300

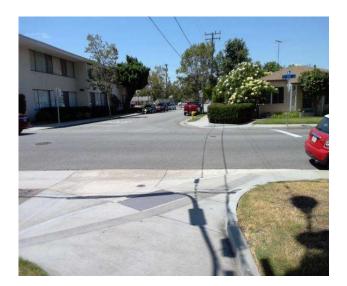
Curb Ramp , Landings and Transitions : Top Landing Clear Length -

Code Reference ADA 406, 406.4,CA 11B-406.5.3

Recommendation At least 48.00 inches

Provide compliant landing \$240

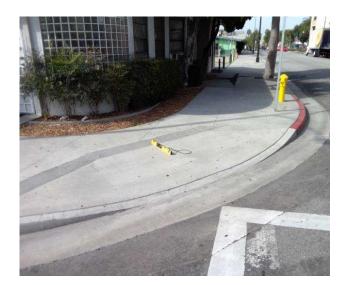
On-Site Finding Not Found

Code Reference CA 11B-406.5.12

Provide detectable warning to \$248 surface

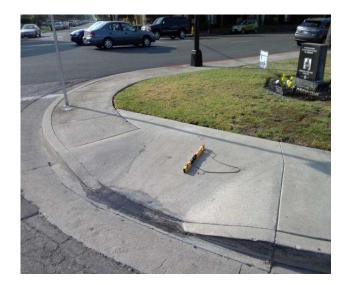
On-Site Finding Not Found

Code Reference CA 11B-406.5.12

Provide detectable warning to \$248 surface

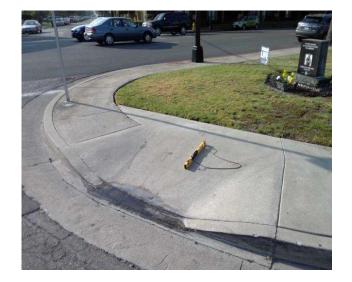
Code Reference ADA 402, 406.1, 405.3,CA 11B-406.5.7

Recommendation Up to 2.08 percent

Install curb ramp \$1,300

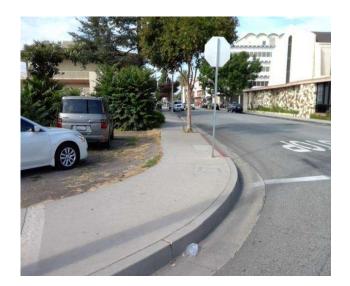
Sidewalks , Hazards & Gratings : Curb is on Path of Travel

Code Reference ADA 402, 303, 406, 403.4, 303.4

Install curb ramp \$2,500

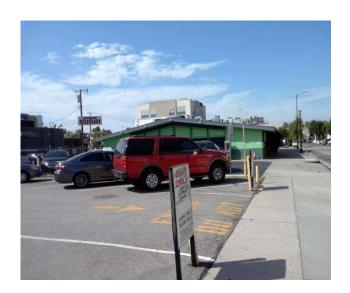
On-Site Finding Not Found

Code Reference ADA 705,CA 11B-705.1.2.5,CA 11B-247.1.2.5

Install compliant detectable \$190

warnings

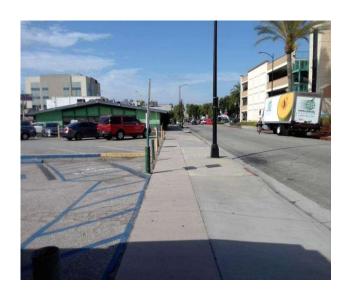
On-Site Finding Not Found

Code Reference ADA 705,CA 11B-705.1.2.5,CA 11B-247.1.2.5

Install compliant detectable \$190

warnings

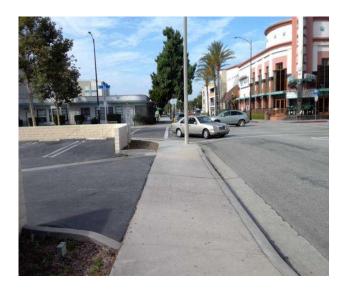
On-Site Finding Not Found

Code Reference ADA 705,CA 11B-705.1.2.5,CA 11B-247.1.2.5

Install compliant detectable \$190 warnings

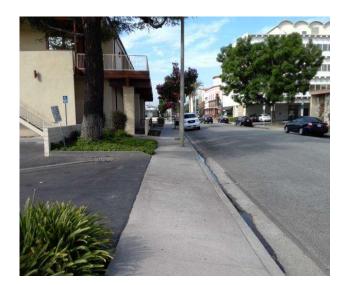
On-Site Finding Not Found

Code Reference ADA 705,CA 11B-705.1.2.5,CA 11B-247.1.2.5

Install compliant detectable \$190 warnings

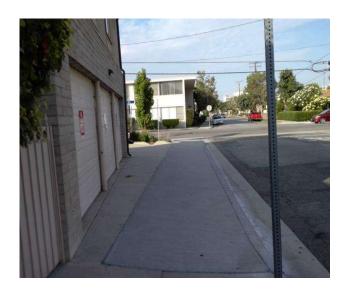
On-Site Finding Not Found

Code Reference ADA 705,CA 11B-705.1.2.5,CA 11B-247.1.2.5

Install compliant detectable \$190

warnings

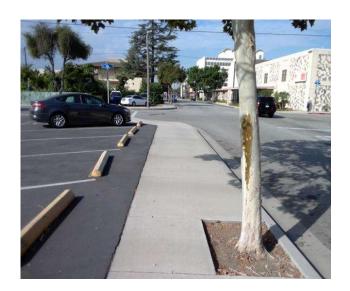
Code Reference ADA 206, 302,CA 11B-403.5.1

Widen the sidewalk to the recommended value.

Recommendation At least 48.00 inches

\$1,260

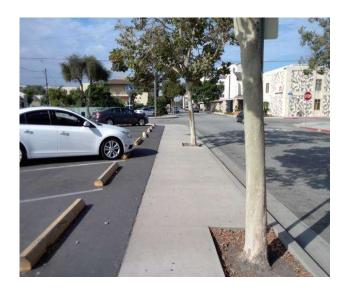
Code Reference ADA 206, 302,CA 11B-403.5.1

Widen the sidewalk to the recommended value.

Recommendation At least 48.00 inches

\$1,260

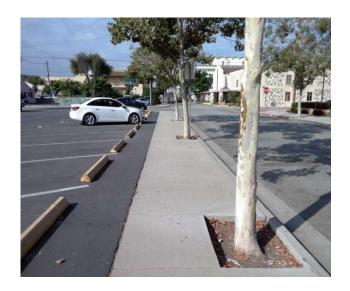
Code Reference ADA 206, 302,CA 11B-403.5.1

Widen the sidewalk to the recommended value.

Recommendation At least 48.00 inches

\$1,260

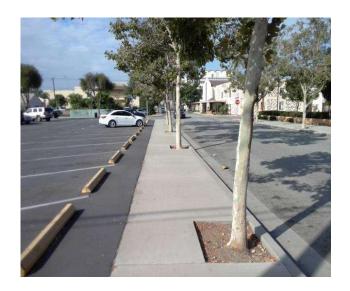
Code Reference ADA 206, 302,CA 11B-403.5.1

Widen the sidewalk to the recommended value.

Recommendation At least 48.00 inches

\$1,260

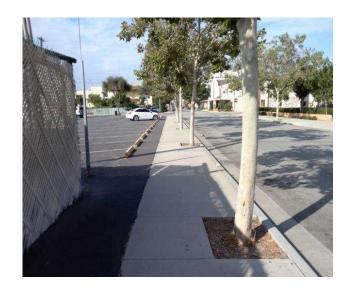
Code Reference ADA 206, 302,CA 11B-403.5.1

Widen the sidewalk to the recommended value.

Recommendation At least 48.00 inches

\$1,260

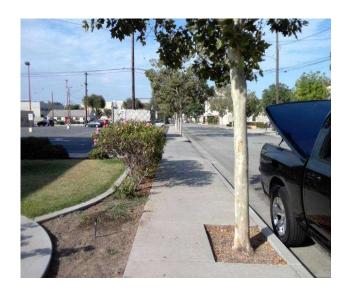
Code Reference ADA 206, 302,CA 11B-403.5.1

Widen the sidewalk to the recommended value.

Recommendation At least 48.00 inches

\$1,260

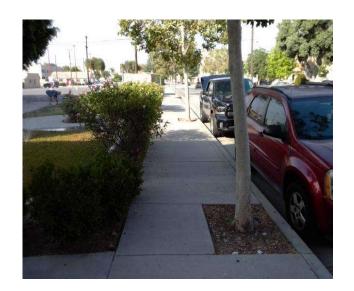
Code Reference ADA 206, 302,CA 11B-403.5.1

Widen the sidewalk to the recommended value.

Recommendation At least 48.00 inches

\$1,260

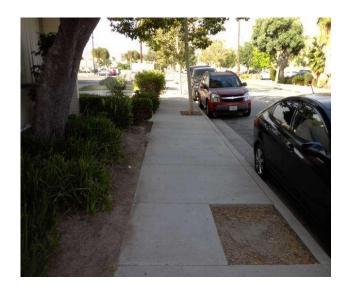
Code Reference ADA 206, 302,CA 11B-403.5.1

Widen the sidewalk to the recommended value.

Recommendation At least 48.00 inches

\$1,260

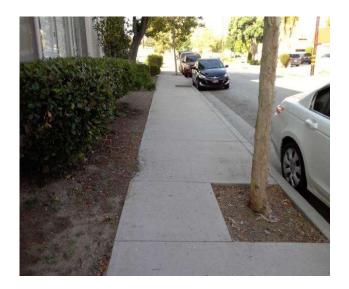
Code Reference ADA 206, 302,CA 11B-403.5.1

Widen the sidewalk to the recommended value.

Recommendation At least 48.00 inches

\$1,260

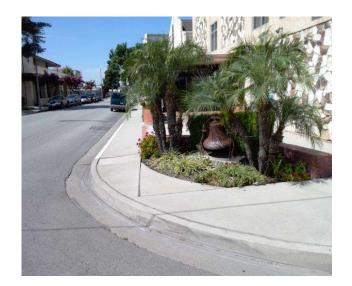
Sidewalks , Hazards & Gratings : Curb is on Path of Travel

Code Reference ADA 402, 303, 406, 403.4, 303.4

Install curb ramp \$2,500

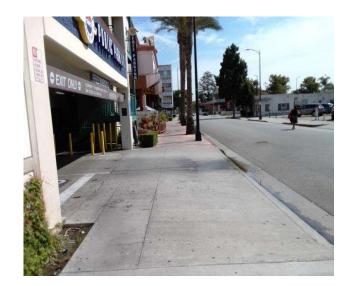
On-Site Finding Not Found

Code Reference ADA 705,CA 11B-705.1.2.5,CA 11B-247.1.2.5

Install compliant detectable \$190 warnings

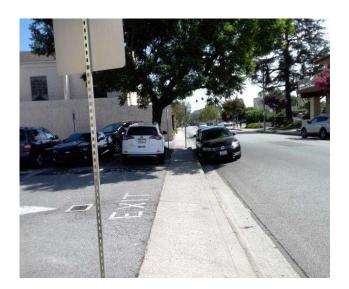
On-Site Finding Not Found

Code Reference ADA 705,CA 11B-705.1.2.5,CA 11B-247.1.2.5

Install compliant detectable \$190

warnings

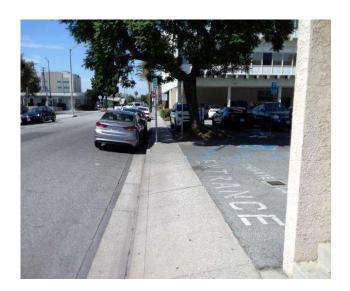
On-Site Finding Not Found

Code Reference ADA 705,CA 11B-705.1.2.5,CA 11B-247.1.2.5

Install compliant detectable \$190 warnings

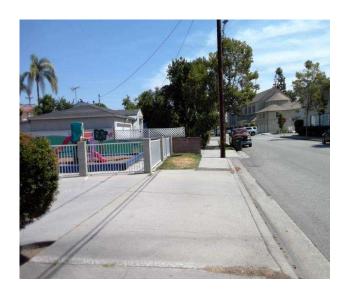
Code Reference ADA 705,CA 11B-705.1.2.5,CA 11B-247.1.2.5

Install compliant detectable \$190

warnings

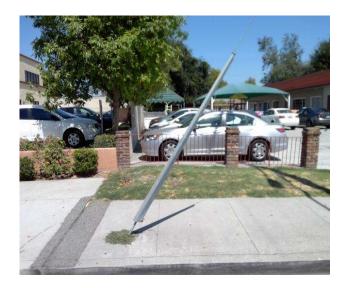
Code Reference ADA 206, 307.4,CA 11B-307.4

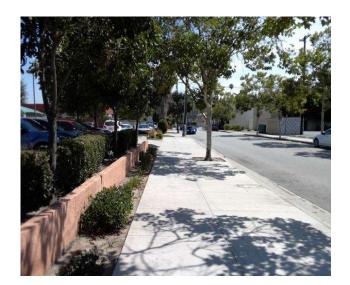
Code Reference ADA 206, 302,CA 11B-403.3

Repave surface \$1,092

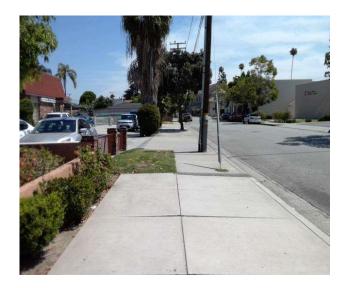
Code Reference ADA 206, 302,CA 11B-403.3

Repave surface \$1,092

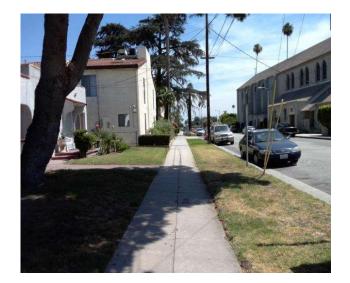
Code Reference ADA 206, 302,CA 11B-403.3

Repave surface \$1,092

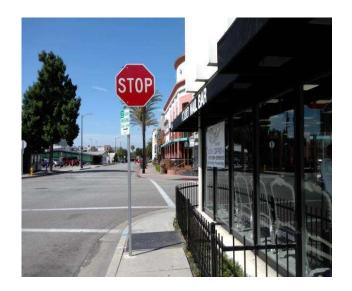
Code Reference ADA 206, 302, 403.5.1,CA 11B-403.5

\$1,260

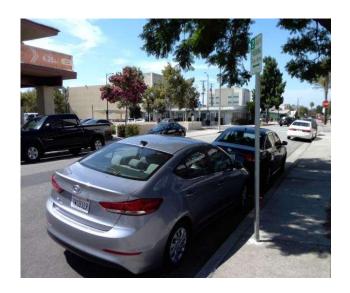
Code Reference ADA 206, 302, 403.5.1,CA 11B-403.5

\$1,260

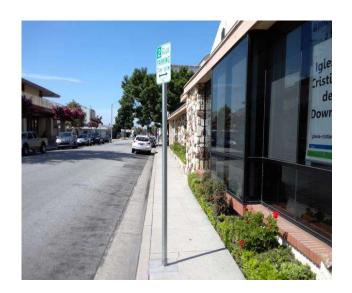
Code Reference ADA 206, 302, 403.5.1,CA 11B-403.5

\$1,260

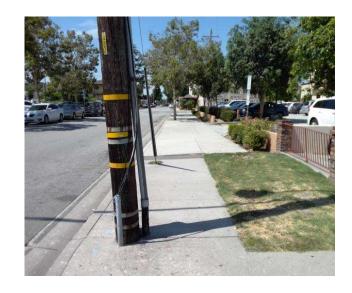
Code Reference ADA 206, 302, 403.5.1,CA 11B-403.5

\$1,260
