# Accessibility Survey

## City of Downey Donovan Street & Lakewood Boulevard

Date of Inspection  
2/9/2017

Prepared By  
**Disability Access Consultants**  
(800) 743-7067

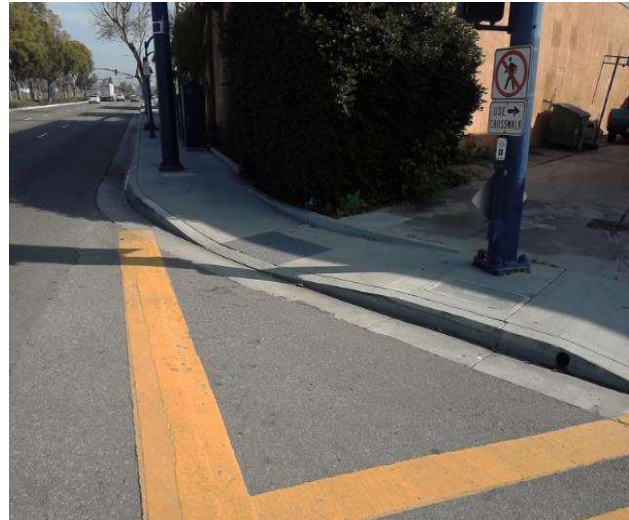
Curb Ramp , Landings and Transitions : Bottom Landing Slope

The slope at the bottom landing is greater than allowed.

**On-Site Finding** 2.70 percent

Provide a compliant bottom landing that does not exceed the maximum slope requirements.

Recommendation Up to 2.08 percent

Provide compliant landing \$240

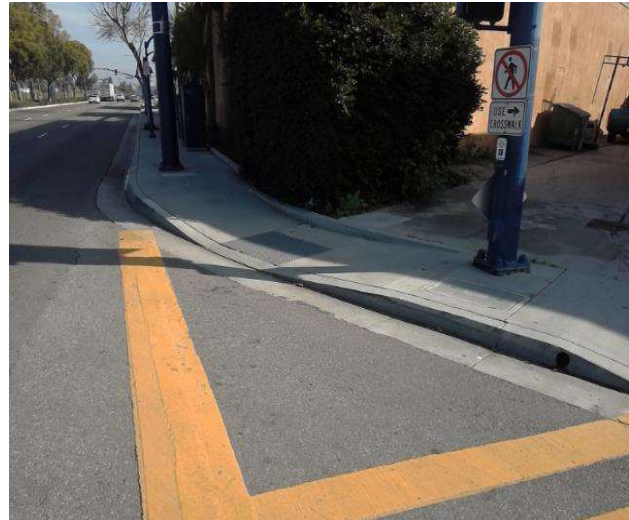
Curb Ramp , Landings and Transitions : Top Landing Right Side Clear Length - Parallel Curb Ramp

Recommendation At least 48.00 inches

Provide compliant landing \$240

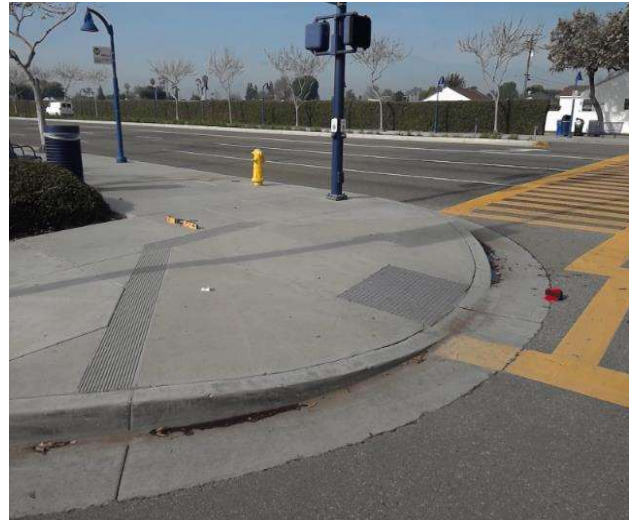
The overlayment causes a noncompliant change in level.

Ensure the change in elevation is within the recommended height.

Recommendation Up to 0.50 inches

Provide smooth surface \$150

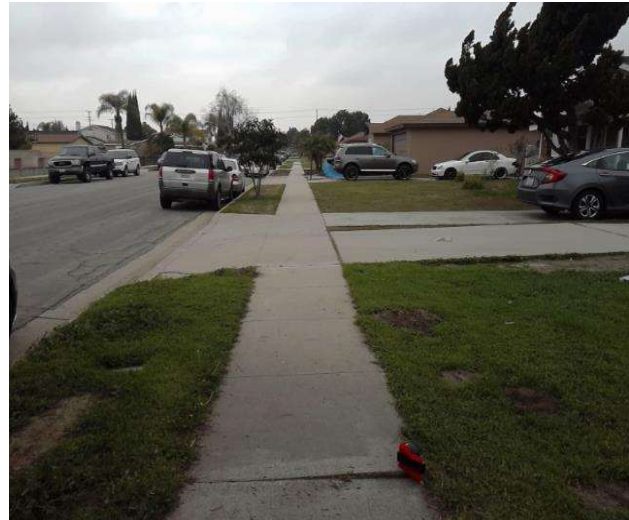
There is a change in elevation greater than recommended value.

Ensure that the change in elevation is within the recommended value.

Recommendation Up to 0.25 inches

Remove tripping hazards \$198

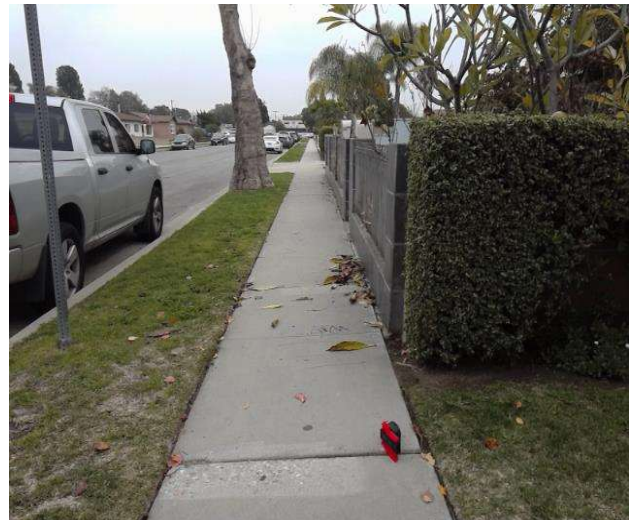
There is a change in elevation greater than recommended value.

Ensure that the change in elevation is within the recommended value.

Recommendation Up to 0.25 inches

Remove tripping hazards \$198

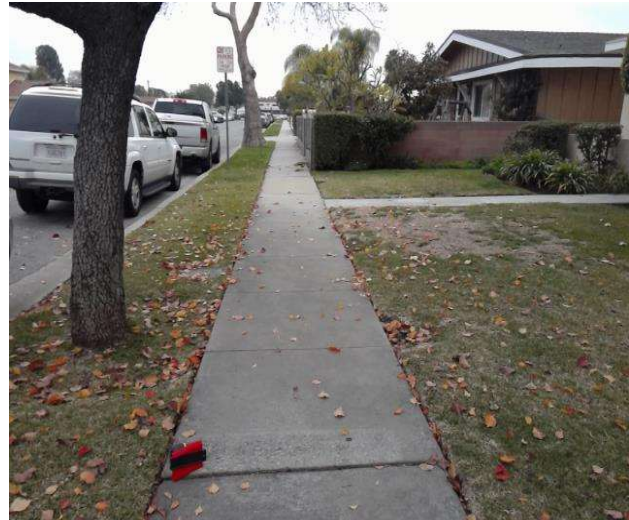
There is a change in elevation greater than recommended value.

Ensure that the change in elevation is within the recommended value.

Recommendation Up to 0.25 inches

Remove tripping hazards \$198
