Accessibility Survey

City of Downey Everest Street - Brookshire Avenue To Birchdale Avenue

Date of Inspection
2/4/2017

Disability Access Consultants

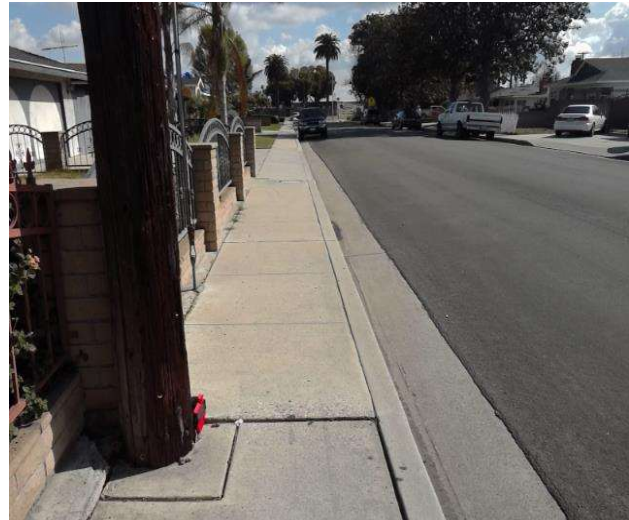
Change In Level East Of Brookshire Avenue @ 33.921516345468, - 118.141079843044

Sidewalks , Change in Level : Change in Level Non Beveled

There is a change in elevation greater than recommended value.

On-Site Finding 0.87 inches

Ensure that the change in elevation is within the recommended value.

Recommendation Up to 0.25 inches

Remove tripping hazards \$198

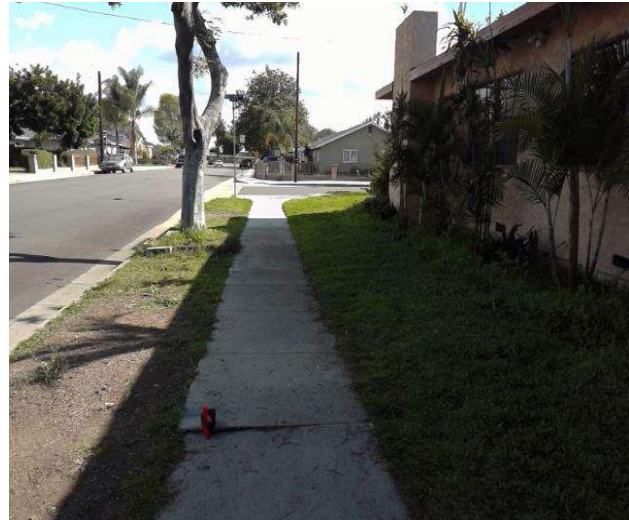
Change In Level West Of Bellder Drive @ 33.921634307725, -118.141572028399

Sidewalks , Change in Level : Change in Level Non Beveled

There is a change in elevation greater than recommended value.

Ensure that the change in elevation is within the recommended value.

Recommendation Up to 0.25 inches

Remove tripping hazards \$198

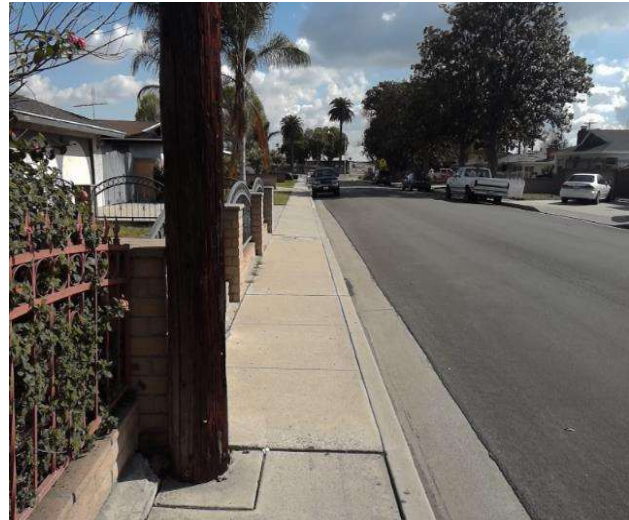
Sidewalks , Hazards & Gratings : Sidewalk Width at Obstruction

Sidewalk width at the obstruction shall have the recommended value.

Recommendation At least 48.00 inches

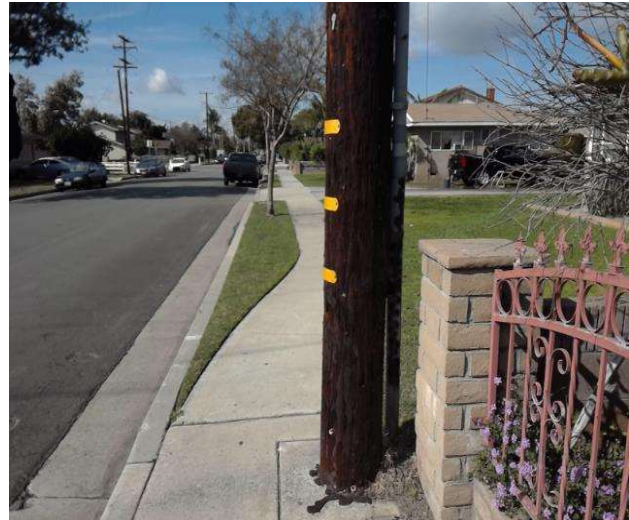
Sidewalks , Hazards & Gratings : Sidewalk Width at Obstruction

Sidewalk width at the obstruction shall have the recommended value.

Recommendation At least 48.00 inches

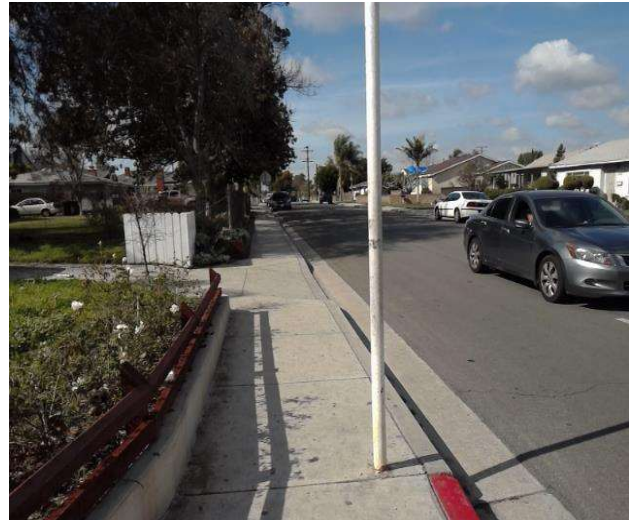
Sidewalks , Hazards & Gratings : Sidewalk Width at Obstruction

Sidewalk width at the obstruction shall have the recommended value.

Recommendation At least 48.00 inches

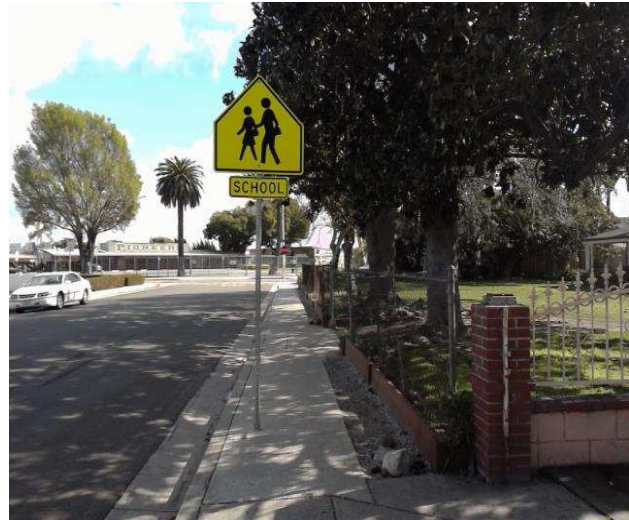
Sidewalks , Hazards & Gratings : Sidewalk Width at Obstruction

Sidewalk width at the obstruction shall have the recommended value.

Recommendation At least 48.00 inches

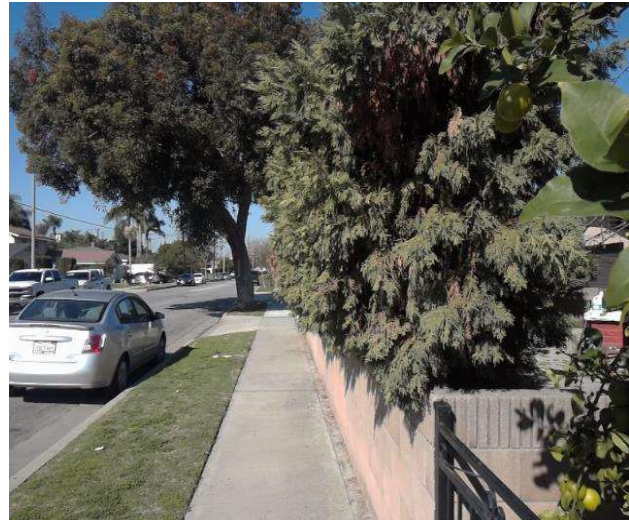
Sidewalks , Hazards & Gratings : Overhead Obstruction Height

Notes : Tree Obstructs For 40 Feet

Recommendation At least 80.00 inches

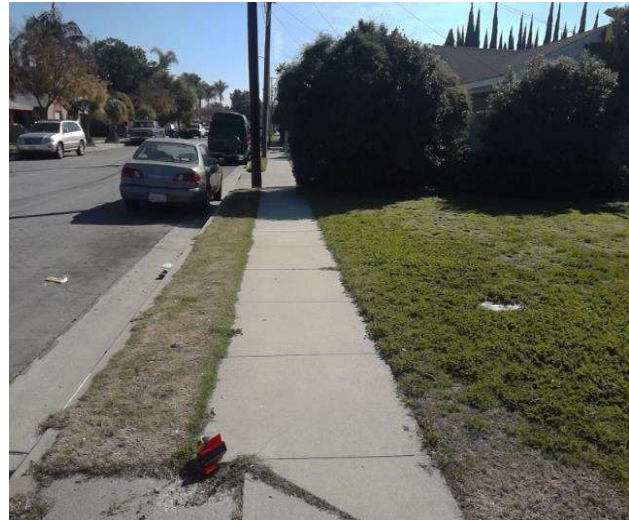
There is a change in elevation greater than recommended value.

Ensure that the change in elevation is within the recommended value.

Recommendation Up to 0.25 inches

Remove tripping hazards \$198

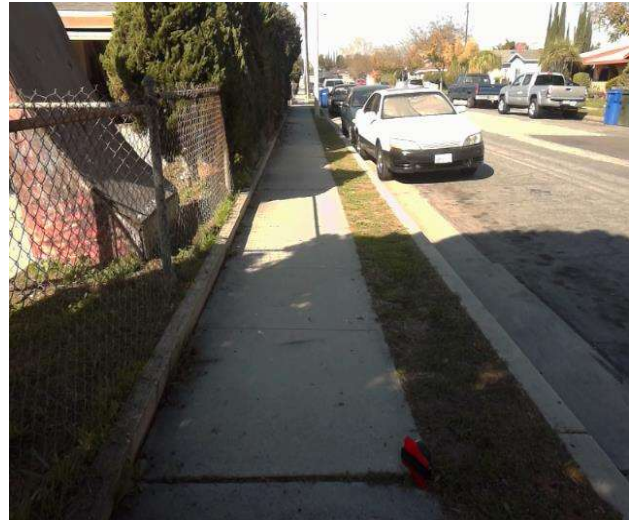
There is a change in elevation greater than recommended value.

Ensure that the change in elevation is within the recommended value.

Recommendation Up to 0.25 inches

Remove tripping hazards \$198

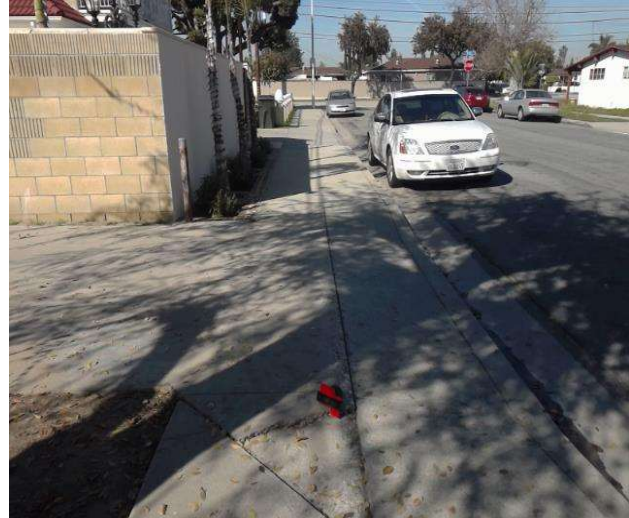
There is a change in elevation greater than recommended value.

Ensure that the change in elevation is within the recommended value.

Recommendation Up to 0.25 inches

Remove tripping hazards \$198

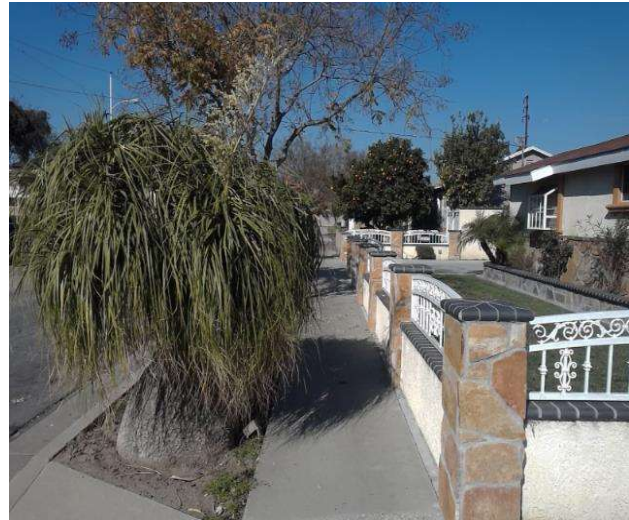
Sidewalks , Hazards & Gratings : Overhead Obstruction Height

Recommendation At least 80.00 inches

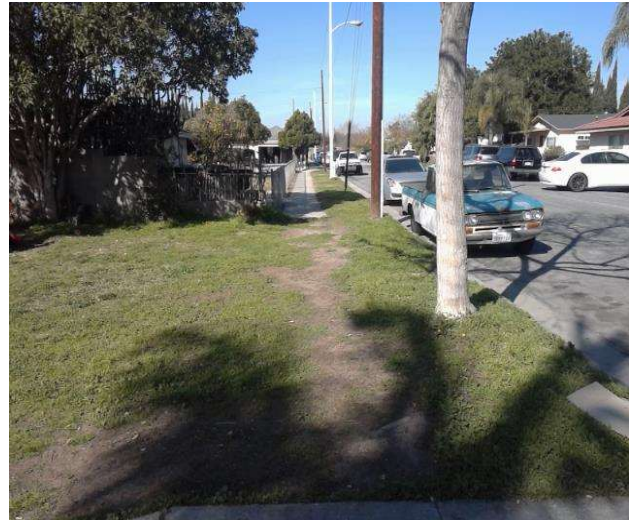
Sidewalks : Missing Sidewalk

Section of sidewalk is missing and consists of dirt, grass or gravel.

Provide a compliant sidewalk for the missing section.

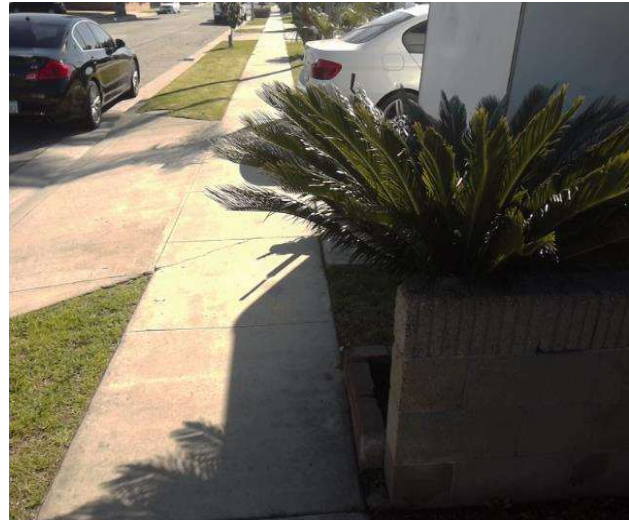
Sidewalks , Hazards & Gratings : Overhead Obstruction Height

Recommendation At least 80.00 inches

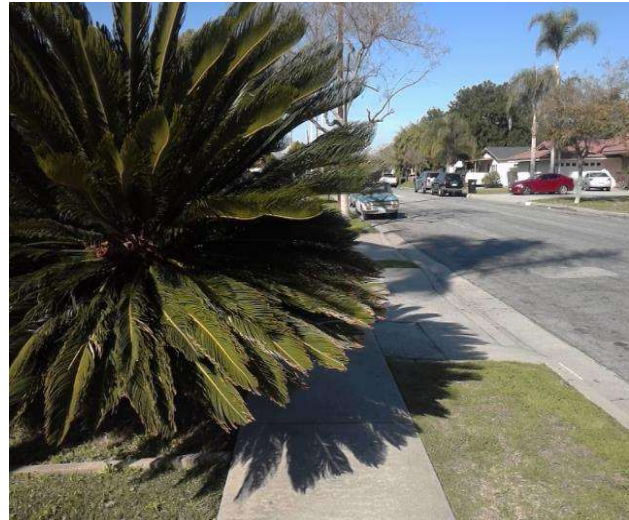
Sidewalks , Hazards & Gratings : Protruding Object Height

Recommendation Up to 4.00 inches

Install wing walls or relocate object \$640

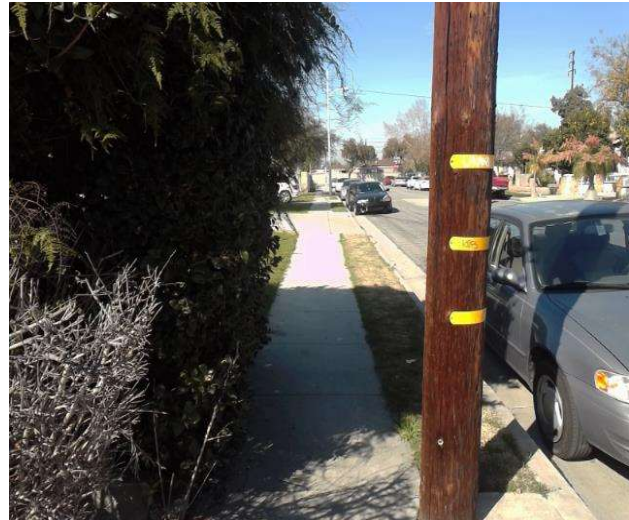
Sidewalks , Hazards & Gratings : Sidewalk Width at Obstruction

Sidewalk width at the obstruction shall have the recommended value.

Recommendation At least 48.00 inches

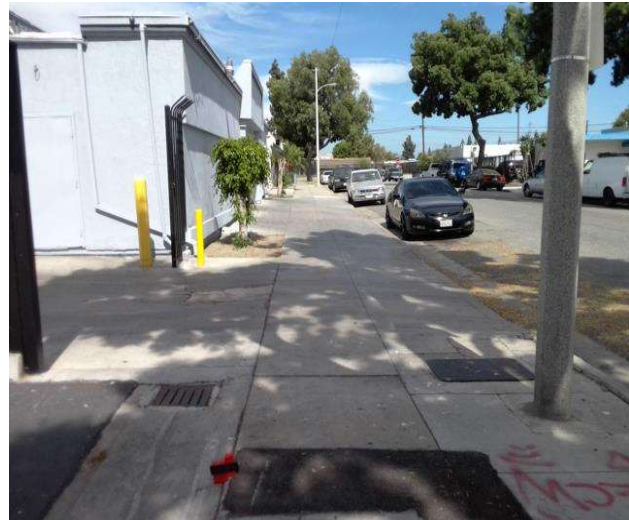
There is a change in elevation greater than recommended value.

Notes : Surface is Rough And Uneven

Ensure that the change in elevation is within the recommended value.

Recommendation Up to 0.25 inches

Remove tripping hazards \$198

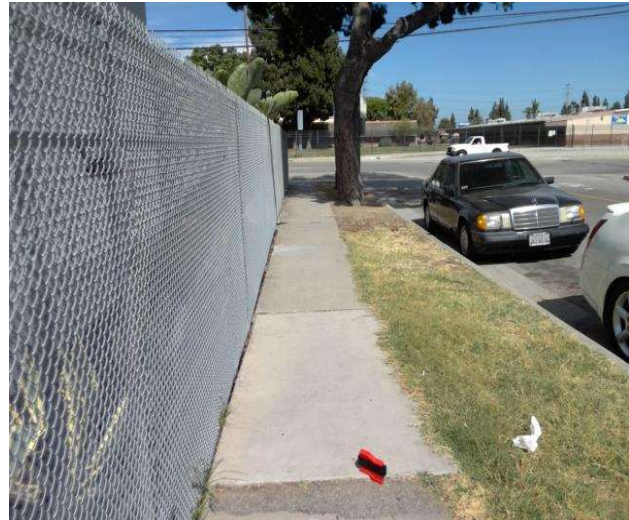
There is a change in elevation greater than recommended value.

Ensure that the change in elevation is within the recommended value.

Recommendation Up to 0.25 inches

Remove tripping hazards \$198

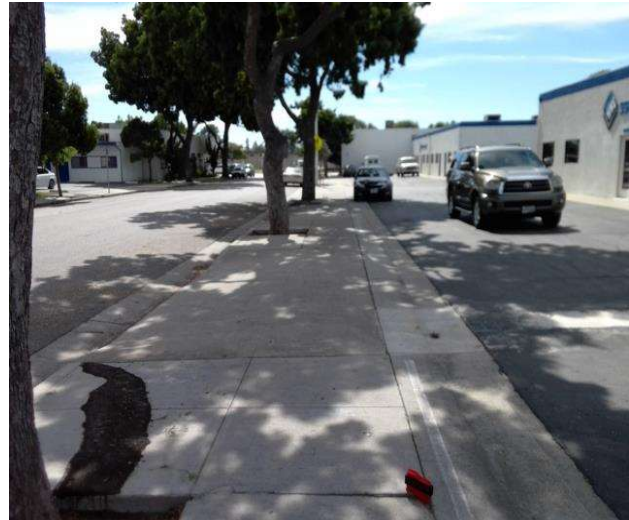
There is a change in elevation greater than recommended value.

Ensure that the change in elevation is within the recommended value.

Recommendation Up to 0.25 inches

Remove tripping hazards \$198

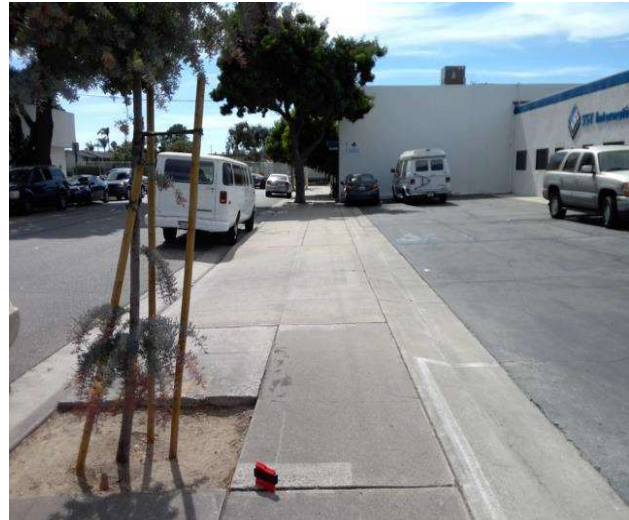
There is a change in elevation greater than recommended value.

Ensure that the change in elevation is within the recommended value.

Recommendation Up to 0.25 inches

Remove tripping hazards \$198

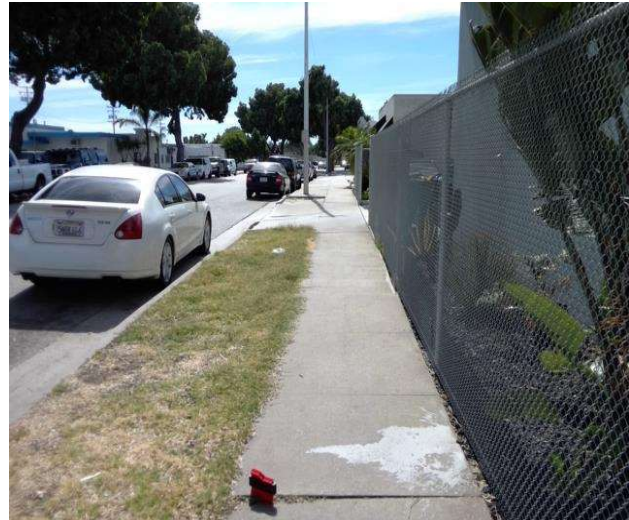
There is a change in elevation greater than recommended value.

Ensure that the change in elevation is within the recommended value.

Recommendation Up to 0.25 inches

Remove tripping hazards \$198

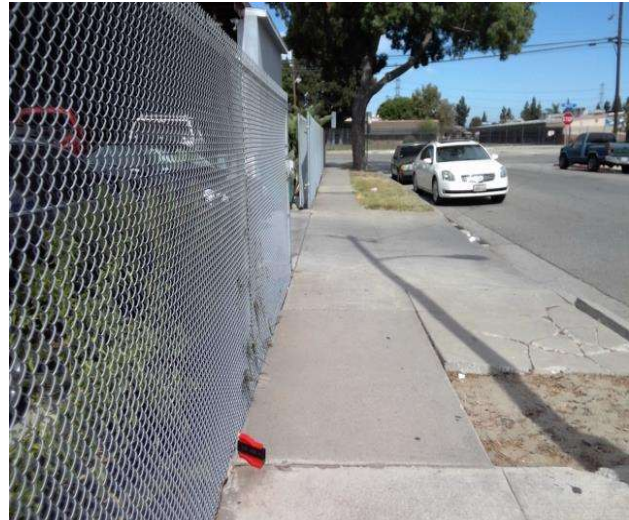
There is a change in elevation greater than recommended value.

Ensure that the change in elevation is within the recommended value.

Recommendation Up to 0.25 inches

Remove tripping hazards \$198

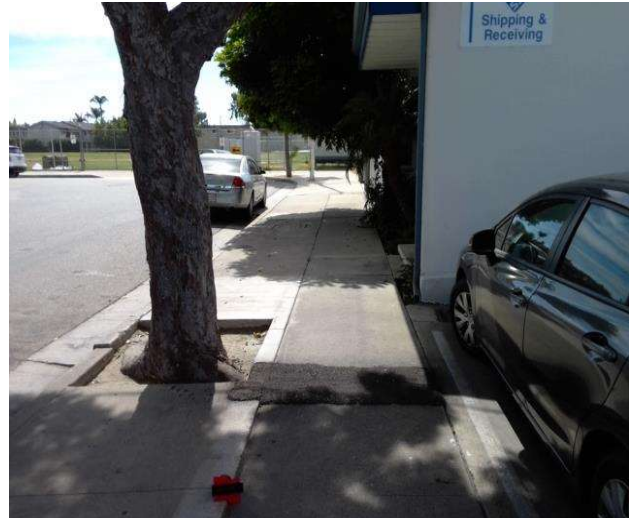
There is a change in elevation greater than recommended value.

Ensure that the change in elevation is within the recommended value.

Recommendation Up to 0.25 inches

Remove tripping hazards \$198

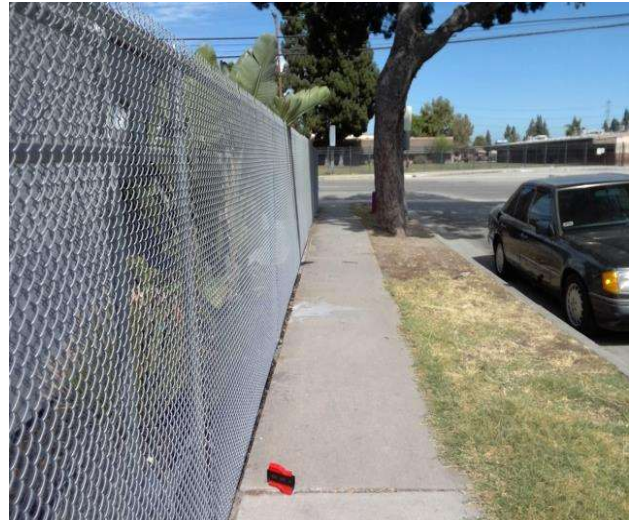
There is a change in elevation greater than recommended value.

Ensure that the change in elevation is within the recommended value.

Recommendation Up to 0.25 inches

Remove tripping hazards \$198

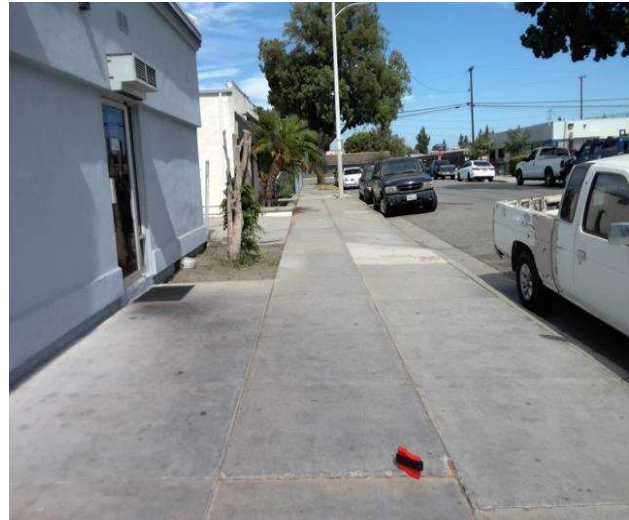
There is a change in elevation greater than recommended value.

Ensure that the change in elevation is within the recommended value.

Recommendation Up to 0.25 inches

Remove tripping hazards \$198

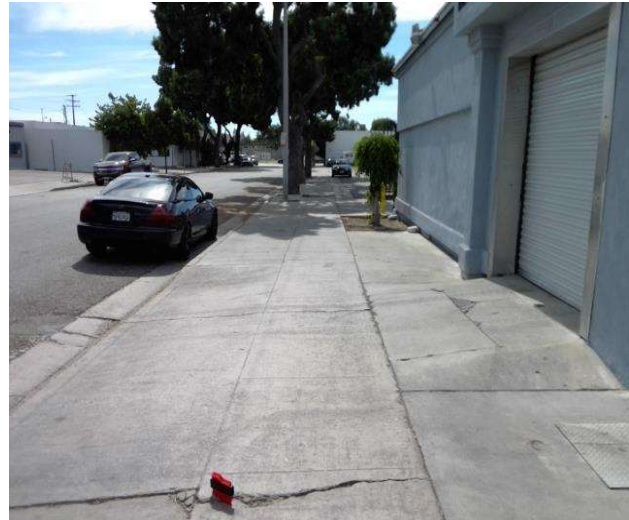
There is a change in elevation greater than recommended value.

Ensure that the change in elevation is within the recommended value.

Recommendation Up to 0.25 inches

Remove tripping hazards \$198

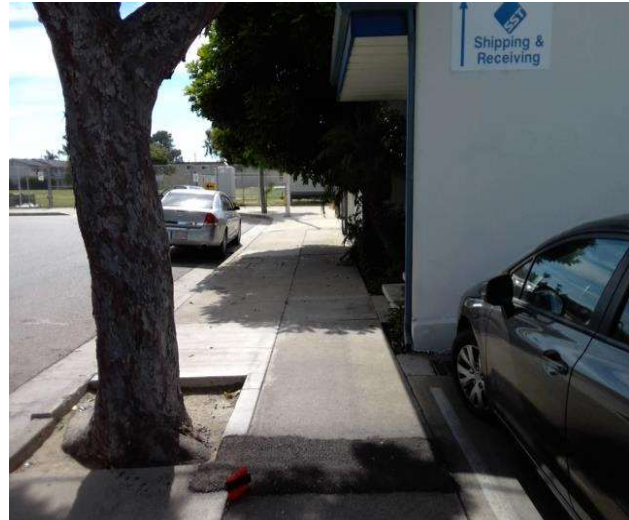
There is a change in elevation greater than recommended value.

Ensure that the change in elevation is within the recommended value.

Recommendation Up to 0.25 inches

Remove tripping hazards \$198

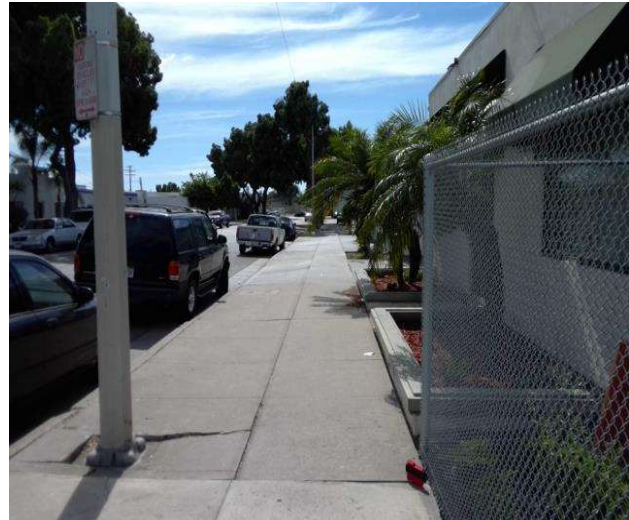
There is a change in elevation greater than recommended value.

Ensure that the change in elevation is within the recommended value.

Recommendation Up to 0.25 inches

Remove tripping hazards \$198

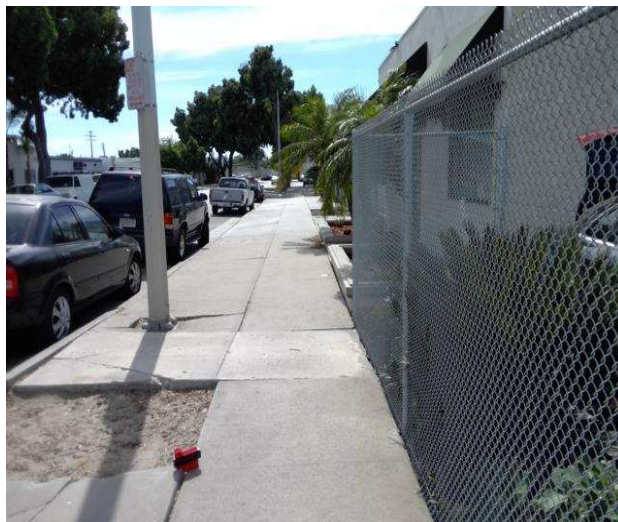
There is a change in elevation greater than recommended value.

Ensure that the change in elevation is within the recommended value.

Recommendation Up to 0.25 inches

Remove tripping hazards \$198

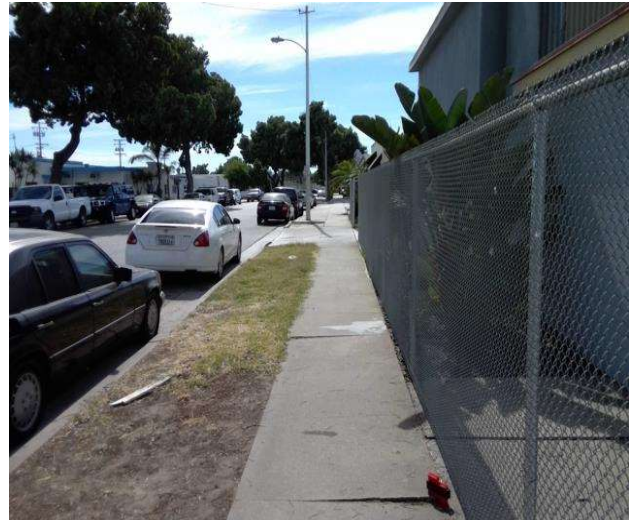
There is a change in elevation greater than recommended value.

Ensure that the change in elevation is within the recommended value.

Recommendation Up to 0.25 inches

Remove tripping hazards \$198

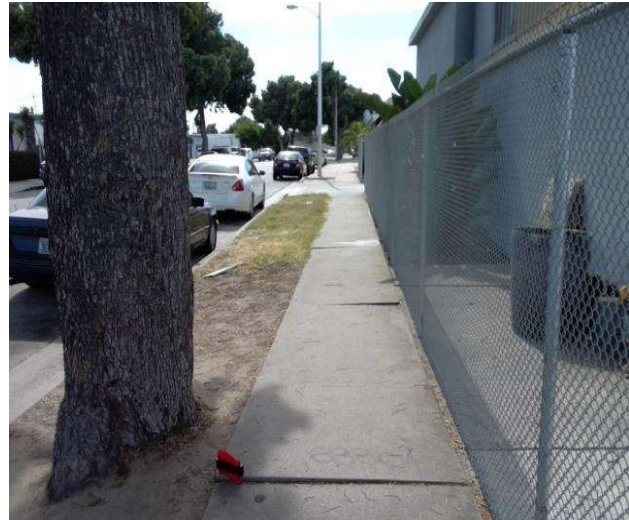
There is a change in elevation greater than recommended value.

Ensure that the change in elevation is within the recommended value.

Recommendation Up to 0.25 inches

Remove tripping hazards \$198

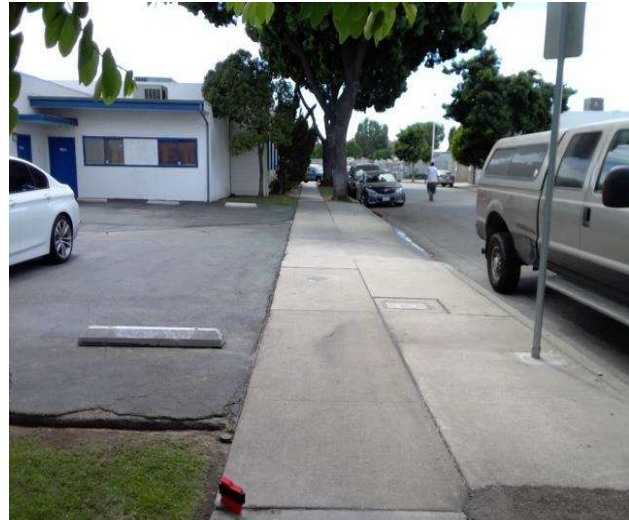
There is a change in elevation greater than recommended value.

Ensure that the change in elevation is within the recommended value.

Recommendation Up to 0.25 inches

Remove tripping hazards \$198

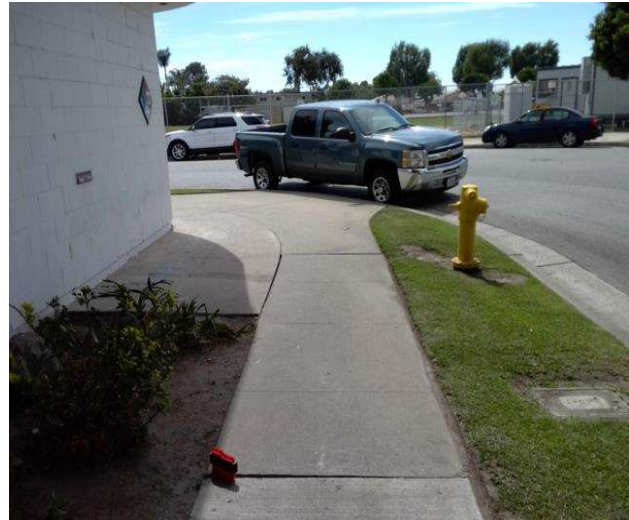
There is a change in elevation greater than recommended value.

Ensure that the change in elevation is within the recommended value.

Recommendation Up to 0.25 inches

Remove tripping hazards \$198

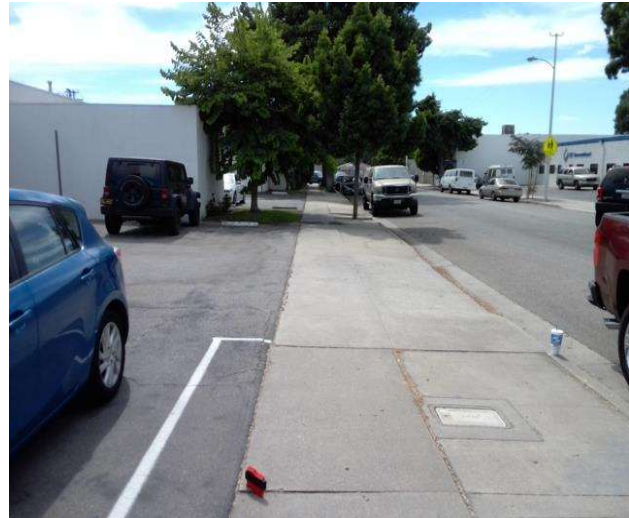
There is a change in elevation greater than recommended value.

Ensure that the change in elevation is within the recommended value.

Recommendation Up to 0.25 inches

Remove tripping hazards \$198

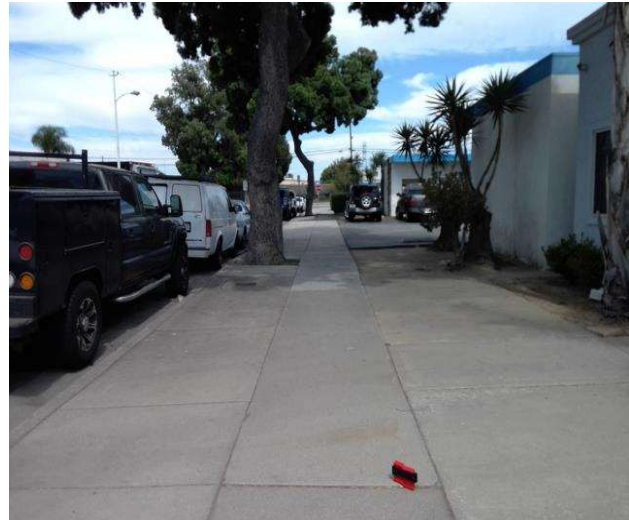
There is a change in elevation greater than recommended value.

Ensure that the change in elevation is within the recommended value.

Recommendation Up to 0.25 inches

Remove tripping hazards \$198

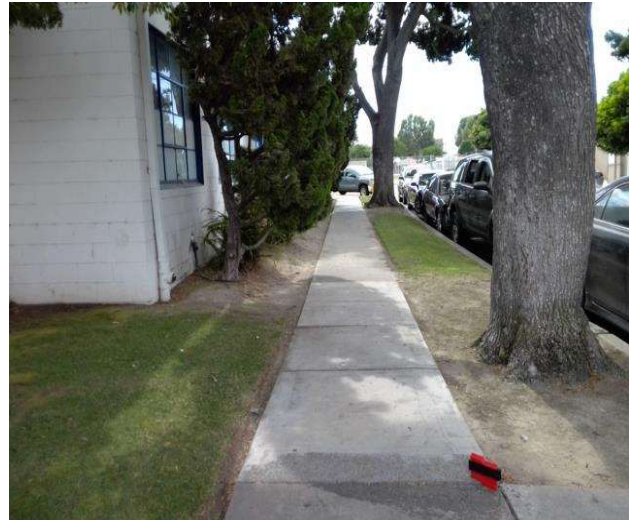
There is a change in elevation greater than recommended value.

Ensure that the change in elevation is within the recommended value.

Recommendation Up to 0.25 inches

Remove tripping hazards \$198

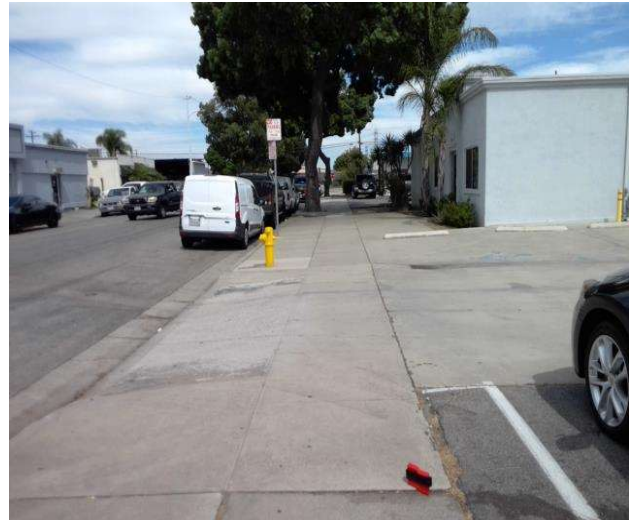
There is a change in elevation greater than recommended value.

Ensure that the change in elevation is within the recommended value.

Recommendation Up to 0.25 inches

Remove tripping hazards \$198

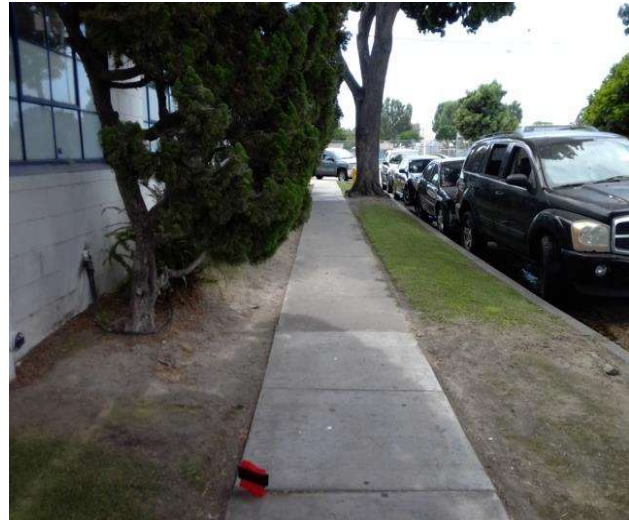
There is a change in elevation greater than recommended value.

Ensure that the change in elevation is within the recommended value.

Recommendation Up to 0.25 inches

Remove tripping hazards \$198

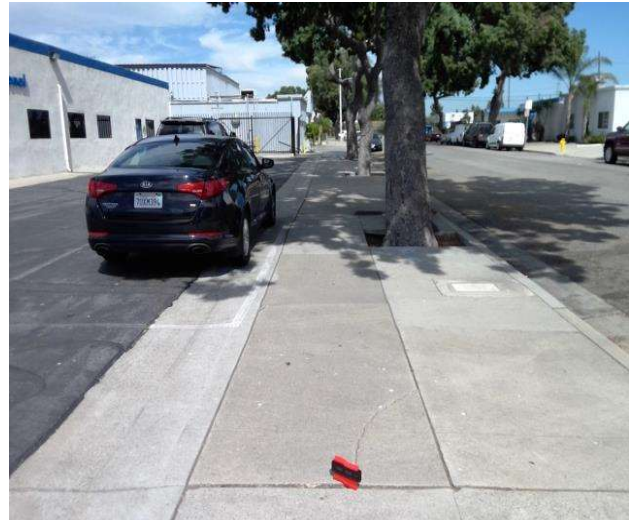
There is a change in elevation greater than recommended value.

Ensure that the change in elevation is within the recommended value.

Recommendation Up to 0.25 inches

Remove tripping hazards \$198

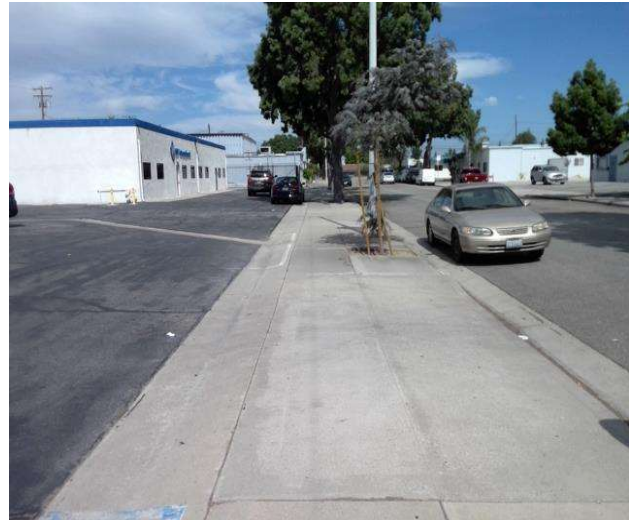
On-Site Finding Not Found

Install compliant detectable warnings \$190

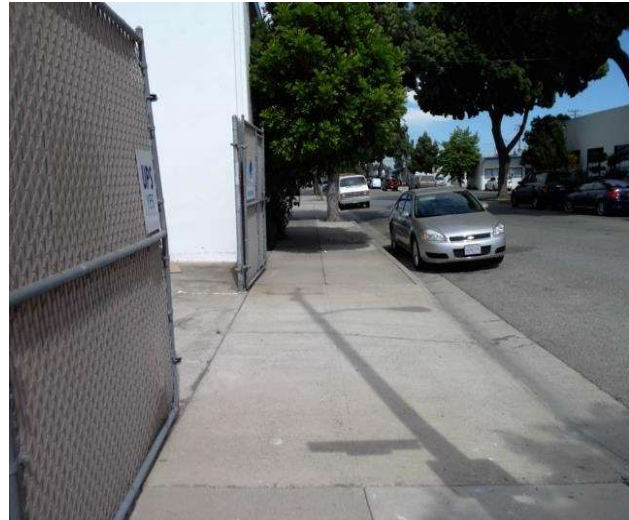
On-Site Finding Not Found

Install compliant detectable warnings \$190

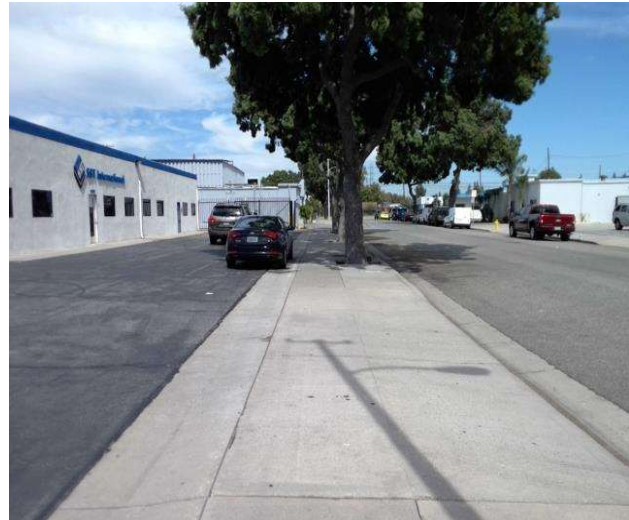
On-Site Finding Not Found

Install compliant detectable warnings \$190

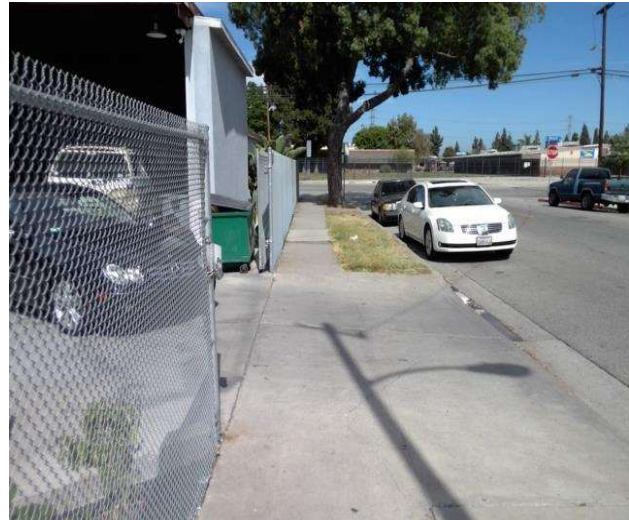
On-Site Finding Not Found

Install compliant detectable warnings \$190

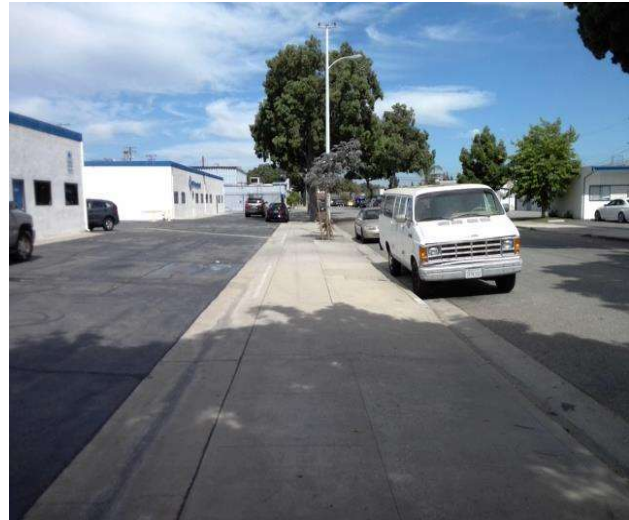
On-Site Finding Not Found

Install compliant detectable warnings \$190

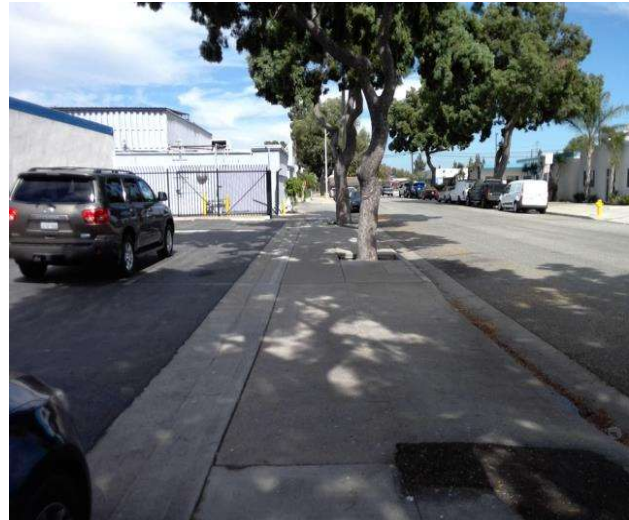
On-Site Finding Not Found

Install compliant detectable warnings \$190

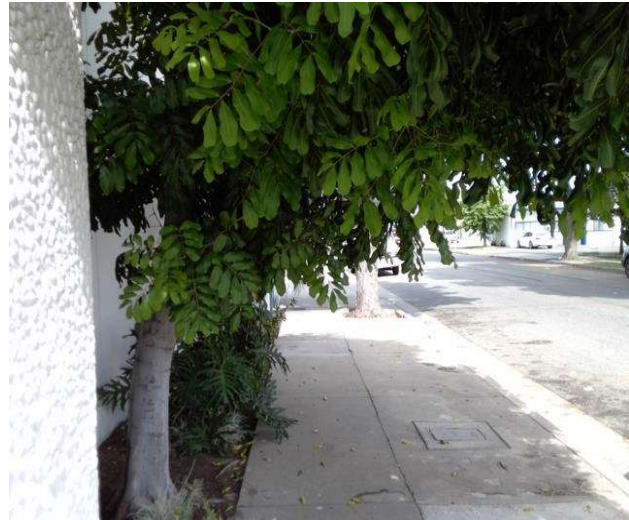
Sidewalks , Hazards & Gratings : Overhead Obstruction Height

Recommendation At least 80.00 inches

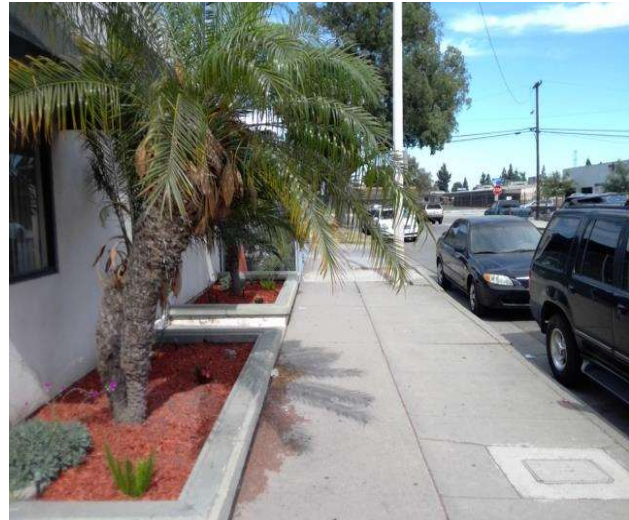
Sidewalks , Hazards & Gratings : Overhead Obstruction Height

Recommendation At least 80.00 inches

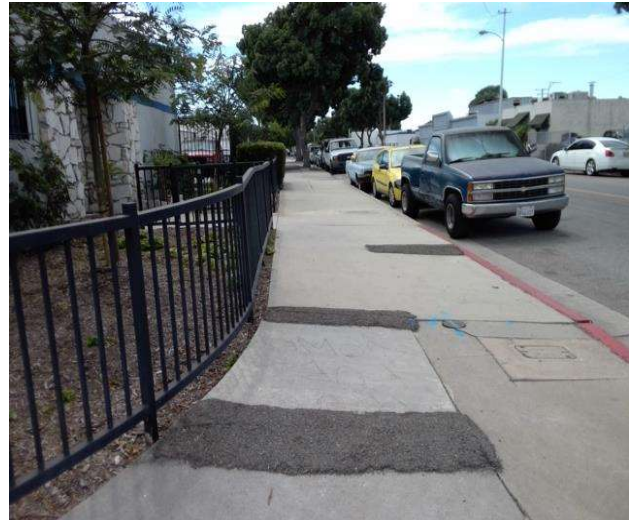
Notes : Surface is Rough And Uneven

Repave surface \$1,092

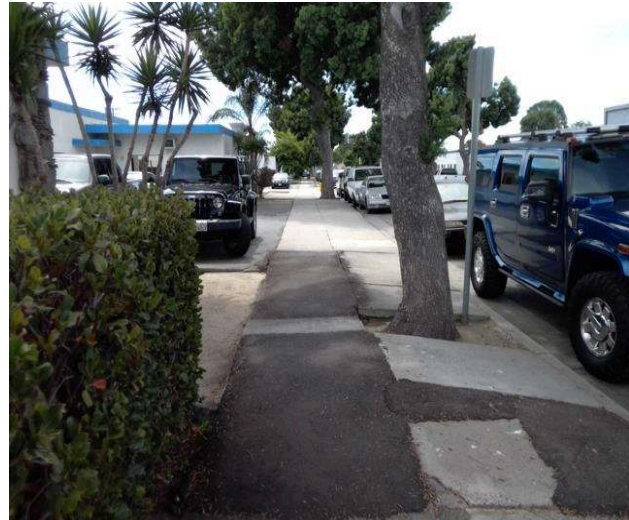
Notes : Surface is Rough And Uneven

Repave surface \$1,092
