Accessibility Survey

City of Downey Fontana Street - Brookshire Avenue to Downey Avenue

Date of Inspection
4/19/2017

Disability Access Consultants

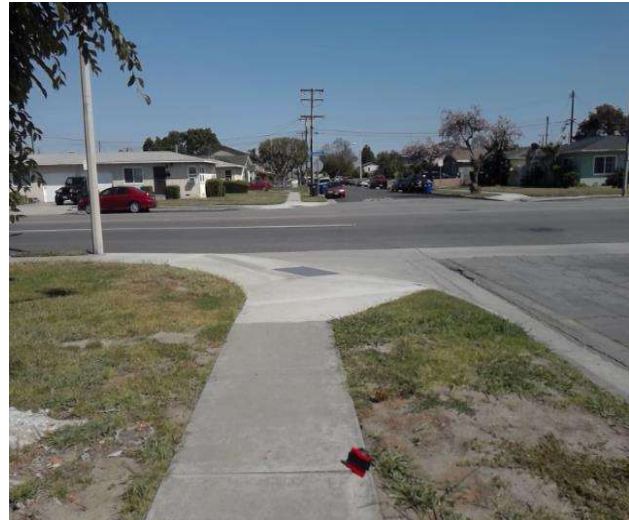
Change In Level East Of Downey Avenue @ 33.931365631255, -118.135141432285

Sidewalks , Change in Level : Change in Level Non Beveled

There is a change in elevation greater than recommended value.

On-Site Finding 0.50 inches

Ensure that the change in elevation is within the recommended value.

Recommendation Up to 0.25 inches

Remove tripping hazards \$198

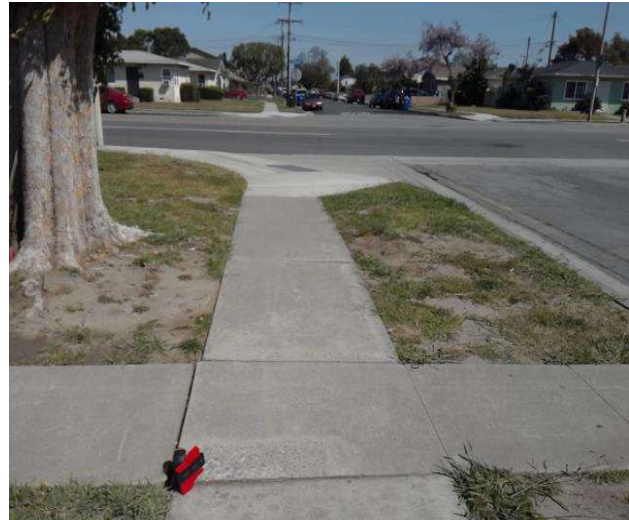
Change In Level East Of Downey Avenue @ 33.931372307596, -118.135160207748

Sidewalks , Change in Level : Change in Level Non Beveled

There is a change in elevation greater than recommended value.

Ensure that the change in elevation is within the recommended value.

Recommendation Up to 0.25 inches

Remove tripping hazards \$198

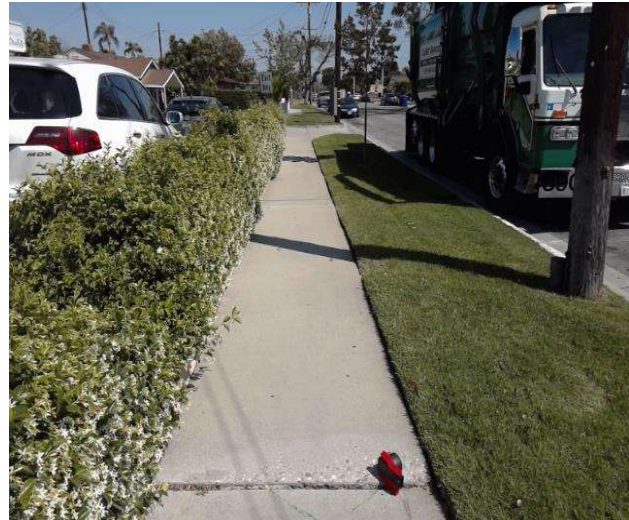
There is a change in elevation greater than recommended value.

Ensure that the change in elevation is within the recommended value.

Recommendation Up to 0.25 inches

Remove tripping hazards \$198

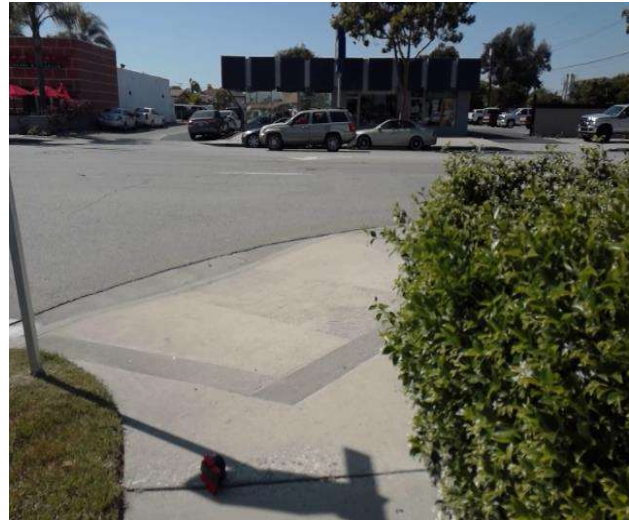
There is a change in elevation greater than recommended value.

Ensure that the change in elevation is within the recommended value.

Recommendation Up to 0.25 inches

Remove tripping hazards \$198

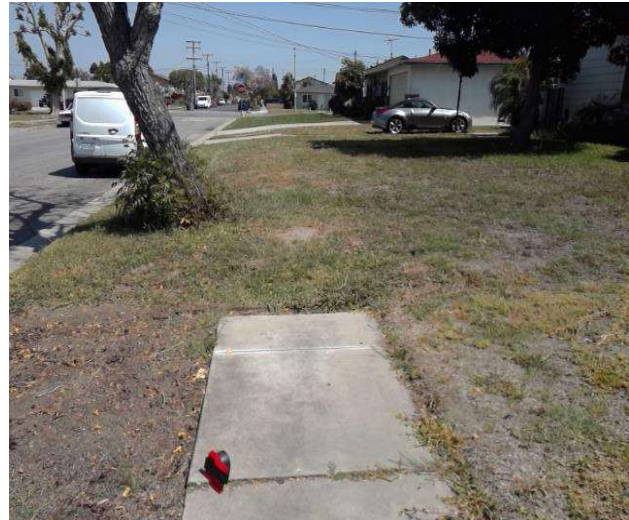
There is a change in elevation greater than recommended value.

Ensure that the change in elevation is within the recommended value.

Recommendation Up to 0.25 inches

Remove tripping hazards \$198

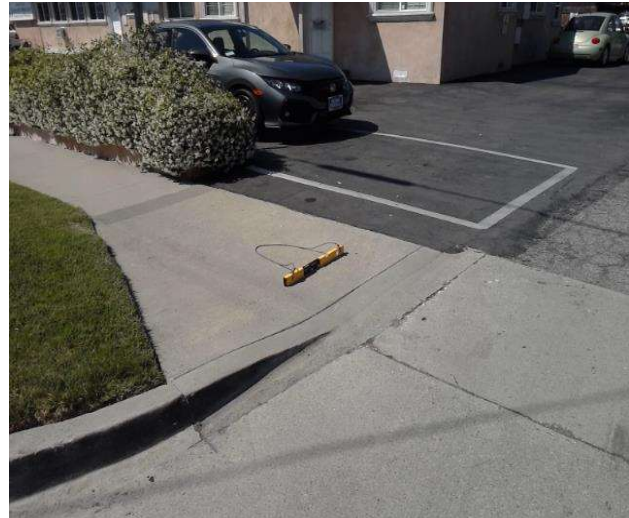
On-Site Finding Not Found

Provide detectable warning to surface \$248

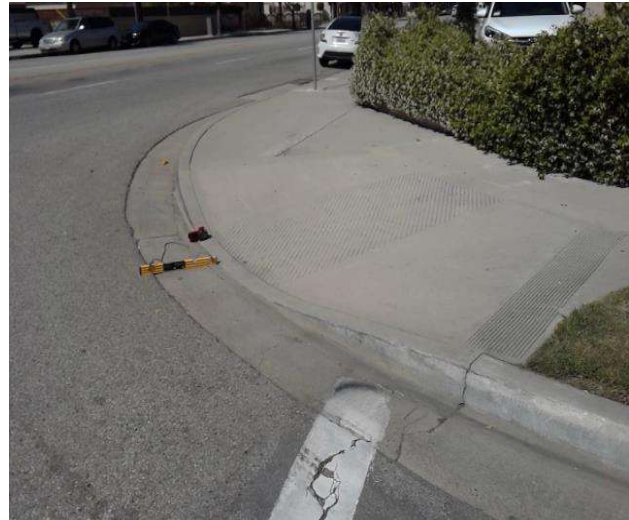
Curb Ramp , Landings And Transitions : Bottom Landing Change in Level

Recommendation Up to 0.50 inches

Patch lip at curb ramp \$255

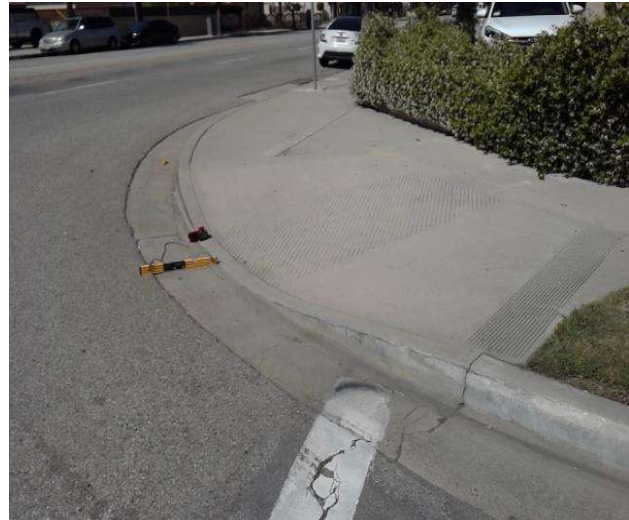
Curb Ramp , Landings and Transitions : Top Landing Clear Length - Landings

Recommendation At least 48.00 inches

Provide compliant landing \$240

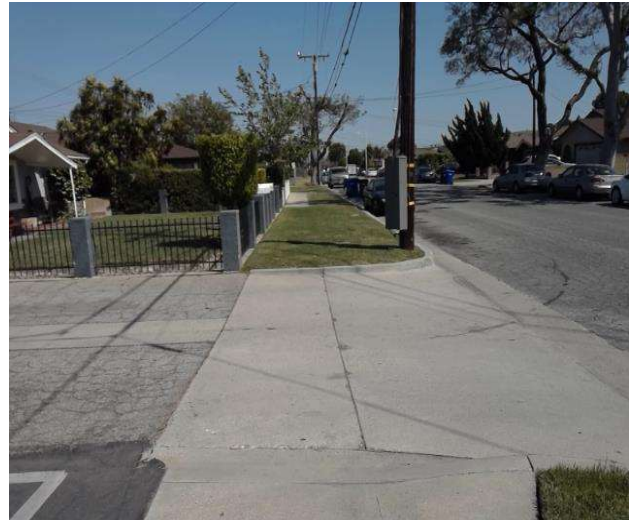
On-Site Finding Not Found

Install compliant detectable warnings \$190

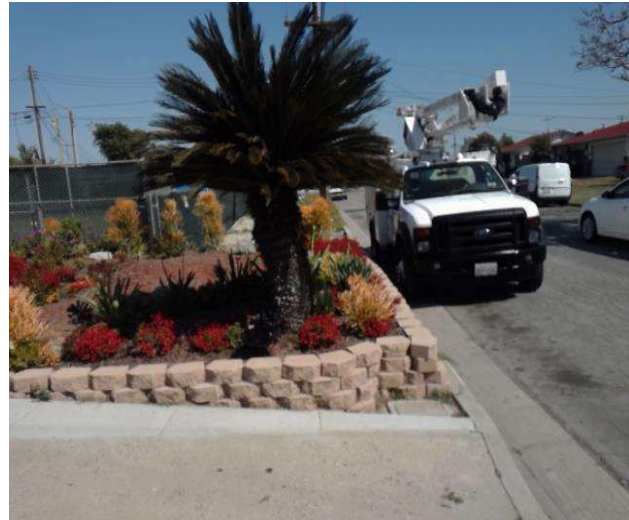
Sidewalks : Missing Sidewalk

Section of sidewalk is missing and consists of dirt, grass or gravel.

Provide a compliant sidewalk for the missing section.

\$1,260

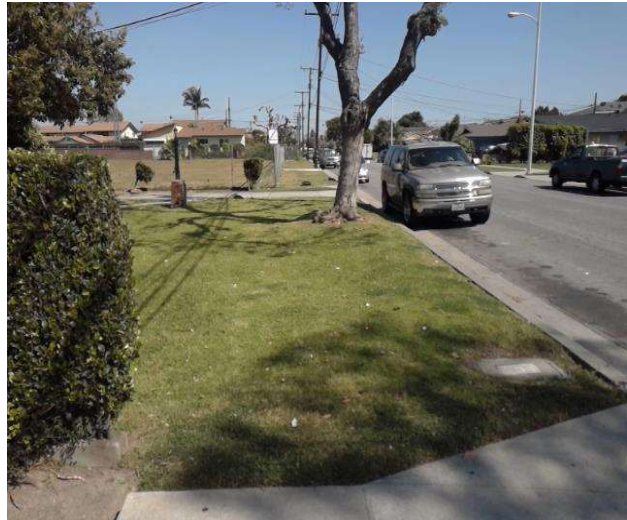
Sidewalks : Missing Sidewalk

Section of sidewalk is missing and consists of dirt, grass or gravel.

Provide a compliant sidewalk for the missing section.

\$1,260

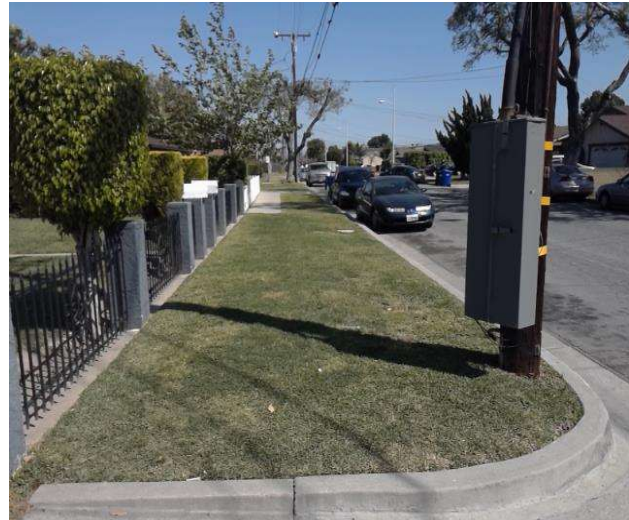
Sidewalks : Missing Sidewalk

Section of sidewalk is missing and consists of dirt, grass or gravel.

Provide a compliant sidewalk for the missing section.

\$1,260

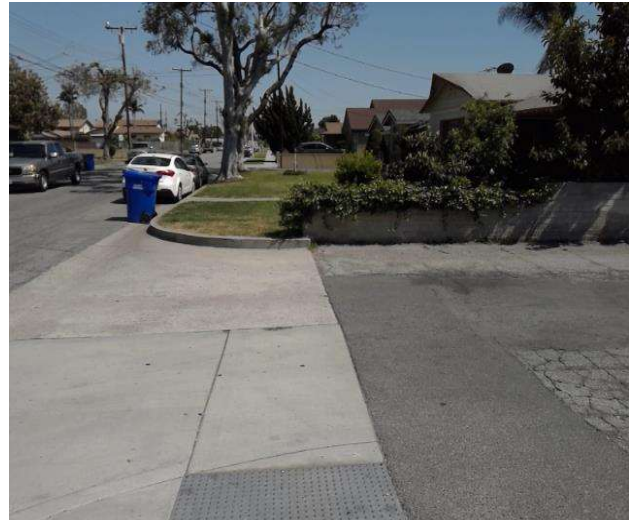
On-Site Finding Not Found

Install compliant detectable warnings \$190

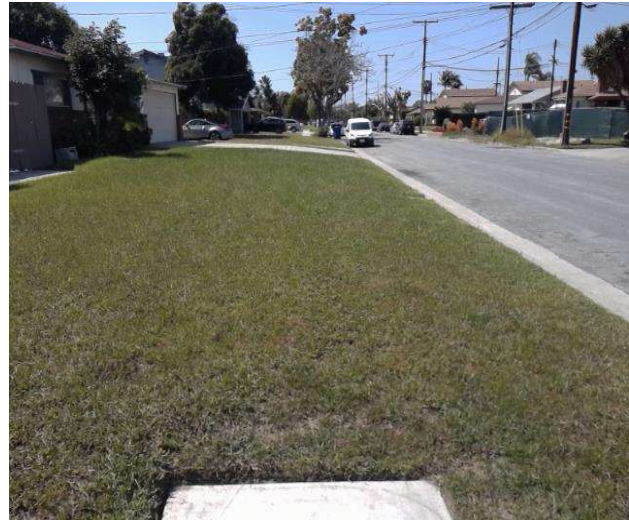
Sidewalks : Missing Sidewalk

Section of sidewalk is missing and consists of dirt, grass or gravel.

Provide a compliant sidewalk for the missing section.

\$1,260

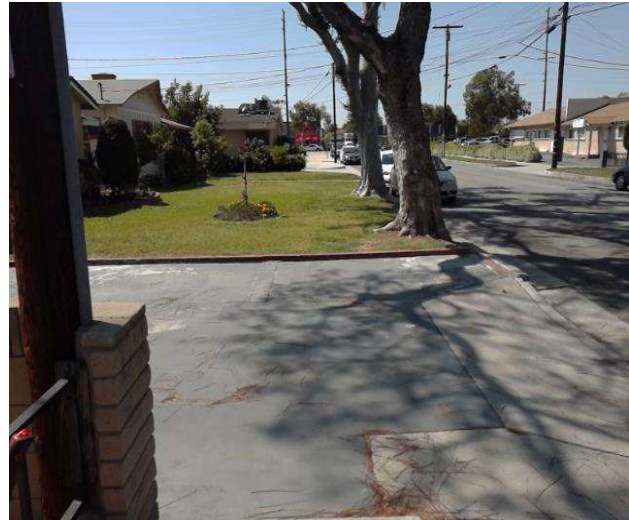
Sidewalks : Missing Sidewalk

Section of sidewalk is missing and consists of dirt, grass or gravel.

Provide a compliant sidewalk for the missing section.

\$1,260

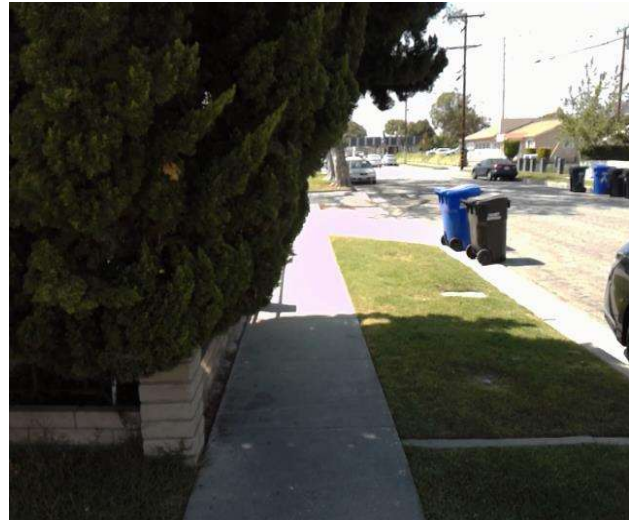
Sidewalks , Hazards & Gratings : Protruding Object Height

Recommendation Up to 4.00 inches

Install wing walls or relocate object \$640

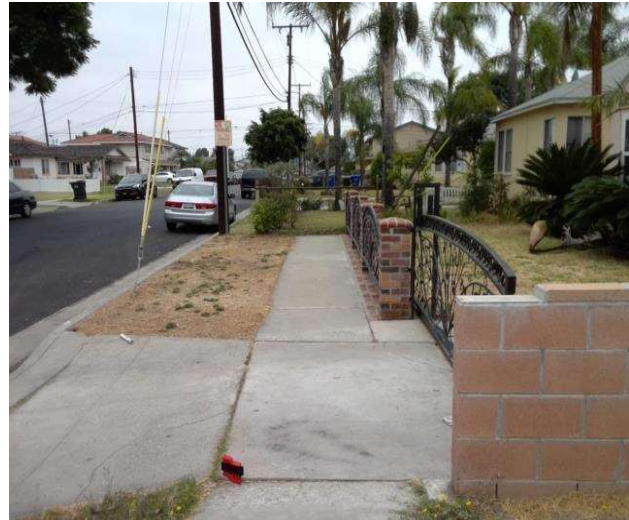
There is a change in elevation greater than recommended value.

Ensure that the change in elevation is within the recommended value.

Recommendation Up to 0.25 inches

Remove tripping hazards \$198

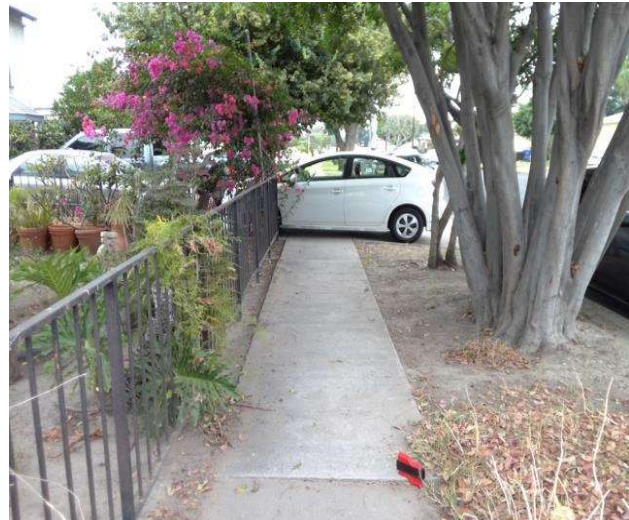
There is a change in elevation greater than recommended value.

Ensure that the change in elevation is within the recommended value.

Recommendation Up to 0.25 inches

Remove tripping hazards \$198

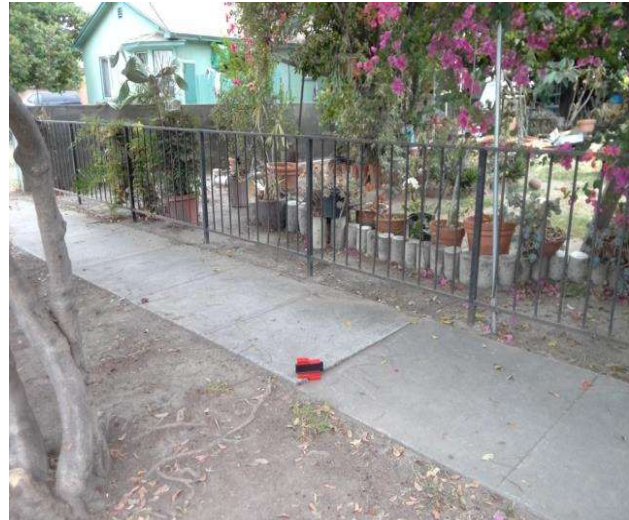
There is a change in elevation greater than recommended value.

Ensure that the change in elevation is within the recommended value.

Recommendation Up to 0.25 inches

Remove tripping hazards \$198

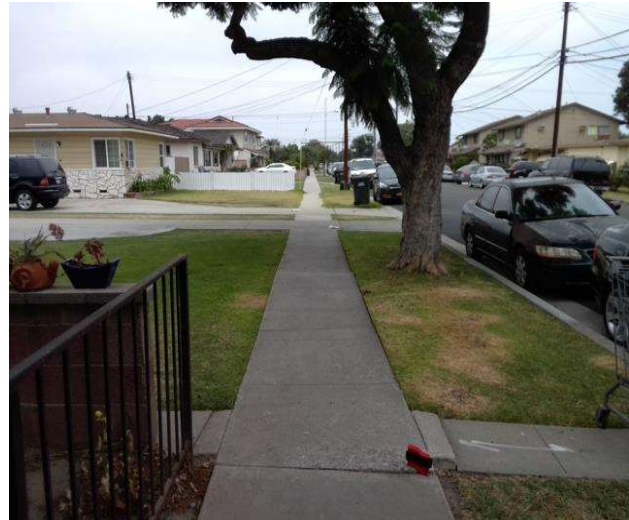
There is a change in elevation greater than recommended value.

Ensure that the change in elevation is within the recommended value.

Recommendation Up to 0.25 inches

Remove tripping hazards \$198

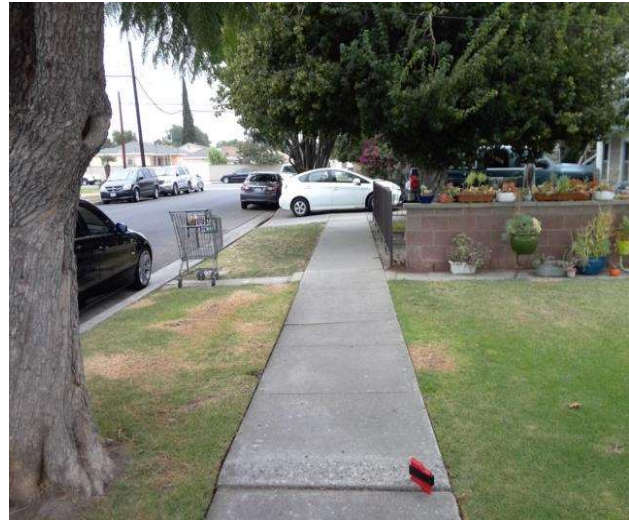
There is a change in elevation greater than recommended value.

Ensure that the change in elevation is within the recommended value.

Recommendation Up to 0.25 inches

Remove tripping hazards \$198

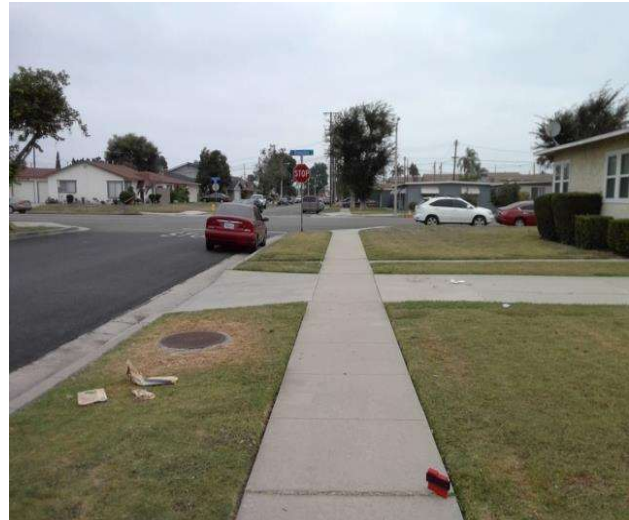
There is a change in elevation greater than recommended value.

Ensure that the change in elevation is within the recommended value.

Recommendation Up to 0.25 inches

Remove tripping hazards \$198

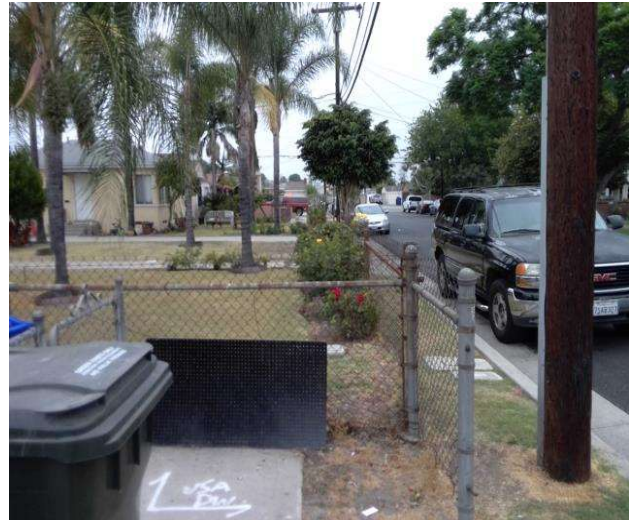
Sidewalks : Missing Sidewalk

Section of sidewalk is missing and consists of dirt, grass or gravel.

Provide a compliant sidewalk for the missing section.

\$1,260

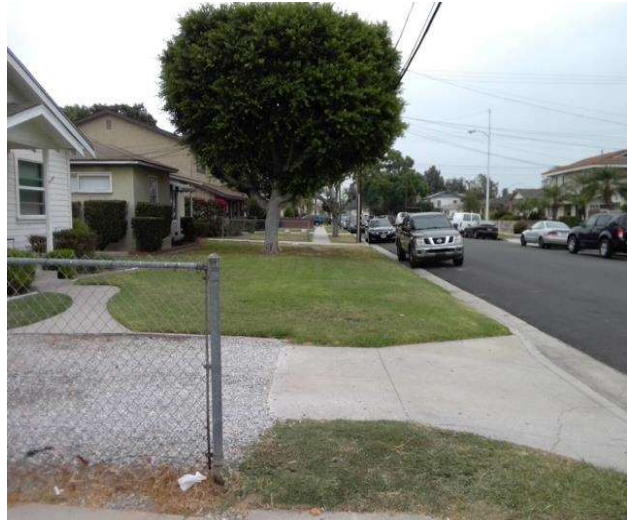
Sidewalks : Missing Sidewalk

Section of sidewalk is missing and consists of dirt, grass or gravel.

Provide a compliant sidewalk for the missing section.

\$1,260

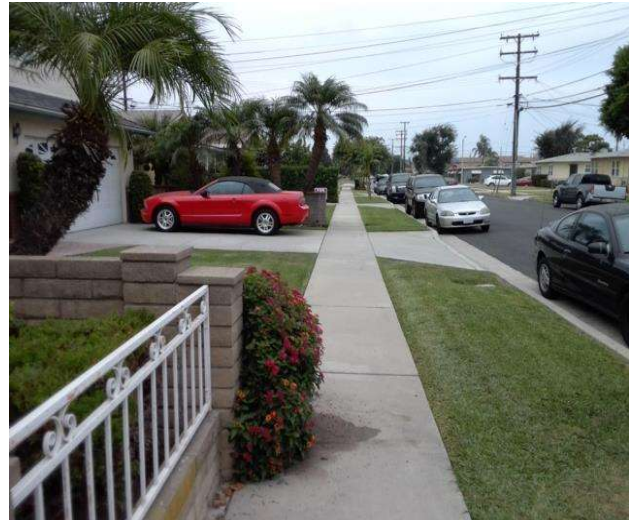
Sidewalks , Hazards & Gratings : Sidewalk Width at Obstruction

Sidewalk width at the obstruction shall have the recommended value.

Recommendation At least 48.00 inches

\$1,260

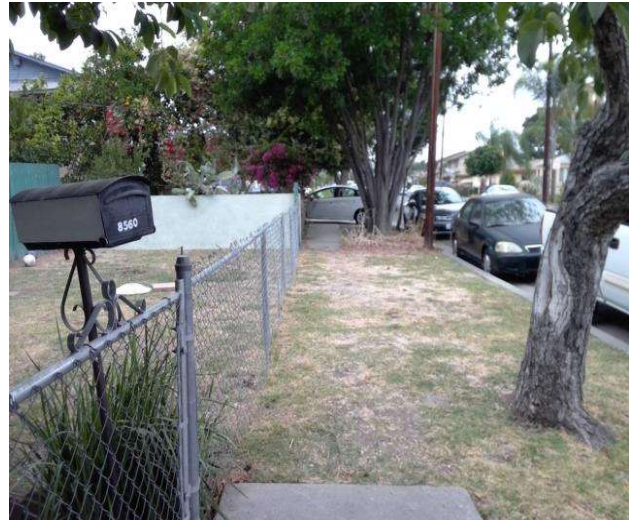
Sidewalks : Missing Sidewalk

Section of sidewalk is missing and consists of dirt, grass or gravel.

Provide a compliant sidewalk for the missing section.

\$1,260

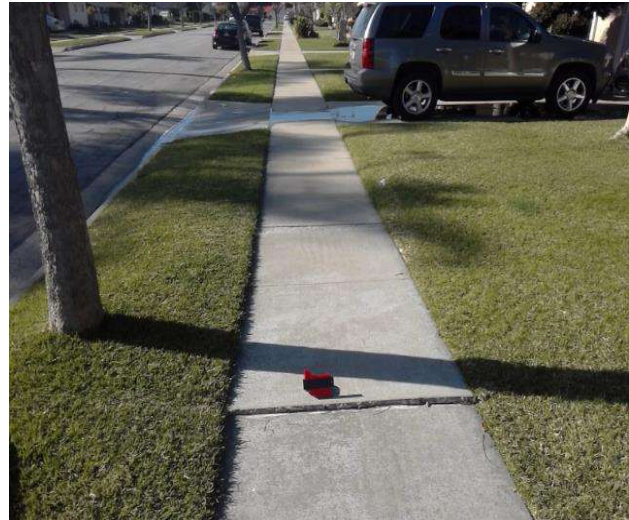
There is a change in elevation greater than recommended value.

Recommendation Up to 0.50 inches

Remove tripping hazards \$198

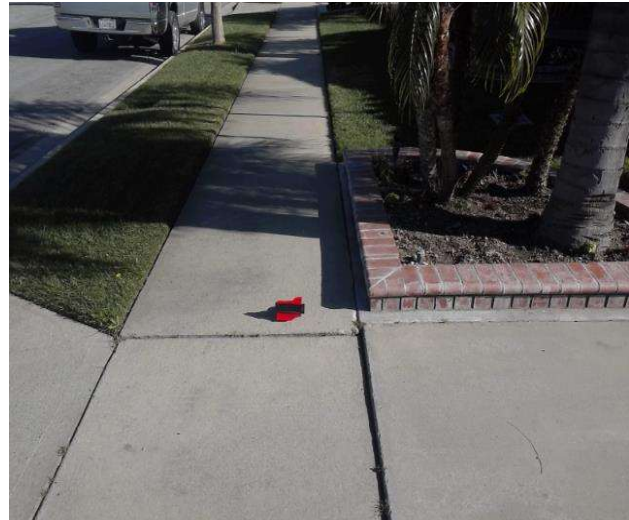
There is a change in elevation greater than recommended value.

Recommendation Up to 0.50 inches

Remove tripping hazards \$198

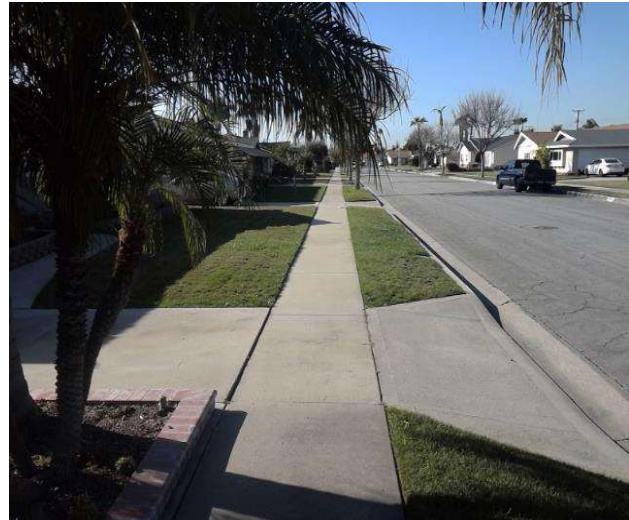
Sidewalks , Hazards & Gratings : Overhead Obstruction Height

Recommendation At least 80.00 inches

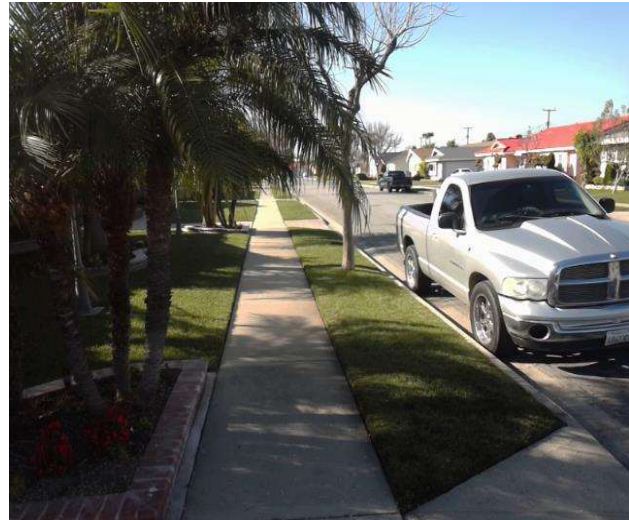
Sidewalks , Hazards & Gratings : Overhead Obstruction Height

Recommendation At least 80.00 inches

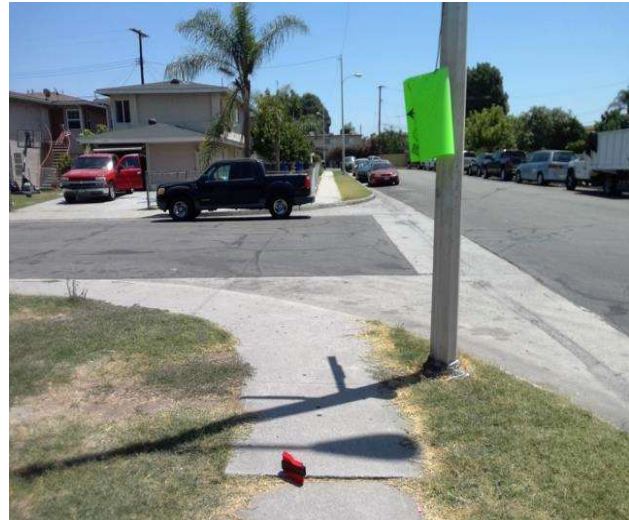
There is a change in elevation greater than recommended value.

Ensure that the change in elevation is within the recommended value.

Recommendation Up to 0.25 inches

Remove tripping hazards \$198

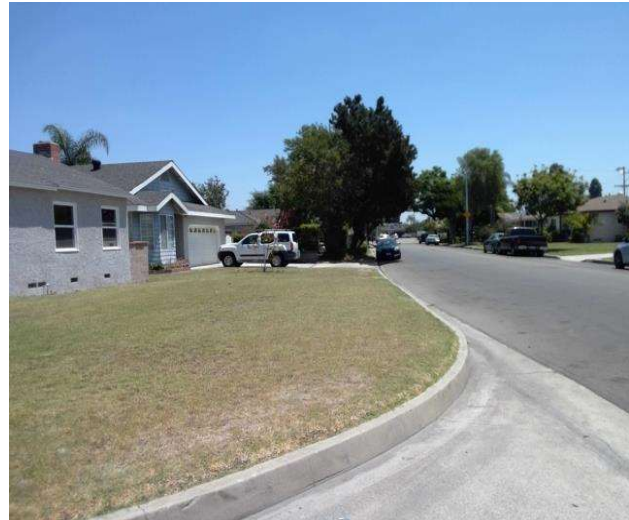
Sidewalks : Missing Sidewalk

Section of sidewalk is missing and consists of dirt, grass or gravel.

Provide a compliant sidewalk for the missing section.

\$1,260

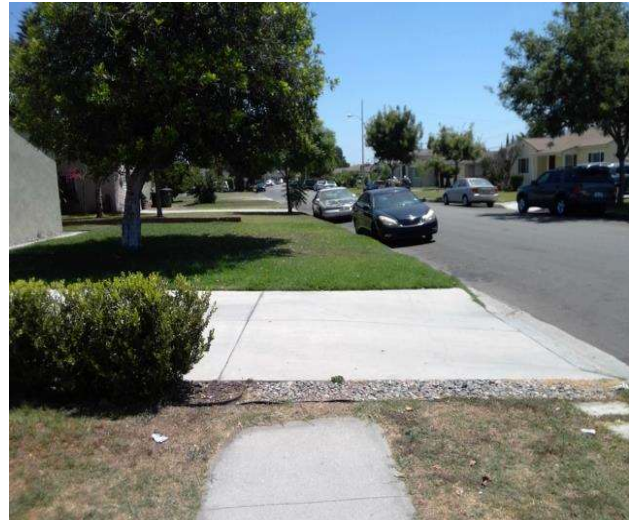
Sidewalks : Missing Sidewalk

Section of sidewalk is missing and consists of dirt, grass or gravel.

Provide a compliant sidewalk for the missing section.

\$1,260

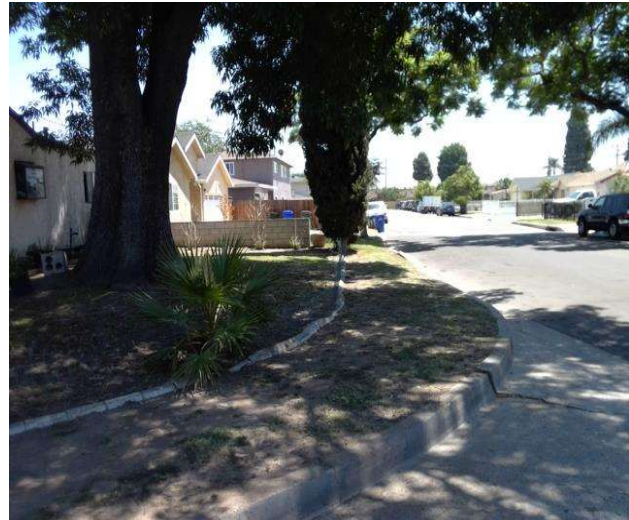
Sidewalks : Missing Sidewalk

Section of sidewalk is missing and consists of dirt, grass or gravel.

Provide a compliant sidewalk for the missing section.

\$1,260

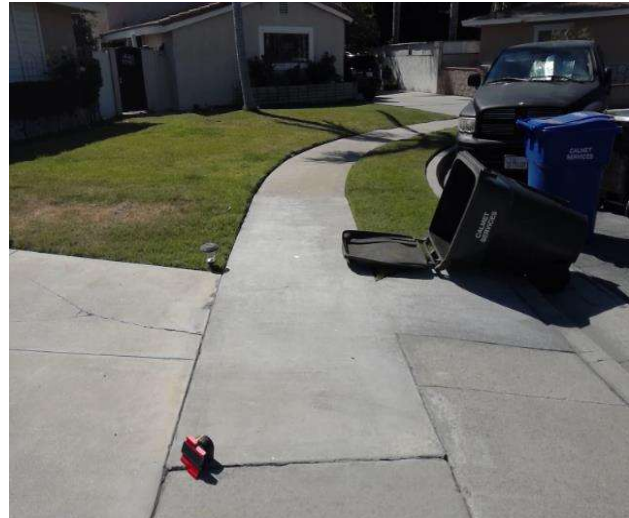
There is a change in elevation greater than recommended value.

Ensure that the change in elevation is within the recommended value.

Recommendation Up to 0.25 inches

Remove tripping hazards \$198

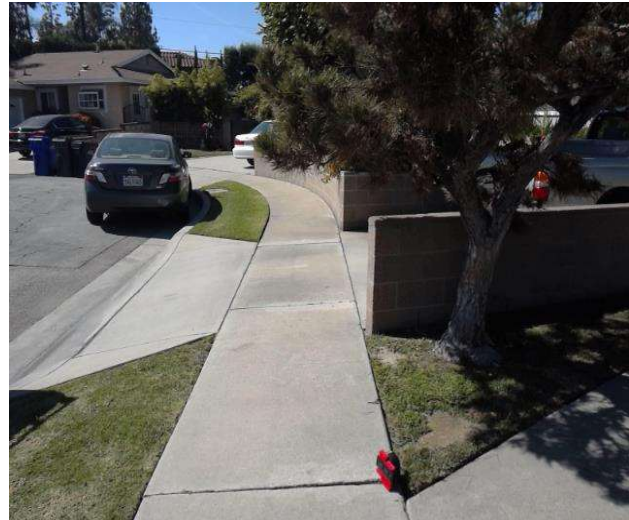
There is a change in elevation greater than recommended value.

Ensure that the change in elevation is within the recommended value.

Recommendation Up to 0.25 inches

Remove tripping hazards \$198

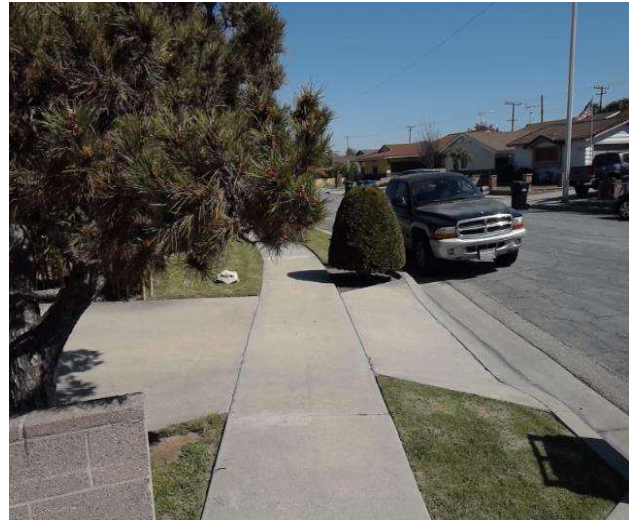
Sidewalks , Hazards & Gratings : Overhead Obstruction Height

Recommendation At least 80.00 inches
