## Accessibility Survey

## City of Downey Luxor Street - Patton Road To Downey Avenue

Date of Inspection  
12/9/2016

**Disability Access Consultants**

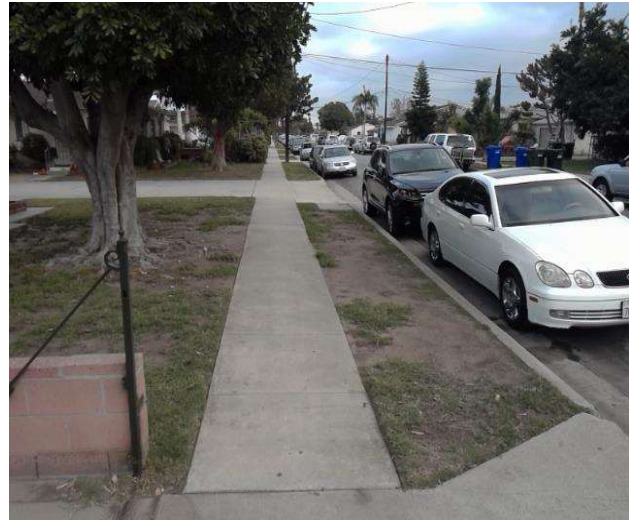
#### Change In Level East Of Downey Avenue @ 33.933800235631, -118.136624693871

Sidewalks , Change in Level : Change in Level Non Beveled

There is a change in elevation greater than recommended value.

**On-Site Finding** 0.50 inches

**Code Reference** ADA 206, 302

Ensure that the change in elevation is within the recommended value.

Recommendation Up to 0.25 inches

Remove tripping hazards \$198

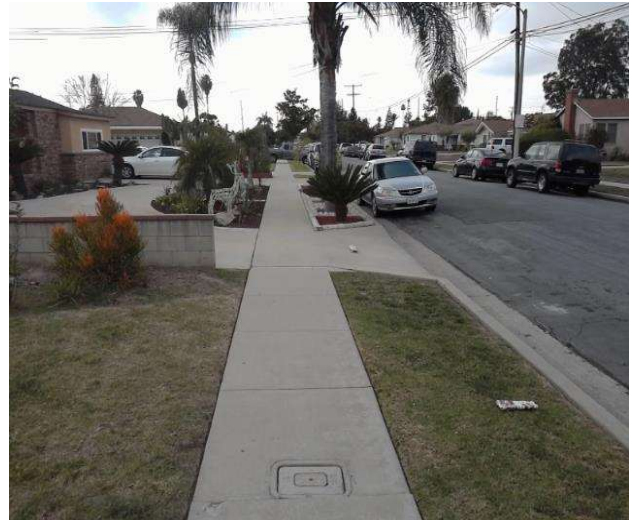
There is a change in elevation greater than recommended value.

**Code Reference** ADA 206, 302

Ensure that the change in elevation is within the recommended value.

Recommendation Up to 0.25 inches

Remove tripping hazards \$198

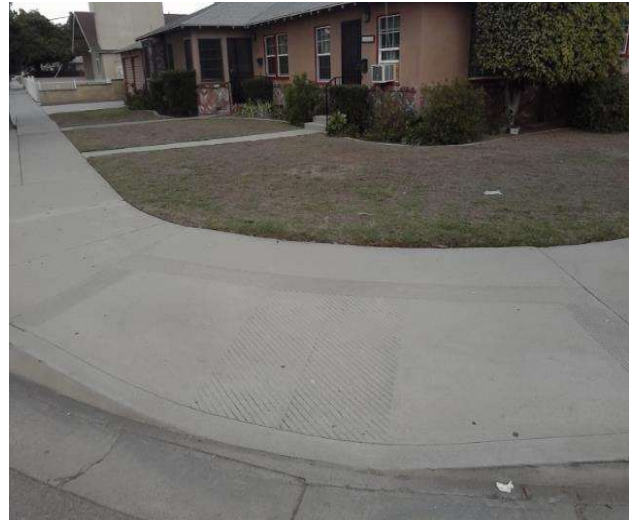
**On-Site Finding** Not Found

**Code Reference** CA 11B-406.5.12

Provide detectable warning to surface \$248

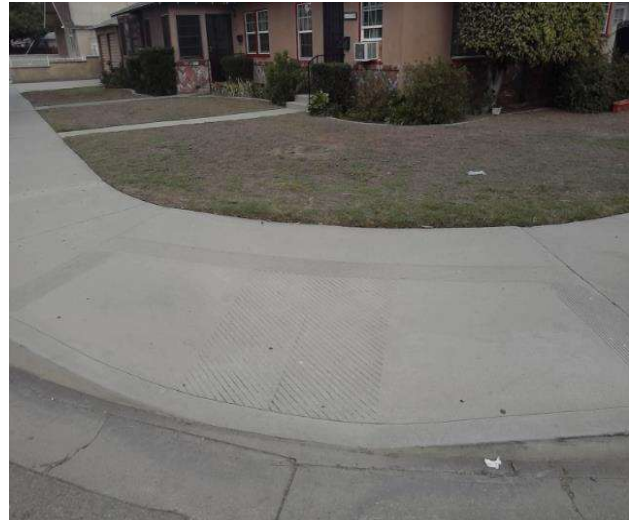
Curb Ramp , Landings and Transitions : Top Landing Clear Length - Landings

**Code Reference** ADA 406, 406.4,CA 11B-406.5.3

Recommendation At least 48.00 inches

Provide compliant landing \$240

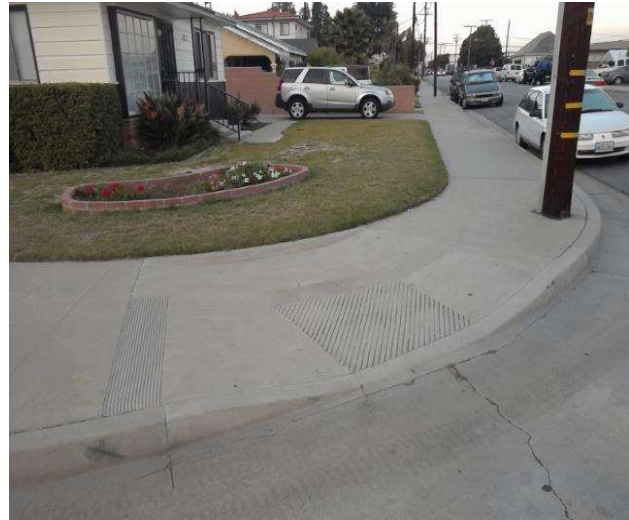
**On-Site Finding** Not Found

**Code Reference** CA 11B-406.5.12

Provide detectable warning to surface \$248

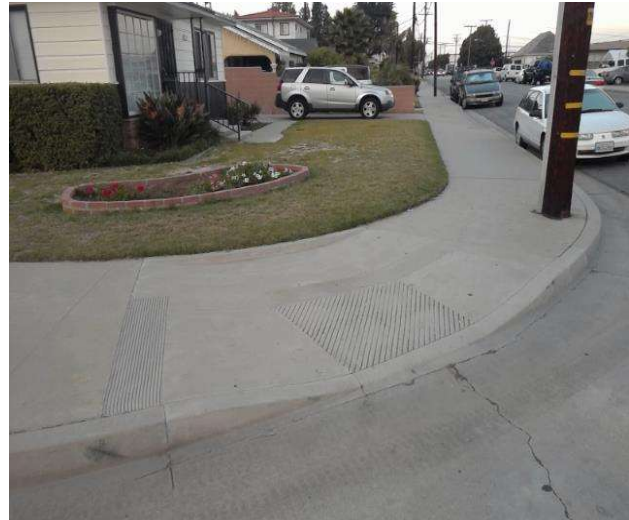
**Code Reference** ADA 406, 406.3, CA 11B-406.2.2

Recommendation Up to 10.00 percent

Install flared sides \$1,300

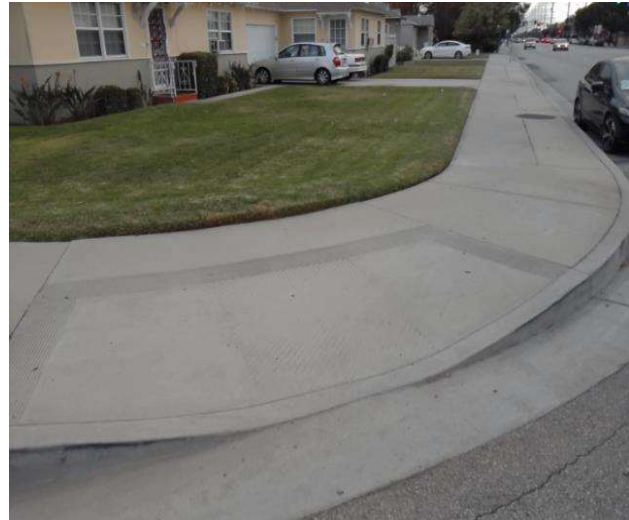
**On-Site Finding** Not Found

**Code Reference** CA 11B-406.5.12

Provide detectable warning to surface \$248

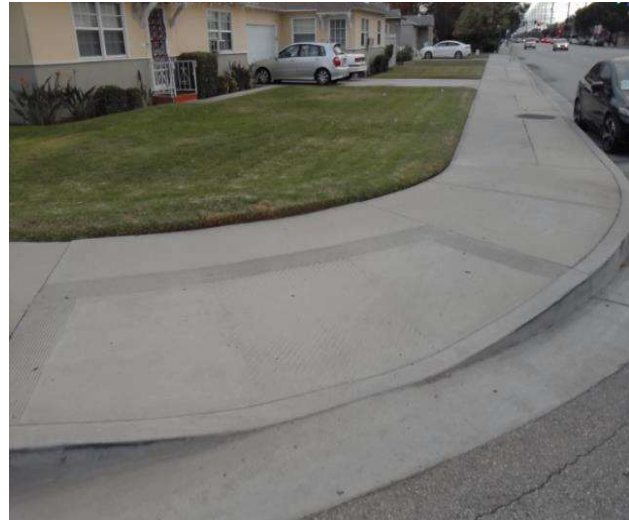
**Code Reference** ADA 406, 406.3, CA 11B-406.2.2

Recommendation Up to 10.00 percent

Install flared sides \$1,300

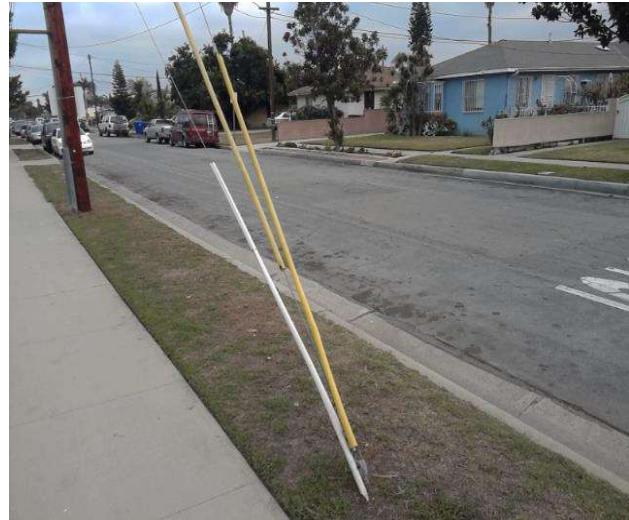
Sidewalks , Hazards & Gratings : Overhead Obstruction Height

**Code Reference** ADA 206, 307.4, CA 11B-307.4

Recommendation At least 80.00 inches

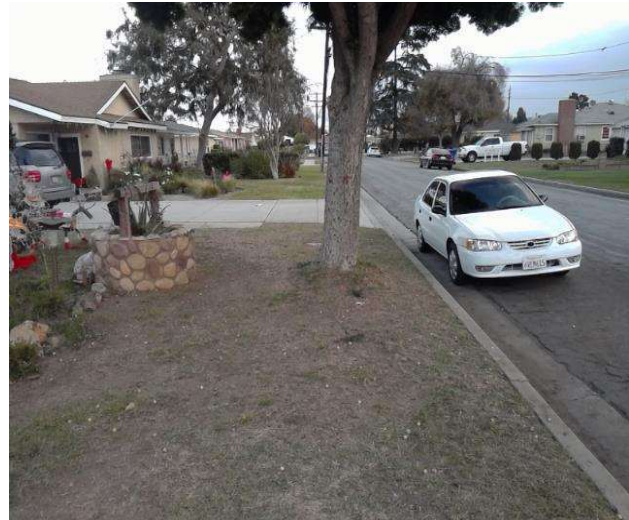
Sidewalks : Missing Sidewalk

Section of sidewalk is missing and consists of dirt, grass or gravel.

**Code Reference** ADA 206, 302,CA 11B-302,CA 11B-206

Provide a compliant sidewalk for the missing section.

\$1,260

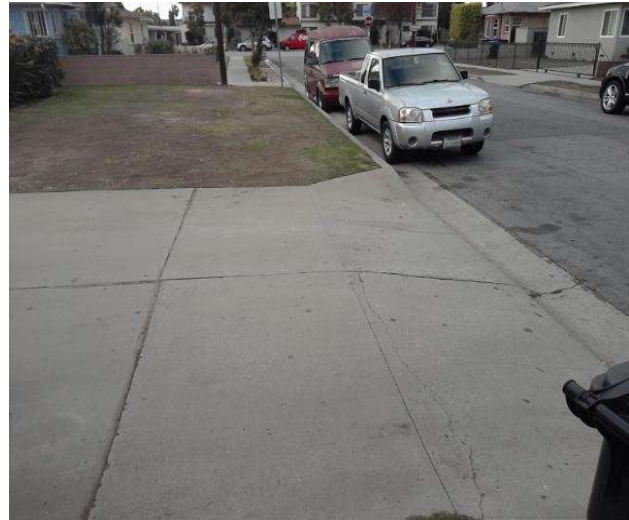
**On-Site Finding** Not Found

**Code Reference** ADA 705,CA 11B-705.1.2.5,CA 11B-247.1.2.5

Install compliant detectable warnings \$190

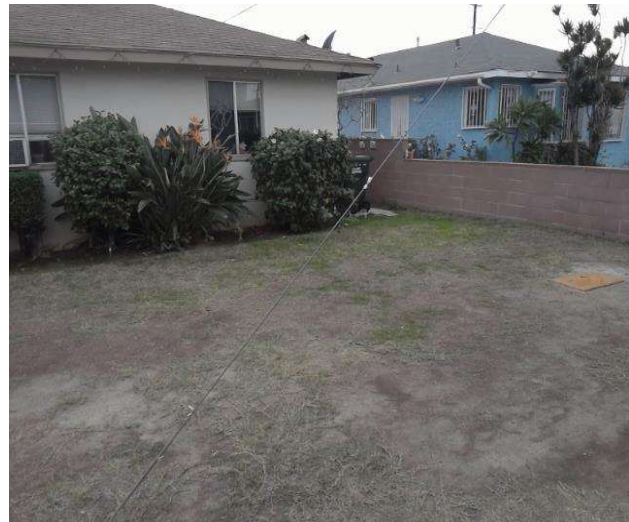
Sidewalks , Hazards & Gratings : Overhead Obstruction Height

**Code Reference** ADA 206, 307.4, CA 11B-307.4

Recommendation At least 80.00 inches

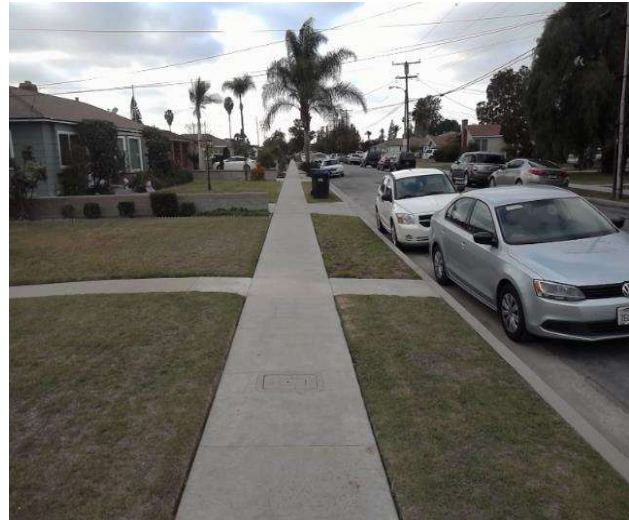
**Code Reference** ADA 206, 302,CA 11B-403.3

Repave the sidewalk surface with the recommended cross slope.

Recommendation Up to 2.08 percent

Repave surface \$1,092

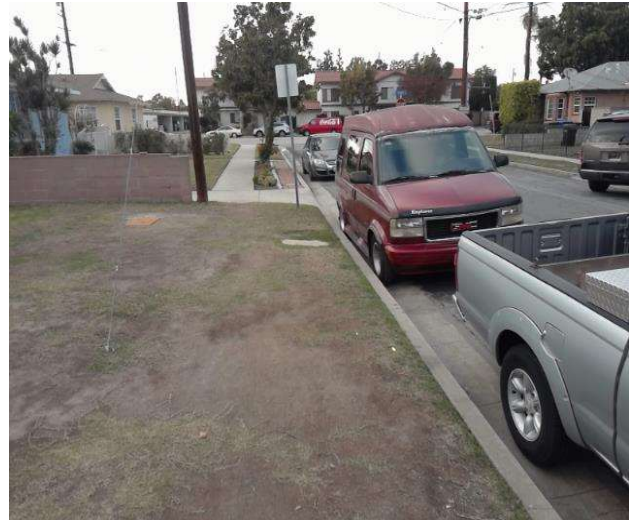
Sidewalks : Missing Sidewalk

Section of sidewalk is missing and consists of dirt, grass or gravel.

**Code Reference** ADA 206, 302,CA 11B-302,CA 11B-206

Provide a compliant sidewalk for the missing section.

\$1,260

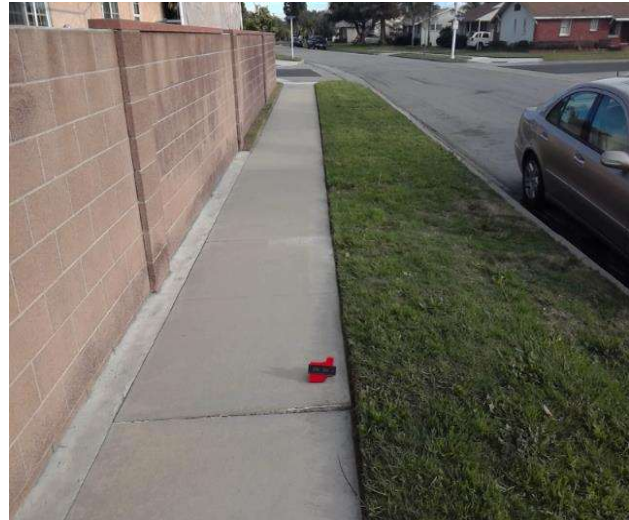
There is a change in elevation greater than recommended value.

**Code Reference** ADA 206, 302

Recommendation Up to 0.50 inches

Remove tripping hazards \$198

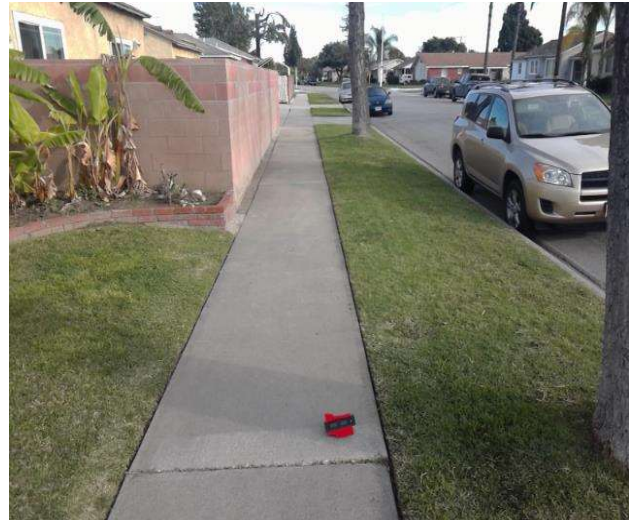
There is a change in elevation greater than recommended value.

**Code Reference** ADA 206, 302

Recommendation Up to 0.50 inches

Remove tripping hazards \$198

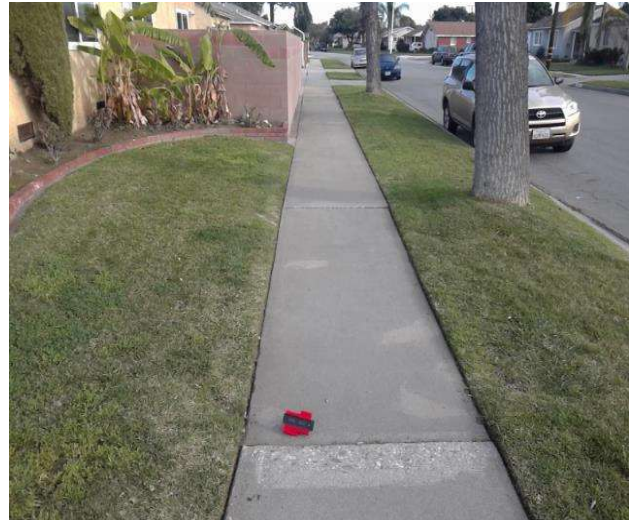
There is a change in elevation greater than recommended value.

**Code Reference** ADA 206, 302

Recommendation Up to 0.50 inches

Remove tripping hazards \$198

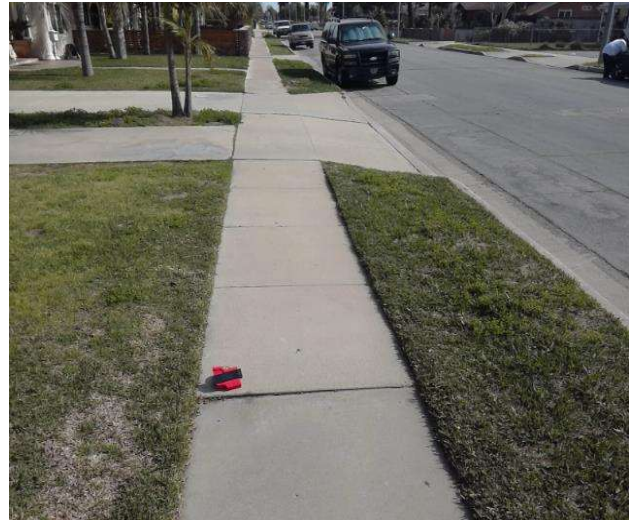
There is a change in elevation greater than recommended value.

**Code Reference** ADA 206, 302

Recommendation Up to 0.50 inches

Remove tripping hazards \$198

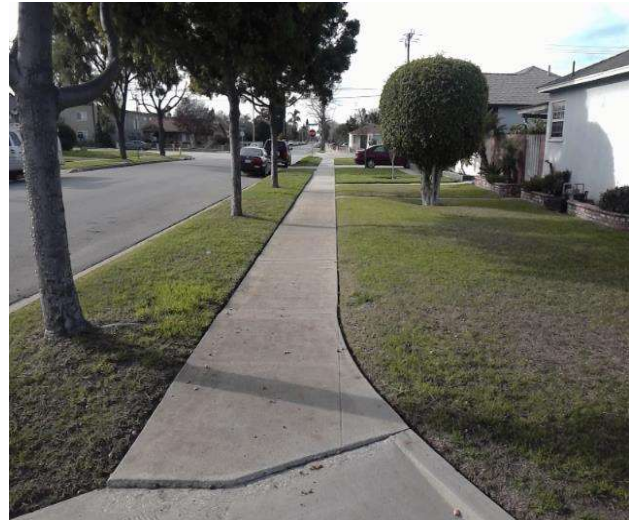
There is a change in elevation greater than recommended value.

**Code Reference** ADA 206, 302

Ensure that the change in elevation is within the recommended value.

Recommendation Up to 0.25 inches

Remove tripping hazards \$198

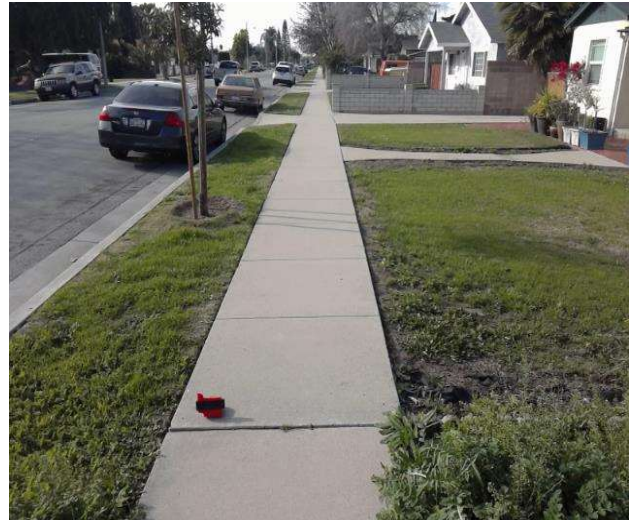
There is a change in elevation greater than recommended value.

**Code Reference** ADA 206, 302

Recommendation Up to 0.50 inches

Remove tripping hazards \$198

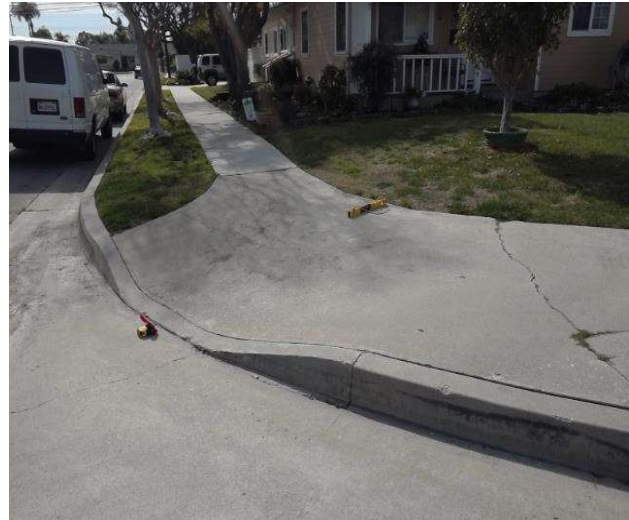
Curb Ramp , Landings and Transitions : Bottom Landing Change in Level - Curb Ramps

**Code Reference** ADA 302, 406.2

Patch lip at curb ramp \$255

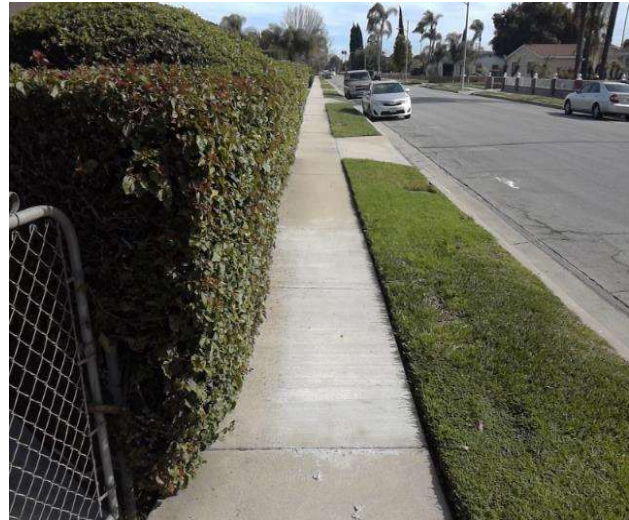
Sidewalks , Hazards & Gratings : Sidewalk Width at Obstruction

**Code Reference** ADA 206, 302, 403.5.1,CA 11B-403.5

Sidewalk width at the obstruction shall have the recommended value.

Recommendation At least 48.00 inches

\$1,260

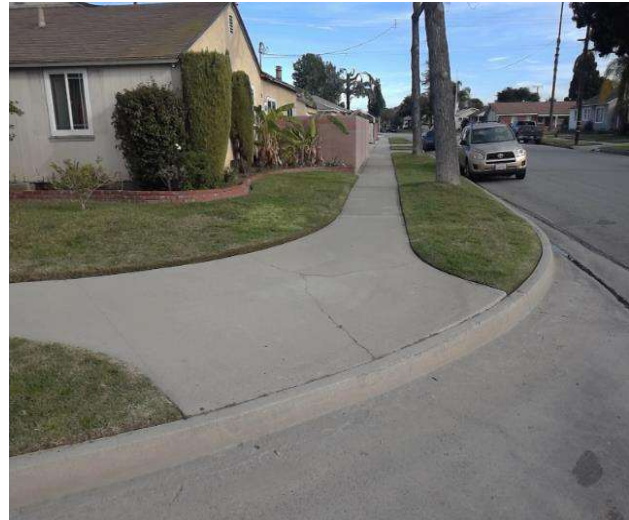
Sidewalks , Hazards & Gratings : Curb is on Path of Travel

**Code Reference** ADA 402, 303, 406, 403.4, 303.4

Install curb ramp \$2,500

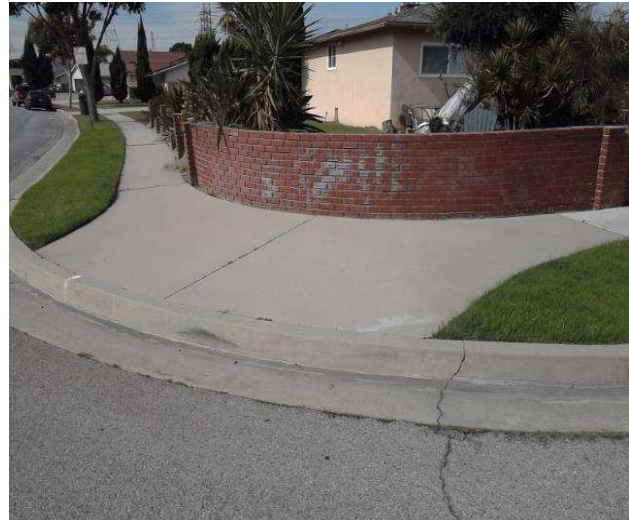
Sidewalks , Hazards & Gratings : Curb is on Path of Travel

**Code Reference** ADA 402, 303, 406, 403.4, 303.4

Install curb ramp \$2,500

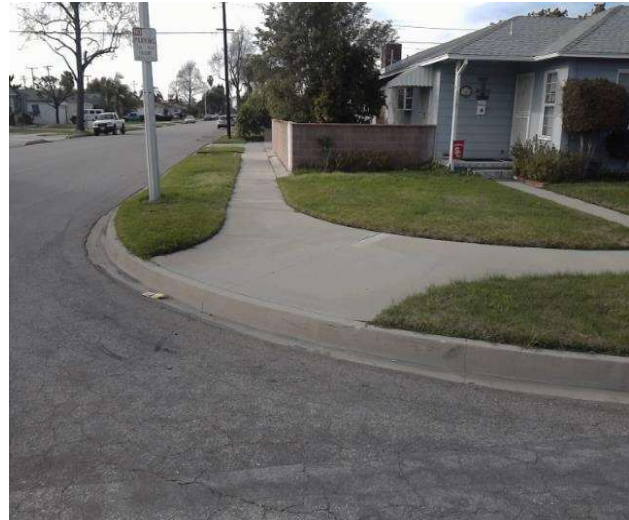
Sidewalks , Hazards & Gratings : Curb is on Path of Travel

**Code Reference** ADA 402, 303, 406, 403.4, 303.4

Install curb ramp \$2,500
