Accessibility Survey

City of Downey Wiley Burke Avenue - 2nd Street to Firestone Boulevard

Date of Inspection
7/6/2017

Disability Access Consultants

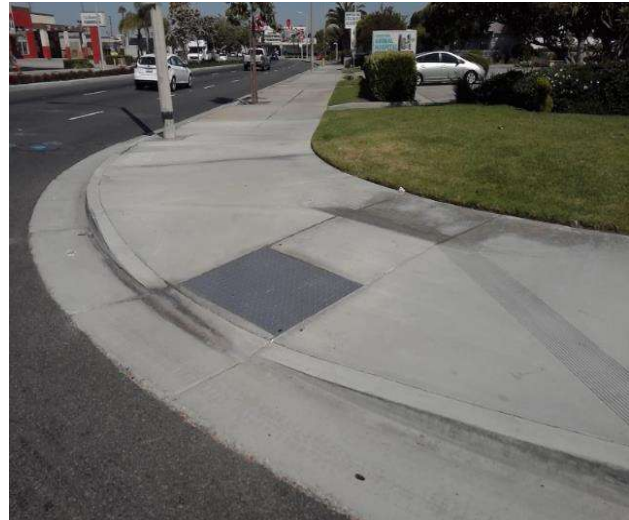
Northwest Corner of Firestone Boulevard @ 33.946802158768, - 118.145243972540

There is not enough top landing clear length.

On-Site Finding 47.00 inches

Curb Ramp , Landings and Transitions : Top Landing Clear Length - Landings

Provide a level top landing with enough clear length.

Recommendation At least 48.00 inches

Provide compliant landing \$240

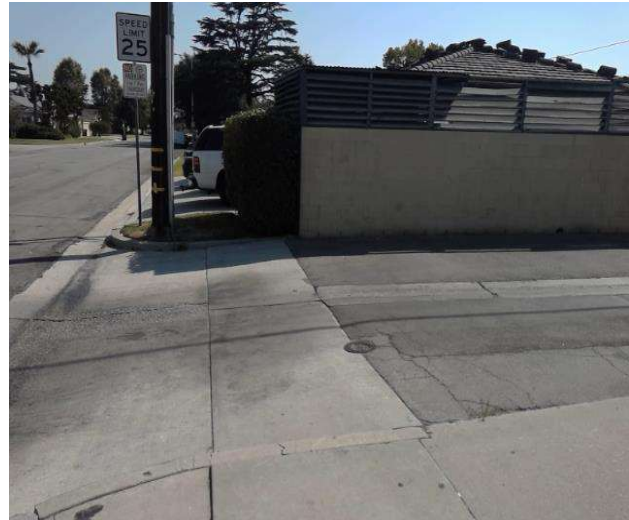
Alley South of 2nd Street @ 33.947033562997, -118.144855052233

There are no detectable warnings where the pedestrian route crosses vehicular traffic.

On-Site Finding Not Found

Provide detectable warnings.

Install compliant detectable warnings \$190

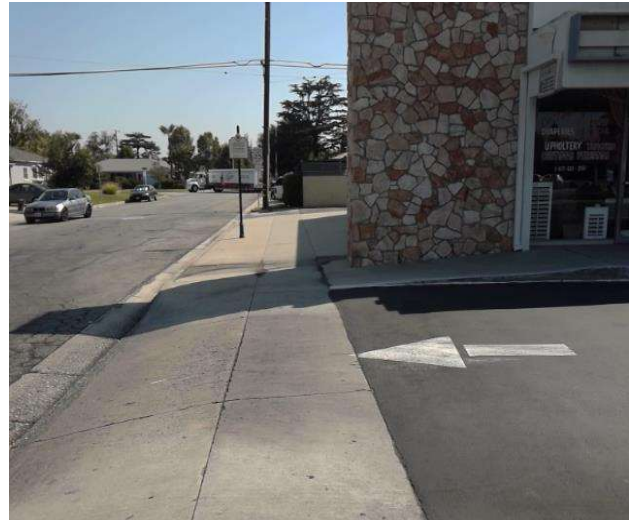
On-Site Finding Not Found

Install compliant detectable warnings \$190

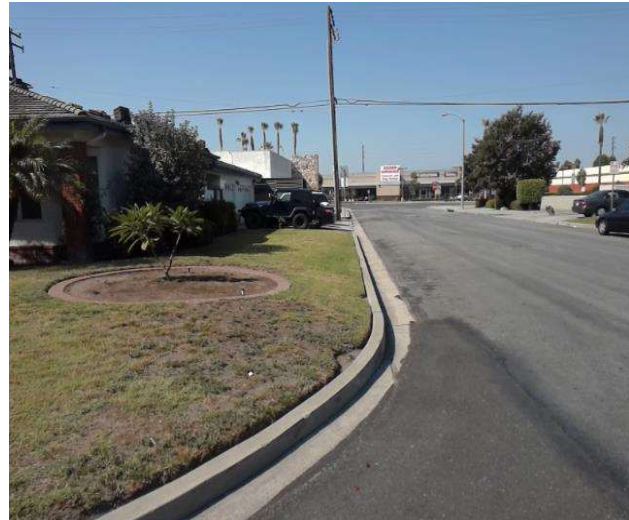
Section of sidewalk is missing and consists of dirt, grass or gravel.

Provide a compliant sidewalk for the missing section.

\$1,260

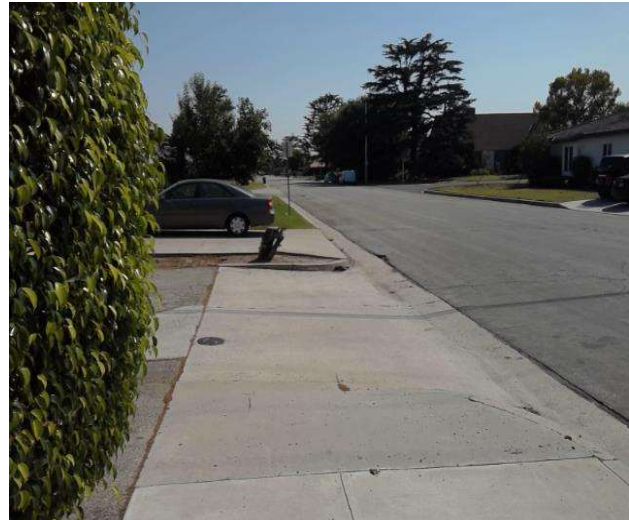
On-Site Finding Not Found

Install compliant detectable warnings \$190

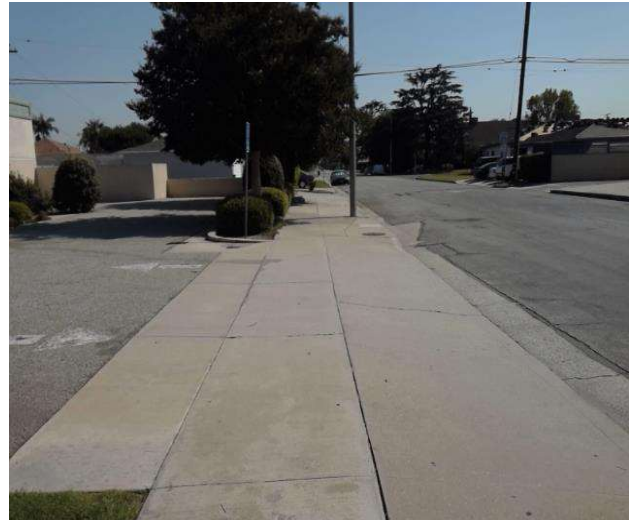
On-Site Finding Not Found

Install compliant detectable warnings \$190

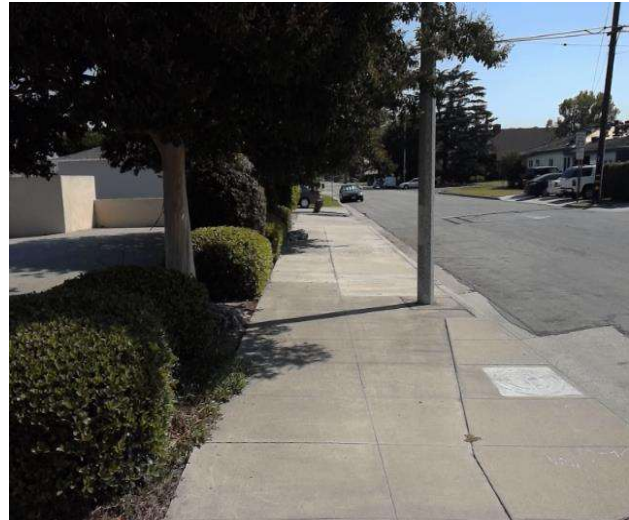
Section of sidewalk is missing and consists of dirt, grass or gravel.

Provide a compliant sidewalk for the missing section.

\$1,260

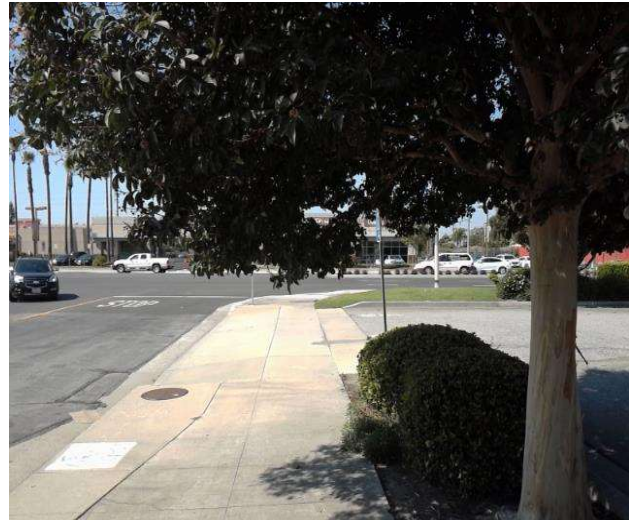
Sidewalks , Hazards & Gratings : Overhead Obstruction Height

Recommendation At least 80.00 inches

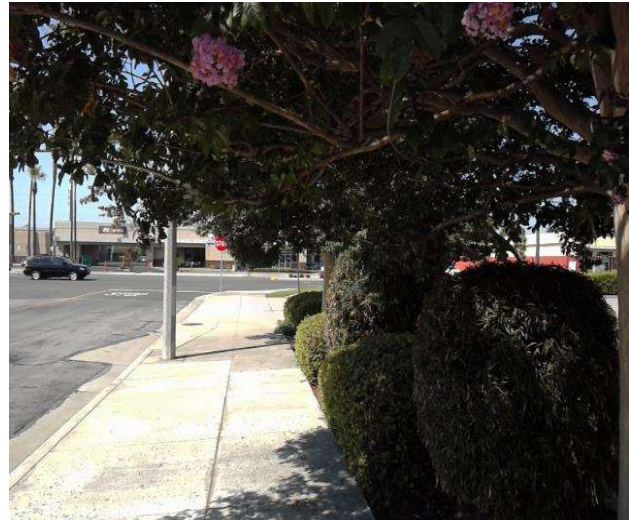
Sidewalks , Hazards & Gratings : Overhead Obstruction Height

Recommendation At least 80.00 inches

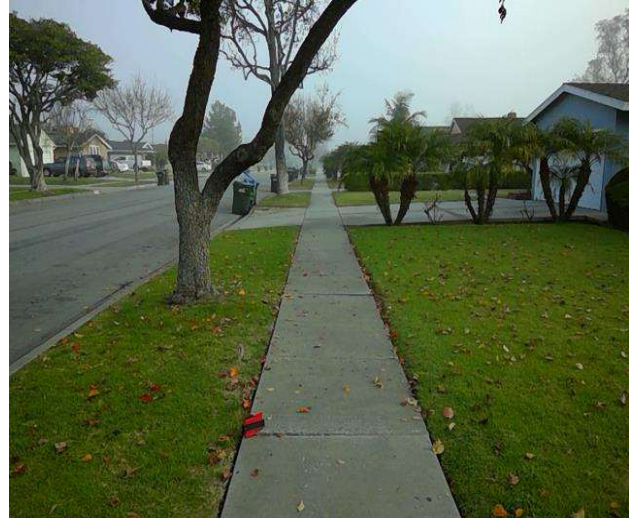
There is a change in elevation greater than recommended value.

Ensure that the change in elevation is within the recommended value.

Recommendation Up to 0.25 inches

Remove tripping hazards \$198

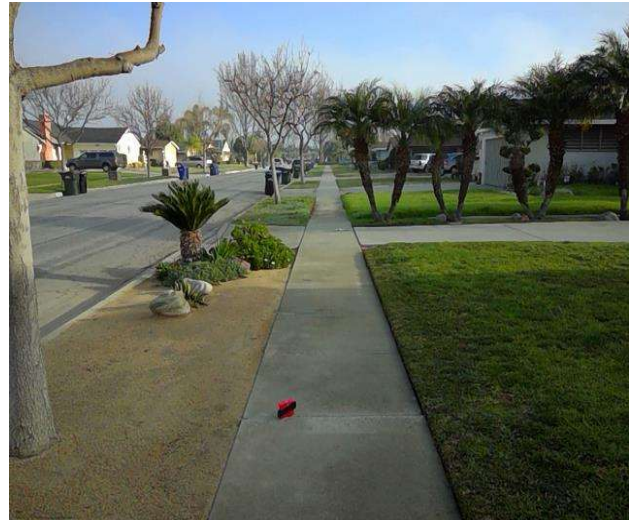
There is a change in elevation greater than recommended value.

Ensure that the change in elevation is within the recommended value.

Recommendation Up to 0.25 inches

Remove tripping hazards \$198

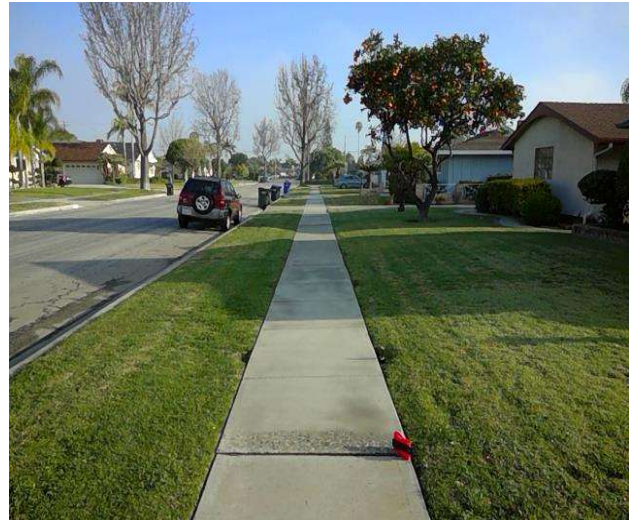
There is a change in elevation greater than recommended value.

Ensure that the change in elevation is within the recommended value.

Recommendation Up to 0.25 inches

Remove tripping hazards \$198

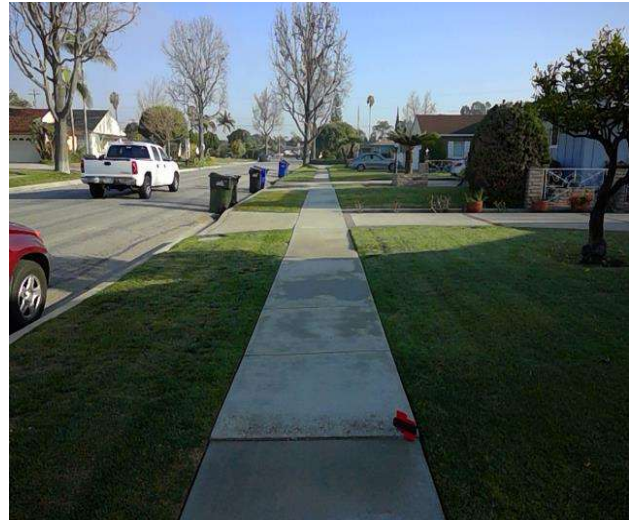
There is a change in elevation greater than recommended value.

Ensure that the change in elevation is within the recommended value.

Recommendation Up to 0.25 inches

Remove tripping hazards \$198

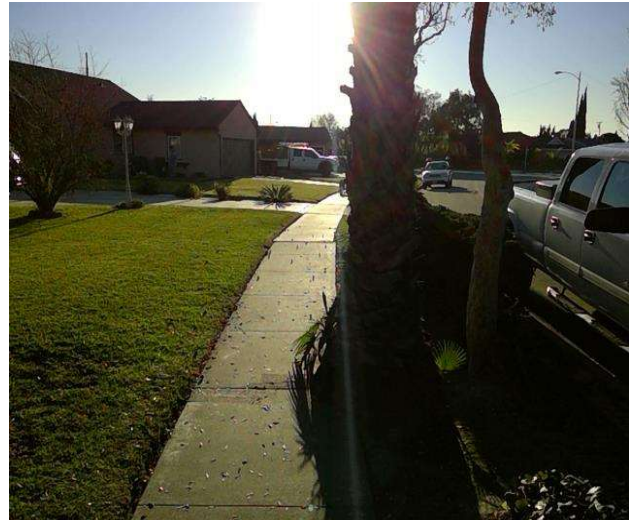
Sidewalks , Hazards & Gratings : Sidewalk Width at Obstruction

Sidewalk width at the obstruction shall have the recommended value.

Recommendation At least 48.00 inches

\$1,260

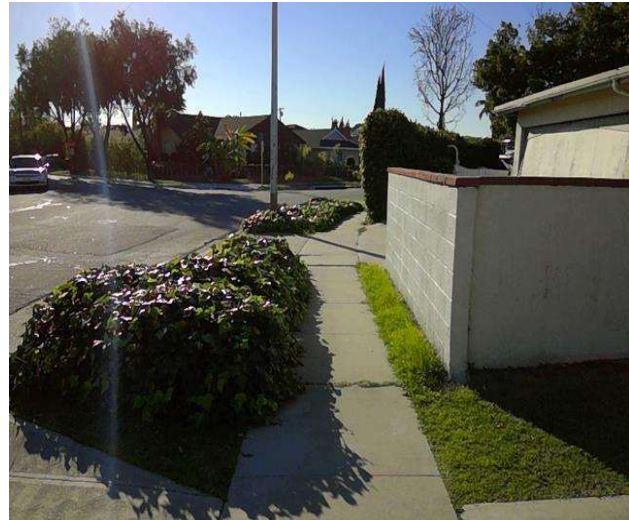
Sidewalks , Hazards & Gratings : Sidewalk Width at Obstruction

Sidewalk width at the obstruction shall have the recommended value.

Recommendation At least 48.00 inches

\$1,260

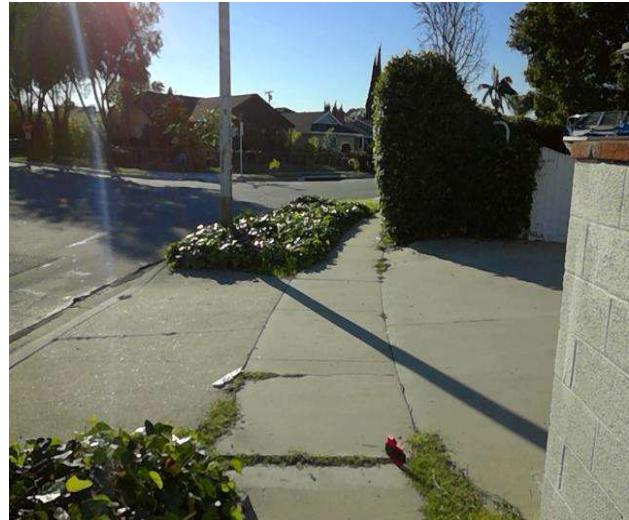
There is a change in elevation greater than recommended value.

Ensure that the change in elevation is within the recommended value.

Recommendation Up to 0.25 inches

Remove tripping hazards \$198

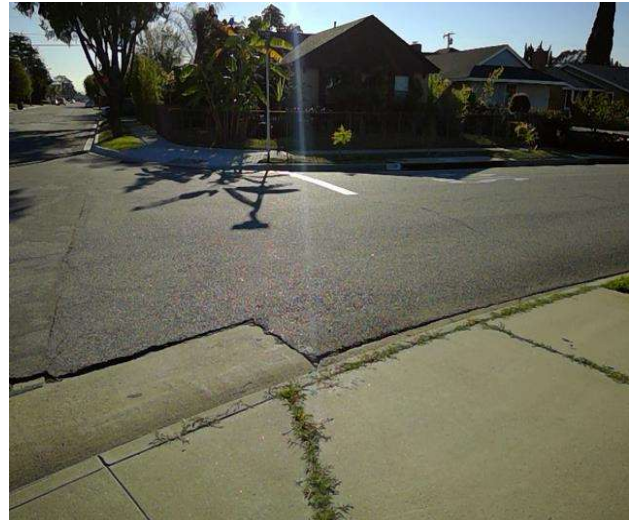
Sidewalks , Hazards & Gratings : Curb is on Path of Travel

Recommendation See Recommendation

Install curb ramp \$2,500

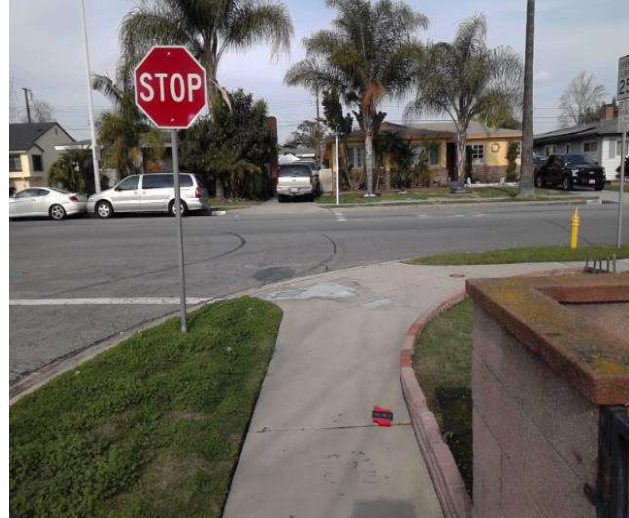
There is a change in elevation greater than recommended value.

Ensure that the change in elevation is within the recommended value.

Recommendation Up to 0.25 inches

Remove tripping hazards \$198
