Accessibility Survey

Adenmoor Avenue - Elm Vista Drive to Cul-De-Sac

Date of Inspection
8/8/2017

Disability Access Consultants

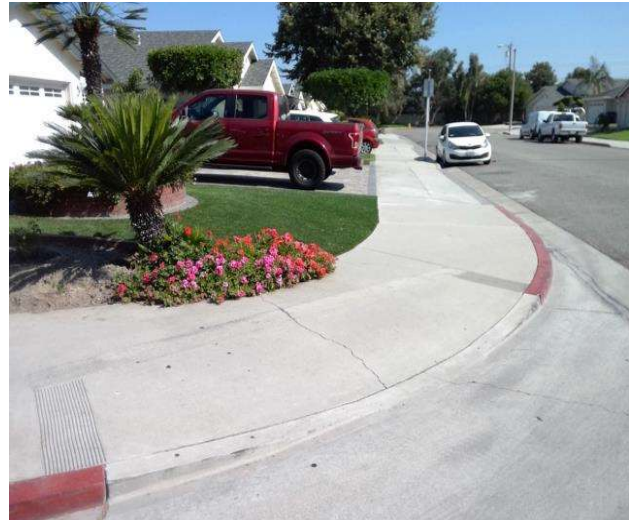
**Northwest Corner of Elm Vista Drive @ 33.926263640863, -
118.124321401119**

Curb Ramp , Landings and Transitions : Top Landing Clear Length - Landings

There is not enough top landing clear length.

On-Site Finding 30.50 inches

Code Reference ADA 406, 406.4,CA 11B-406.5.3

Notes : Top Landing Reduced By Plants

Provide a level top landing with enough clear length.

Recommendation At least 48.00 inches

Provide compliant landing \$240

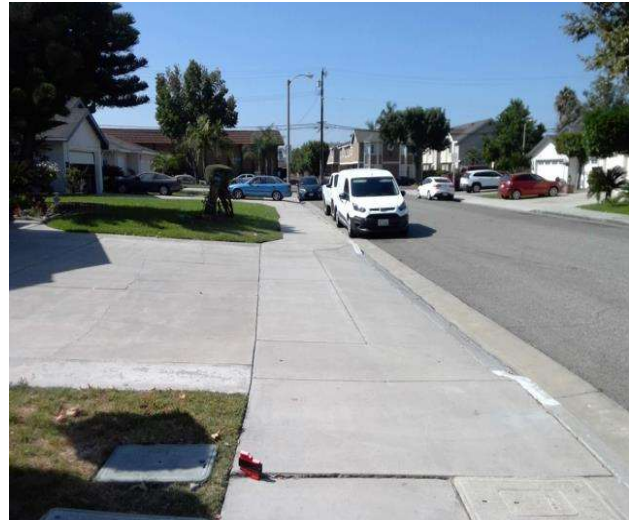
Change in Level South of Cul-De-Sac @ 33.926759943859, -118.124159127474

Sidewalks , Change in Level : Change in Level Non Beveled

There is a change in elevation greater than recommended value.

On-Site Finding 1.00 inches

Code Reference ADA 206, 302

Ensure that the change in elevation is within the recommended value.

Recommendation Up to 0.25 inches

Remove tripping hazards \$198

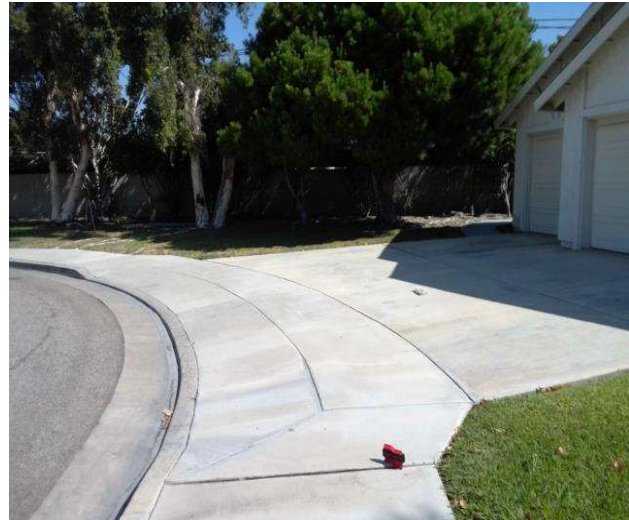
There is a change in elevation greater than recommended value.

Ensure that the change in elevation is within the recommended value.

Recommendation Up to 0.25 inches

Remove tripping hazards \$198

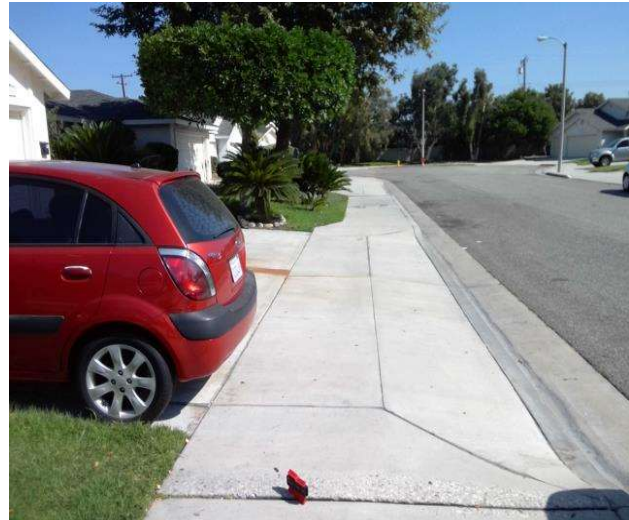
There is a change in elevation greater than recommended value.

Ensure that the change in elevation is within the recommended value.

Recommendation Up to 0.25 inches

Remove tripping hazards \$198

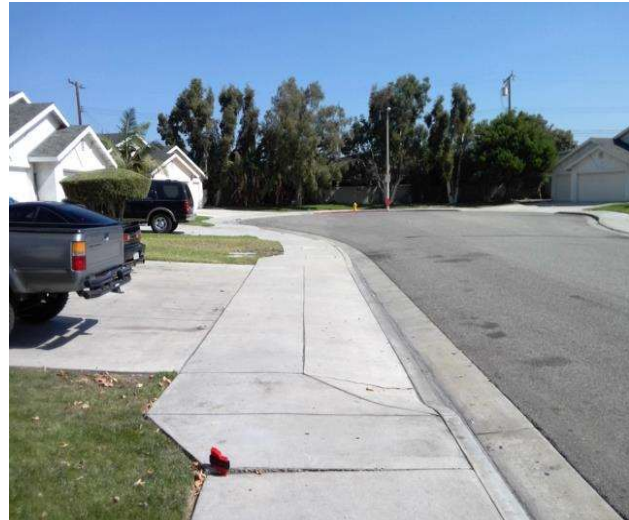
There is a change in elevation greater than recommended value.

Ensure that the change in elevation is within the recommended value.

Recommendation Up to 0.25 inches

Remove tripping hazards \$198

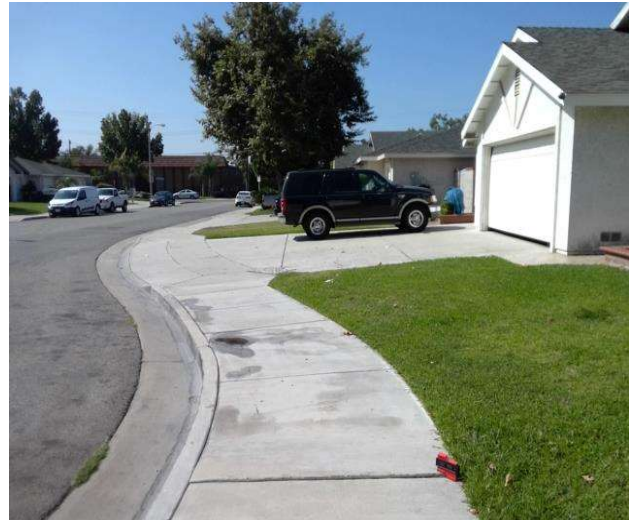
There is a change in elevation greater than recommended value.

Ensure that the change in elevation is within the recommended value.

Recommendation Up to 0.25 inches

Remove tripping hazards \$198

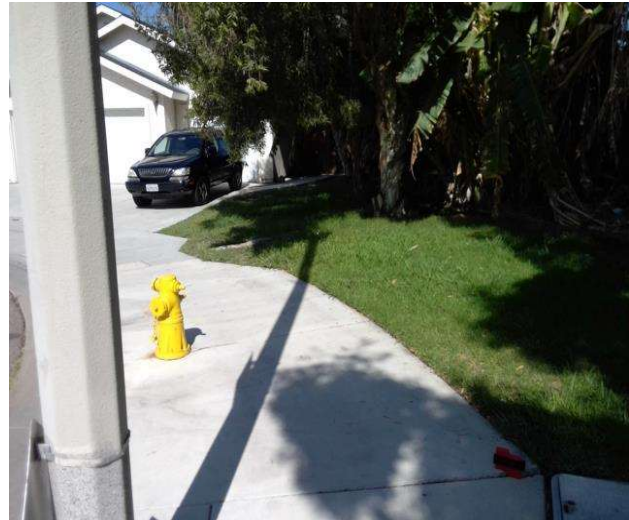
There is a change in elevation greater than recommended value.

Ensure that the change in elevation is within the recommended value.

Recommendation Up to 0.25 inches

Remove tripping hazards \$198

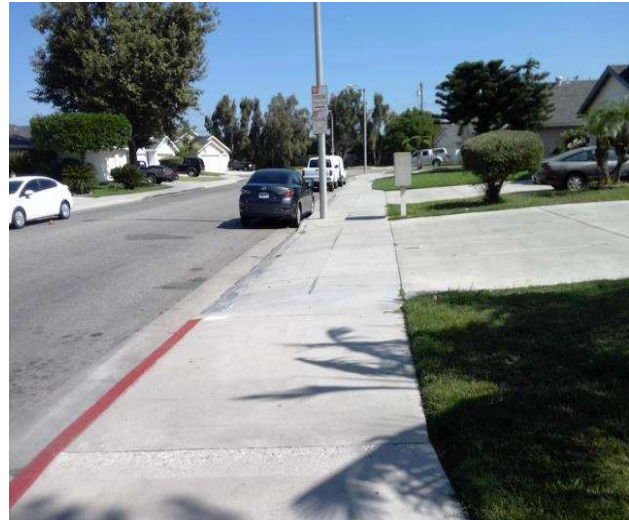
Code Reference ADA 206, 302,CA 11B-403.3

Repave the sidewalk surface with the recommended cross slope.

Recommendation Up to 2.08 percent

Repave surface \$1,092

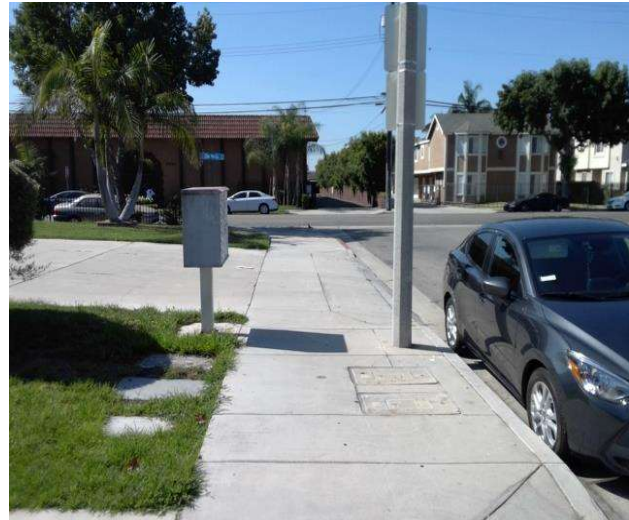
Code Reference ADA 206, 302, CA 11B-403.3

Repave the sidewalk surface with the recommended cross slope.

Recommendation Up to 2.08 percent

Repave surface \$1,092

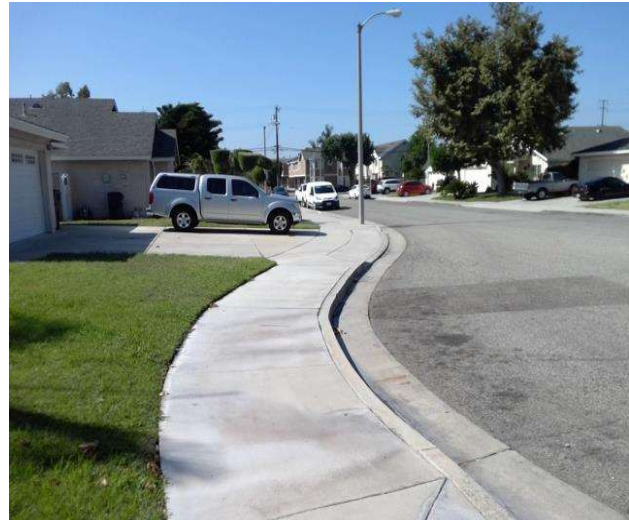
Code Reference ADA 206, 302,CA 11B-403.3

Repave the sidewalk surface with the recommended cross slope.

Recommendation Up to 2.08 percent

Repave surface \$1,092

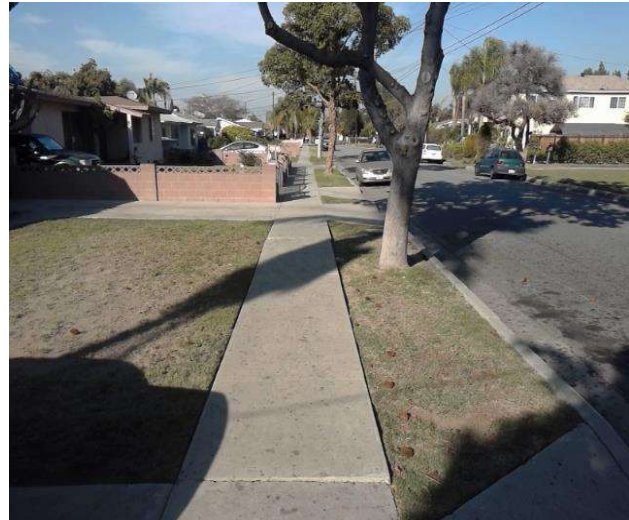
There is a change in elevation greater than recommended value.

Ensure that the change in elevation is within the recommended value.

Recommendation Up to 0.25 inches

Remove tripping hazards \$198

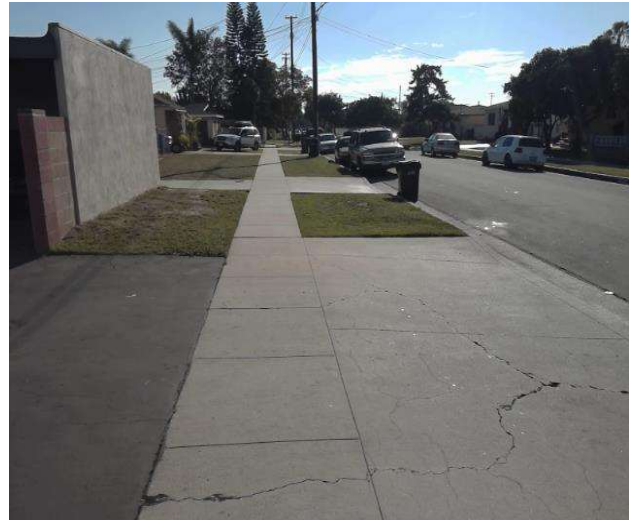
There is a change in elevation greater than recommended value.

Ensure that the change in elevation is within the recommended value.

Recommendation Up to 0.25 inches

Remove tripping hazards \$198

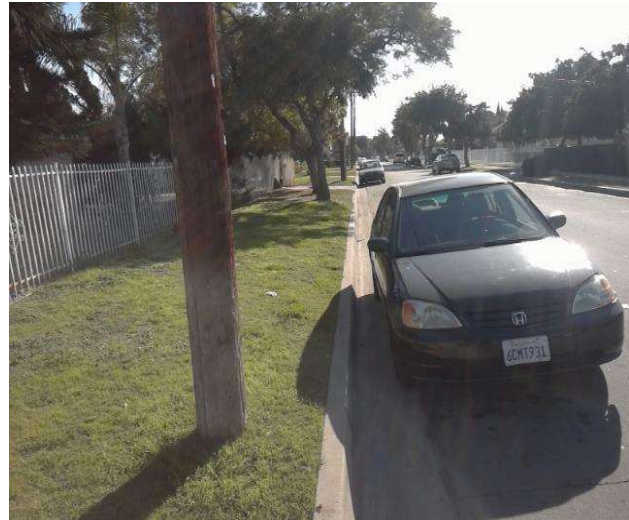
Sidewalks : Missing Sidewalk

Section of sidewalk is missing and consists of dirt, grass or gravel.

Provide a compliant sidewalk for the missing section.

\$1,260

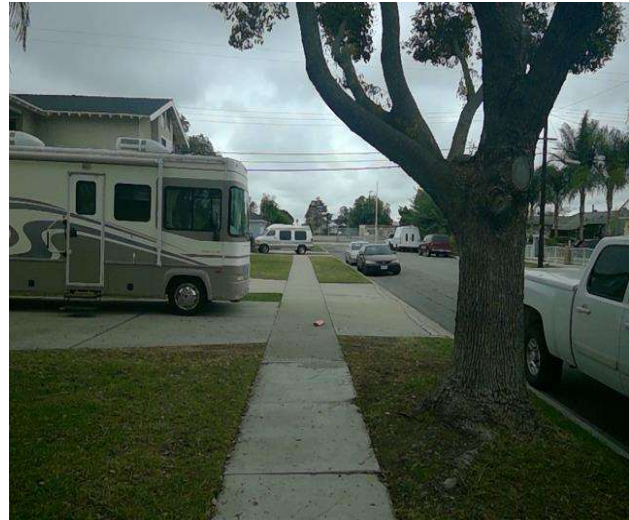
There is a change in elevation greater than recommended value.

Ensure that the change in elevation is within the recommended value.

Recommendation Up to 0.25 inches

Remove tripping hazards \$198

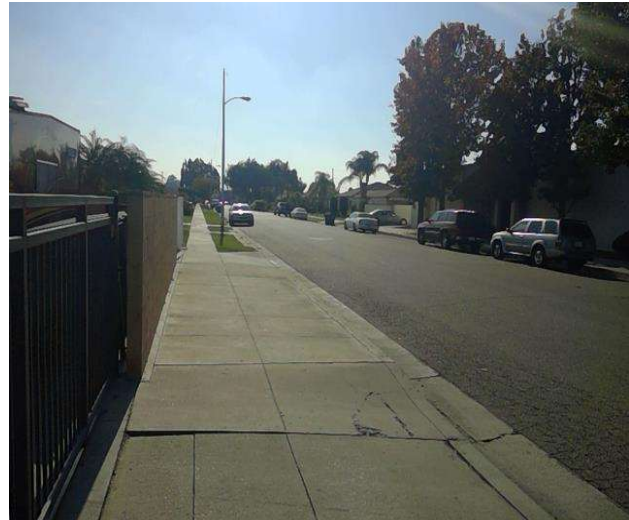
There is a change in elevation greater than recommended value.

Ensure that the change in elevation is within the recommended value.

Recommendation Up to 0.25 inches

Remove tripping hazards \$198

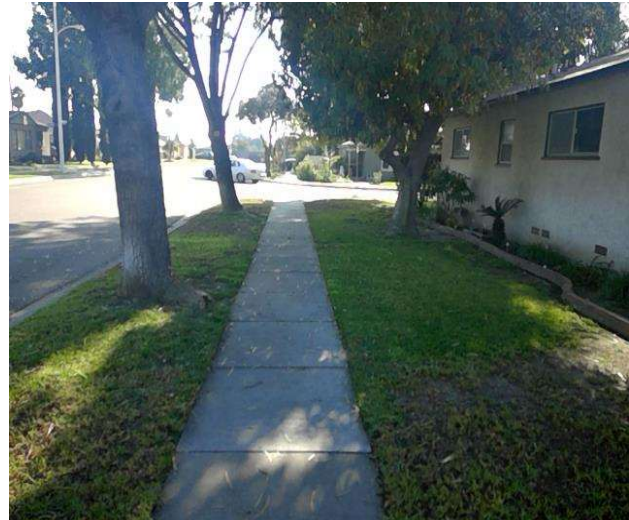
There is a change in elevation greater than recommended value.

Ensure that the change in elevation is within the recommended value.

Recommendation Up to 0.25 inches

Remove tripping hazards \$198

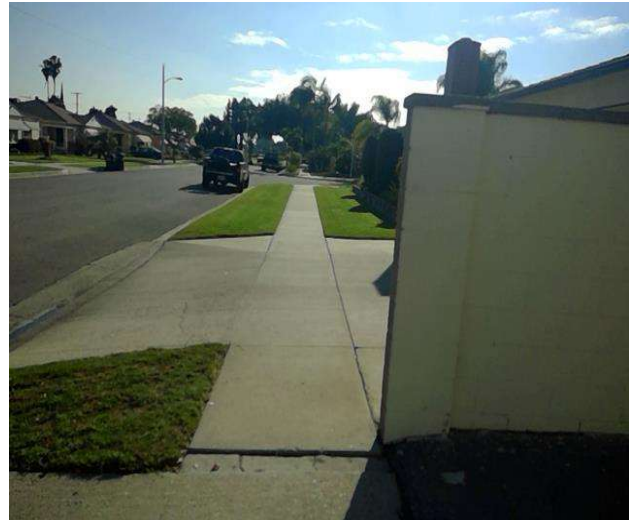
There is a change in elevation greater than recommended value.

Ensure that the change in elevation is within the recommended value.

Recommendation Up to 0.25 inches

Remove tripping hazards \$198

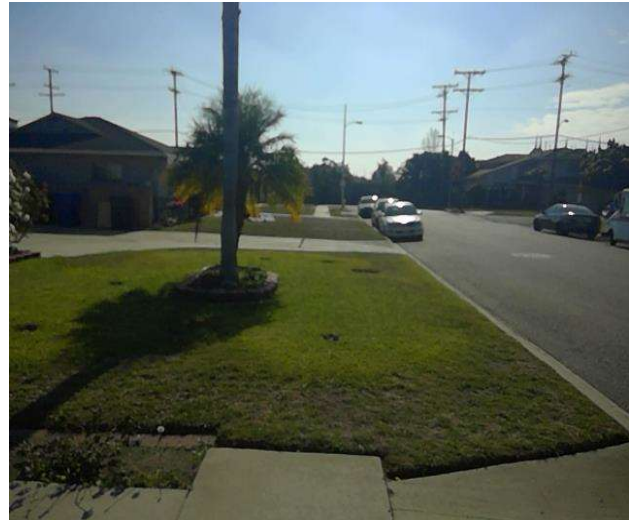
Sidewalks : Missing Sidewalk

Section of sidewalk is missing and consists of dirt, grass or gravel.

Provide a compliant sidewalk for the missing section.

\$1,260

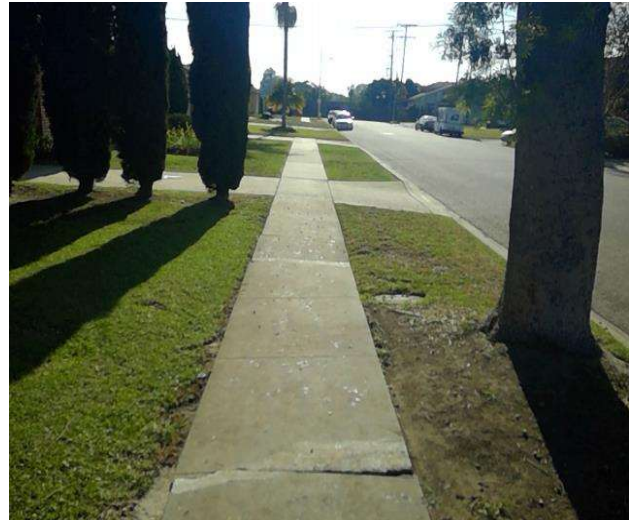
Code Reference ADA 206, 302,CA 11B-403.3

Repave the sidewalk surface with the recommended cross slope.

Recommendation Up to 2.08 percent

Repave surface \$1,092

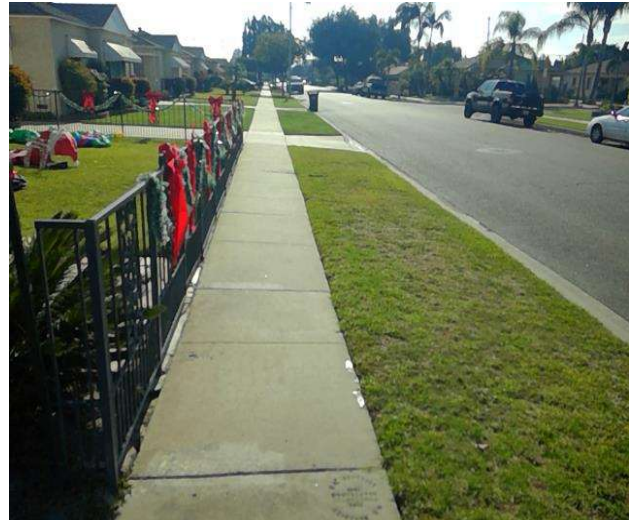
Code Reference ADA 206, 302,CA 11B-403.3

Repave the sidewalk surface with the recommended cross slope.

Recommendation Up to 2.08 percent

Repave surface \$1,092
