Accessibility Survey

City of Downey

Benares Street - Norlain Avenue To Julius Avenue

Date of Inspection
2/14/2017

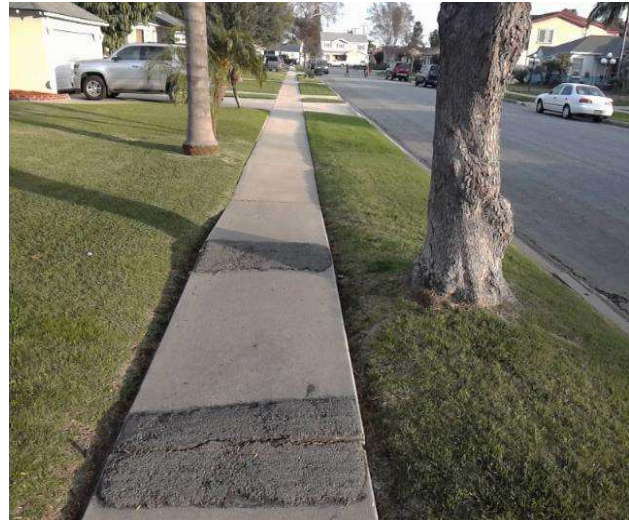
Change In Level East Of Norlain Avenue @ 33.942153915586, -118.151103258133

Sidewalks , Change in Level : Change in Level Non Beveled

There is a change in elevation greater than recommended value.

On-Site Finding 1.25 inches

Ensure that the change in elevation is within the recommended value.

Recommendation Up to 0.25 inches

Remove tripping hazards \$198

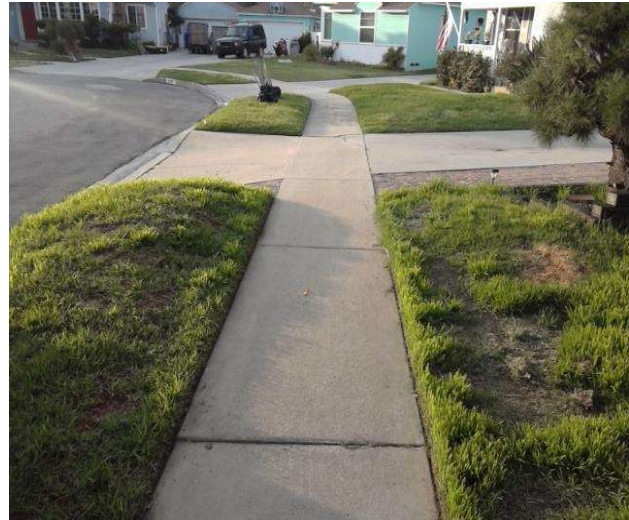
Change In Level East Of Norlain Avenue @ 33.942300776362, -118.151301741600

Sidewalks , Change in Level : Change in Level Non Beveled

There is a change in elevation greater than recommended value.

On-Site Finding 0.62 inches

Ensure that the change in elevation is within the recommended value.

Recommendation Up to 0.25 inches

Remove tripping hazards \$198

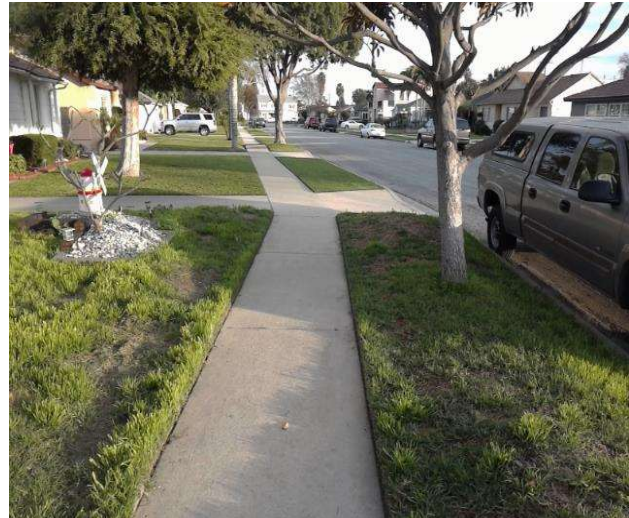
North Side @ 33.942300776362, -118.151301741600

Sidewalks : 60X60 Turn Area

There is no 60X60 turn area at every 200 feet.

On-Site Finding Not Found

Provide a 60X60 turn every 200 feet on the sidewalk.

\$2,400

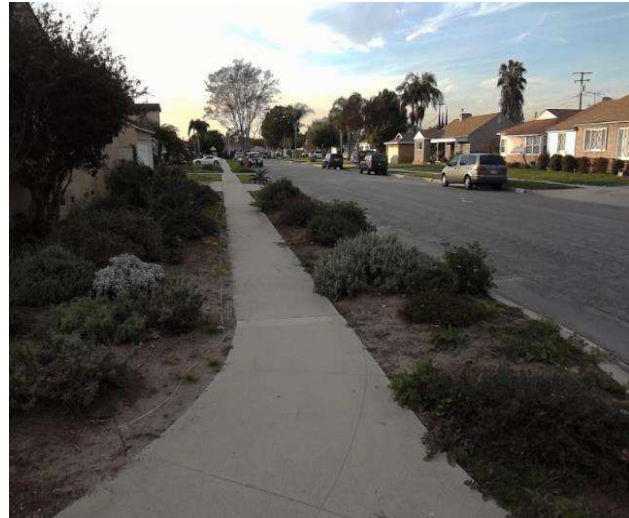
South Side @ 33.941357302719, -118.149976730347

Sidewalks : 60X60 Turn Area

There is no 60X60 turn area at every 200 feet.

On-Site Finding Not Found

Provide a 60X60 turn every 200 feet on the sidewalk.

\$2,400

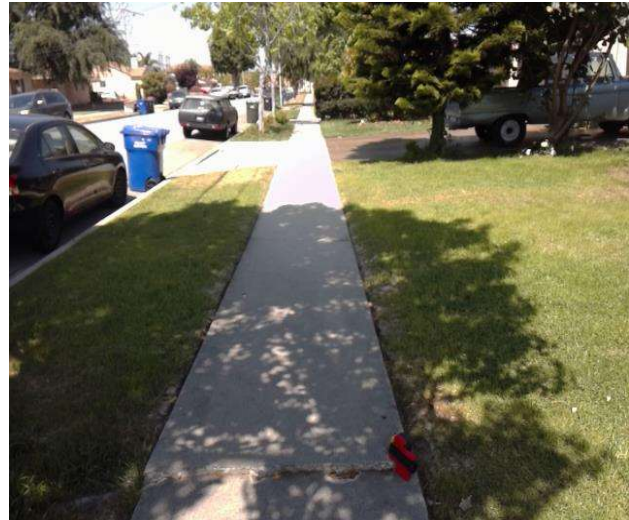
There is a change in elevation greater than recommended value.

Ensure that the change in elevation is within the recommended value.

Recommendation Up to 0.25 inches

Remove tripping hazards \$198

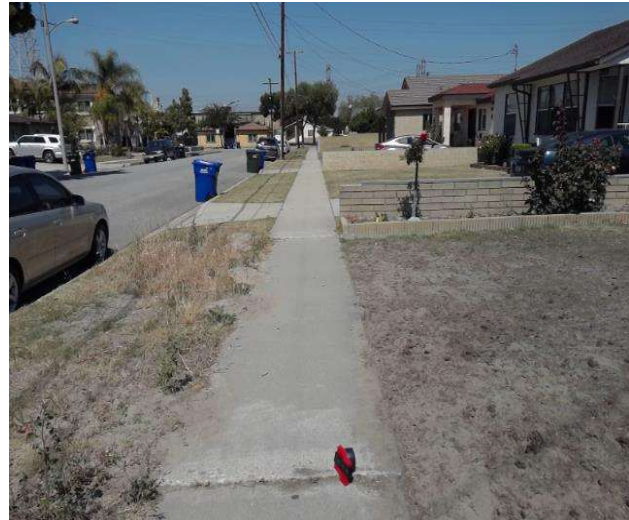
There is a change in elevation greater than recommended value.

Ensure that the change in elevation is within the recommended value.

Recommendation Up to 0.25 inches

Remove tripping hazards \$198

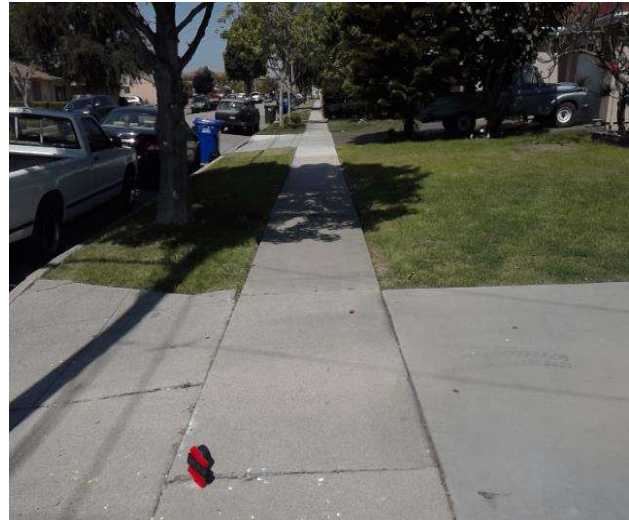
There is a change in elevation greater than recommended value.

Ensure that the change in elevation is within the recommended value.

Recommendation Up to 0.25 inches

Remove tripping hazards \$198

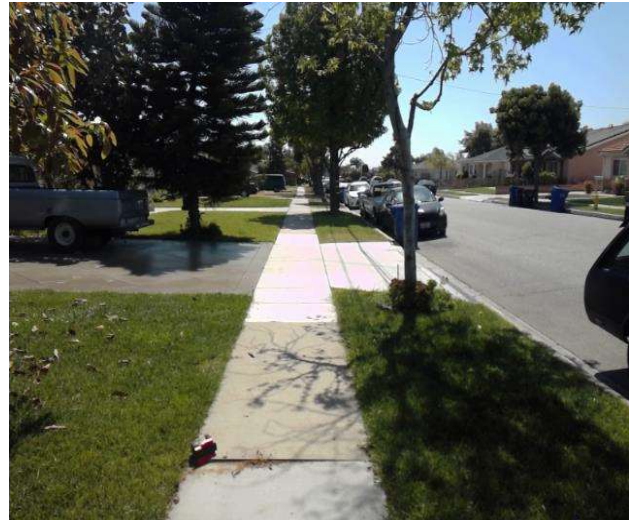
There is a change in elevation greater than recommended value.

Ensure that the change in elevation is within the recommended value.

Recommendation Up to 0.25 inches

Remove tripping hazards \$198

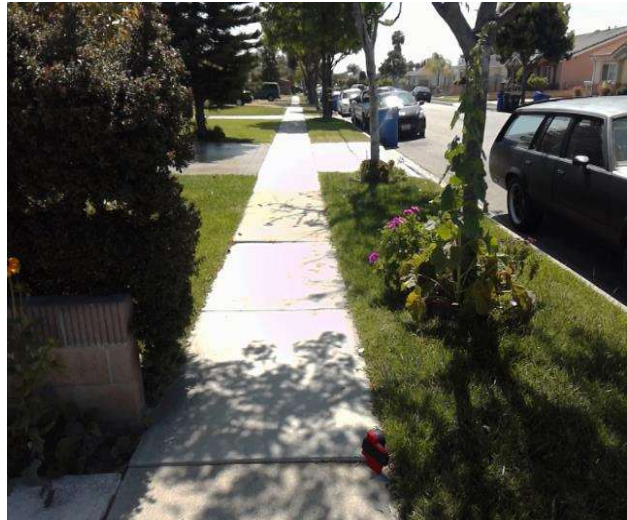
There is a change in elevation greater than recommended value.

Ensure that the change in elevation is within the recommended value.

Recommendation Up to 0.25 inches

Remove tripping hazards \$198

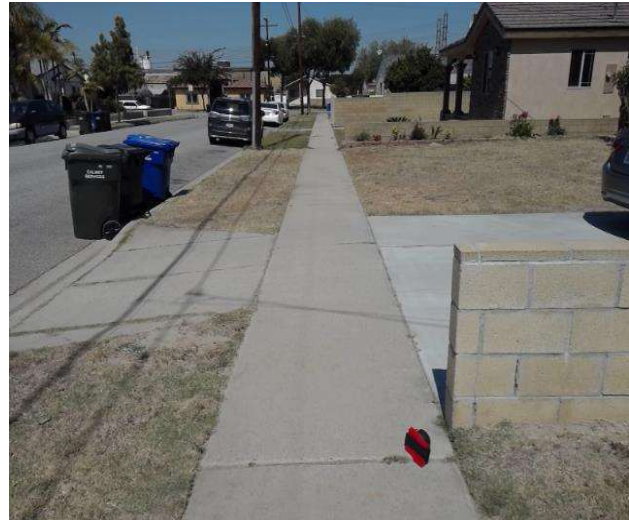
There is a change in elevation greater than recommended value.

Ensure that the change in elevation is within the recommended value.

Recommendation Up to 0.25 inches

Remove tripping hazards \$198

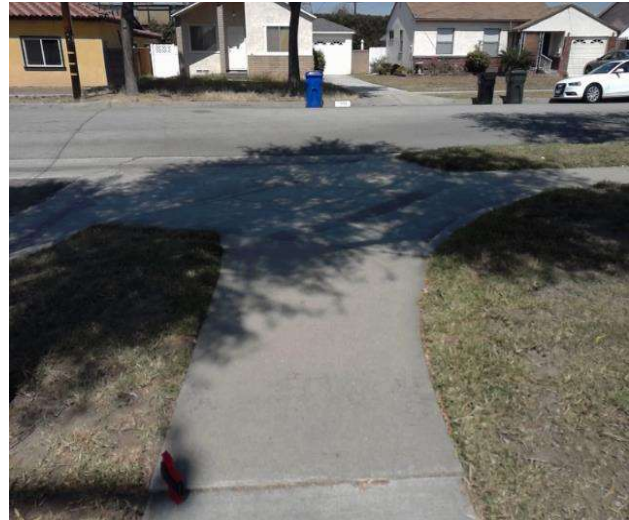
There is a change in elevation greater than recommended value.

Ensure that the change in elevation is within the recommended value.

Recommendation Up to 0.25 inches

Remove tripping hazards \$198

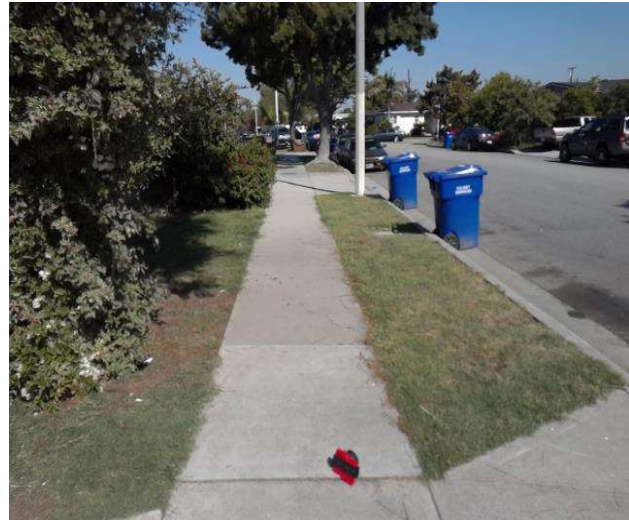
There is a change in elevation greater than recommended value.

Ensure that the change in elevation is within the recommended value.

Recommendation Up to 0.25 inches

Remove tripping hazards \$198

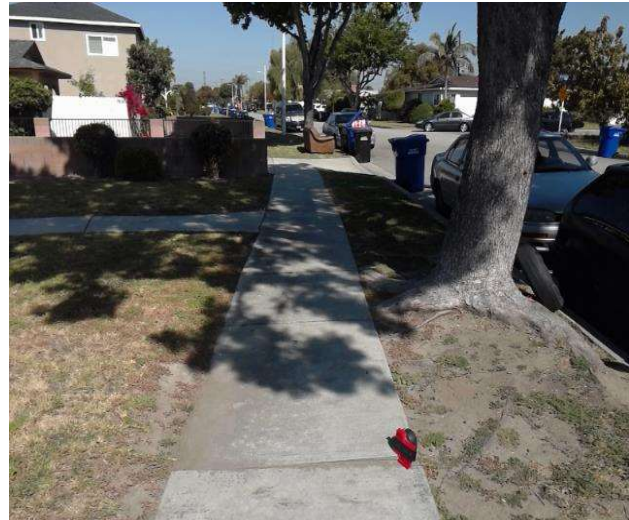
There is a change in elevation greater than recommended value.

Ensure that the change in elevation is within the recommended value.

Recommendation Up to 0.25 inches

Remove tripping hazards \$198

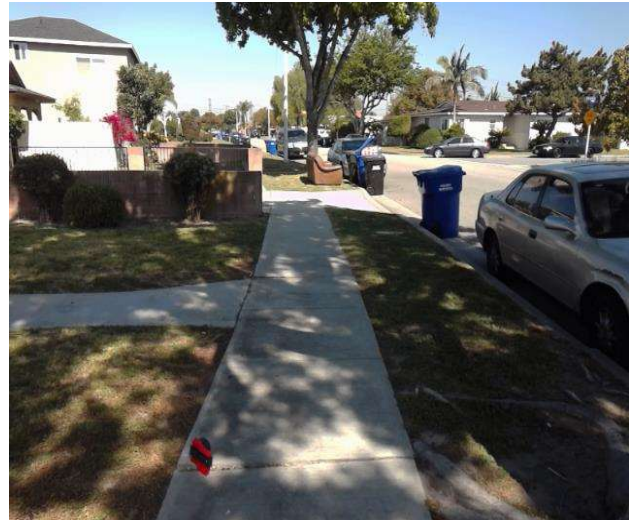
There is a change in elevation greater than recommended value.

Ensure that the change in elevation is within the recommended value.

Recommendation Up to 0.25 inches

Remove tripping hazards \$198

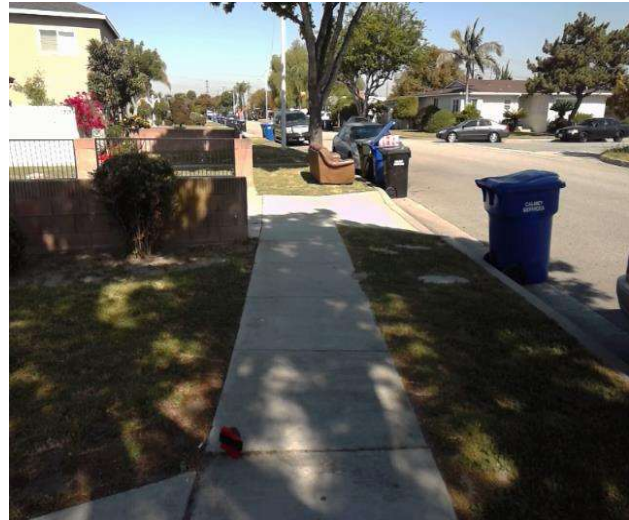
There is a change in elevation greater than recommended value.

Ensure that the change in elevation is within the recommended value.

Recommendation Up to 0.25 inches

Remove tripping hazards \$198

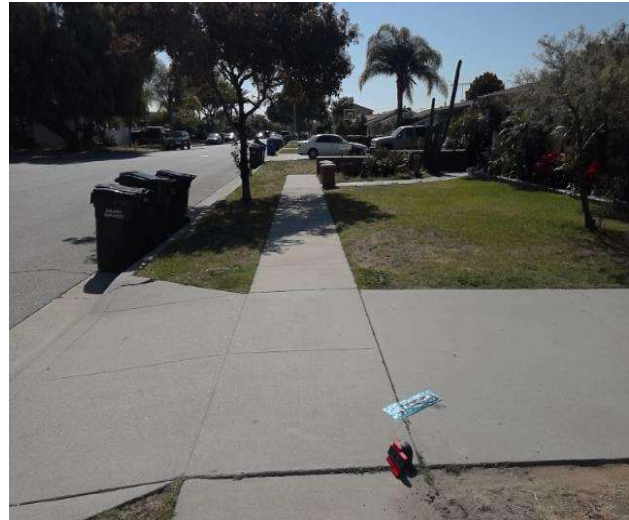
There is a change in elevation greater than recommended value.

Ensure that the change in elevation is within the recommended value.

Recommendation Up to 0.25 inches

Remove tripping hazards \$198

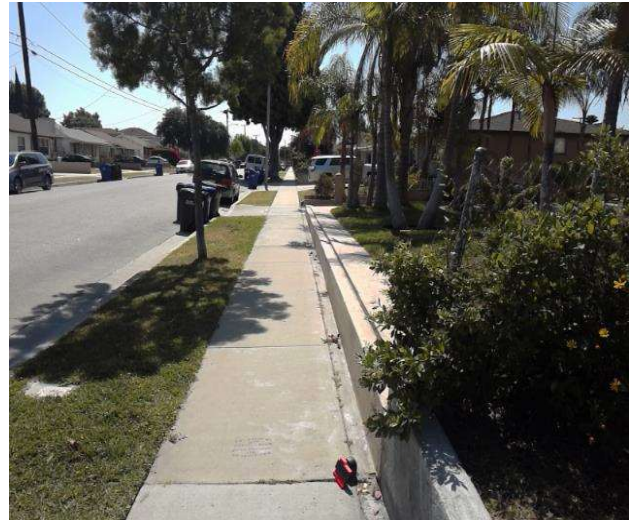
There is a change in elevation greater than recommended value.

Ensure that the change in elevation is within the recommended value.

Recommendation Up to 0.25 inches

Remove tripping hazards \$198

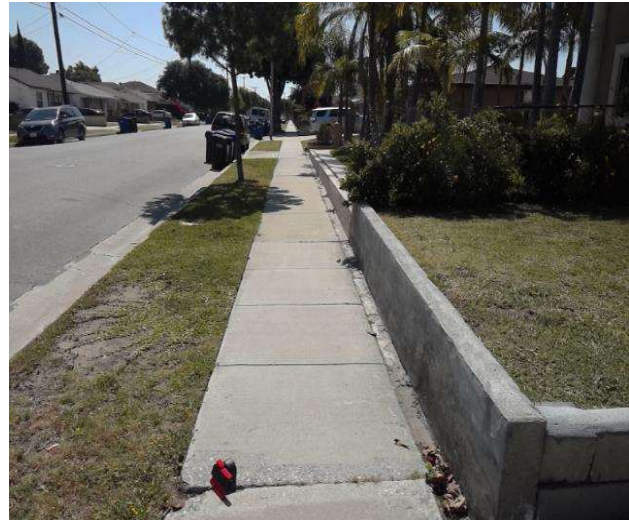
There is a change in elevation greater than recommended value.

Ensure that the change in elevation is within the recommended value.

Recommendation Up to 0.25 inches

Remove tripping hazards \$198

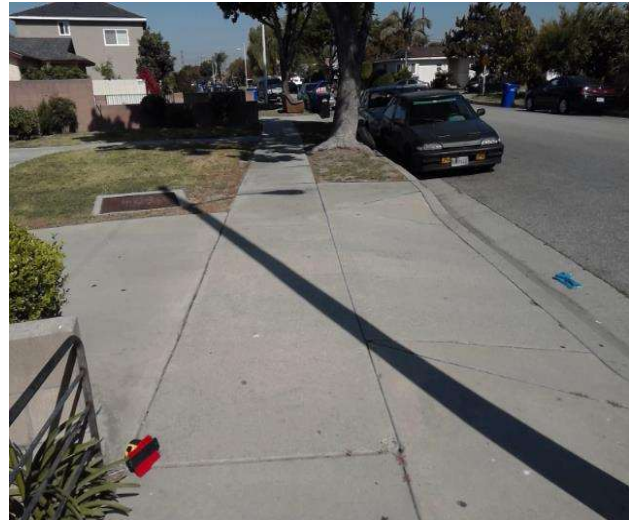
There is a change in elevation greater than recommended value.

Ensure that the change in elevation is within the recommended value.

Recommendation Up to 0.25 inches

Remove tripping hazards \$198

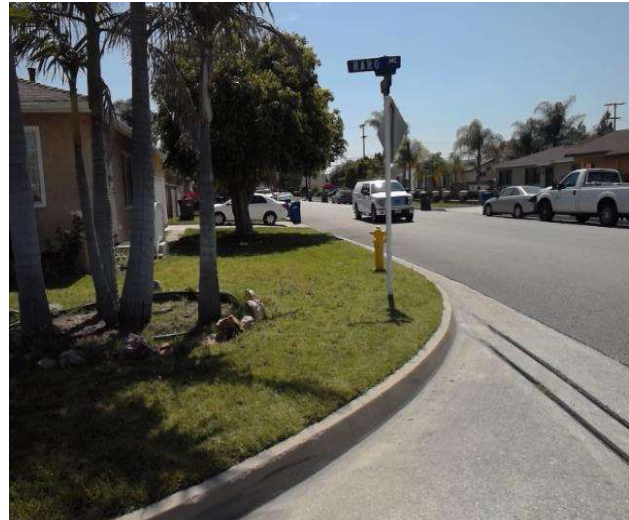
Sidewalks : Missing Sidewalk

Section of sidewalk is missing and consists of dirt, grass or gravel.

Provide a compliant sidewalk for the missing section.

\$1,260

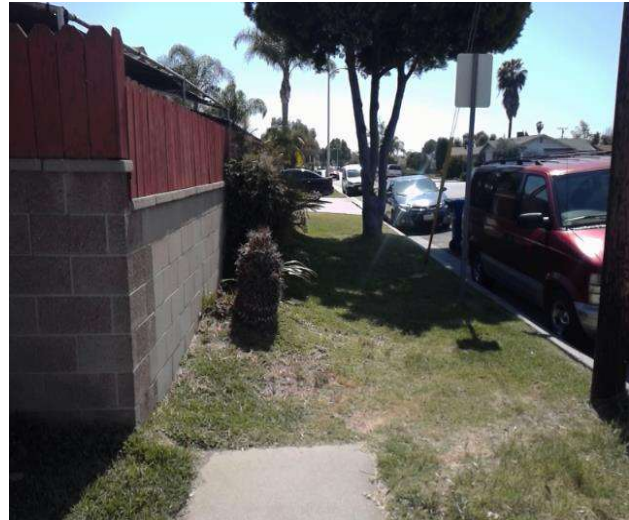
Sidewalks : Missing Sidewalk

Section of sidewalk is missing and consists of dirt, grass or gravel.

Provide a compliant sidewalk for the missing section.

\$1,260

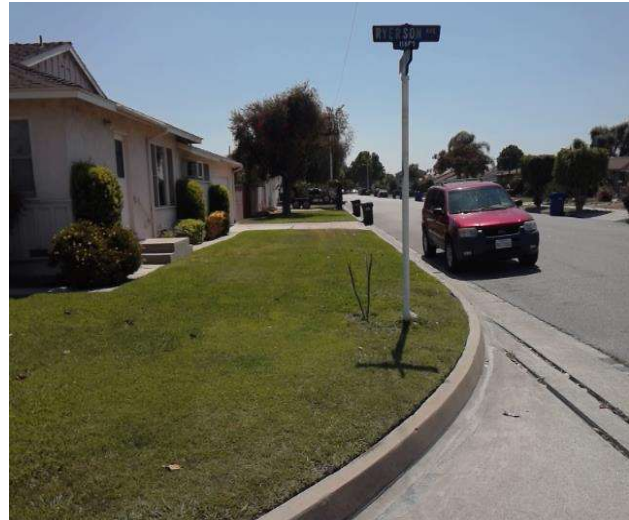
Sidewalks : Missing Sidewalk

Section of sidewalk is missing and consists of dirt, grass or gravel.

Provide a compliant sidewalk for the missing section.

\$1,260

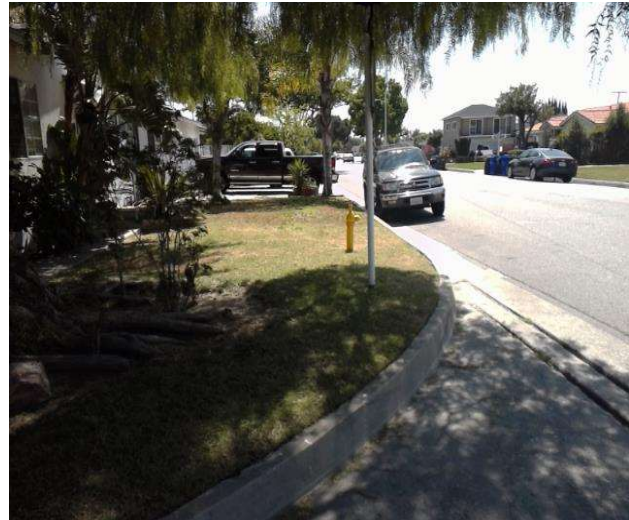
Sidewalks : Missing Sidewalk

Section of sidewalk is missing and consists of dirt, grass or gravel.

Provide a compliant sidewalk for the missing section.

\$1,260

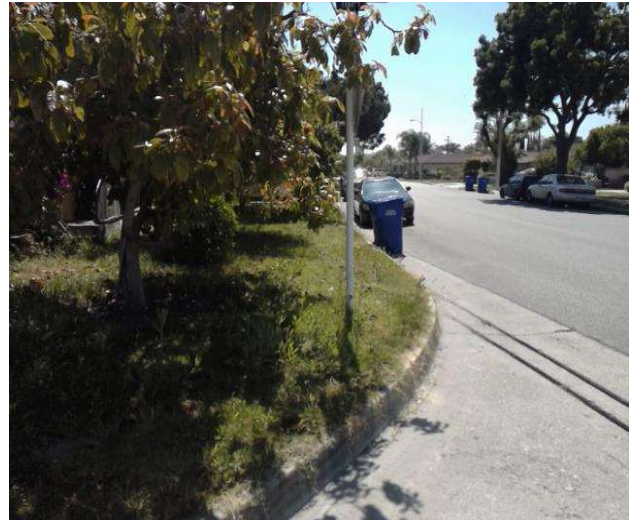
Sidewalks : Missing Sidewalk

Section of sidewalk is missing and consists of dirt, grass or gravel.

Provide a compliant sidewalk for the missing section.

\$1,260

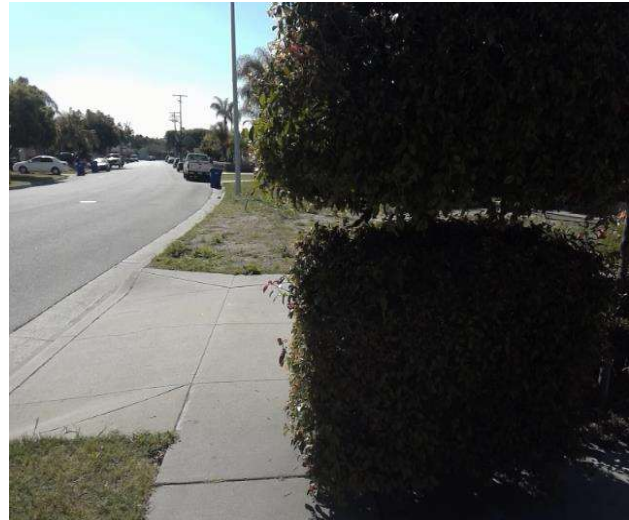
Sidewalks , Hazards & Gratings : Sidewalk Width at Obstruction

Sidewalk width at the obstruction shall have the recommended value.

Recommendation At least 48.00 inches

\$1,260

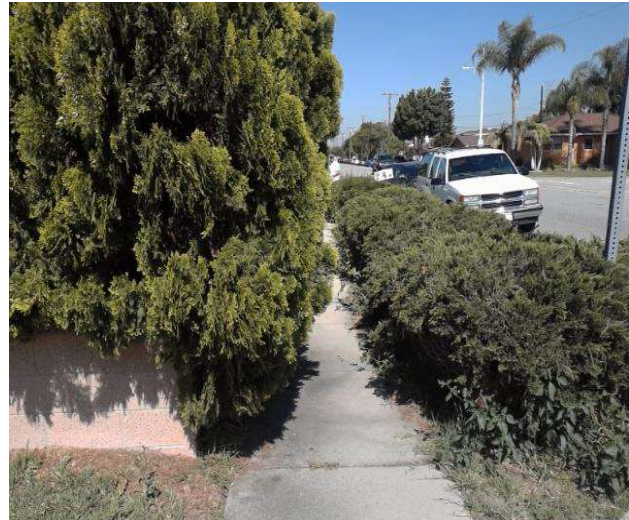
Sidewalks , Hazards & Gratings : Sidewalk Width at Obstruction

Sidewalk width at the obstruction shall have the recommended value.

Recommendation At least 48.00 inches

\$1,260

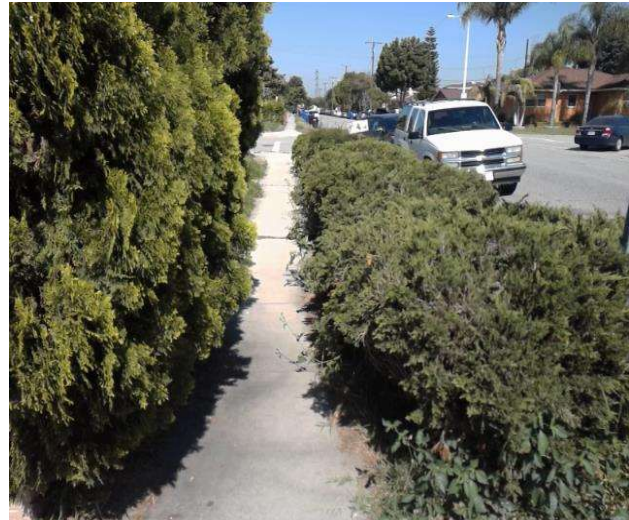
Sidewalks , Hazards & Gratings : Sidewalk Width at Obstruction

Sidewalk width at the obstruction shall have the recommended value.

Recommendation At least 48.00 inches

\$1,260

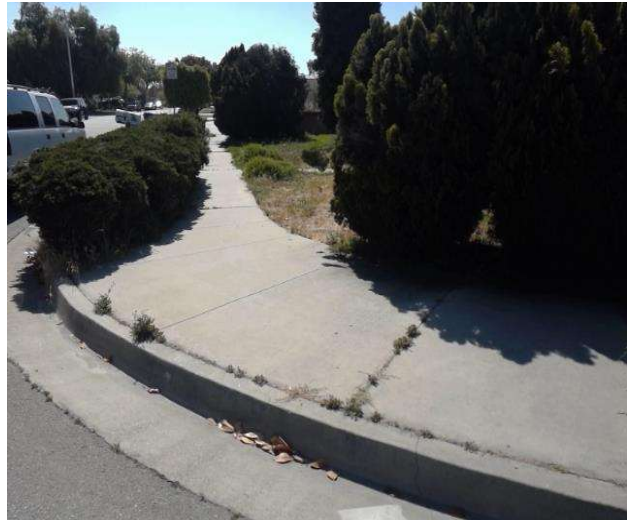
Sidewalks , Hazards & Gratings : Curb is on Path of Travel

Install curb ramp \$2,500

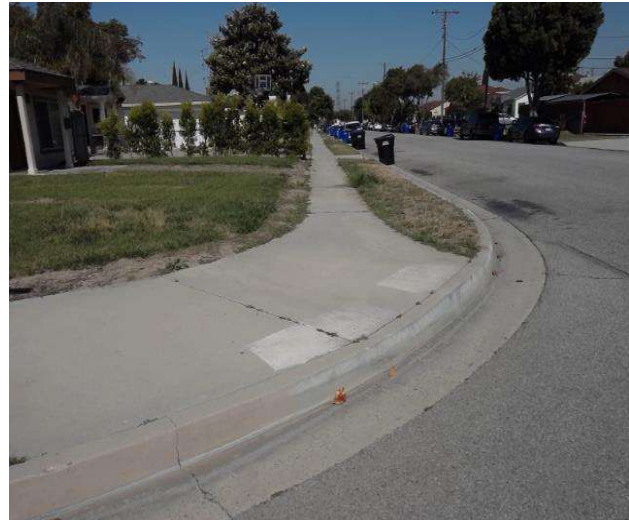
Sidewalks , Hazards & Gratings : Curb is on Path of Travel

Install curb ramp \$2,500

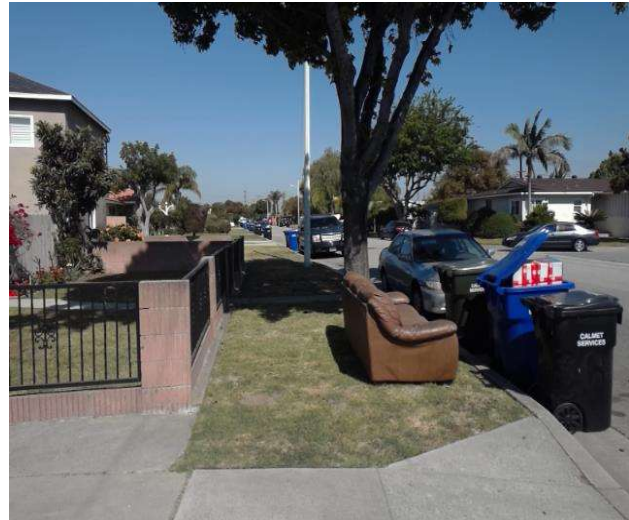
Sidewalks : Missing Sidewalk

Section of sidewalk is missing and consists of dirt, grass or gravel.

Provide a compliant sidewalk for the missing section.

\$1,260

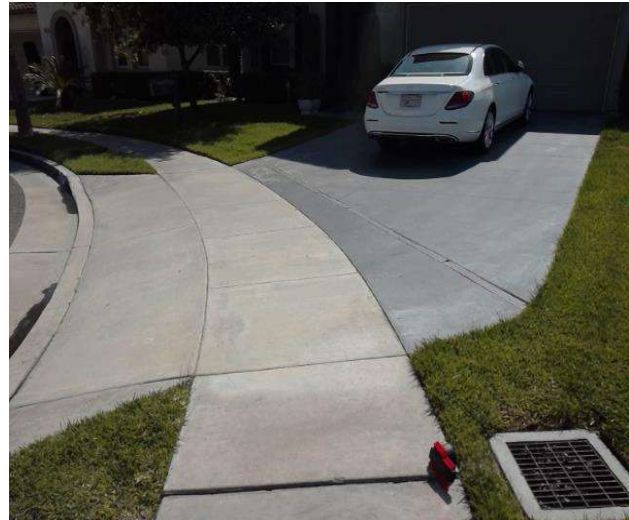
There is a change in elevation greater than recommended value.

Ensure that the change in elevation is within the recommended value.

Recommendation Up to 0.25 inches

Remove tripping hazards \$198

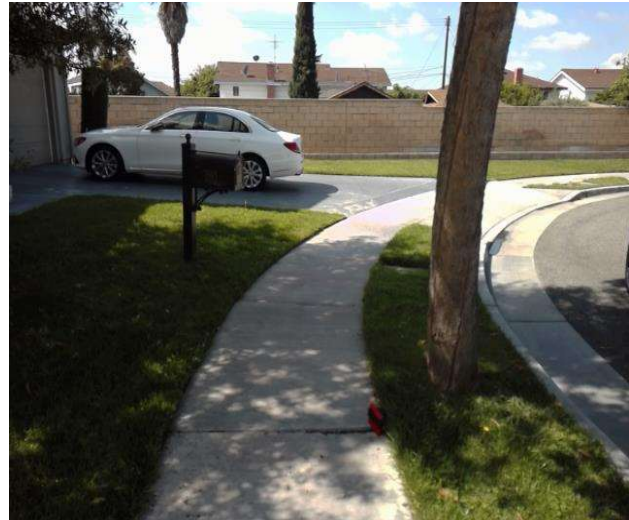
There is a change in elevation greater than recommended value.

Ensure that the change in elevation is within the recommended value.

Recommendation Up to 0.25 inches

Remove tripping hazards \$198

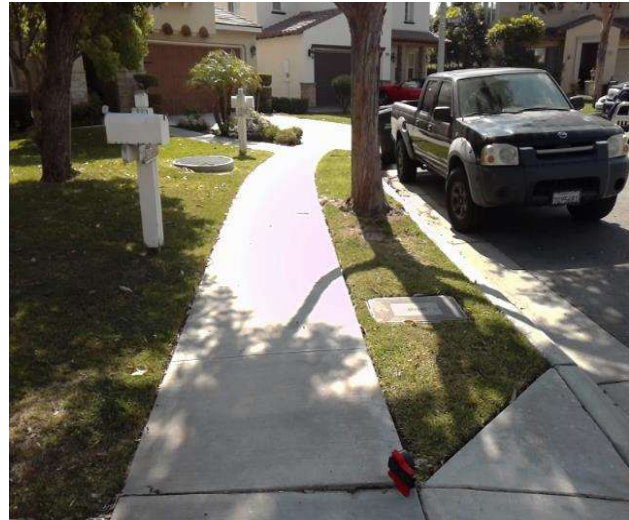
There is a change in elevation greater than recommended value.

Ensure that the change in elevation is within the recommended value.

Recommendation Up to 0.25 inches

Remove tripping hazards \$198

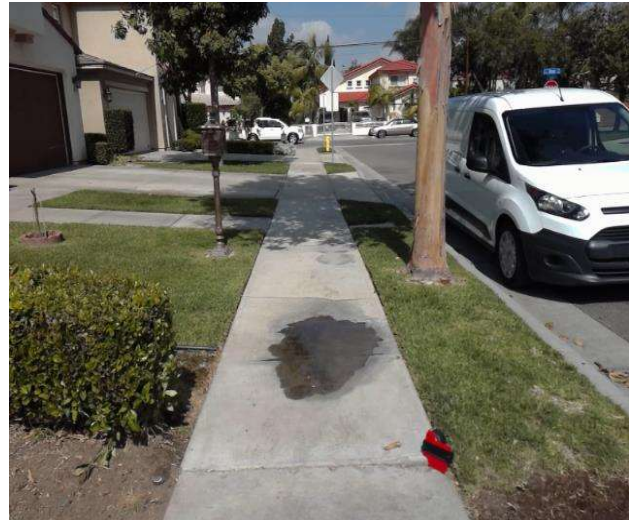
There is a change in elevation greater than recommended value.

Ensure that the change in elevation is within the recommended value.

Recommendation Up to 0.25 inches

Remove tripping hazards \$198
