Accessibility Survey

City of Downey Danvers Street - Lowman Avenue to End

Date of Inspection
2/5/2017

Prepared By
Disability Access Consultants
(800) 743-7067

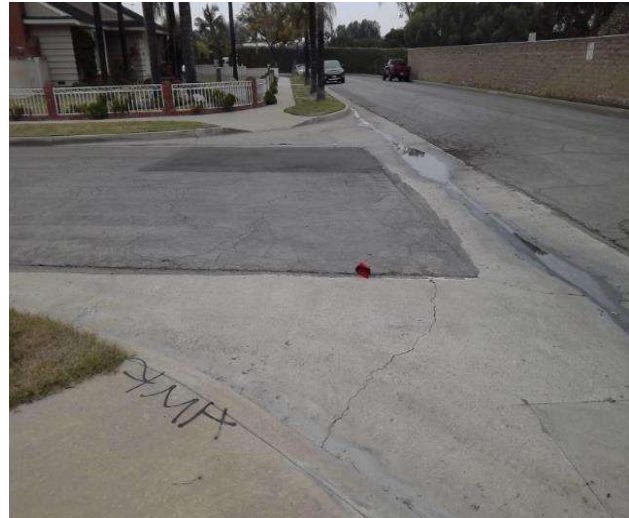
Allengrove Street South Crossing @ 33.963915473930, -118.121589571238

Sidewalks , Change in Level : Change in Level Non Beveled

There is a change in elevation greater than recommended value.

On-Site Finding 0.62 inches

Code Reference ADA 206, 302

Ensure that the change in elevation is within the recommended value.

Recommendation Up to 0.25 inches

Remove tripping hazards \$198

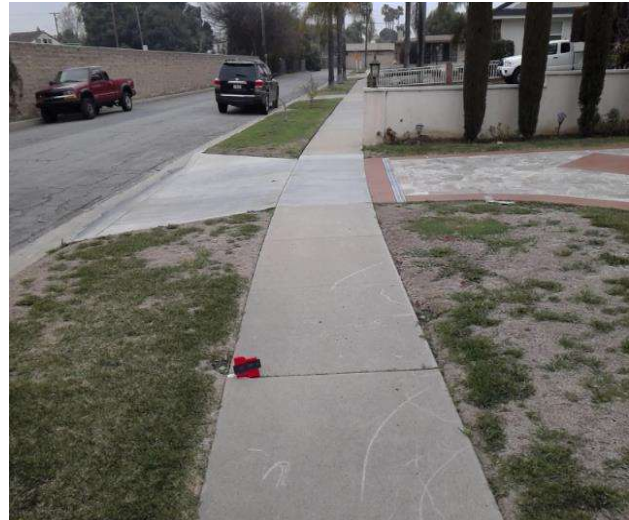
Change In Level East Of Lowman Avenue @ 33.964302552792, -118.121193945408

Sidewalks , Change in Level : Change in Level Non Beveled

There is a change in elevation greater than recommended value.

On-Site Finding 0.87 inches

Code Reference ADA 206, 302

Ensure that the change in elevation is within the recommended value.

Recommendation Up to 0.25 inches

Remove tripping hazards \$198

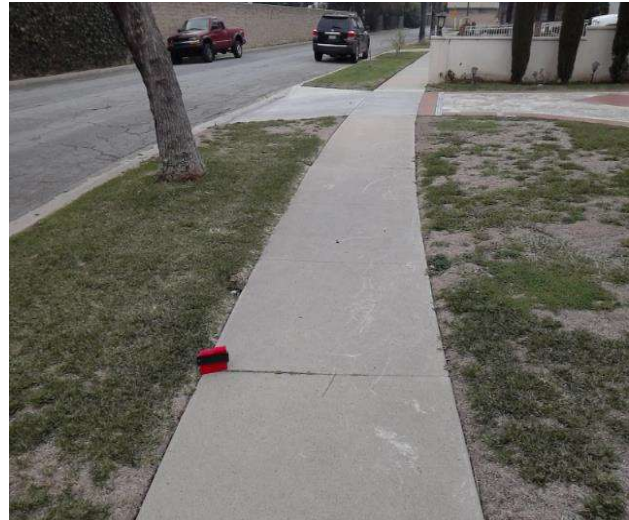
Change In Level East Of Lowman Avenue @ 33.964331472406, -118.121172487736

Sidewalks , Change in Level : Change in Level Non Beveled

There is a change in elevation greater than recommended value.

On-Site Finding 0.50 inches

Code Reference ADA 206, 302

Ensure that the change in elevation is within the recommended value.

Recommendation Up to 0.25 inches

Remove tripping hazards \$198

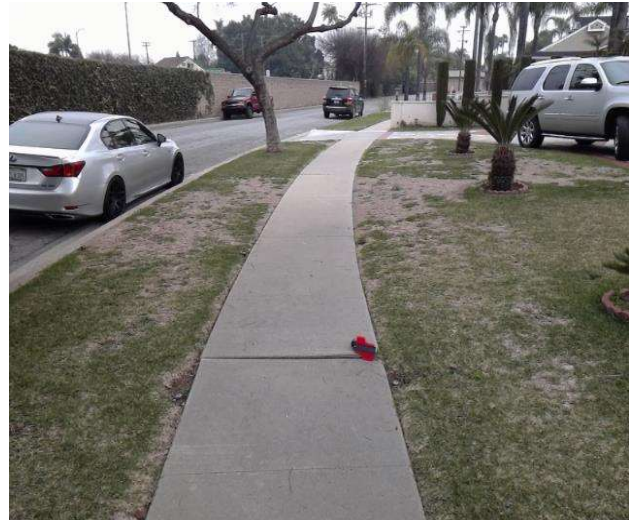
Change In Level East Of Lowman Avenue @ 33.964416006607, -118.121120184660

Sidewalks , Change in Level : Change in Level Non Beveled

There is a change in elevation greater than recommended value.

On-Site Finding 1.25 inches

Code Reference ADA 206, 302

Ensure that the change in elevation is within the recommended value.

Recommendation Up to 0.25 inches

Remove tripping hazards \$198

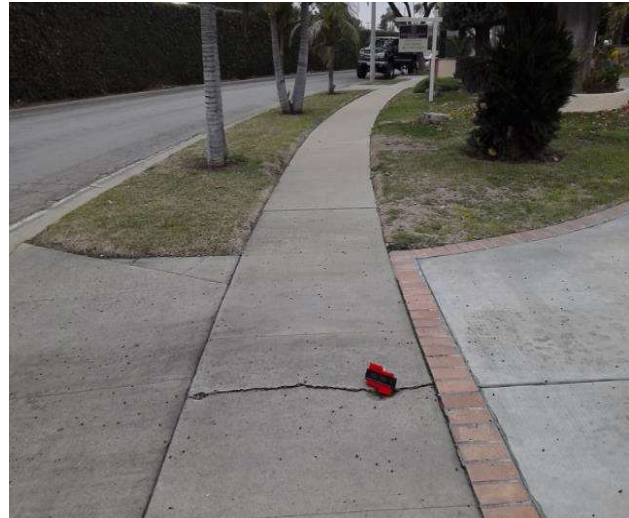
Change In Level East Of Lowman Avenue @ 33.964721886237, -118.121098726988

Sidewalks , Change in Level : Change in Level Non Beveled

There is a change in elevation greater than recommended value.

On-Site Finding 0.62 inches

Code Reference ADA 206, 302

Ensure that the change in elevation is within the recommended value.

Recommendation Up to 0.25 inches

Remove tripping hazards \$198

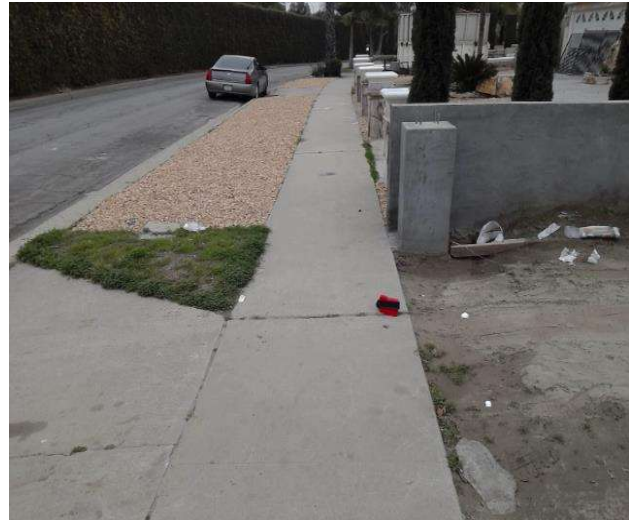
Change In Level East Of Lowman Avenue @ 33.964937669751, -118.121189922094

Sidewalks , Change in Level : Change in Level Non Beveled

There is a change in elevation greater than recommended value.

On-Site Finding 0.62 inches

Code Reference ADA 206, 302

Ensure that the change in elevation is within the recommended value.

Recommendation Up to 0.25 inches

Remove tripping hazards \$198

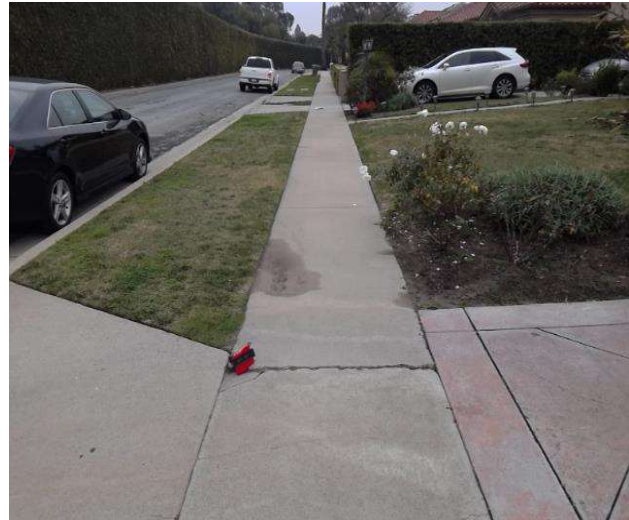
There is a change in elevation greater than recommended value.

On-Site Finding 0.50 inches

Code Reference ADA 206, 302

Ensure that the change in elevation is within the recommended value.

Recommendation Up to 0.25 inches

Remove tripping hazards \$198

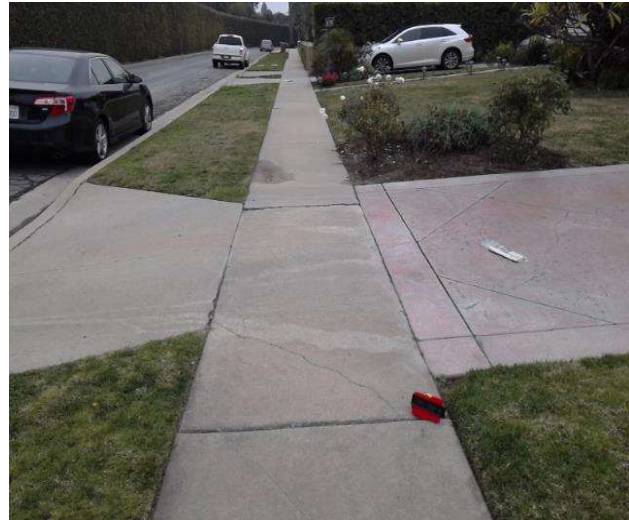
There is a change in elevation greater than recommended value.

Code Reference ADA 206, 302

Ensure that the change in elevation is within the recommended value.

Recommendation Up to 0.25 inches

Remove tripping hazards \$198

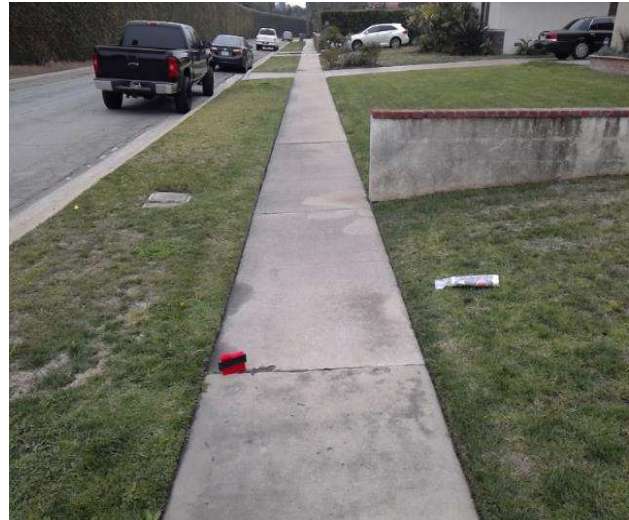
There is a change in elevation greater than recommended value.

Code Reference ADA 206, 302

Ensure that the change in elevation is within the recommended value.

Recommendation Up to 0.25 inches

Remove tripping hazards \$198

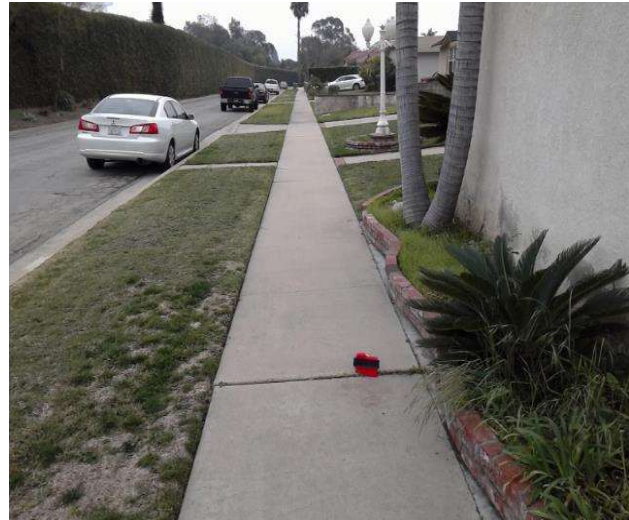
There is a change in elevation greater than recommended value.

Code Reference ADA 206, 302

Ensure that the change in elevation is within the recommended value.

Recommendation Up to 0.25 inches

Remove tripping hazards \$198

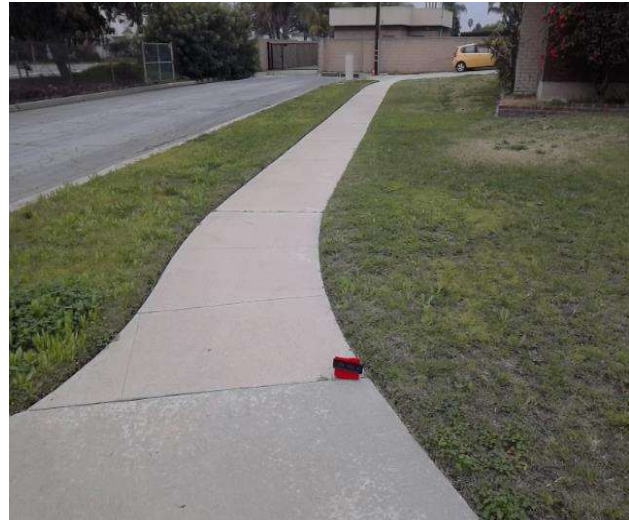
There is a change in elevation greater than recommended value.

Code Reference ADA 206, 302

Ensure that the change in elevation is within the recommended value.

Recommendation Up to 0.25 inches

Remove tripping hazards \$198

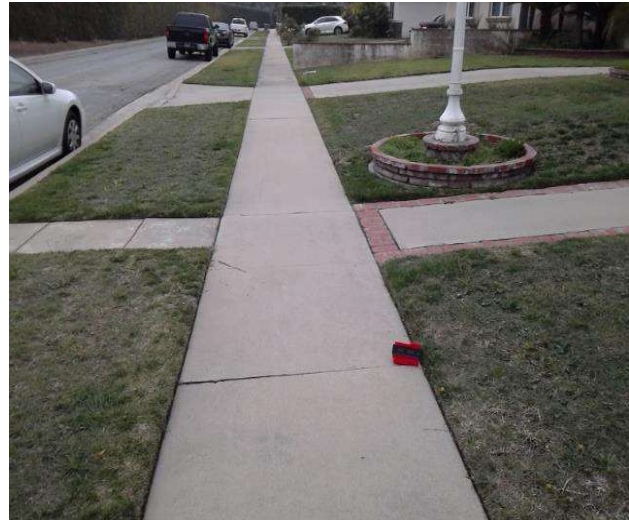
There is a change in elevation greater than recommended value.

Code Reference ADA 206, 302

Ensure that the change in elevation is within the recommended value.

Recommendation Up to 0.25 inches

Remove tripping hazards \$198

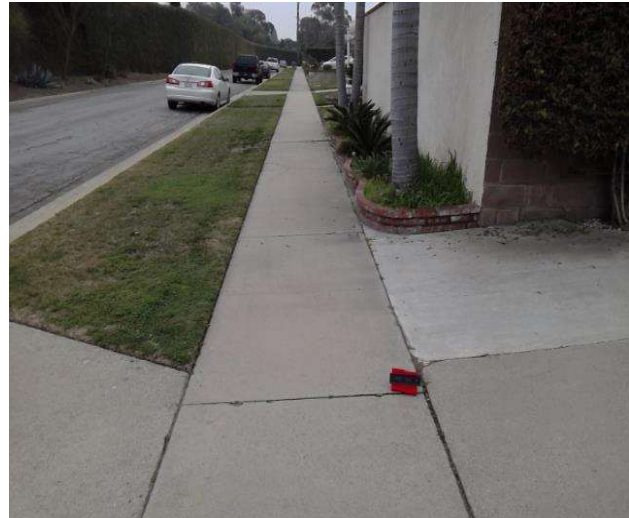
There is a change in elevation greater than recommended value.

Code Reference ADA 206, 302

Ensure that the change in elevation is within the recommended value.

Recommendation Up to 0.25 inches

Remove tripping hazards \$198

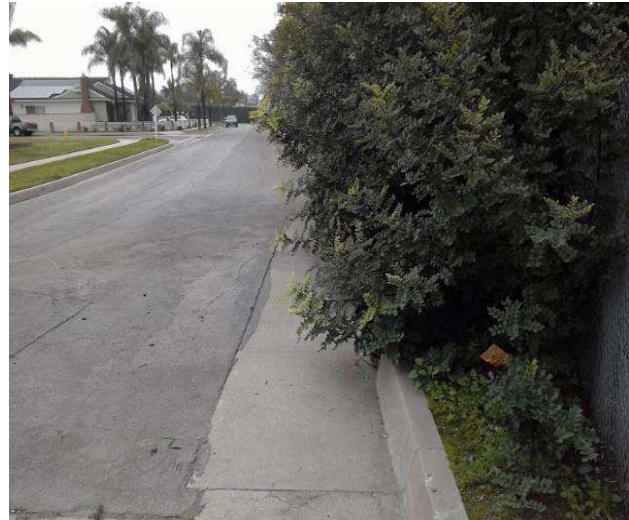
Sidewalks : Missing Sidewalk

Section of sidewalk is missing and consists of dirt, grass or gravel.

Code Reference ADA 206, 302,CA 11B-302,CA 11B-206

Provide a compliant sidewalk for the missing section.

\$1,260

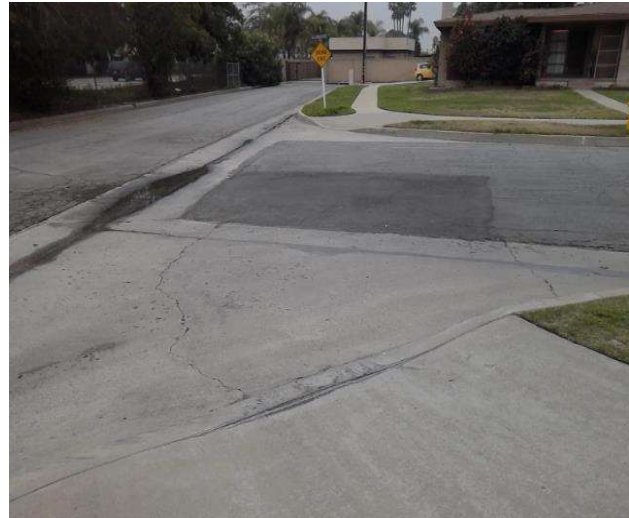
Code Reference ADA 206, 302, CA 11B-403.3

Recommendation Up to 2.08 percent

Repave surface \$1,092

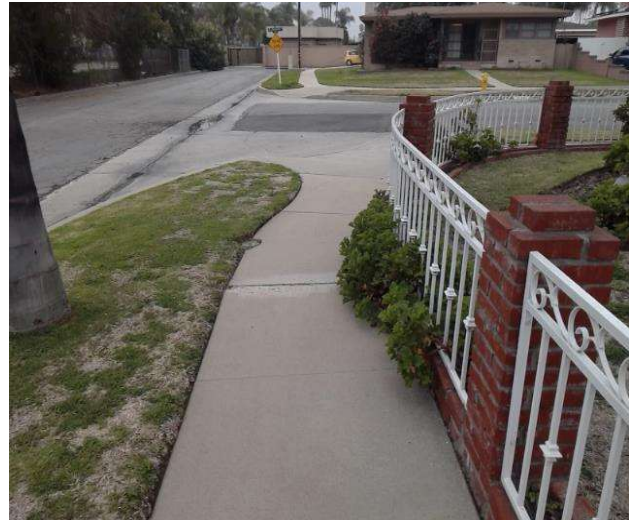
Sidewalks , Hazards & Gratings : Sidewalk Width at Obstruction

Code Reference ADA 206, 302, 403.5.1,CA 11B-403.5

Sidewalk width at the obstruction shall have the recommended value.

Recommendation At least 48.00 inches

\$1,260

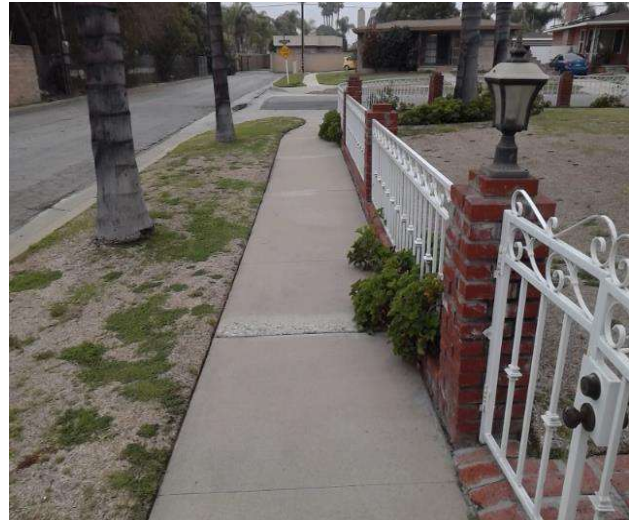
Sidewalks , Hazards & Gratings : Sidewalk Width at Obstruction

Code Reference ADA 206, 302, 403.5.1, CA 11B-403.5

Sidewalk width at the obstruction shall have the recommended value.

Recommendation At least 48.00 inches

\$1,260

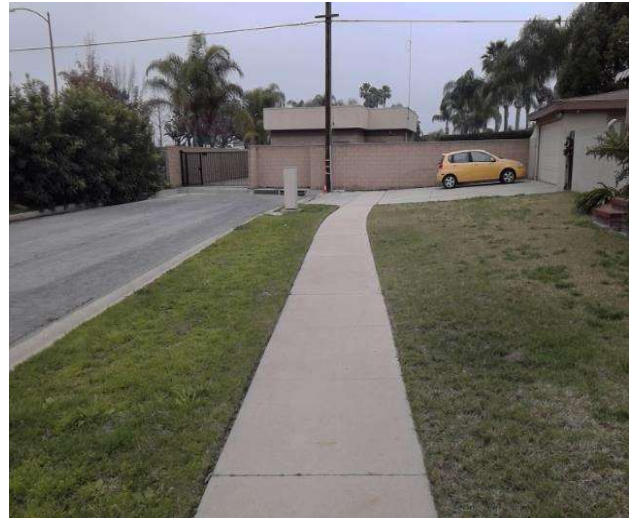
Code Reference ADA 206, 302,CA 11B-403.3

Repave the sidewalk surface with the recommended cross slope.

Recommendation Up to 2.08 percent

Repave surface \$1,092

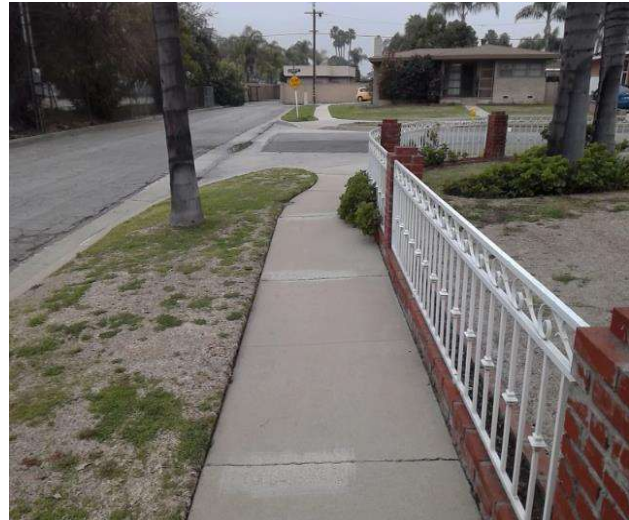
Code Reference ADA 206, 302,CA 11B-403.3

Repave the sidewalk surface with the recommended cross slope.

Recommendation Up to 2.08 percent

Repave surface \$1,092

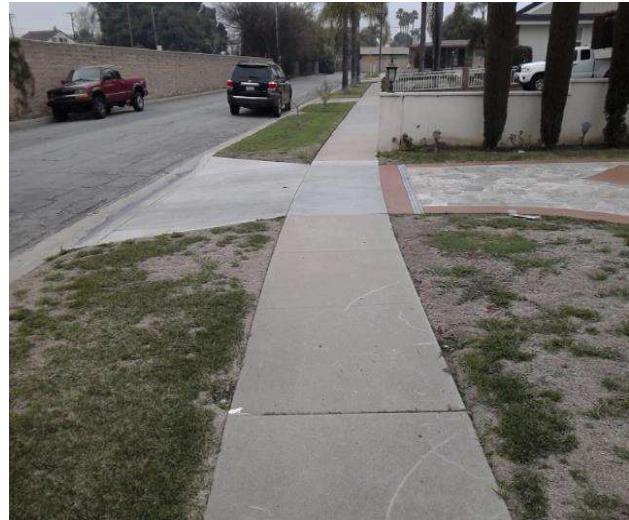
Code Reference ADA 206, 302,CA 11B-403.3

Repave the sidewalk surface with the recommended cross slope.

Recommendation Up to 2.08 percent

Repave surface \$1,092

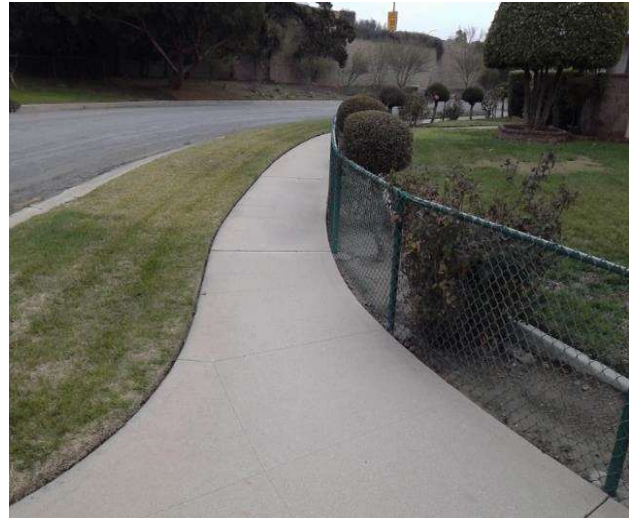
Code Reference ADA 206, 302,CA 11B-403.3

Repave the sidewalk surface with the recommended cross slope.

Recommendation Up to 2.08 percent

Repave surface \$1,092

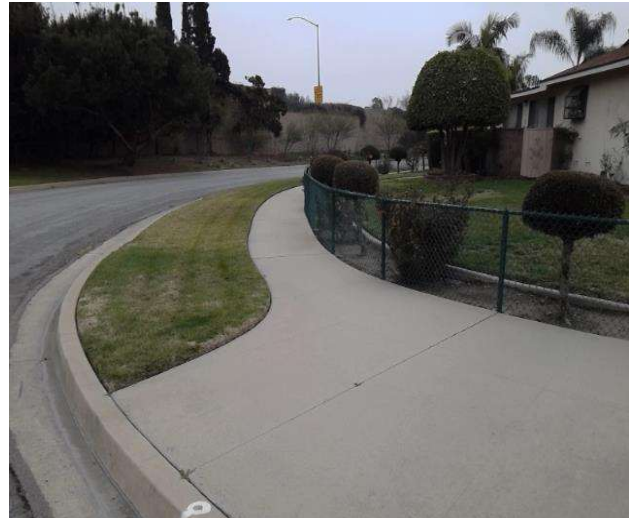
On-Site Finding Not Found

Code Reference ADA 206, 302

Recommendation See Recommendation

\$2,400

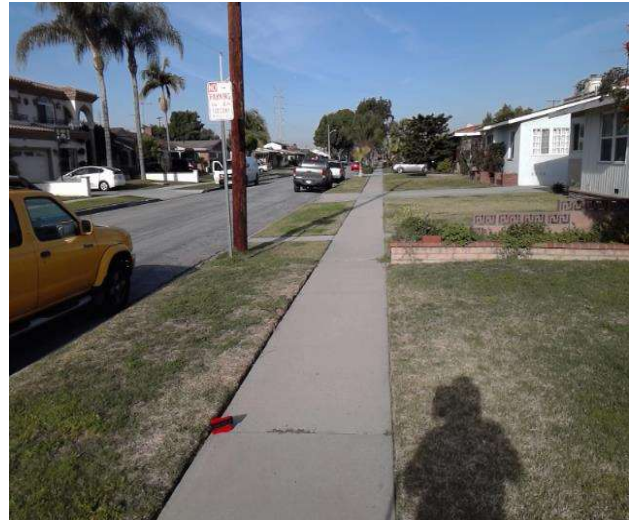
There is a change in elevation greater than recommended value.

Code Reference ADA 206, 302

Ensure that the change in elevation is within the recommended value.

Recommendation Up to 0.25 inches

Remove tripping hazards \$198

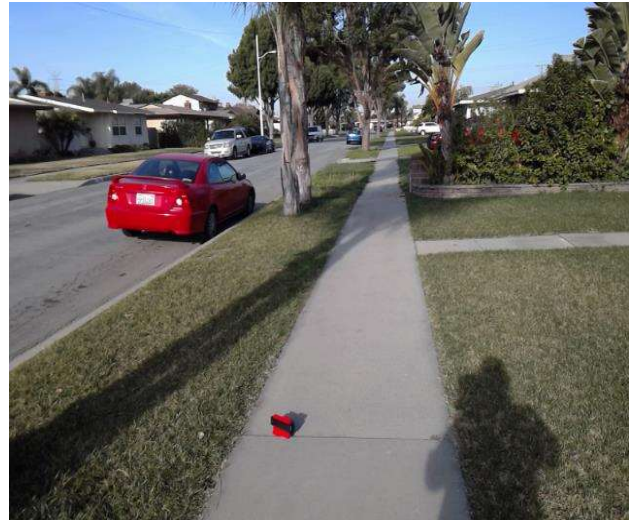
There is a change in elevation greater than recommended value.

Code Reference ADA 206, 302

Ensure that the change in elevation is within the recommended value.

Recommendation Up to 0.25 inches

Remove tripping hazards \$198

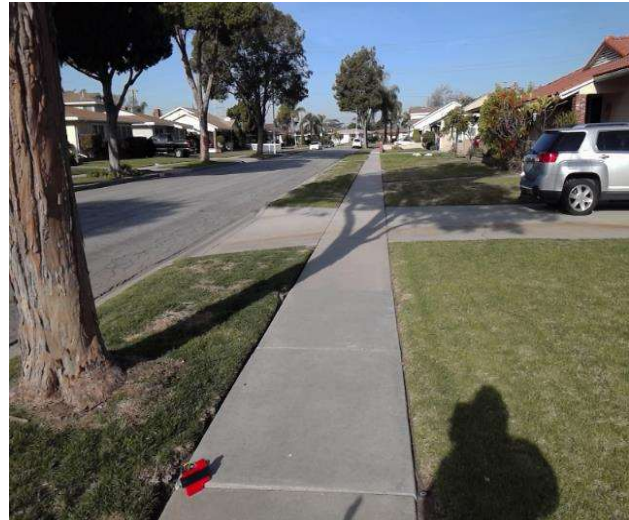
There is a change in elevation greater than recommended value.

Code Reference ADA 206, 302

Ensure that the change in elevation is within the recommended value.

Recommendation Up to 0.25 inches

Remove tripping hazards \$198

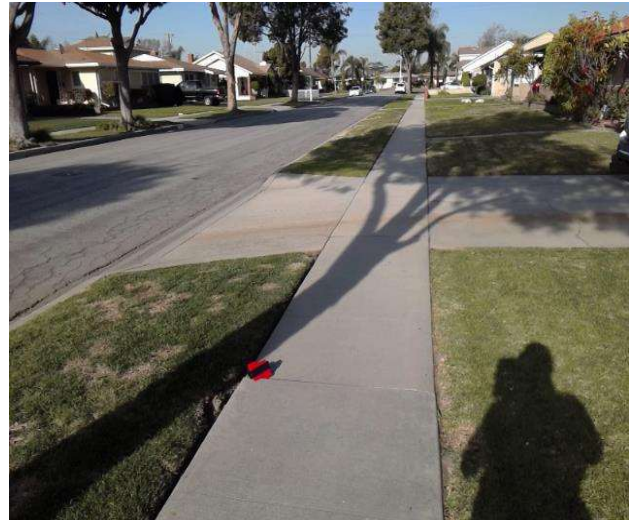
There is a change in elevation greater than recommended value.

Code Reference ADA 206, 302

Ensure that the change in elevation is within the recommended value.

Recommendation Up to 0.25 inches

Remove tripping hazards \$198

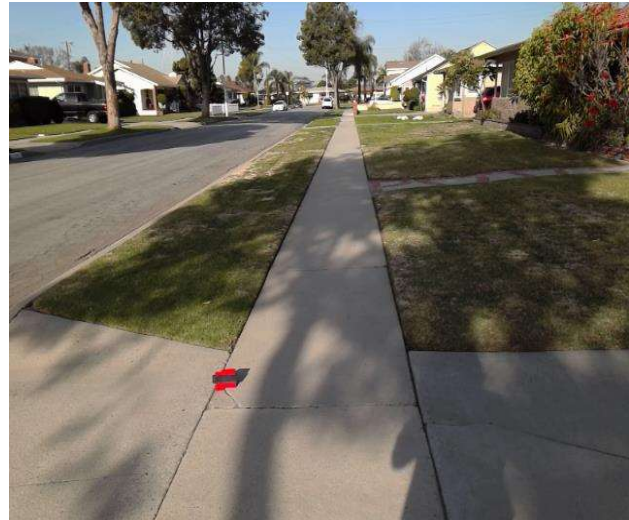
There is a change in elevation greater than recommended value.

Code Reference ADA 206, 302

Ensure that the change in elevation is within the recommended value.

Recommendation Up to 0.25 inches

Remove tripping hazards \$198

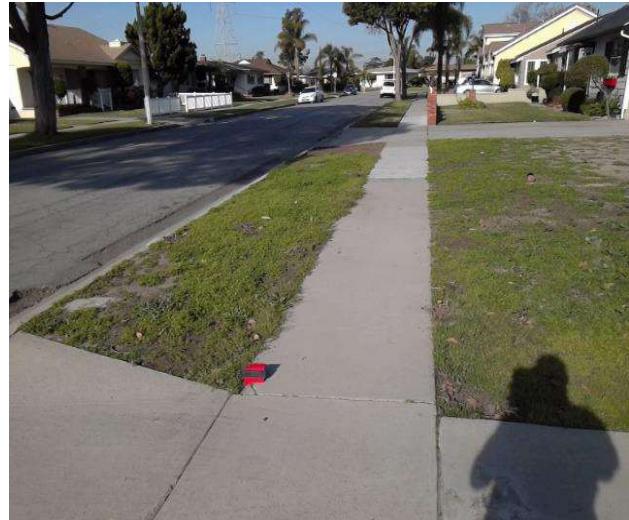
There is a change in elevation greater than recommended value.

Code Reference ADA 206, 302

Ensure that the change in elevation is within the recommended value.

Recommendation Up to 0.25 inches

Remove tripping hazards \$198

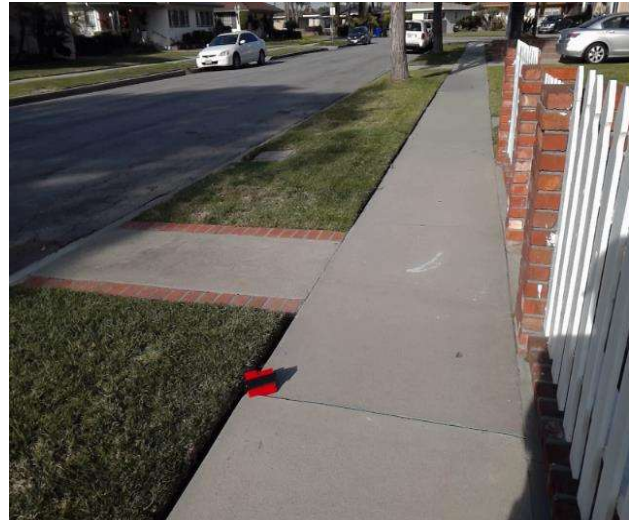
There is a change in elevation greater than recommended value.

Code Reference ADA 206, 302

Ensure that the change in elevation is within the recommended value.

Recommendation Up to 0.25 inches

Remove tripping hazards \$198

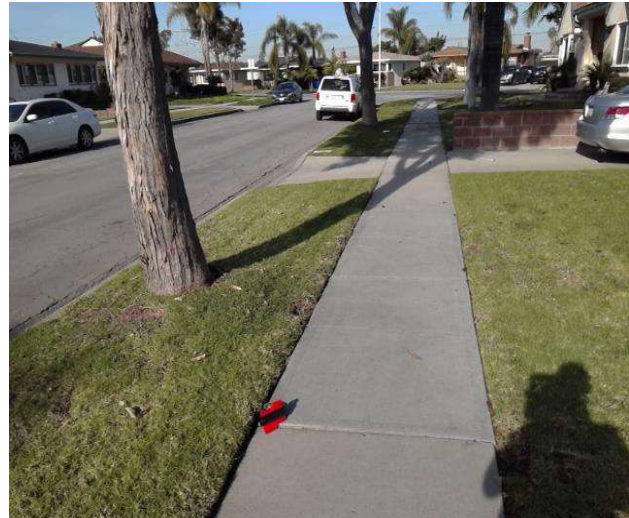
There is a change in elevation greater than recommended value.

Code Reference ADA 206, 302

Ensure that the change in elevation is within the recommended value.

Recommendation Up to 0.25 inches

Remove tripping hazards \$198

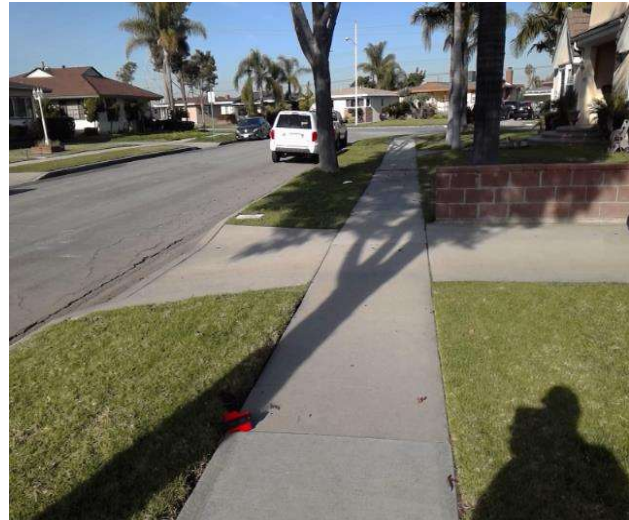
There is a change in elevation greater than recommended value.

Code Reference ADA 206, 302

Ensure that the change in elevation is within the recommended value.

Recommendation Up to 0.25 inches

Remove tripping hazards \$198

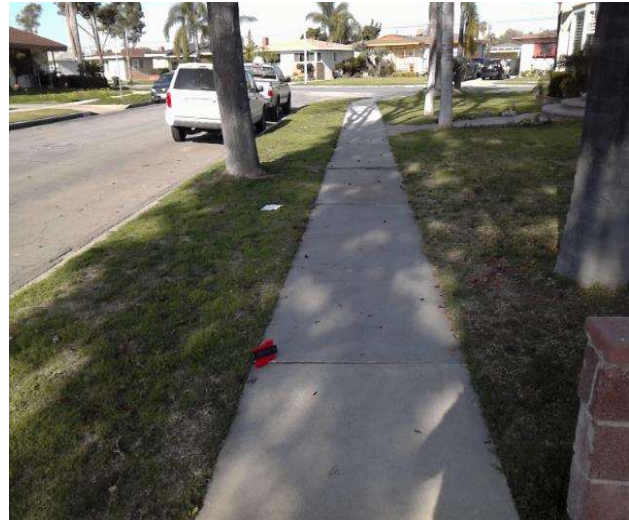
There is a change in elevation greater than recommended value.

Code Reference ADA 206, 302

Ensure that the change in elevation is within the recommended value.

Recommendation Up to 0.25 inches

Remove tripping hazards \$198

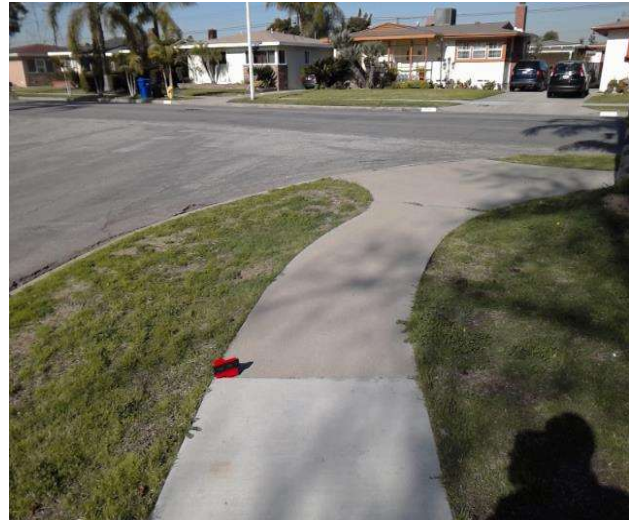
There is a change in elevation greater than recommended value.

Code Reference ADA 206, 302

Ensure that the change in elevation is within the recommended value.

Recommendation Up to 0.25 inches

Remove tripping hazards \$198

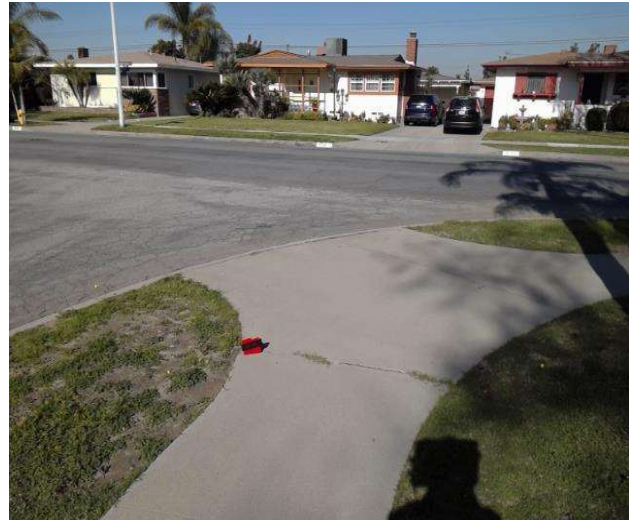
There is a change in elevation greater than recommended value.

Code Reference ADA 206, 302

Ensure that the change in elevation is within the recommended value.

Recommendation Up to 0.25 inches

Remove tripping hazards \$198

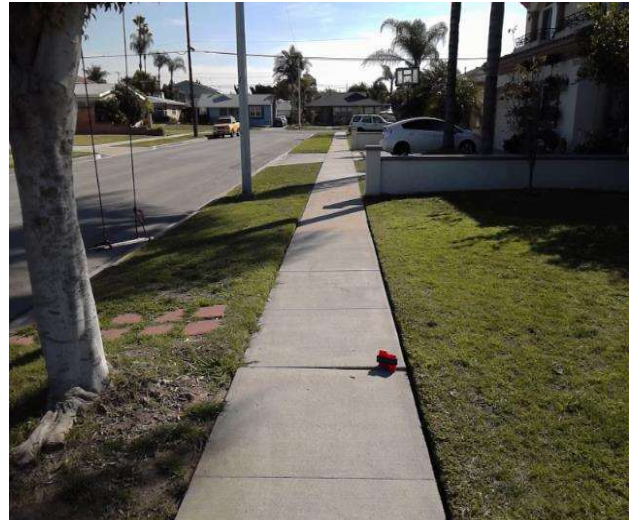
There is a change in elevation greater than recommended value.

Code Reference ADA 206, 302

Ensure that the change in elevation is within the recommended value.

Recommendation Up to 0.25 inches

Remove tripping hazards \$198

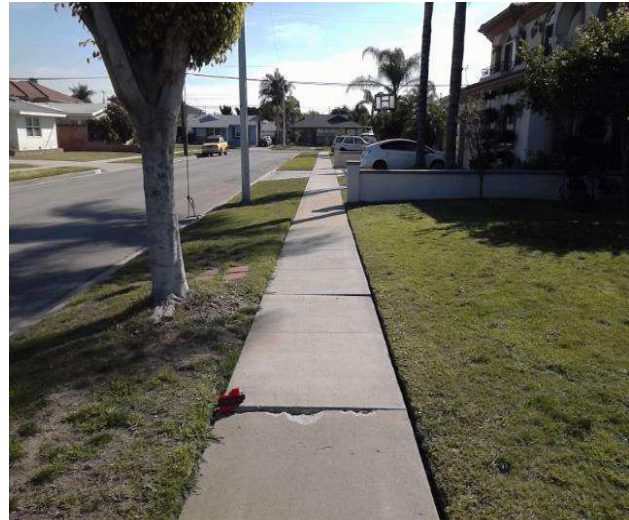
There is a change in elevation greater than recommended value.

Code Reference ADA 206, 302

Ensure that the change in elevation is within the recommended value.

Recommendation Up to 0.25 inches

Remove tripping hazards \$198

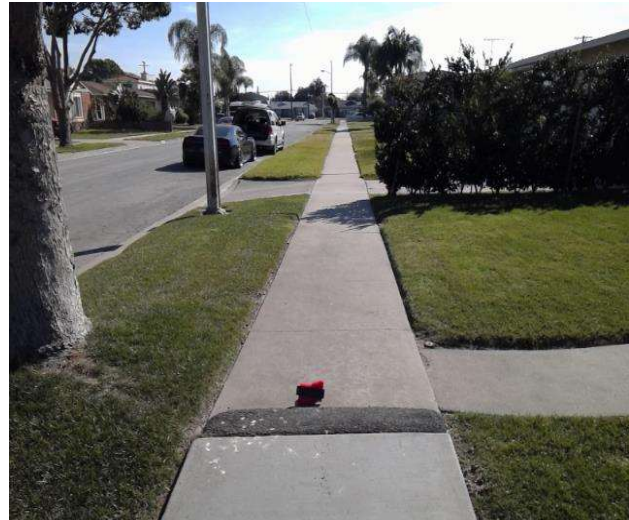
There is a change in elevation greater than recommended value.

Code Reference ADA 206, 302

Recommendation Up to 0.50 inches

Remove tripping hazards \$198

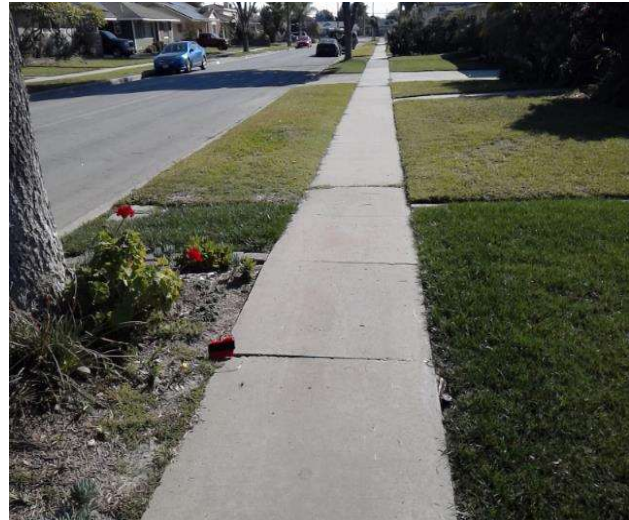
There is a change in elevation greater than recommended value.

Code Reference ADA 206, 302

Ensure that the change in elevation is within the recommended value.

Recommendation Up to 0.25 inches

Remove tripping hazards \$198

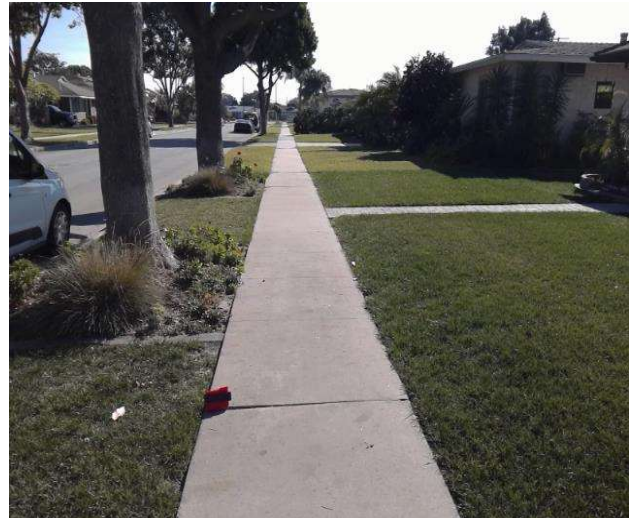
There is a change in elevation greater than recommended value.

Code Reference ADA 206, 302

Ensure that the change in elevation is within the recommended value.

Recommendation Up to 0.25 inches

Remove tripping hazards \$198

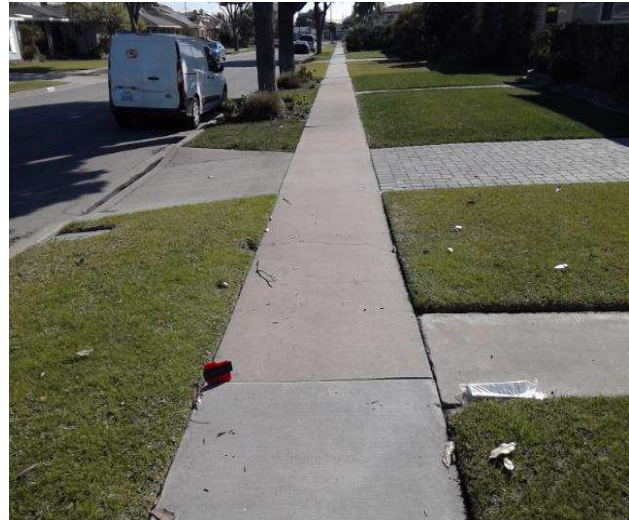
There is a change in elevation greater than recommended value.

Code Reference ADA 206, 302

Ensure that the change in elevation is within the recommended value.

Recommendation Up to 0.25 inches

Remove tripping hazards \$198

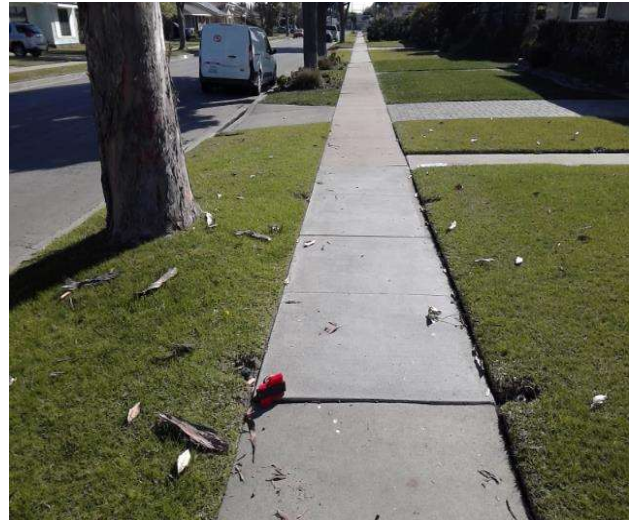
There is a change in elevation greater than recommended value.

Code Reference ADA 206, 302

Ensure that the change in elevation is within the recommended value.

Recommendation Up to 0.25 inches

Remove tripping hazards \$198

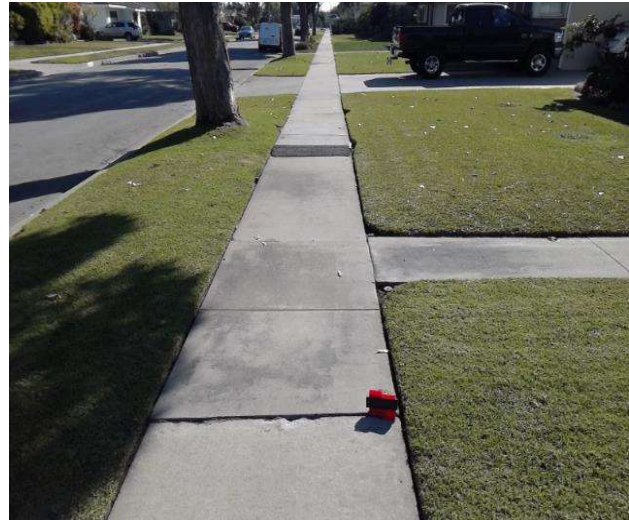
There is a change in elevation greater than recommended value.

Code Reference ADA 206, 302

Ensure that the change in elevation is within the recommended value.

Recommendation Up to 0.25 inches

Remove tripping hazards \$198

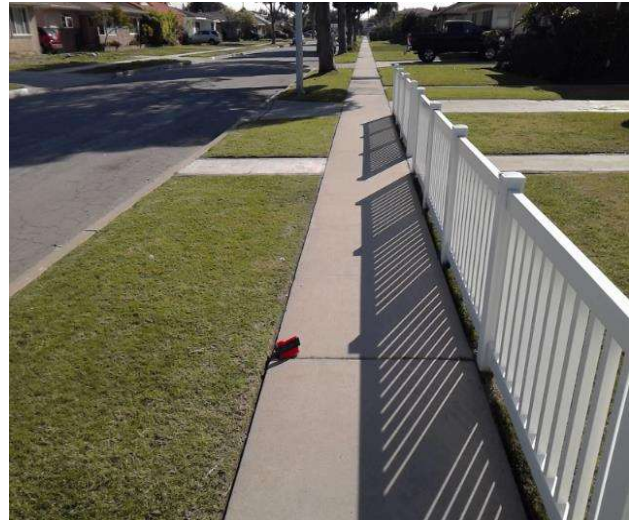
There is a change in elevation greater than recommended value.

Code Reference ADA 206, 302

Ensure that the change in elevation is within the recommended value.

Recommendation Up to 0.25 inches

Remove tripping hazards \$198

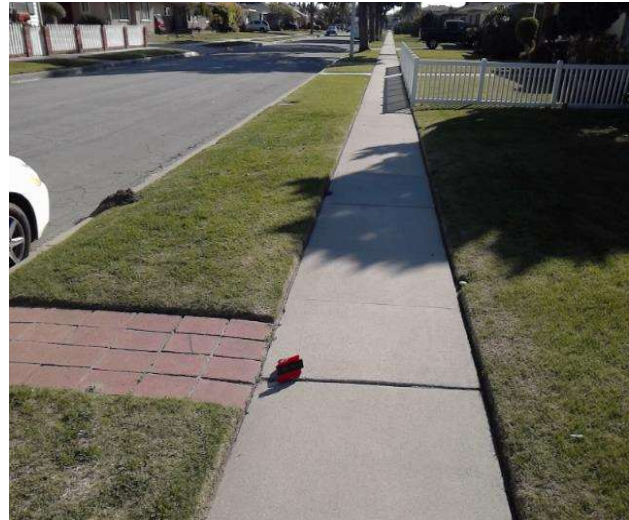
There is a change in elevation greater than recommended value.

Code Reference ADA 206, 302

Ensure that the change in elevation is within the recommended value.

Recommendation Up to 0.25 inches

Remove tripping hazards \$198

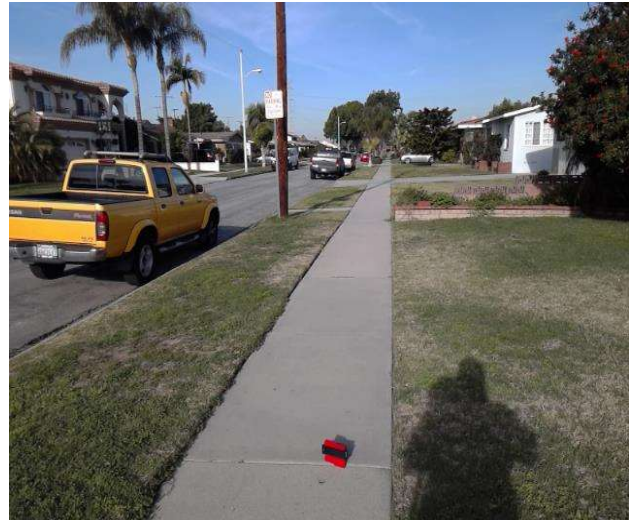
There is a change in elevation greater than recommended value.

Code Reference ADA 206, 302

Ensure that the change in elevation is within the recommended value.

Recommendation Up to 0.25 inches

Remove tripping hazards \$198

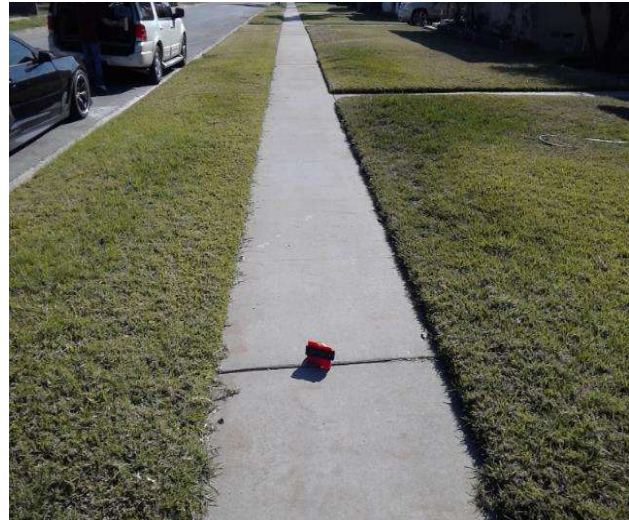
There is a change in elevation greater than recommended value.

Code Reference ADA 206, 302

Ensure that the change in elevation is within the recommended value.

Recommendation Up to 0.25 inches

Remove tripping hazards \$198

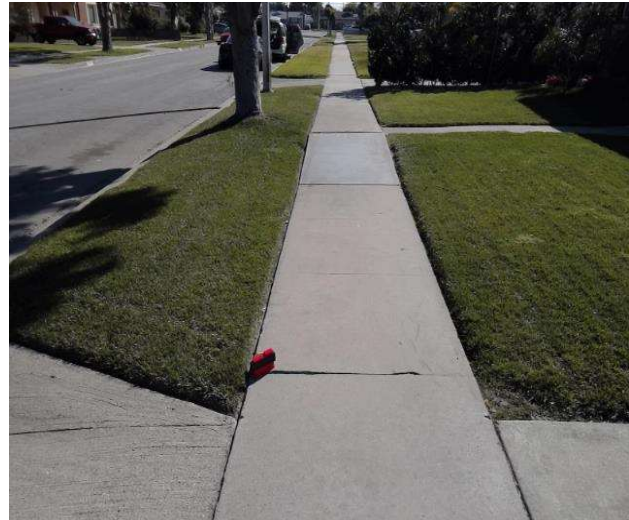
There is a change in elevation greater than recommended value.

Code Reference ADA 206, 302

Ensure that the change in elevation is within the recommended value.

Recommendation Up to 0.25 inches

Remove tripping hazards \$198

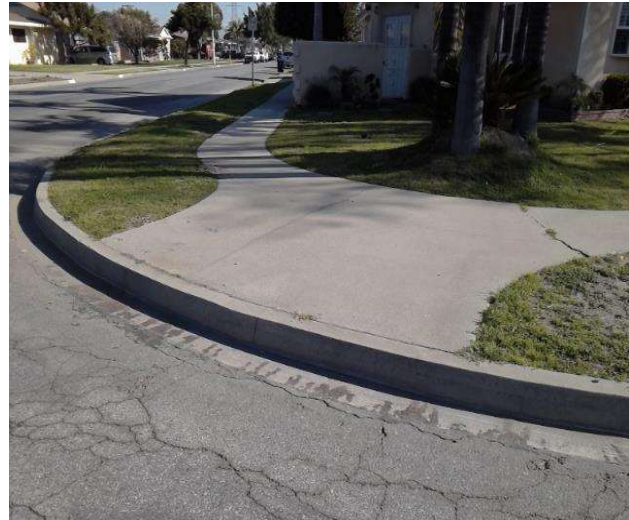
Sidewalks , Hazards & Gratings : Curb is on Path of Travel

Code Reference ADA 402, 303, 406, 403.4, 303.4

Install curb ramp \$2,500

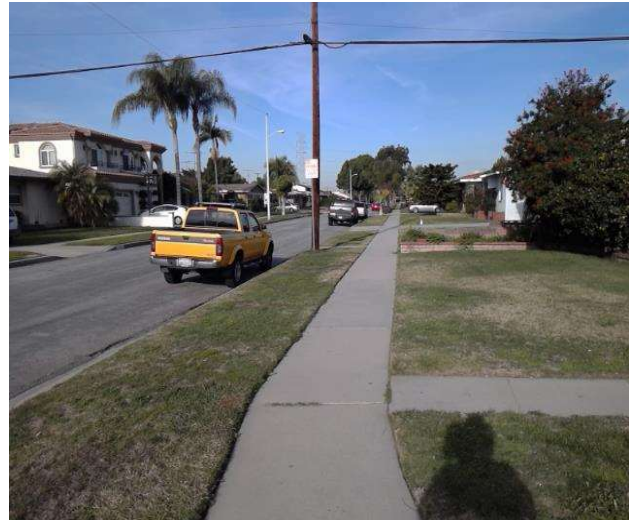
Code Reference ADA 206, 302,CA 11B-403.3

Repave the sidewalk surface with the recommended cross slope.

Recommendation Up to 2.08 percent

Repave surface \$1,092

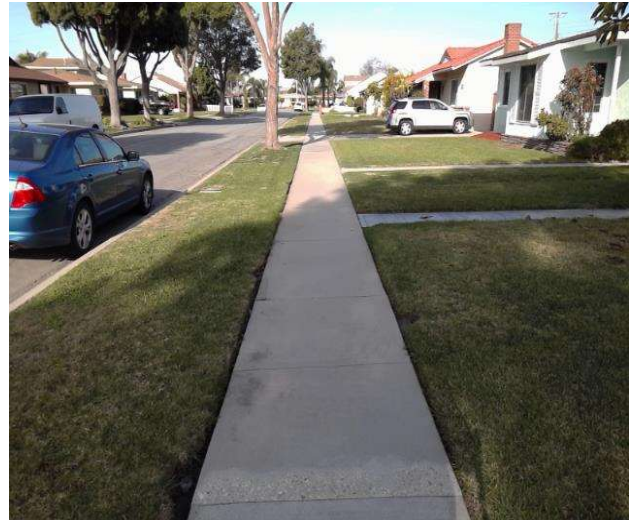
Code Reference ADA 206, 302, CA 11B-403.3

Repave the sidewalk surface with the recommended cross slope.

Recommendation Up to 2.08 percent

Repave surface \$1,092

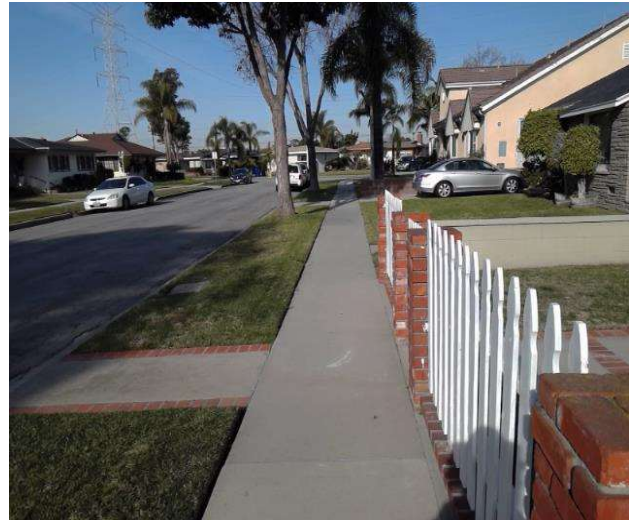
Code Reference ADA 206, 302,CA 11B-403.3

Repave the sidewalk surface with the recommended cross slope.

Recommendation Up to 2.08 percent

Repave surface \$1,092

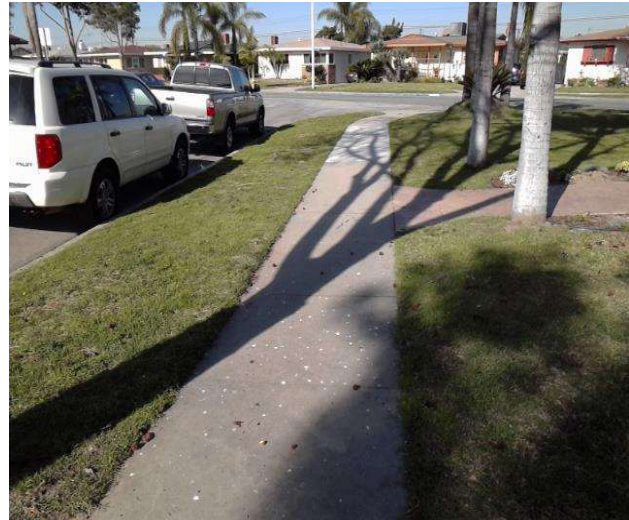
Code Reference ADA 206, 302,CA 11B-403.3

Repave the sidewalk surface with the recommended cross slope.

Recommendation Up to 2.08 percent

Repave surface \$1,092

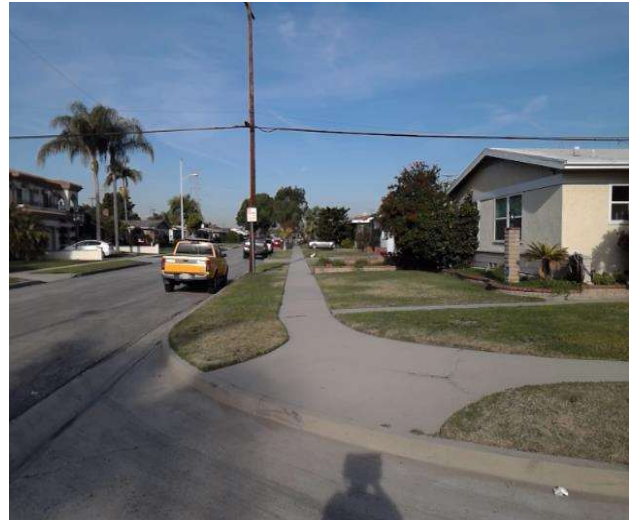
On-Site Finding Not Found

Code Reference ADA 206, 302

Recommendation See Recommendation

\$2,400

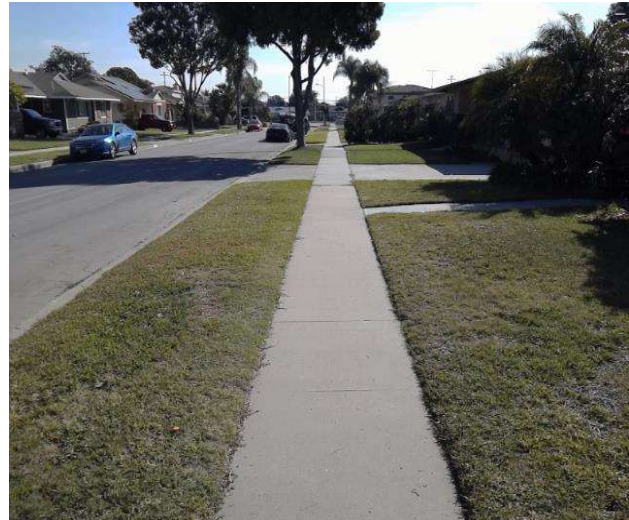
Code Reference ADA 206, 302,CA 11B-403.3

Repave the sidewalk surface with the recommended cross slope.

Recommendation Up to 2.08 percent

Repave surface \$1,092

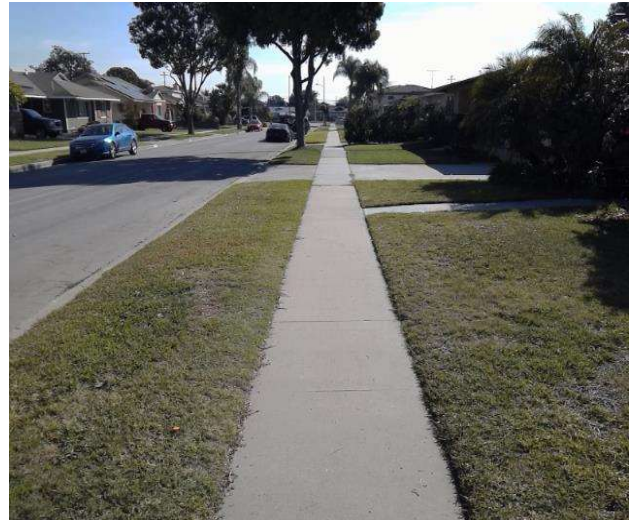
Code Reference ADA 206, 302

Repave the sidewalk surface with the recommended running slope.

Recommendation Up to 5.00 percent

Repave surface \$1,184

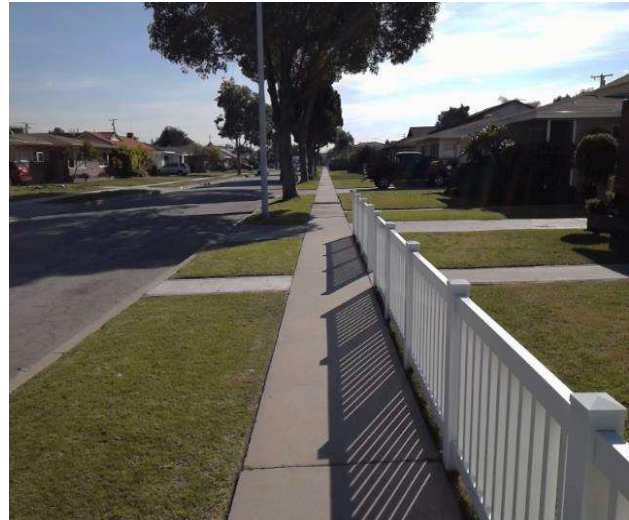
Code Reference ADA 206, 302, CA 11B-403.3

Repave the sidewalk surface with the recommended cross slope.

Recommendation Up to 2.08 percent

Repave surface \$1,092

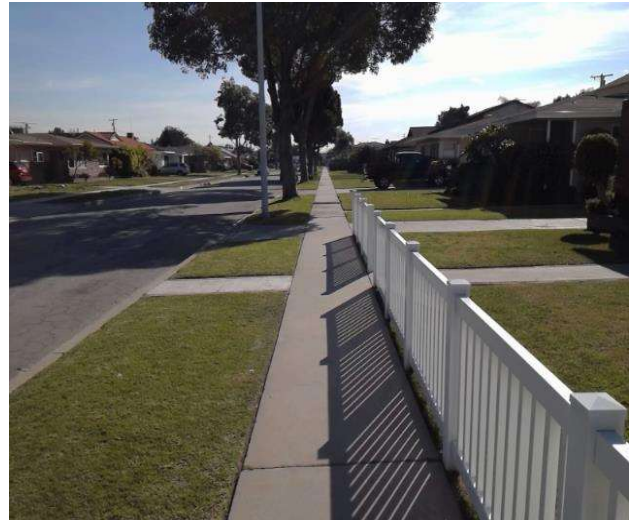
Code Reference ADA 206, 302

Repave the sidewalk surface with the recommended running slope.

Recommendation Up to 5.00 percent

Repave surface \$1,184

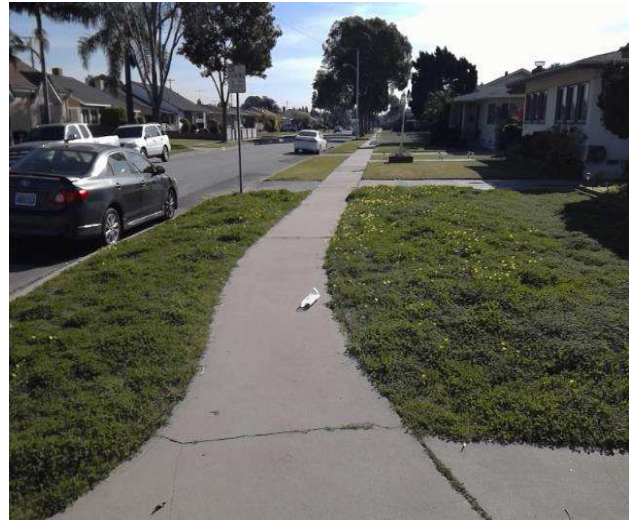
Code Reference ADA 206, 302, CA 11B-403.3

Repave the sidewalk surface with the recommended cross slope.

Recommendation Up to 2.08 percent

Repave surface \$1,092

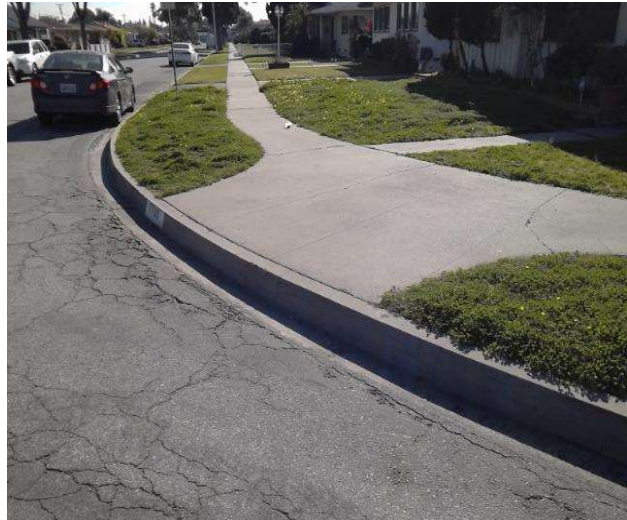
Sidewalks , Hazards & Gratings : Curb is on Path of Travel

Code Reference ADA 402, 303, 406, 403.4, 303.4

Install curb ramp \$2,500
