Accessibility Survey

City of Downey Danvers Street - Lowman Avenue to End

Date of Inspection
2/5/2017

Prepared By
Disability Access Consultants
(800) 743-7067

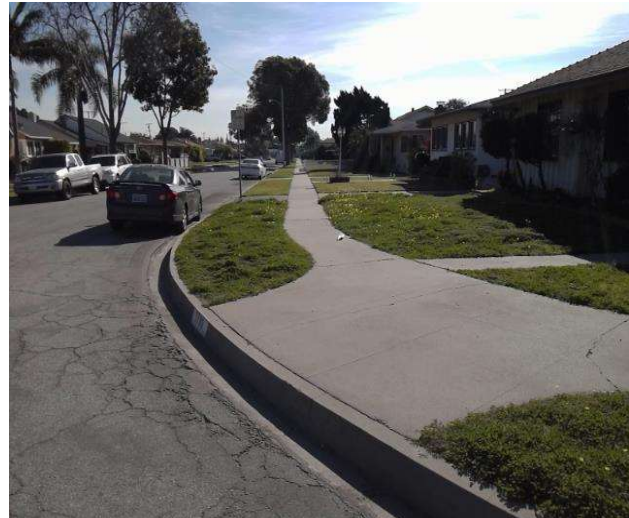
On-Site Finding Not Found

Code Reference ADA 206, 302

Recommendation See Recommendation

\$2,400
