## Accessibility Survey

## City of Downey Pellet Street - Pangborn Avenue To End

Date of Inspection  
5/3/2017

Prepared By  
**Disability Access Consultants**  
(800) 743-7067

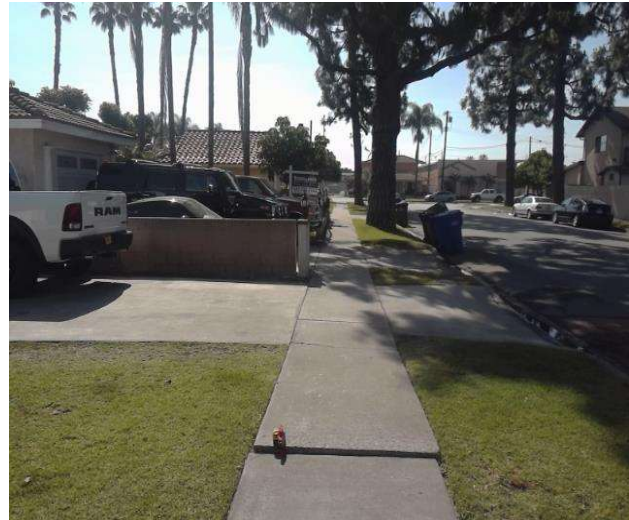
**Change In Level East Of Casanes Avenue @ 33.931939794683, -118.113721311092**

Sidewalks , Change in Level : Change in Level Non Beveled

There is a change in elevation greater than recommended value.

**On-Site Finding** 1.62 inches

Ensure that the change in elevation is within the recommended value.

Recommendation Up to 0.25 inches

Remove tripping hazards \$198

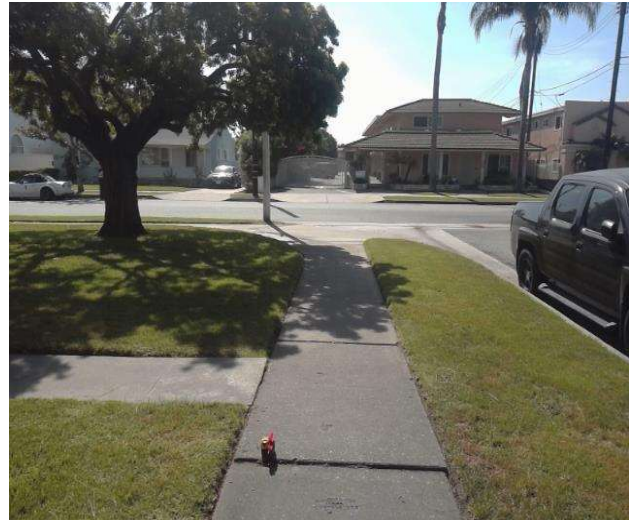
There is a change in elevation greater than recommended value.

Ensure that the change in elevation is within the recommended value.

Recommendation Up to 0.25 inches

Remove tripping hazards \$198

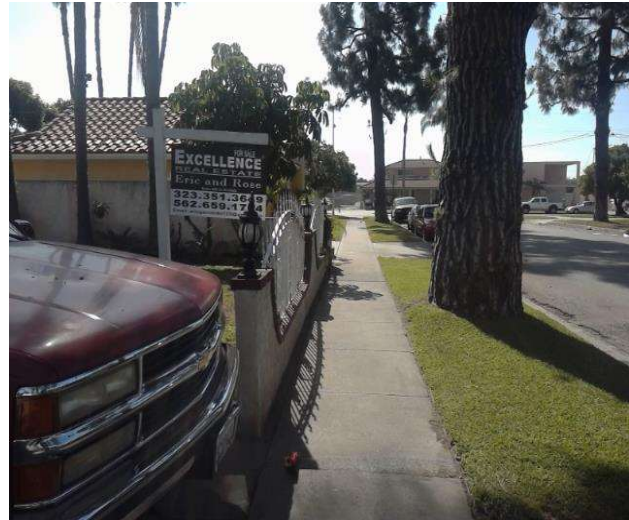
There is a change in elevation greater than recommended value.

Ensure that the change in elevation is within the recommended value.

Recommendation Up to 0.25 inches

Remove tripping hazards \$198

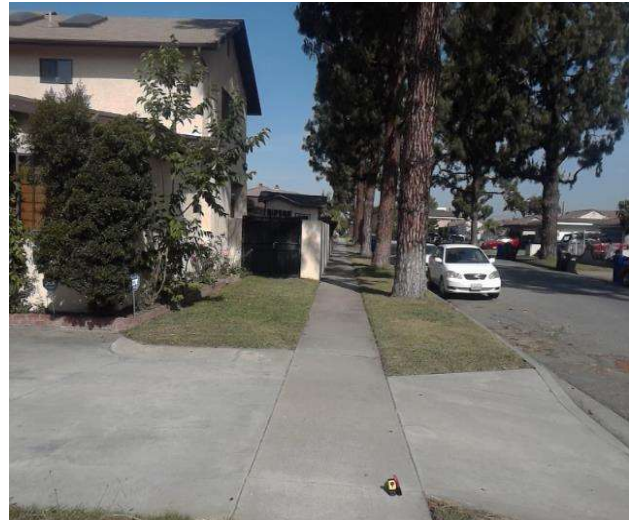
There is a change in elevation greater than recommended value.

Ensure that the change in elevation is within the recommended value.

Recommendation Up to 0.25 inches

Remove tripping hazards \$198

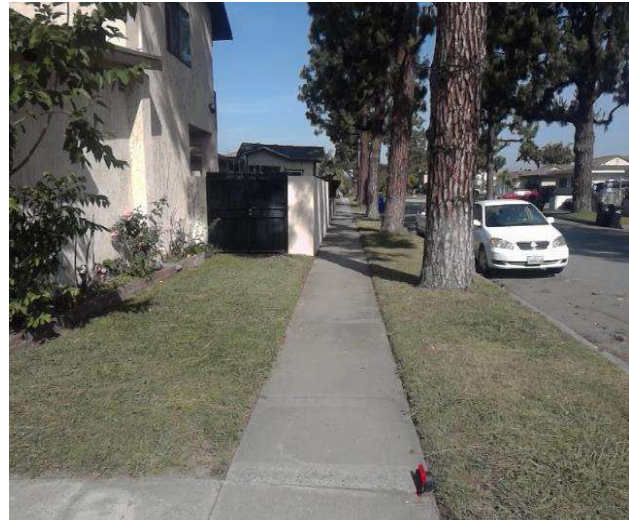
There is a change in elevation greater than recommended value.

Ensure that the change in elevation is within the recommended value.

Recommendation Up to 0.25 inches

Remove tripping hazards \$198

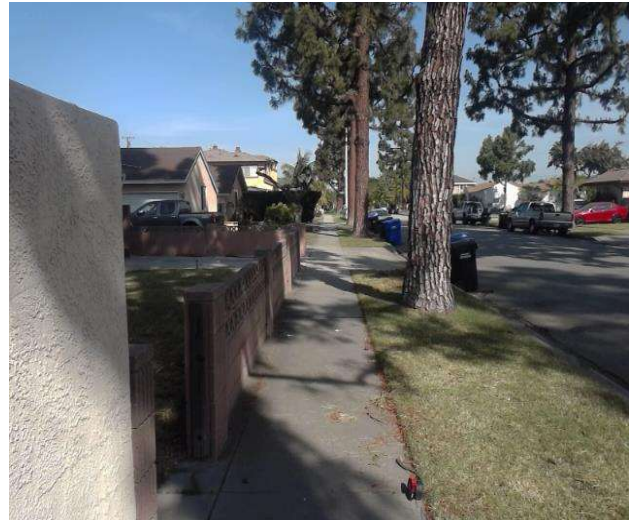
There is a change in elevation greater than recommended value.

Ensure that the change in elevation is within the recommended value.

Recommendation Up to 0.25 inches

Remove tripping hazards \$198

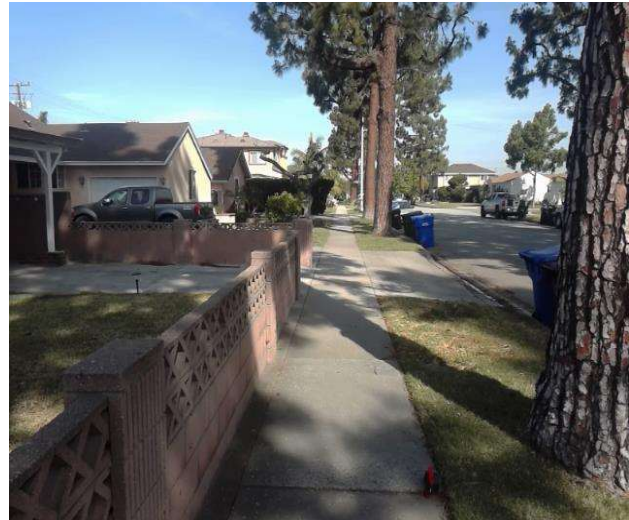
There is a change in elevation greater than recommended value.

Ensure that the change in elevation is within the recommended value.

Recommendation Up to 0.25 inches

Remove tripping hazards \$198

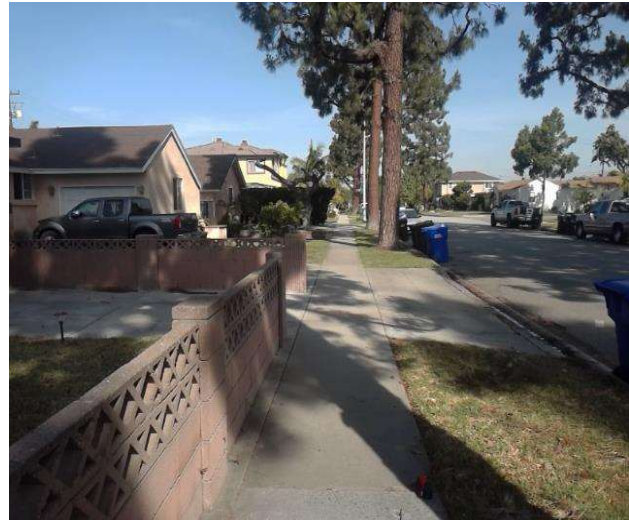
There is a change in elevation greater than recommended value.

Ensure that the change in elevation is within the recommended value.

Recommendation Up to 0.25 inches

Remove tripping hazards \$198

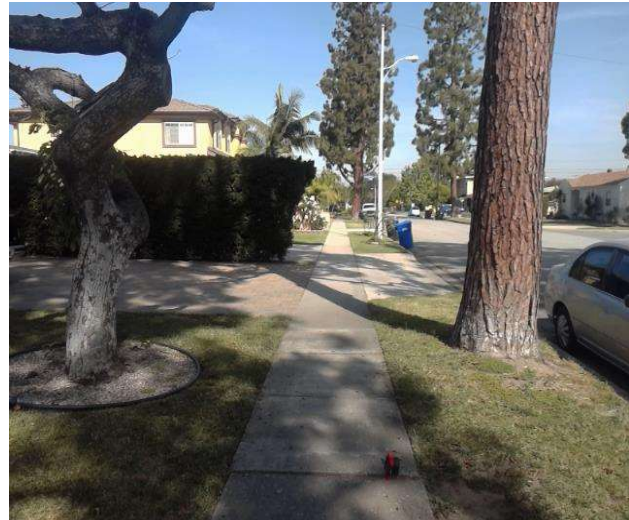
There is a change in elevation greater than recommended value.

Ensure that the change in elevation is within the recommended value.

Recommendation Up to 0.25 inches

Remove tripping hazards \$198

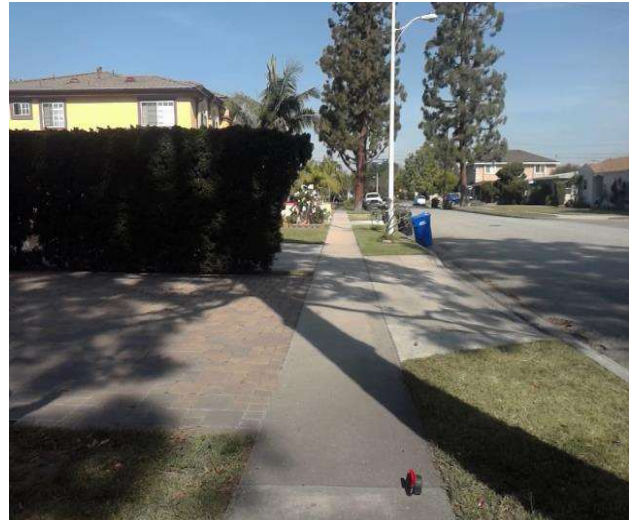
There is a change in elevation greater than recommended value.

Ensure that the change in elevation is within the recommended value.

Recommendation Up to 0.25 inches

Remove tripping hazards \$198

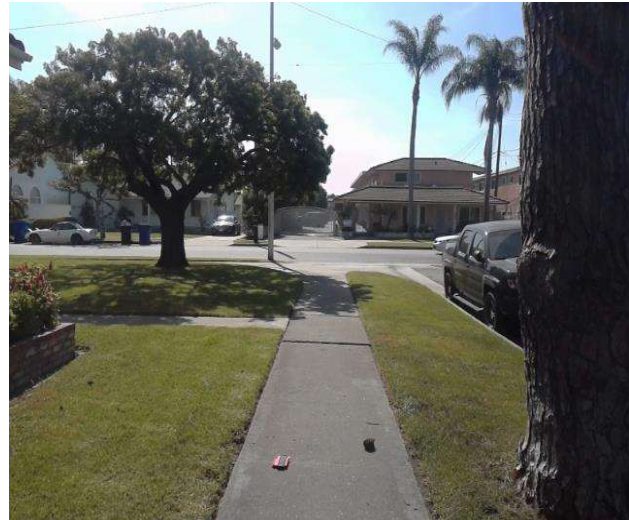
There is a change in elevation greater than recommended value.

Ensure that the change in elevation is within the recommended value.

Recommendation Up to 0.25 inches

Remove tripping hazards \$198

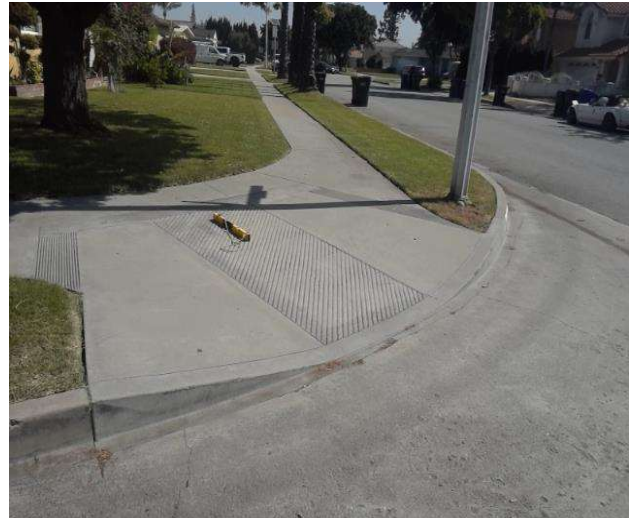
**On-Site Finding** Not Found

Provide detectable warning to surface \$248

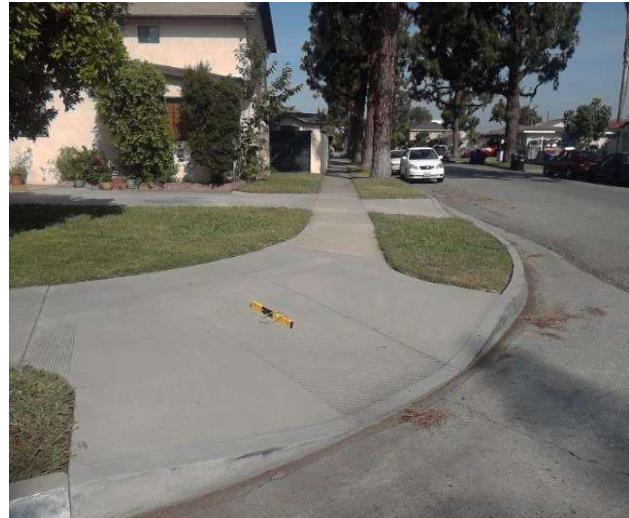
**On-Site Finding** Not Found

Provide detectable warning to surface \$248

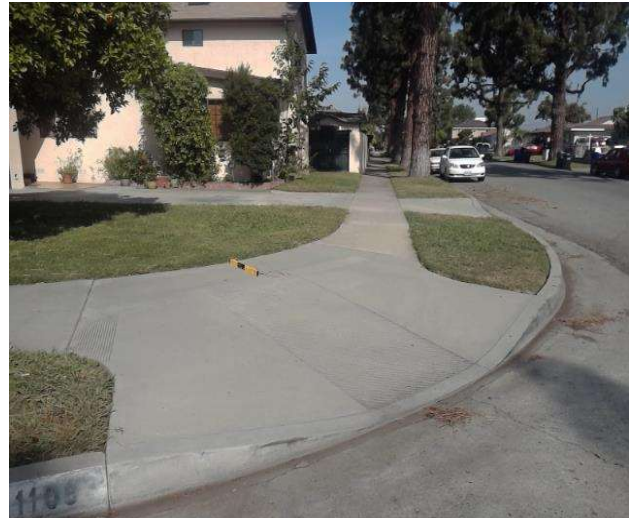
Curb Ramp , Landings and Transitions : Bottom Landing Change in Level - Curb Ramps

Patch lip at curb ramp \$255

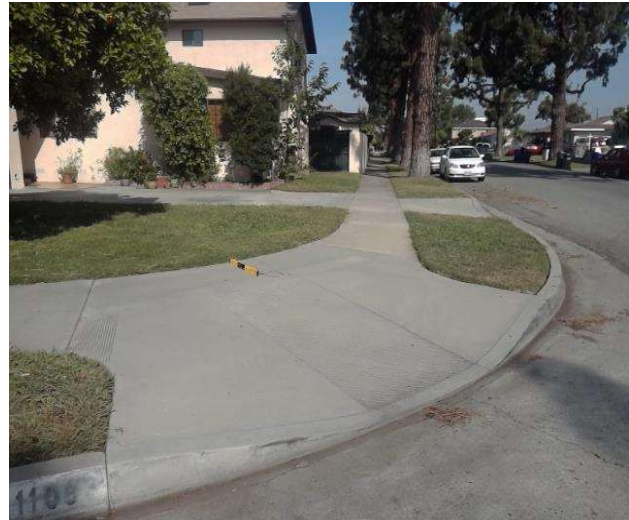
Curb Ramp , Landings and Transitions : Top Landing Clear Length - Landings

Recommendation At least 48.00 inches

Provide compliant landing \$240

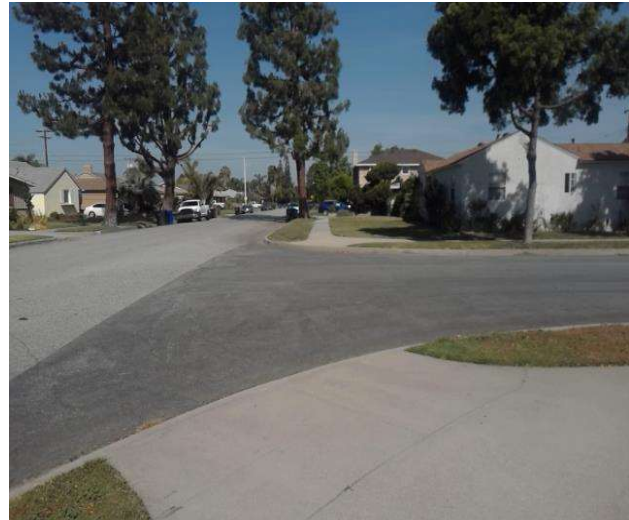
Sidewalks , Hazards & Gratings : Curb is on Path of Travel

Install curb ramp \$2,500

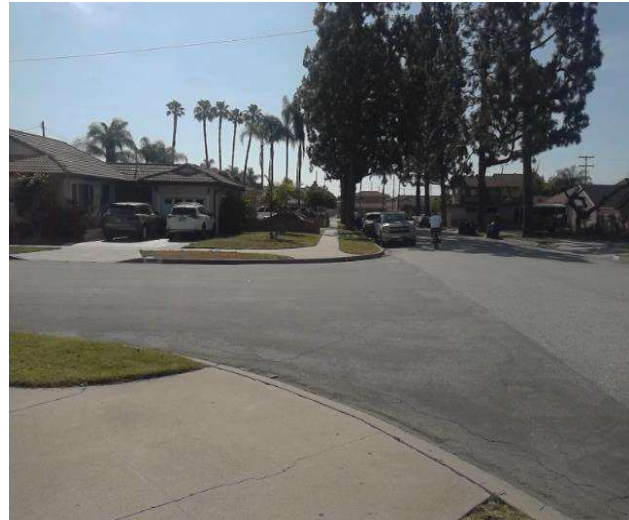
Sidewalks , Hazards & Gratings : Curb is on Path of Travel

Install curb ramp \$2,500

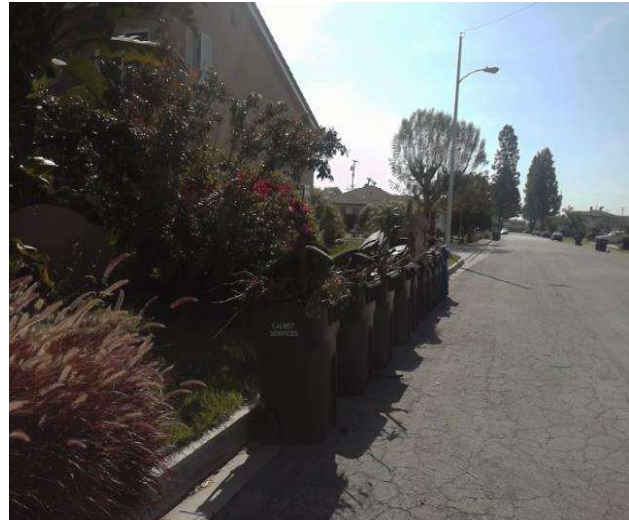
Sidewalks : Missing Sidewalk

Section of sidewalk is missing and consists of dirt, grass or gravel.

Provide a compliant sidewalk for the missing section.

\$1,260

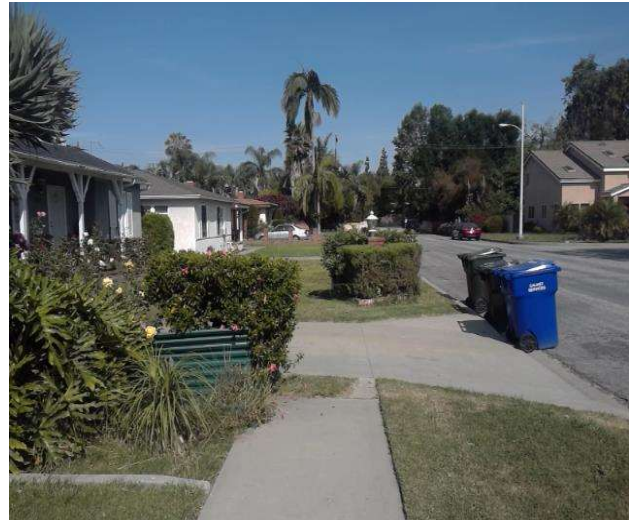
Sidewalks : Missing Sidewalk

Section of sidewalk is missing and consists of dirt, grass or gravel.

Provide a compliant sidewalk for the missing section.

\$1,260

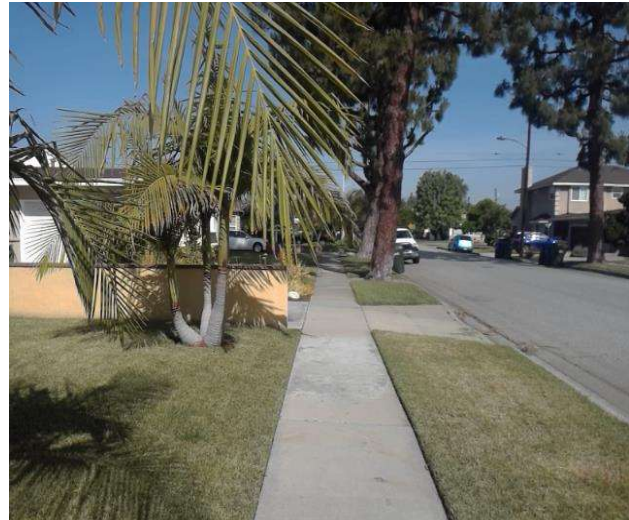
Sidewalks , Hazards & Gratings : Overhead Obstruction Height

Recommendation At least 80.00 inches

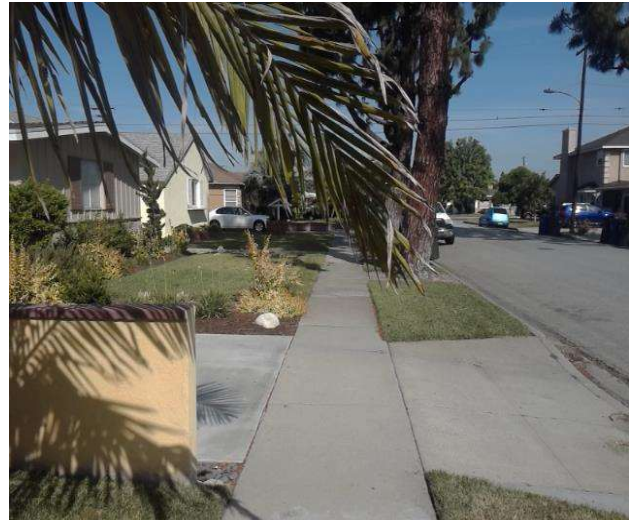
Sidewalks , Hazards & Gratings : Overhead Obstruction Height

Recommendation At least 80.00 inches

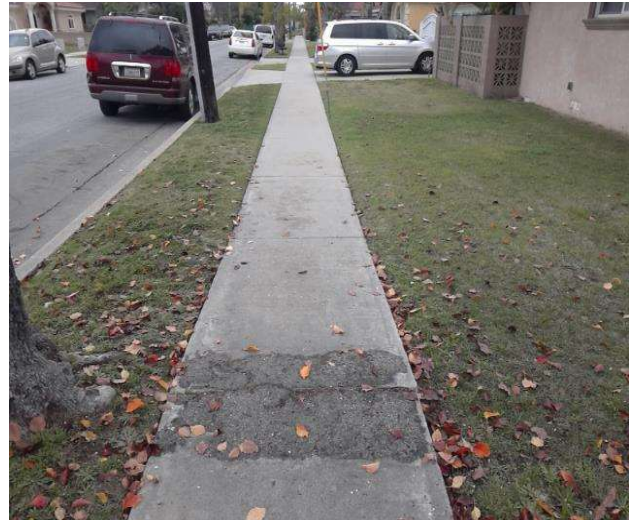
There is a change in elevation greater than recommended value.

Ensure that the change in elevation is within the recommended value.

Recommendation Up to 0.25 inches

Remove tripping hazards \$198

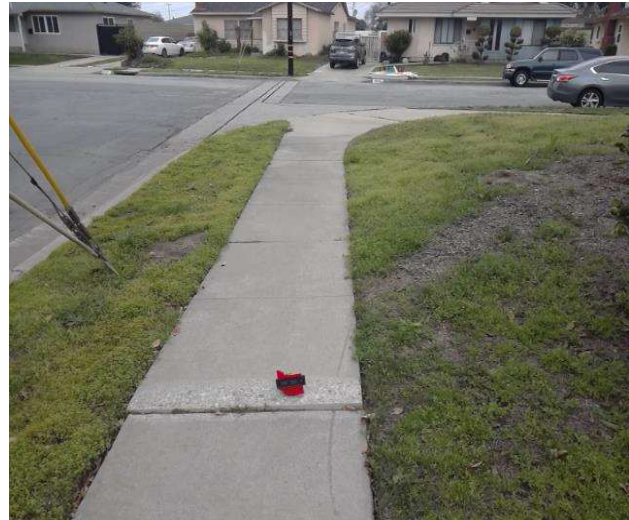
There is a change in elevation greater than recommended value.

Recommendation Up to 0.50 inches

Remove tripping hazards \$198

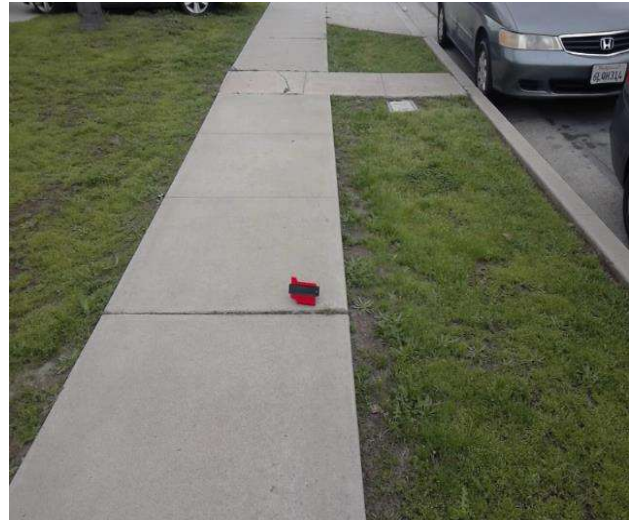
There is a change in elevation greater than recommended value.

Recommendation Up to 0.50 inches

Remove tripping hazards \$198

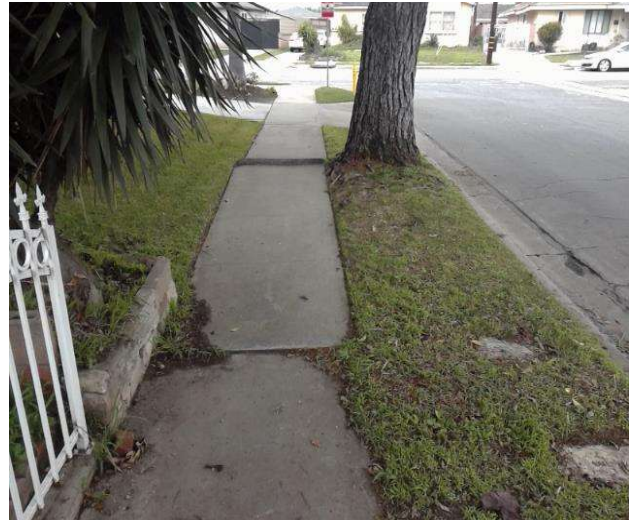
There is a change in elevation greater than recommended value.

Recommendation Up to 0.50 inches

Remove tripping hazards \$198

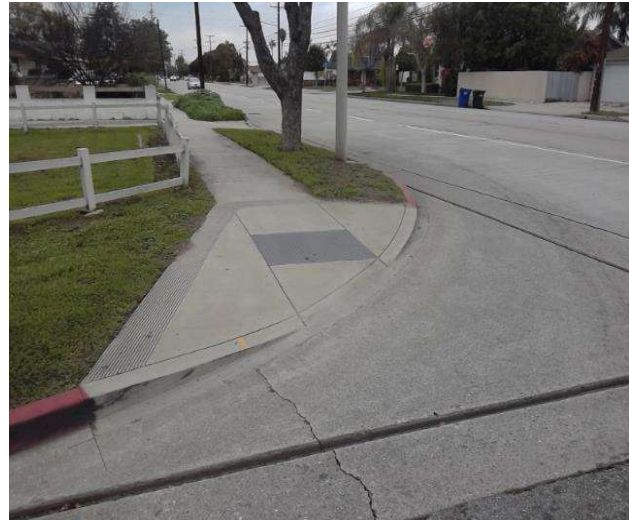
**On-Site Finding** Not Found

Apply contrasting finish to surface \$155

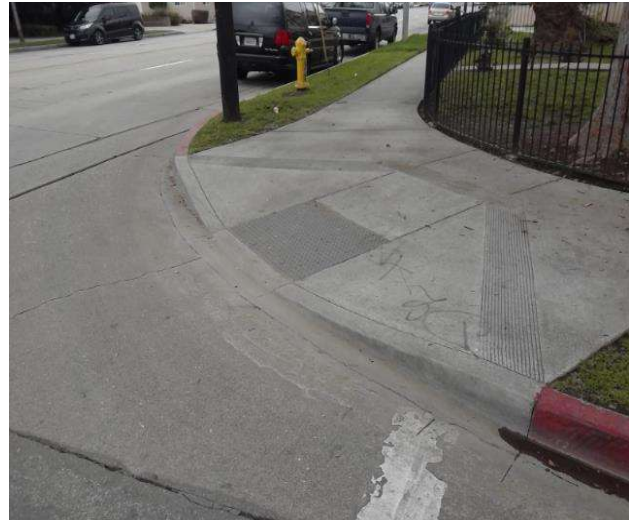
**On-Site Finding** Not Found

Apply contrasting finish to surface \$155

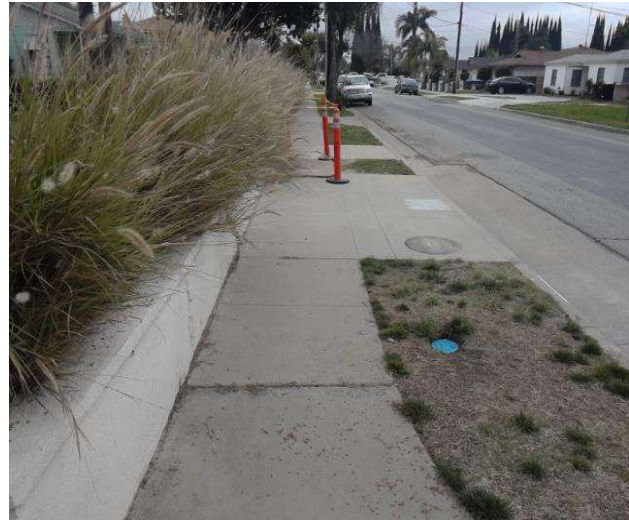
Sidewalks , Hazards & Gratings : Sidewalk Width at Obstruction

Sidewalk width at the obstruction shall have the recommended value.

Recommendation At least 48.00 inches

\$1,260

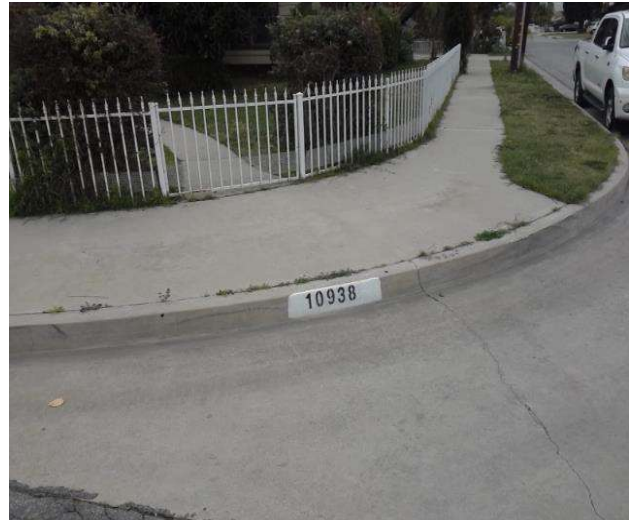
Sidewalks , Hazards & Gratings : Curb is on Path of Travel

Install curb ramp \$2,500

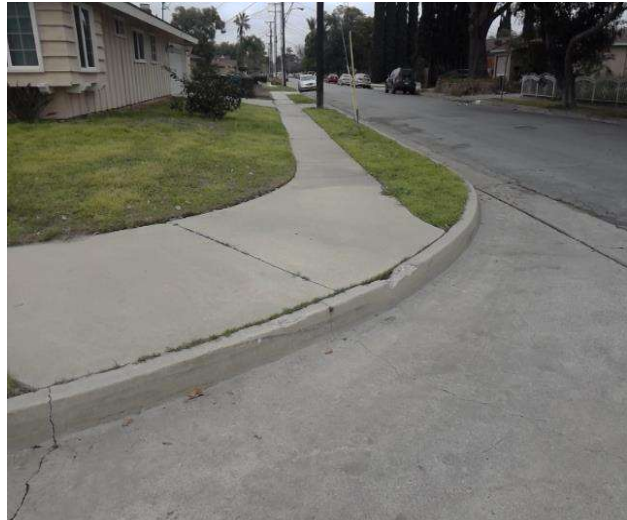
Sidewalks , Hazards & Gratings : Curb is on Path of Travel

Install curb ramp \$2,500

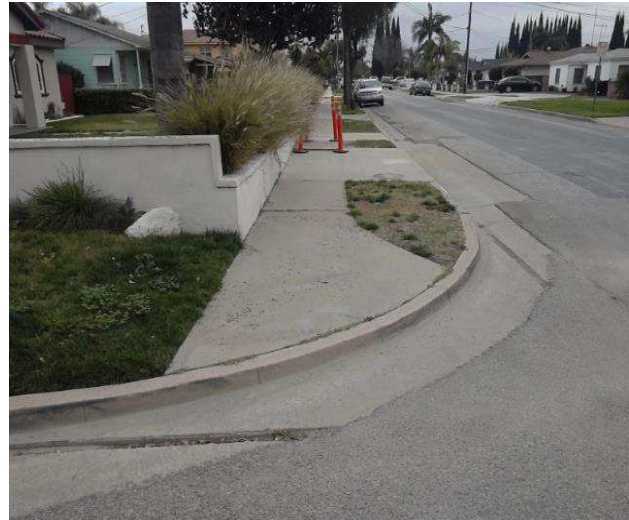
Sidewalks , Hazards & Gratings : Curb is on Path of Travel

Install curb ramp \$2,500

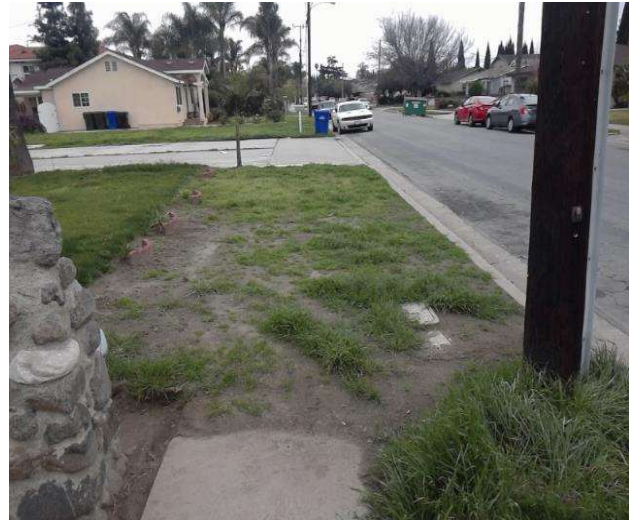
Sidewalks : Missing Sidewalk

Section of sidewalk is missing and consists of dirt, grass or gravel.

Provide a compliant sidewalk for the missing section.

\$1,260

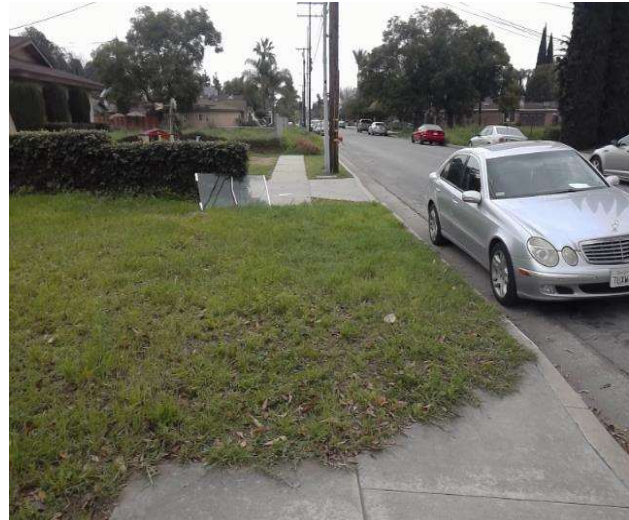
Sidewalks : Missing Sidewalk

Section of sidewalk is missing and consists of dirt, grass or gravel.

Provide a compliant sidewalk for the missing section.

\$1,260

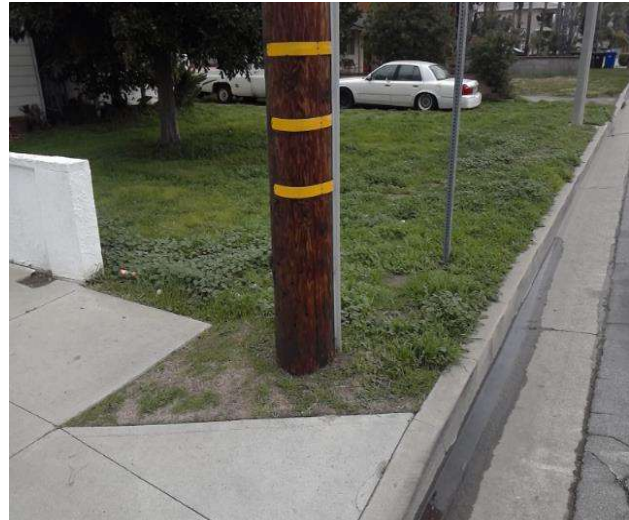
Sidewalks : Missing Sidewalk

Section of sidewalk is missing and consists of dirt, grass or gravel.

Provide a compliant sidewalk for the missing section.

\$1,260

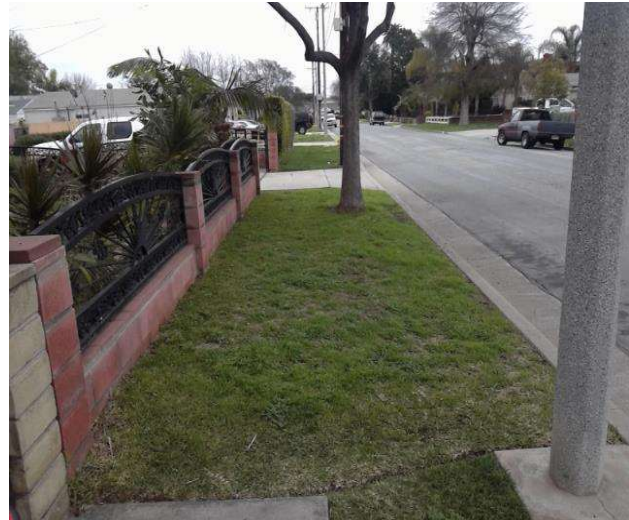
Sidewalks : Missing Sidewalk

Section of sidewalk is missing and consists of dirt, grass or gravel.

Provide a compliant sidewalk for the missing section.

\$1,260

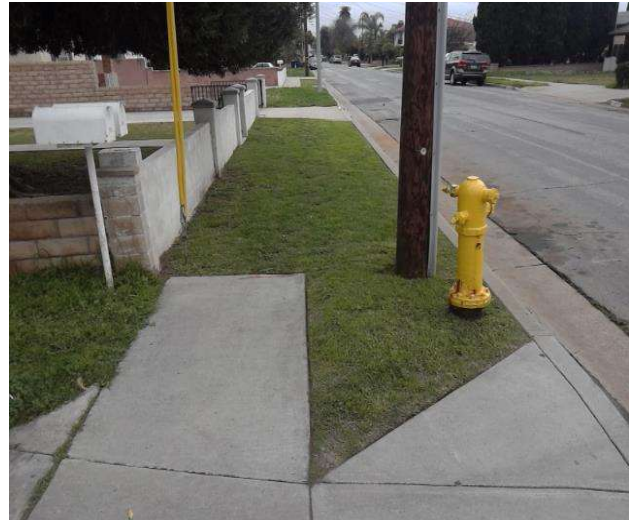
Sidewalks : Missing Sidewalk

Section of sidewalk is missing and consists of dirt, grass or gravel.

Provide a compliant sidewalk for the missing section.

\$1,260

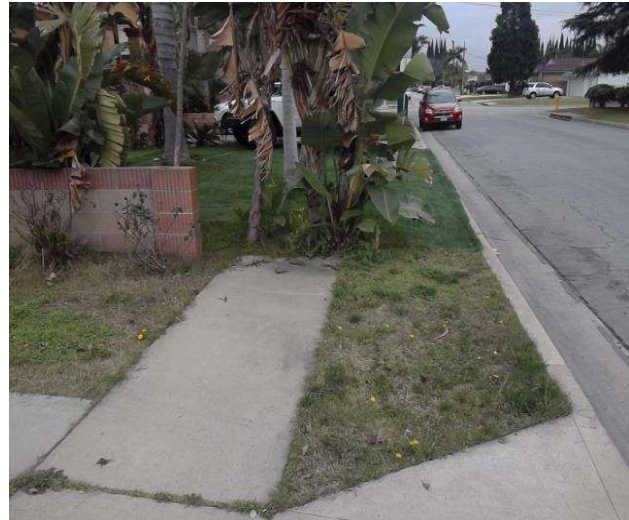
Sidewalks : Missing Sidewalk

Section of sidewalk is missing and consists of dirt, grass or gravel.

Provide a compliant sidewalk for the missing section.

\$1,260

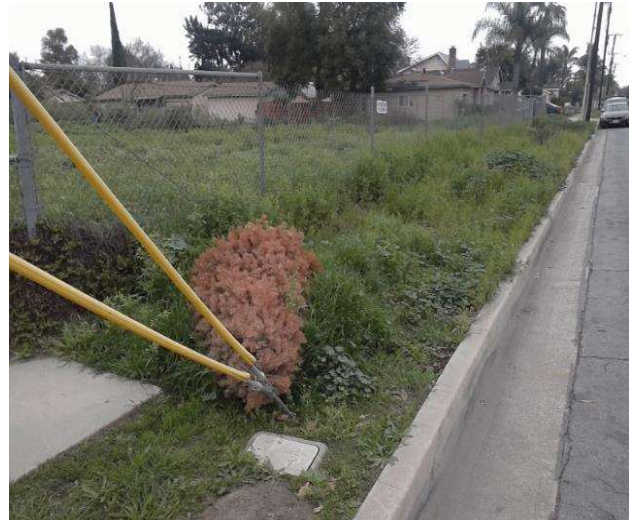
Sidewalks : Missing Sidewalk

Section of sidewalk is missing and consists of dirt, grass or gravel.

Provide a compliant sidewalk for the missing section.

\$1,260

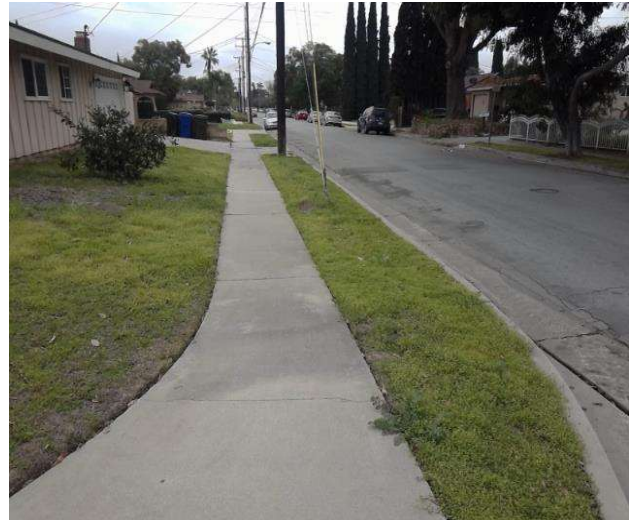
**On-Site Finding** Not Found

\$2,400

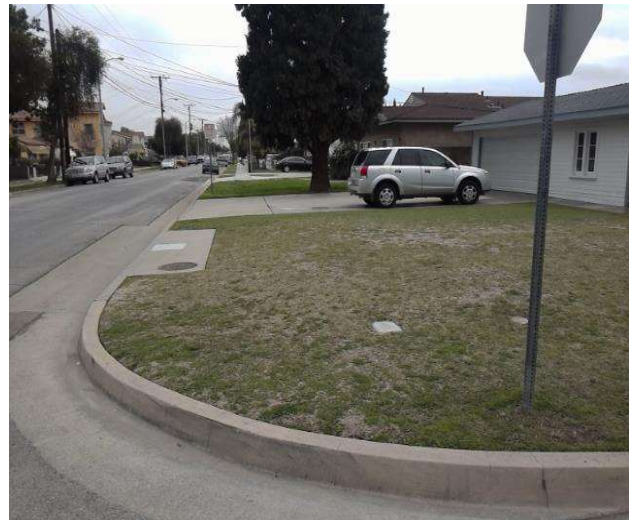
Sidewalks , Hazards & Gratings : Curb is on Path of Travel

Install curb ramp \$2,500

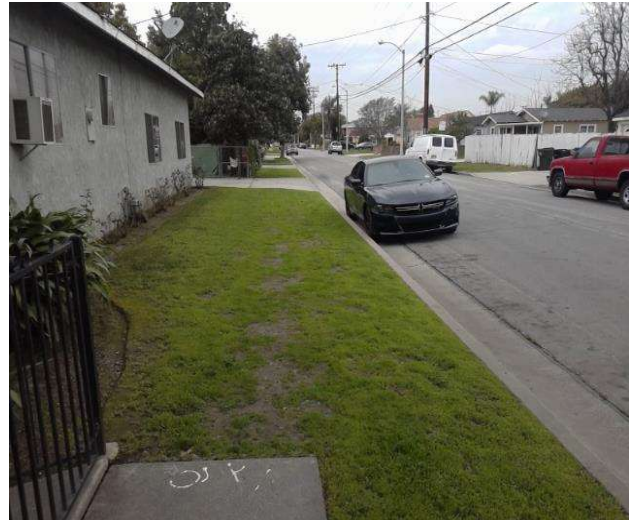
Sidewalks : Missing Sidewalk

Section of sidewalk is missing and consists of dirt, grass or gravel.

Provide a compliant sidewalk for the missing section.

\$1,260

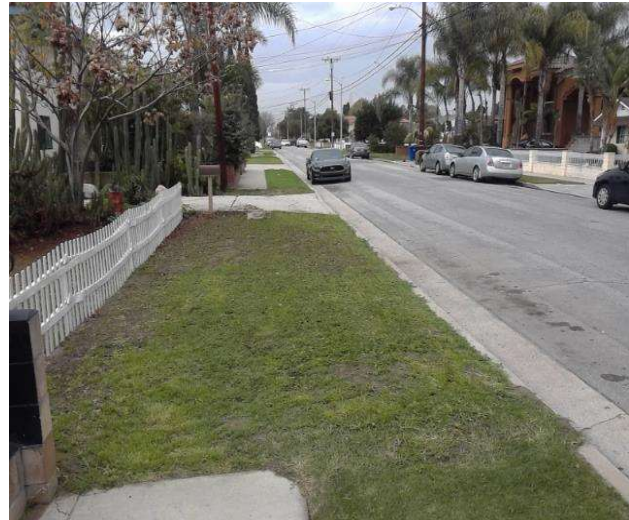
Sidewalks : Missing Sidewalk

Section of sidewalk is missing and consists of dirt, grass or gravel.

Provide a compliant sidewalk for the missing section.

\$1,260

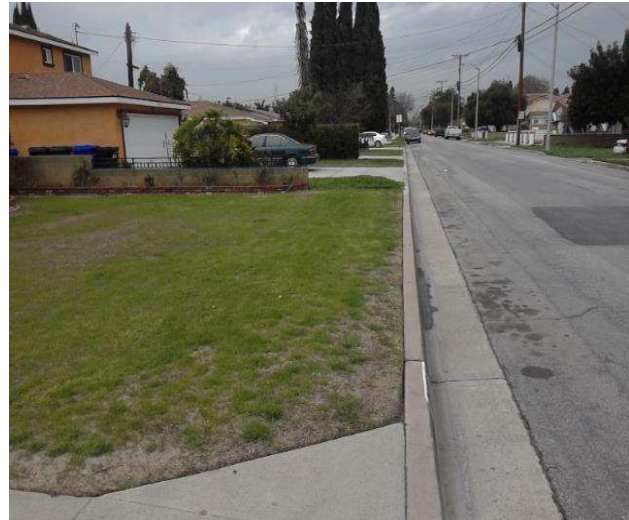
Sidewalks : Missing Sidewalk

Section of sidewalk is missing and consists of dirt, grass or gravel.

Provide a compliant sidewalk for the missing section.

\$1,260

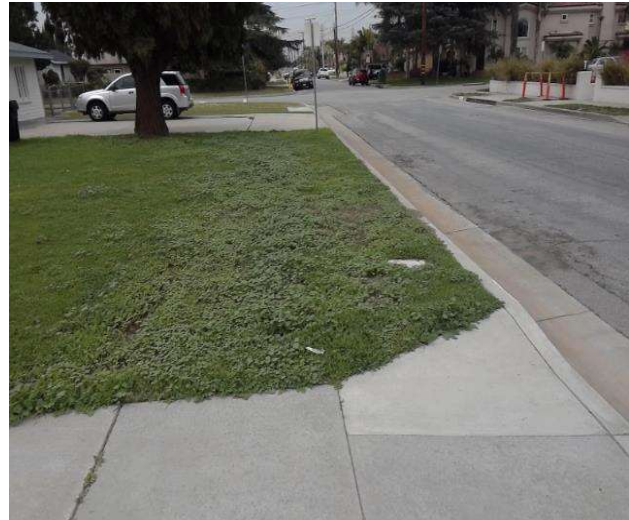
Sidewalks : Missing Sidewalk

Section of sidewalk is missing and consists of dirt, grass or gravel.

Provide a compliant sidewalk for the missing section.

\$1,260

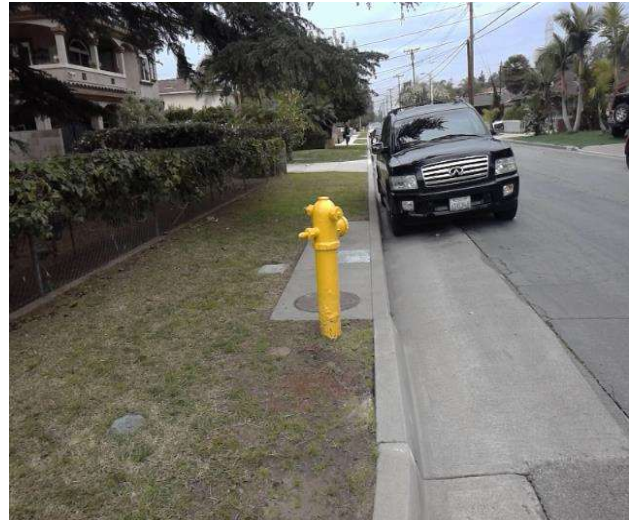
Sidewalks : Missing Sidewalk

Section of sidewalk is missing and consists of dirt, grass or gravel.

Provide a compliant sidewalk for the missing section.

\$1,260

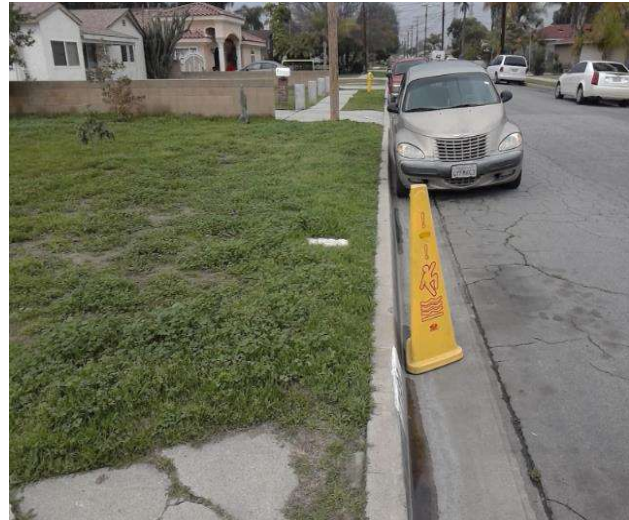
Sidewalks : Missing Sidewalk

Section of sidewalk is missing and consists of dirt, grass or gravel.

Provide a compliant sidewalk for the missing section.

\$1,260
