Accessibility Survey

City of Downey Barlin Avenue - Cheyenne Street To Gardendale Street

Date of Inspection
4/10/2017

Disability Access Consultants

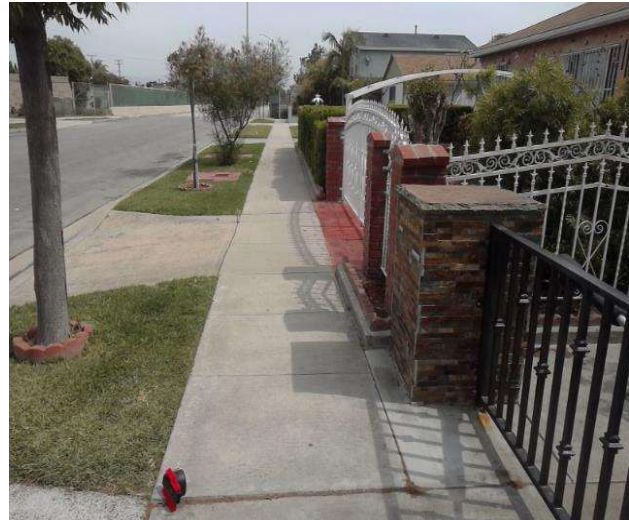
Change In Level South Of Cheyenne Street @ 33.912109999121, -118.145195692778

Sidewalks , Change in Level : Change in Level Non Beveled

There is a change in elevation greater than recommended value.

On-Site Finding 0.62 inches

Ensure that the change in elevation is within the recommended value.

Recommendation Up to 0.25 inches

Remove tripping hazards \$198

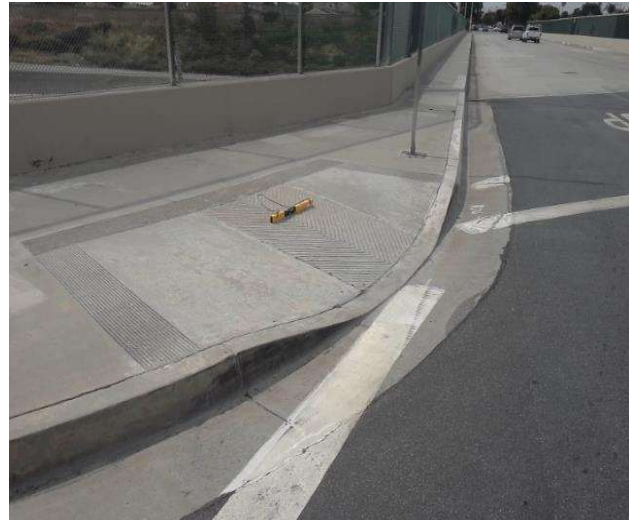
Southeast Corner Of Cheyenne Street @ 33.913561306289, - 118.144138902426

Curb Ramp : No Detectable Warnings

The curb ramp does not provide a detectable warning surface which includes truncated domes.

On-Site Finding Not Found

Provide compliant detectable warnings to surface.

Provide detectable warning to surface \$248

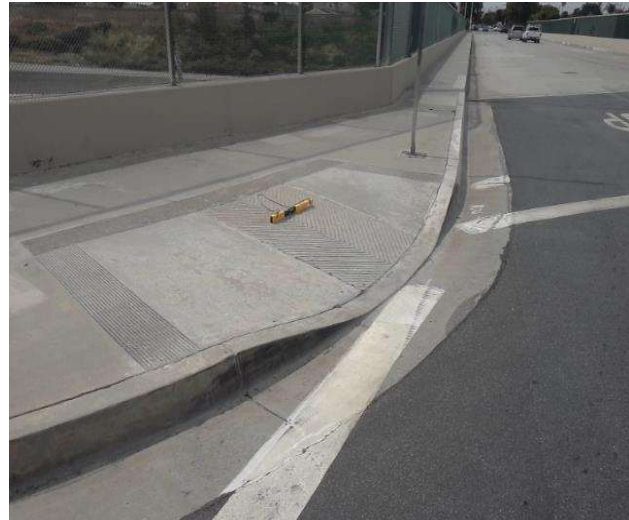
Southeast Corner Of Cheyenne Street @ 33.913561306289, - 118.144138902426

Curb Ramp : Not Wholly Contained Within The Marked Crossing

The curb ramp is not wholly contained within the marked crossing.

Provide a marked crossing on the path of travel; make certain the curb ramp is wholly contained within the marked crossing.

Install crosswalk \$800

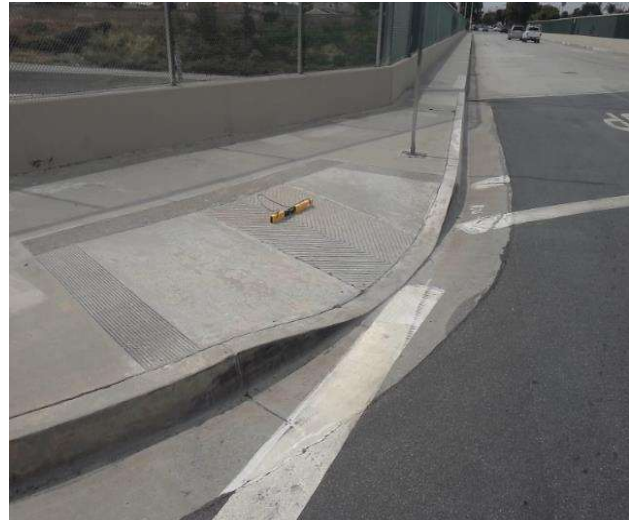
Southeast Corner Of Cheyenne Street @ 33.913561306289, - 118.144138902426

Curb Ramp : Curb Ramp - Cross Slope

The cross slope is greater than allowed.

On-Site Finding 4.20 percent

Provide a compliant curb ramp.

Recommendation Up to 2.08 percent

Install curb ramp \$1,300

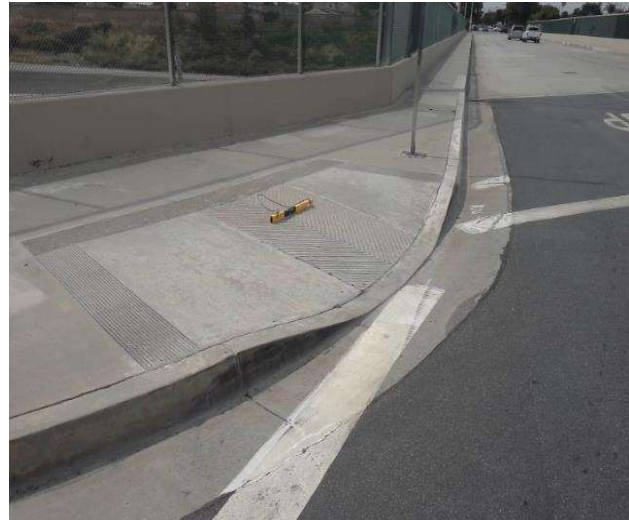
Southeast Corner Of Cheyenne Street @ 33.913561306289, - 118.144138902426

Curb Ramp : Side Flare Slope

The slope of the curb ramp side flare is greater than allowed.

On-Site Finding 16.50 percent

Provide curb ramp side flares with a compliant slope.

Recommendation Up to 10.00 percent

Install flared sides \$1,300

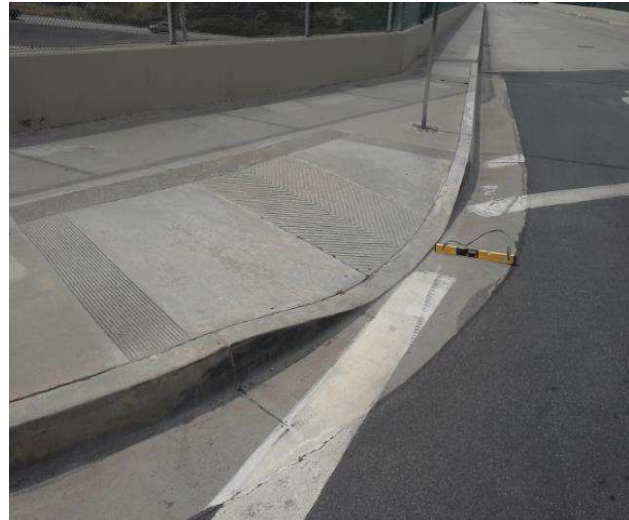
Southeast Corner Of Cheyenne Street @ 33.913561306289, - 118.144138902426

Curb Ramp : Bottom Landing Slope

The bottom landing of the curb ramp is on the street, and the slope of the bottom landing is not compliant.

Recommendation Up to 5.00 percent

Repave landing \$1,260

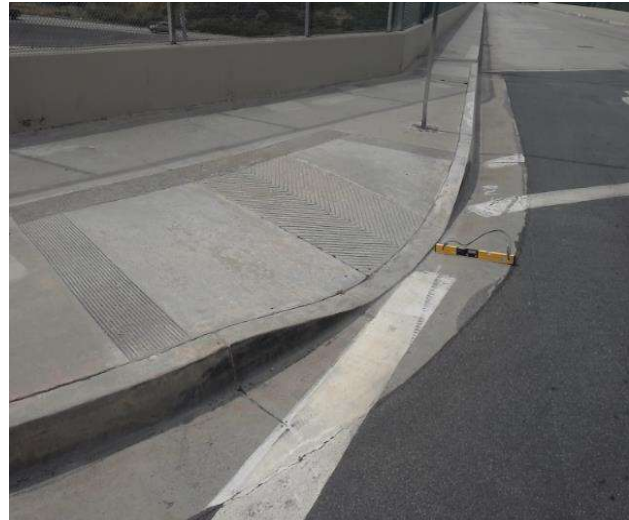
Curb Ramp , Landings And Transitions : Bottom Landing Change in Level

Recommendation Up to 0.50 inches

Patch lip at curb ramp \$255

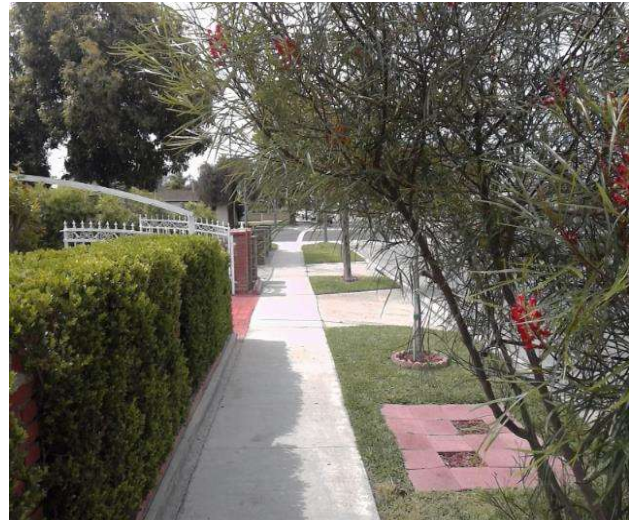
Sidewalks , Hazards & Gratings : Overhead Obstruction Height

Recommendation At least 80.00 inches

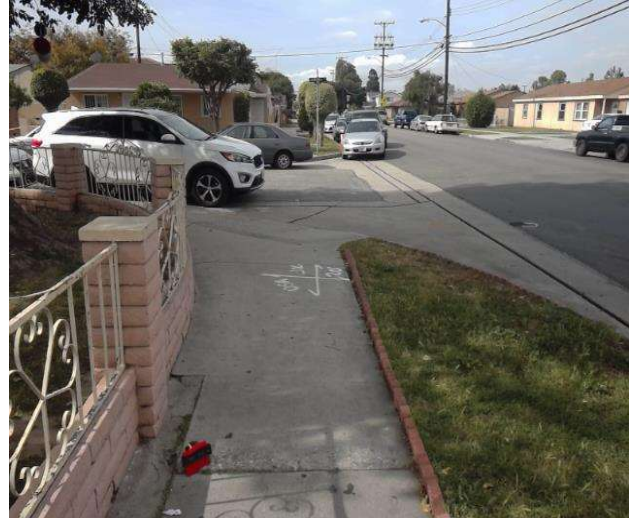
There is a change in elevation greater than recommended value.

Ensure that the change in elevation is within the recommended value.

Recommendation Up to 0.25 inches

Remove tripping hazards \$198

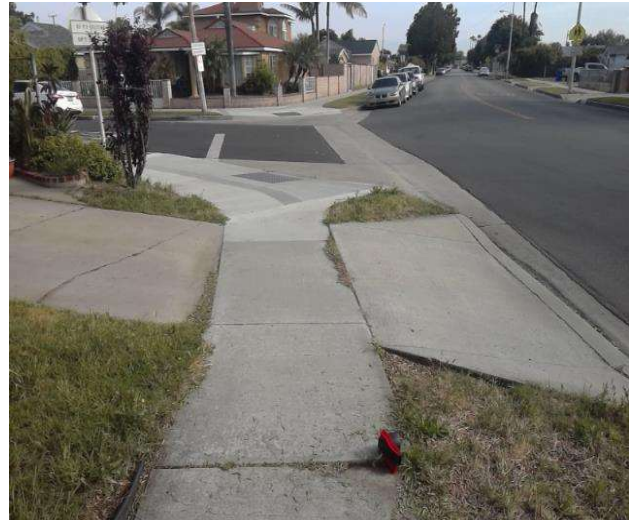
There is a change in elevation greater than recommended value.

Ensure that the change in elevation is within the recommended value.

Recommendation Up to 0.25 inches

Remove tripping hazards \$198

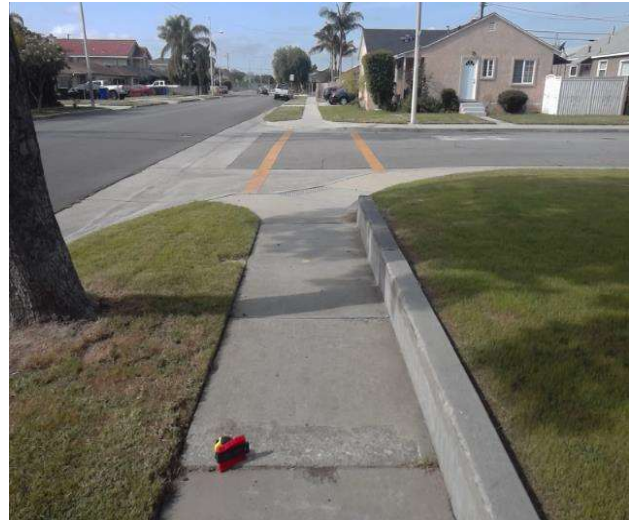
There is a change in elevation greater than recommended value.

Ensure that the change in elevation is within the recommended value.

Recommendation Up to 0.25 inches

Remove tripping hazards \$198

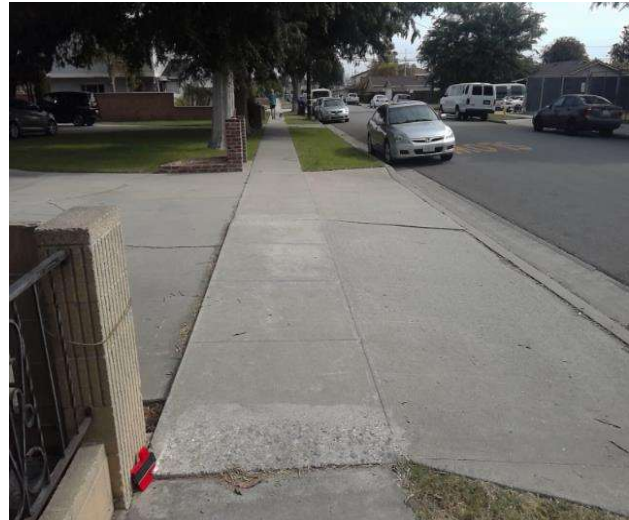
There is a change in elevation greater than recommended value.

Ensure that the change in elevation is within the recommended value.

Recommendation Up to 0.25 inches

Remove tripping hazards \$198

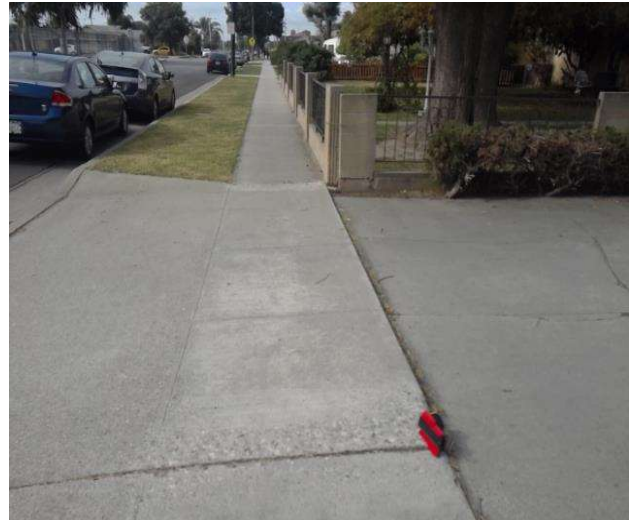
There is a change in elevation greater than recommended value.

Ensure that the change in elevation is within the recommended value.

Recommendation Up to 0.25 inches

Remove tripping hazards \$198

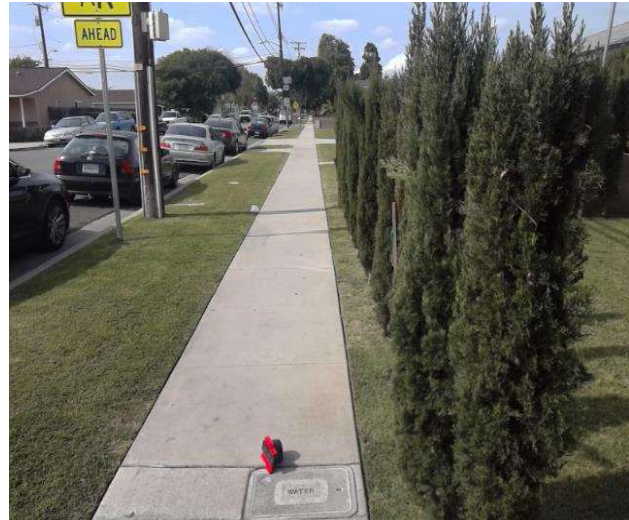
There is a change in elevation greater than recommended value.

Ensure that the change in elevation is within the recommended value.

Recommendation Up to 0.25 inches

Remove tripping hazards \$198

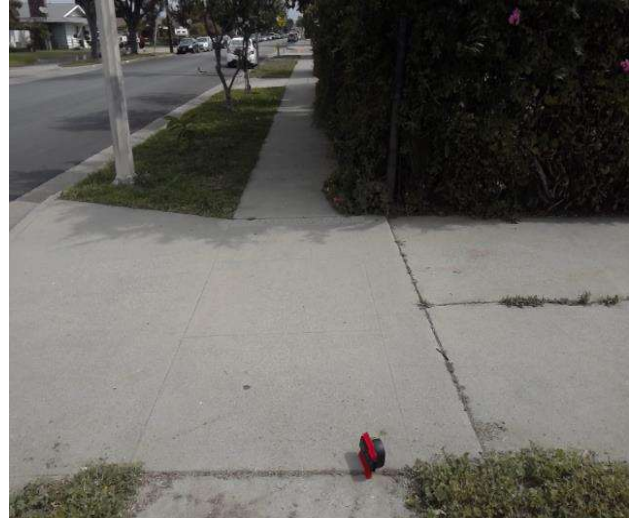
There is a change in elevation greater than recommended value.

Ensure that the change in elevation is within the recommended value.

Recommendation Up to 0.25 inches

Remove tripping hazards \$198

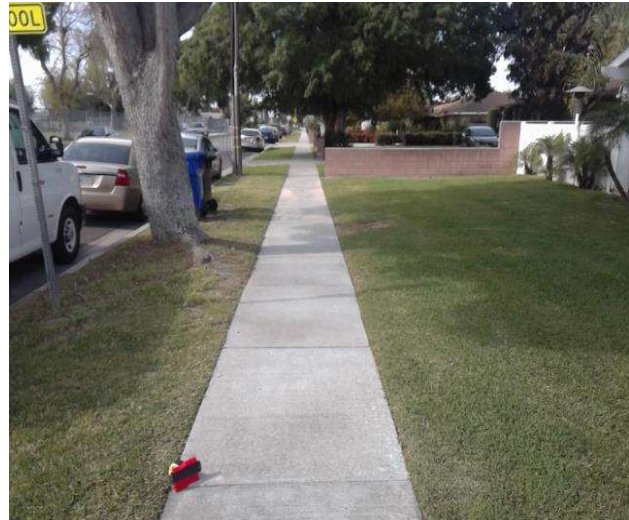
There is a change in elevation greater than recommended value.

Ensure that the change in elevation is within the recommended value.

Recommendation Up to 0.25 inches

Remove tripping hazards \$198

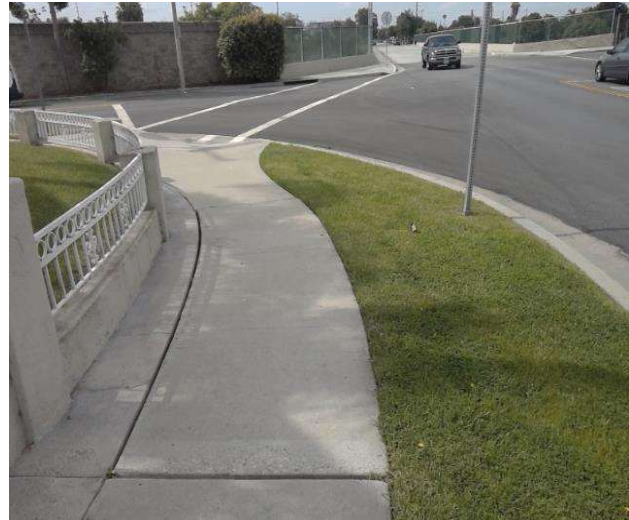
Notes : Opening continues for 13 feet

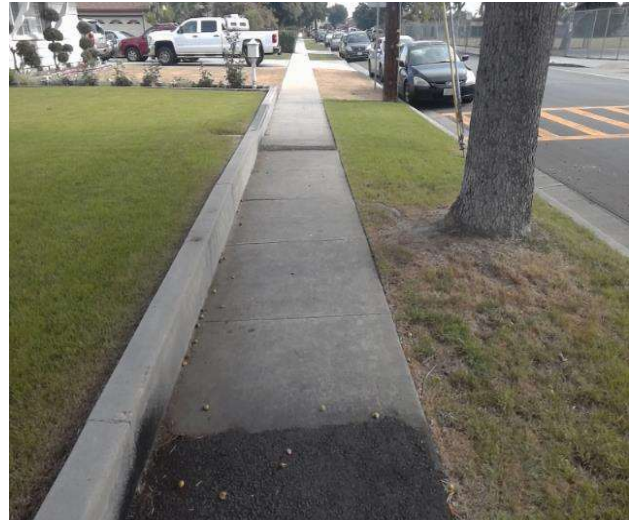
Notes : Surface is rough and uneven for 4 feet.

Repave the sidewalk surface with the recommended running slope.

Recommendation Up to 5.00 percent

Repave surface \$1,184

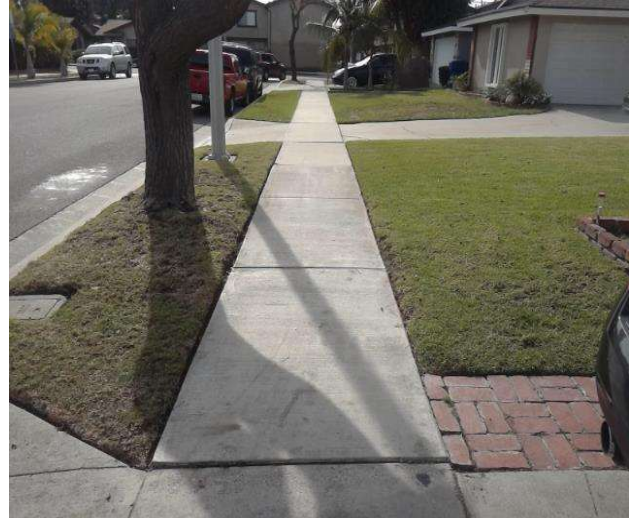
There is a change in elevation greater than recommended value.

Ensure that the change in elevation is within the recommended value.

Recommendation Up to 0.25 inches

Remove tripping hazards \$198

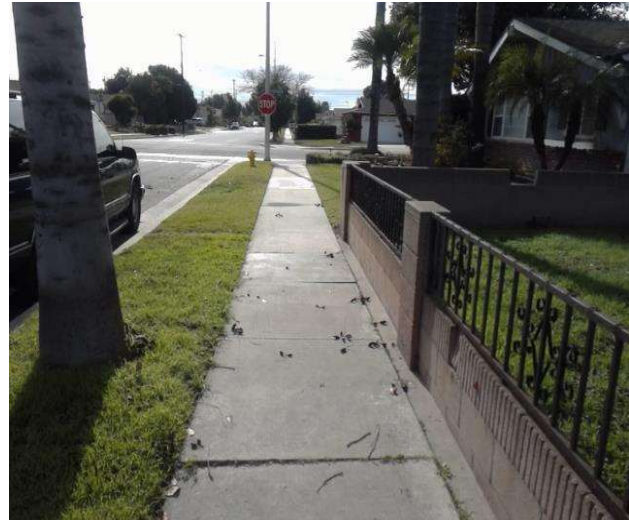
There is a change in elevation greater than recommended value.

Ensure that the change in elevation is within the recommended value.

Recommendation Up to 0.25 inches

Remove tripping hazards \$198

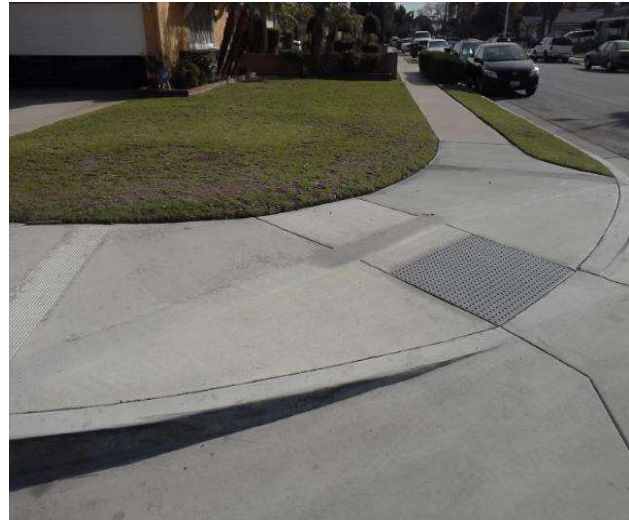
Curb Ramp , Landings and Transitions : Top Landing Clear Length - Landings

Recommendation At least 48.00 inches

Provide compliant landing \$240

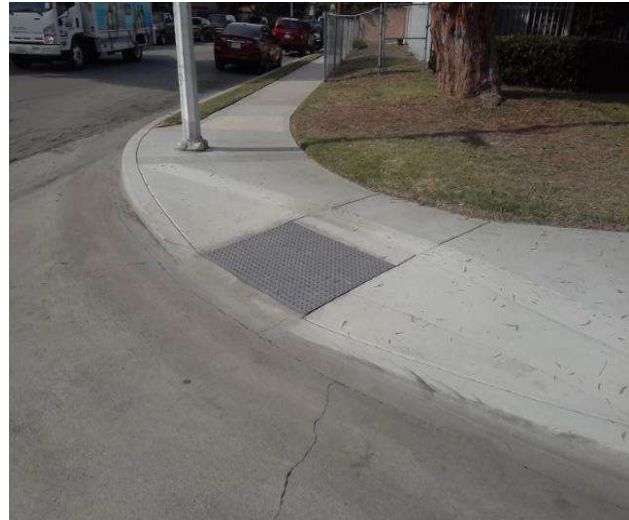
Curb Ramp , Landings and Transitions : Top Landing Clear Length - Landings

Recommendation At least 48.00 inches

Provide compliant landing \$240

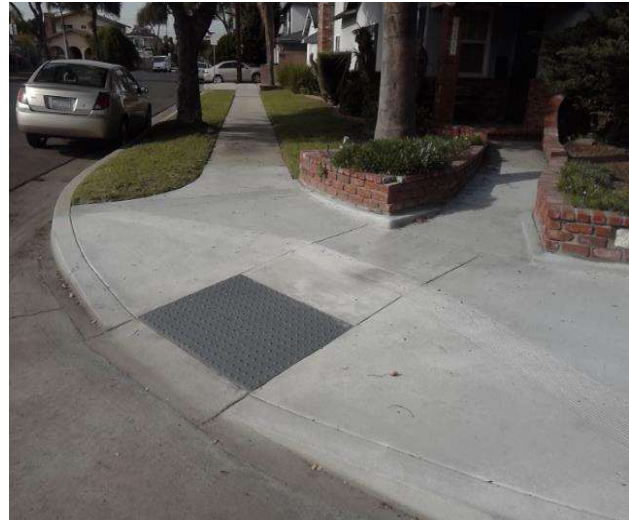
Curb Ramp , Landings and Transitions : Top Landing Clear Length - Landings

Recommendation At least 48.00 inches

Provide compliant landing \$240

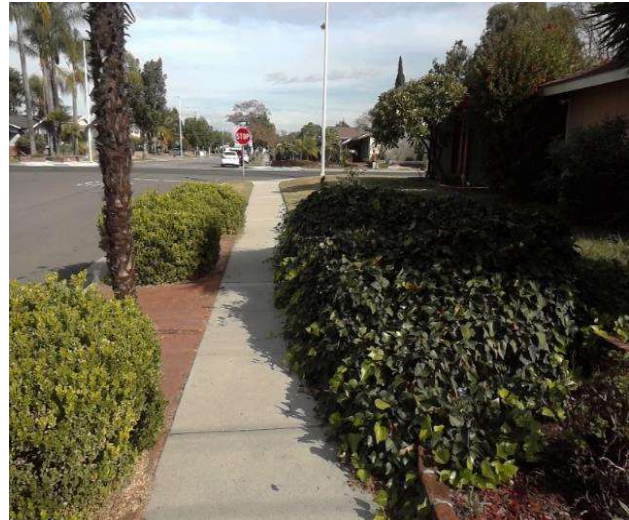
Sidewalks , Hazards & Gratings : Sidewalk Width at Obstruction

Sidewalk width at the obstruction shall have the recommended value.

Recommendation At least 48.00 inches

\$1,260

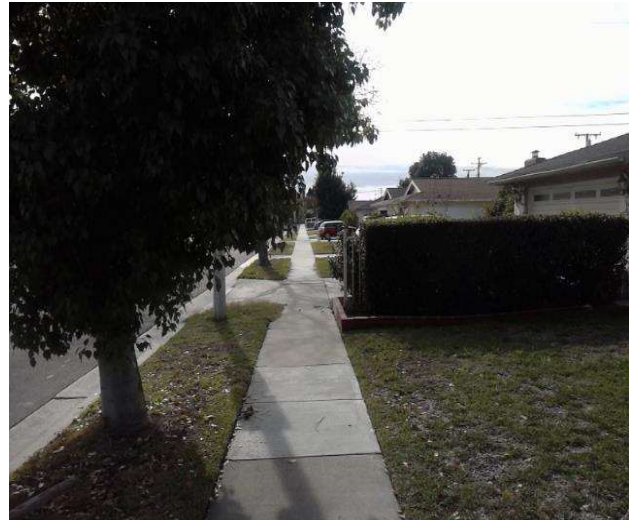
Sidewalks , Hazards & Gratings : Overhead Obstruction Height

Recommendation At least 80.00 inches

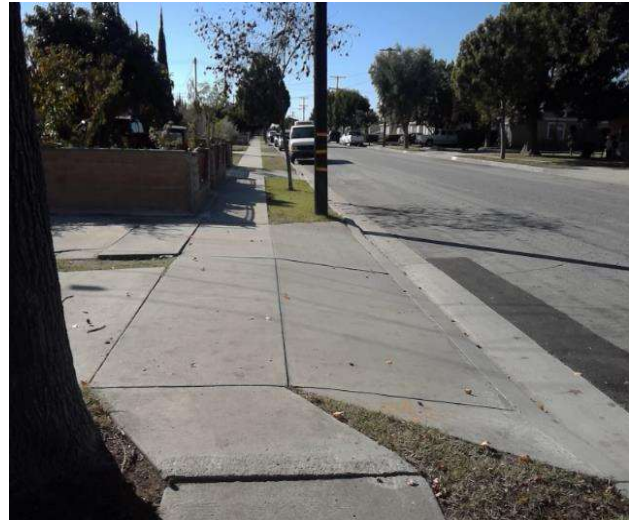
There is a change in elevation greater than recommended value.

Ensure that the change in elevation is within the recommended value.

Recommendation Up to 0.25 inches

Remove tripping hazards \$198

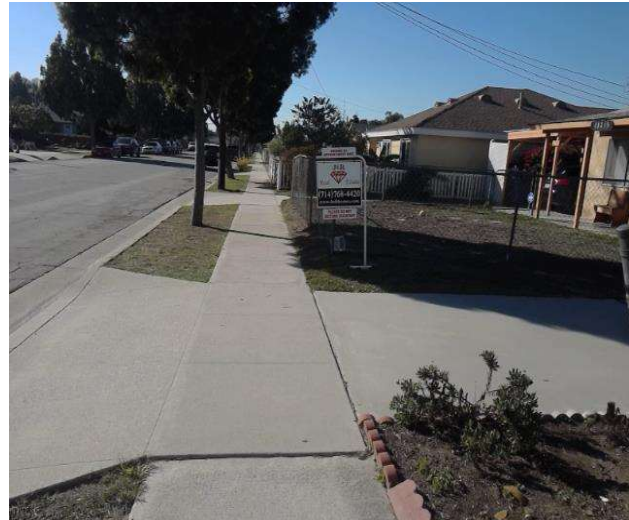
There is a change in elevation greater than recommended value.

Ensure that the change in elevation is within the recommended value.

Recommendation Up to 0.25 inches

Remove tripping hazards \$198

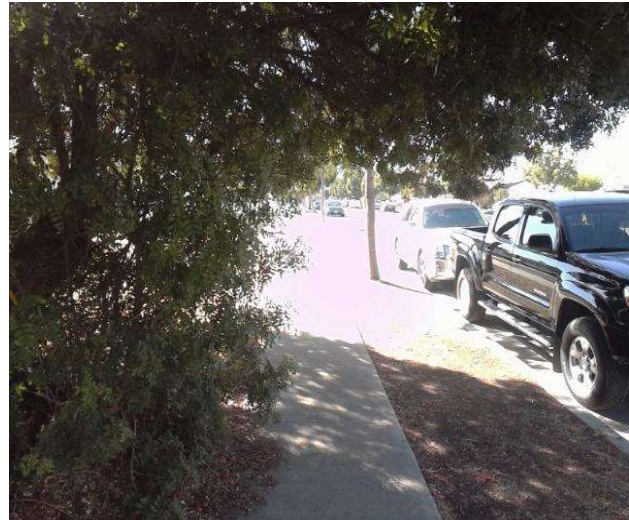
Sidewalks , Hazards & Gratings : Sidewalk Width at Obstruction

Sidewalk width at the obstruction shall have the recommended value.

Recommendation At least 48.00 inches

\$1,260

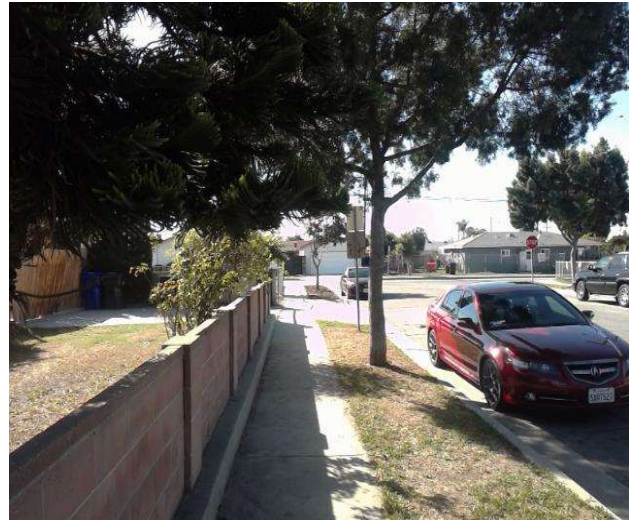
Sidewalks , Hazards & Gratings : Overhead Obstruction Height

Recommendation At least 80.00 inches

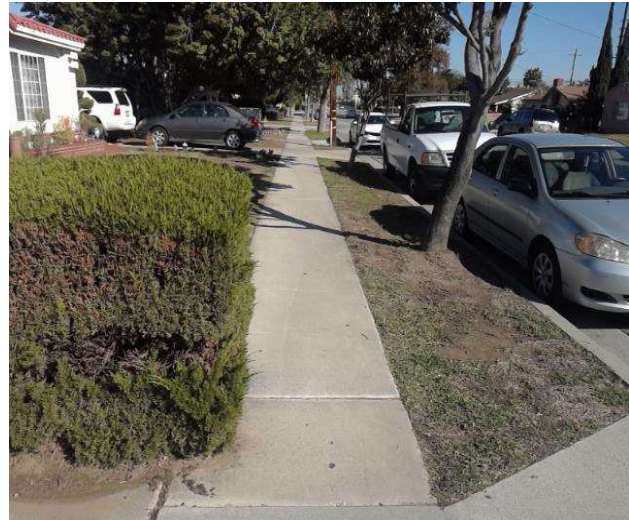
Sidewalks , Hazards & Gratings : Sidewalk Width at Obstruction

Sidewalk width at the obstruction shall have the recommended value.

Recommendation At least 48.00 inches

\$1,260
